SPECIALIZED POST-TENSIONING ASSESSMENT AND REPAIR OF BRIDGES

WJE ENGINEERS ARCHITECTS PROFESSIONAL SCIENTISTS
Wiss, Janney, Elstner Associates, Inc.

PAUL PARFITT, P.E., S.E.
SENIOR ASSOCIATE

2017 Spring Convention | March 15-17 | Montreal, Canada

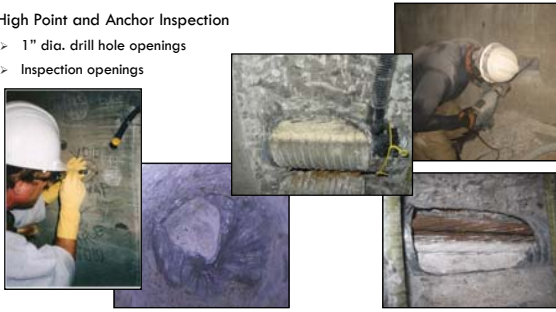
PT Assessment Methods

- High Point and Anchor Inspection
 - 1" dia. drill hole openings
 - Inspection openings

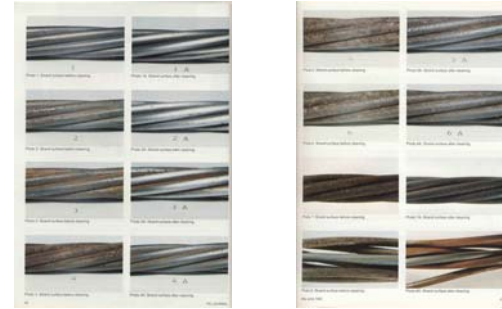
PCI Grading of Strands

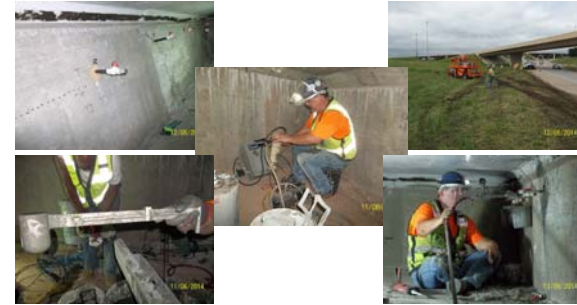
Common Remedial Actions Vacuum Assisted Grouting

- May do nothing if:
 - No grout voids, corrosion, or moisture infiltration noted
 - Grout voids observed but strands are protected by grout
- If corrosion, voids, etc. are noted, perform detailed analysis to determine how many strands or tendons are needed?
- If repairs are needed (client often decides this due to various considerations):
 - Remedial grouting if strands are exposed to air/moisture infiltration
 - Vacuum grouting, vacuum assisted grouting, pressure grouting
 - Tendon replacement or strengthening (typically external)
 - Rehabilitation of PT anchor protection systems (install permanent grout caps and treat pourbacks)
 - HDPE pipe repair (heat shrink sleeves)
- As an alternate, consider periodic assessments/monitoring
