November/December 2024  
Vol. 37, No. 6

CONCRETE REPAIR BULLETIN

## ICRI PROJECT, SAFETY, AND SUSTAINABILITY AWARDS

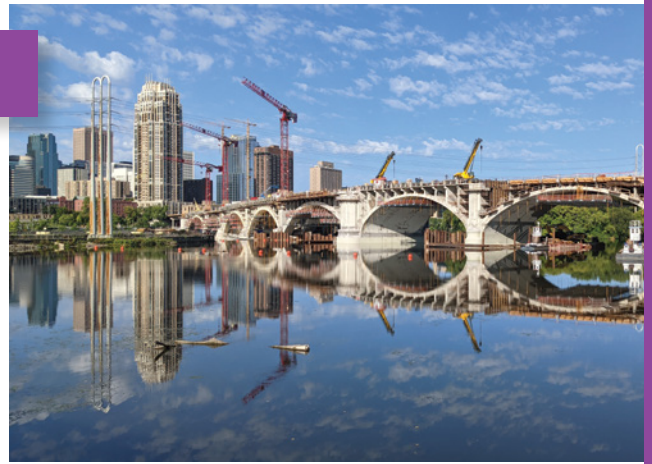
Image 1: (Cover picture) View of historic 3rd Avenue Bridge in downtown Minneapolis during rehabilitation

The 3rd Avenue Bridge, originally designed and constructed in the early 1900s, is a listed historic structure and classic example of the open spandrel concrete arch bridges that were common in that era (Image 1). Located in downtown Minneapolis, Minnesota, the 3rd Avenue Bridge is unique because of its scale, its use of Melan reinforcing system, and its S-curve geometry to avoid breaks in the limestone riverbed. The bridge, opened in 1918, is one of 24 bridges of prominent historic significance that has been selected for long-term preservation, and it is included in the Statewide Historic Bridge Management Plan.

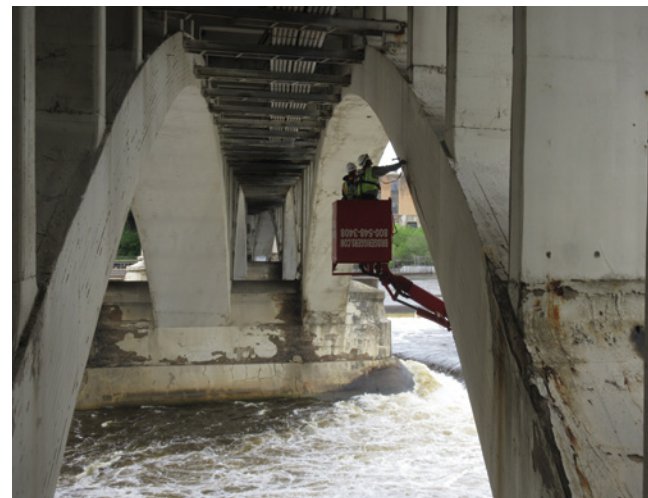
Image 2: Hands-on inspection from under-bridge inspection unit (snooper), illustrating deterioration of arch ribs and pier bases

The condition assessment for the 3rd Avenue Bridge was performed in two phases. Phase 1 consisted of a close-up, element-level bridge inspection and representative sounding of 100% of the exposed surfaces (Image 2, Image 3). Distress conditions and condition states were digitally mapped on scaled drawings using tablets.

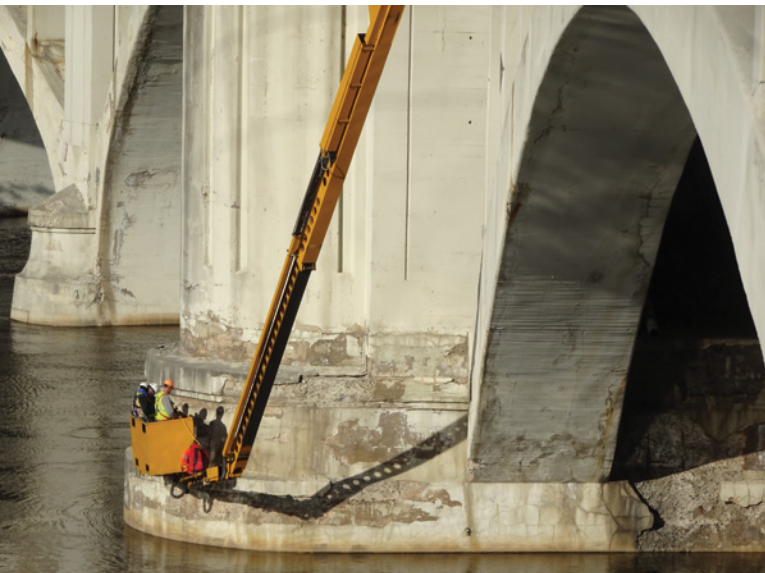
Image 3: Close-up inspection, illustrating deterioration in pier bases and arch ribs

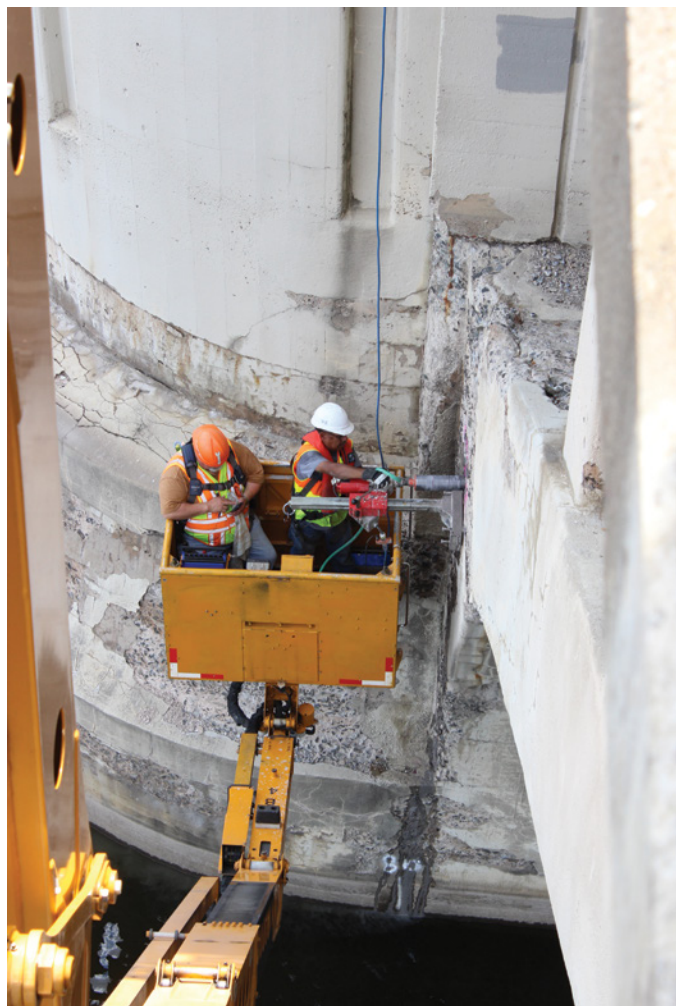
Image 4: Core sampling through deep freeze-thaw damage in arch rib near springline

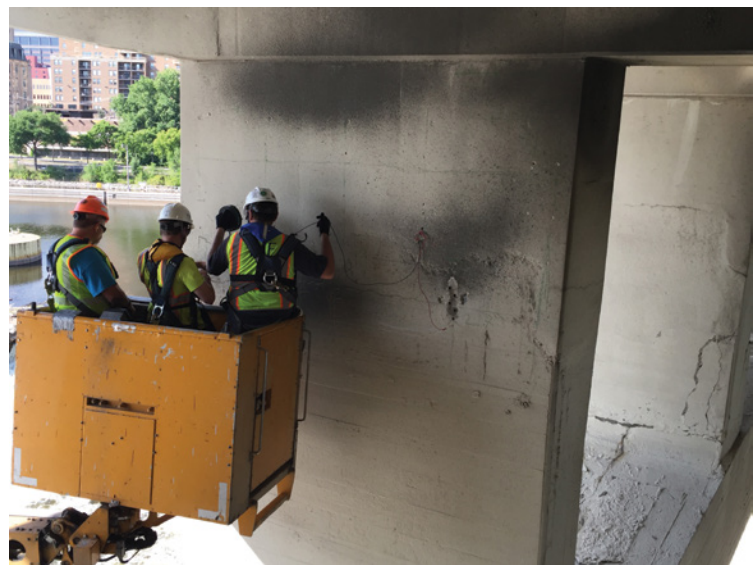
Image 5: Non-destructive testing at spandrel column during bridge inspection and assessment phase

Field testing methods at over 100 study areas utilized on the 3rd Avenue Bridge included half-cell potential surveys, corrosion rate measurements, resistivity testing, carbonation testing, and ultrasonic thickness testing of steel truss members (Image 4, Image 5). Lab testing of material samples taken from the bridge, comprising over 80 concrete cores and 10 steel samples, included testing for mechanical properties of concrete and steel materials, chloride content profiling, and petrographic analyses of numerous cores to identify vulnerabilities specific to the concrete in this structure. Service life projections were developed for each element type, which were used to inform the development of rehabilitation alternatives and life cycle cost comparisons.

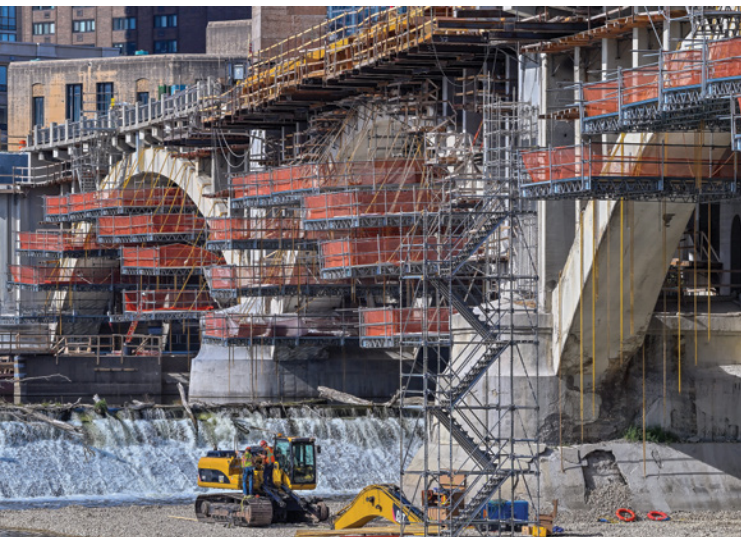
Image 6: View of multiple means of access, including suspended scaffolding and dewatered cofferdam. (Photo credit: Joe Szurszewski Photography)

constructed within the bridge piers to accomplish the deck and column replacements, with assistance from smaller mobile cranes. Access to the substructure required complicated suspended scaffolding and dewatered cofferdams in the fast-moving river (Image 6).

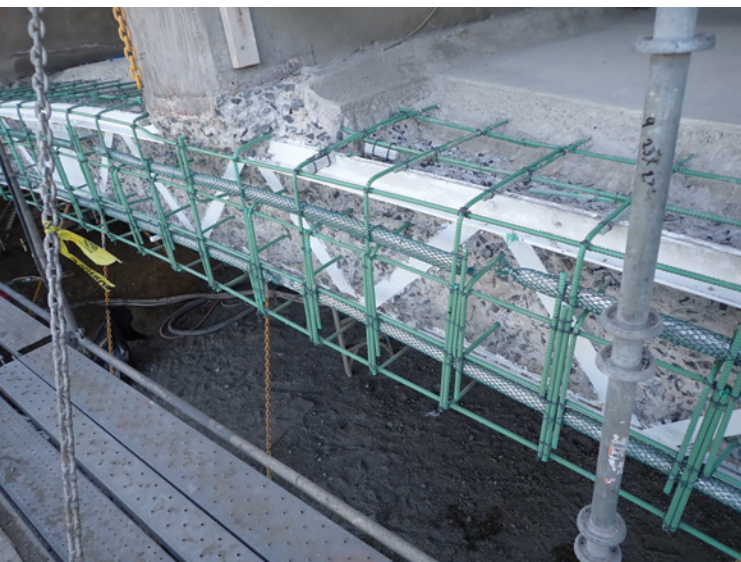
Image 7: Arch corner repair extending across full height of barrel arch, showing continuous and discrete CP anodes, supplemental rebar/anchorages, and coated Melan steel

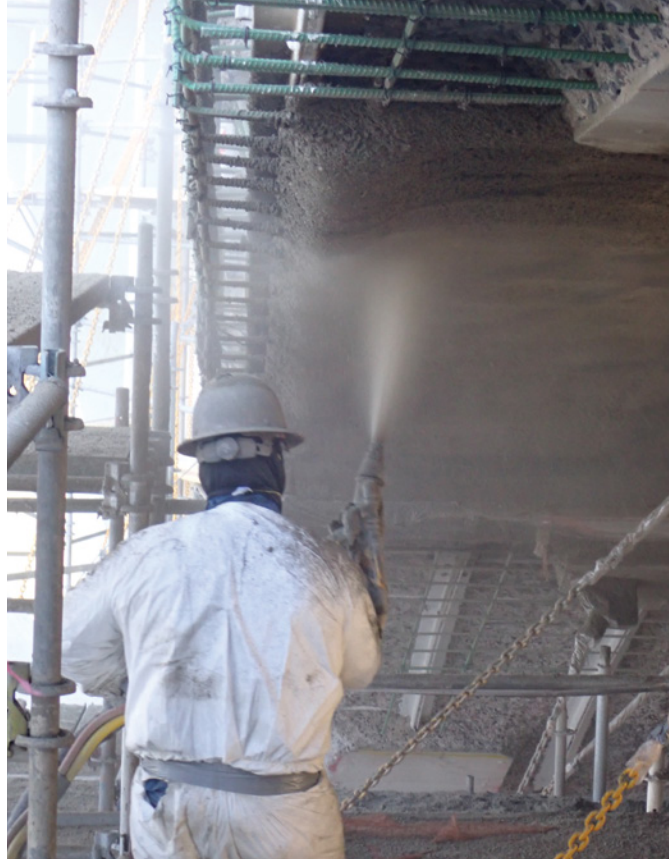
Image 8: Application of wet-mix shotcrete to arch underside

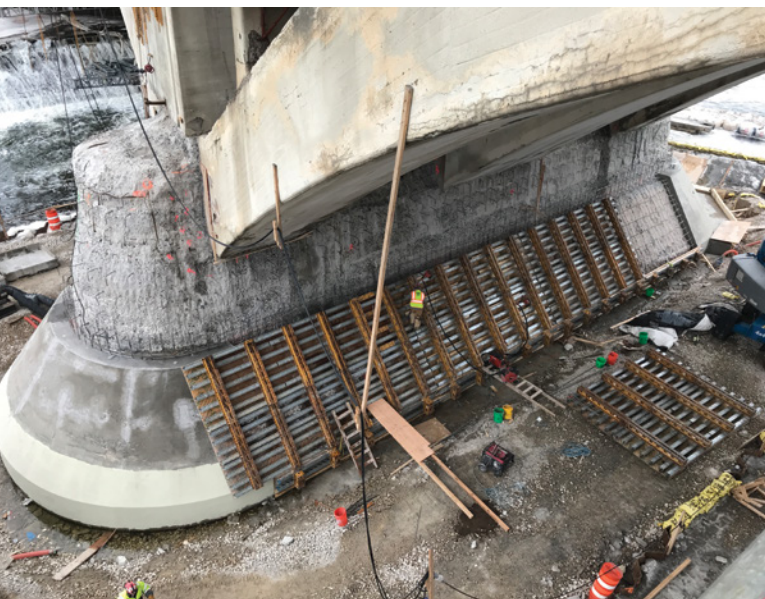
Image 9: Pier base jacket repair in progress, showing cofferdam, concrete removals, and supplemental rebar/anchorages at top, and formwork and new concrete jacket at bottom of pier

Even deeper freeze-thaw damage was present at the pier bases, near the waterline and below drain discharges. Maximum concrete erosion was up to 17 inches and freeze-thaw damage up to another 8 inches was present beyond that. Rather than removing all the freeze-thaw damaged concrete, the repair details required removal of a uniform 12 inches of concrete to reach what was defined as an "intact concrete substrate" (aggregates firmly embedded in solid paste but some freeze-thaw related cracking allowed). Deeper removals were performed in localized "pockets" to reach an intact surface. Longer epoxy-anchorages were installed deeper into the sound material beyond the removal depth, and a new grid of stainless-steel reinforcement was installed near the surface (Image 9).

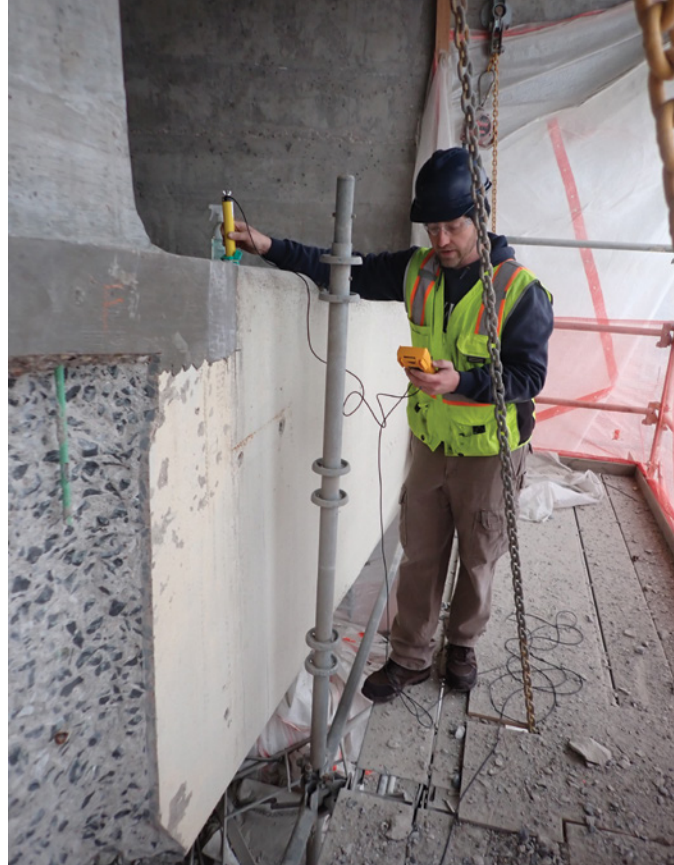
Image 10: Half-cell potential testing during construction

To mitigate future deterioration along the arch corners where there was no current distress, a targeted cathodic protection approach was implemented. Discrete, two-stage anodes were field located based on half-cell potential testing performed during the construction phase (Image 10, Image 11).

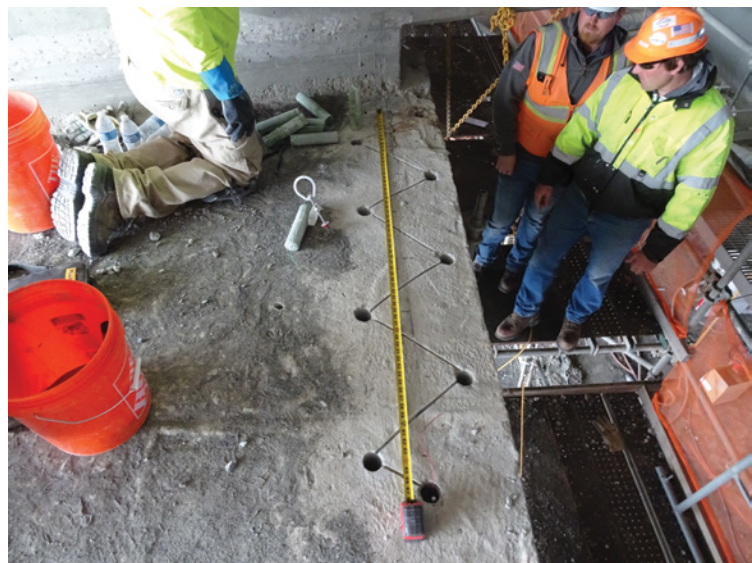
Image 11: Discrete, two-stage anodes installed in cored holes along sound arch corners between corner repairs

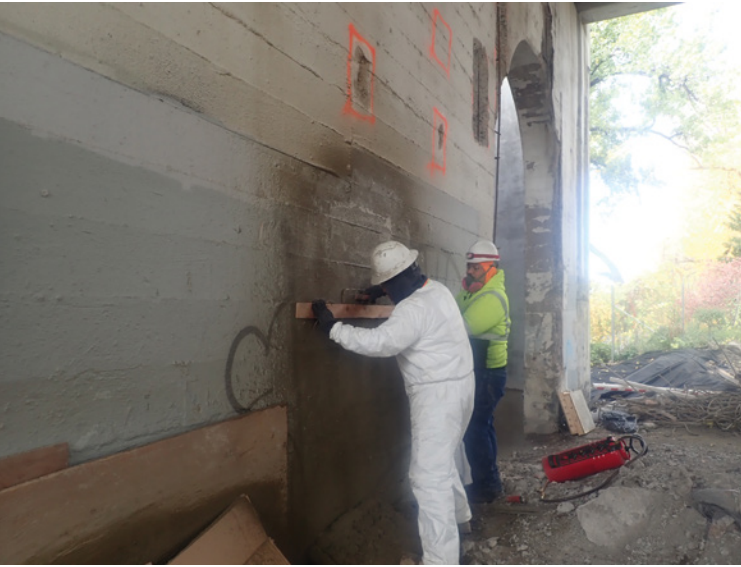
Image 12: Hand-finishing board form lines in shotcrete repairs on pier face to match existing surface texture

Preserving aesthetics meant that original profiles needed to be replicated accurately. The intricate profile of the monumental piers was reproduced in the pier jackets using field-built formwork and self-consolidating concrete. Shotcrete repairs in areas most visible to the public were hand-finished to match the board-form lines in the adjacent original concrete (Image 12). Pier walls that were replaced utilized form liners to replicate the board form finish. The surface coating applied over the entire bridge was color-matched to the original colors during the period of historical significance. For each type of concrete repair, mockups were required so that both quality and aesthetics could be confirmed.

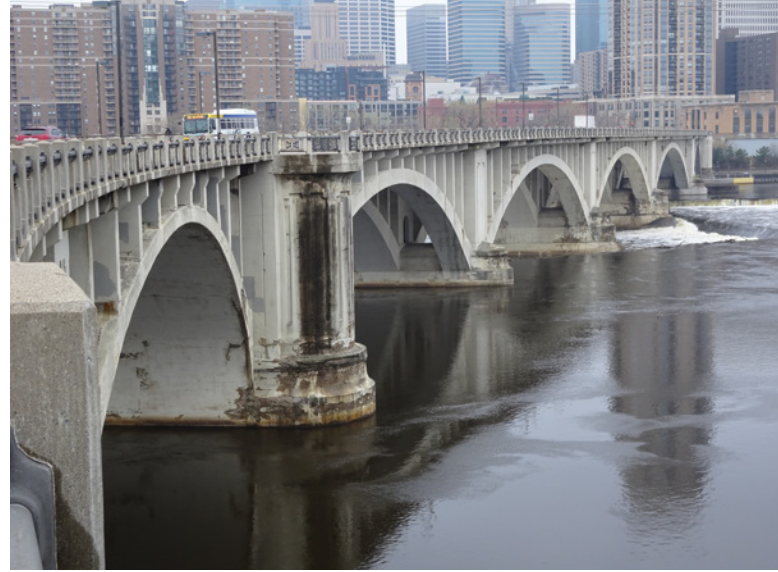
Image 13: "Before" photograph along upstream side of bridge, showing concrete deterioration in pier bases and arches

Rehabilitation was completed and the bridge was opened to traffic in October 2023 (Image 13, Image 14, Image 15). Total construction cost was approximately \$150 million, over 100,000 SF of concrete surface repairs were installed by shotcreting, and over 10,000 cathodic protection anodes were placed. The beauty and longevity of the rehabilitated bridge achieved by the collective skills of a team of experts in concrete repair design, materials, and construction make this one of the most impressive historic bridges in the country that will be admired for generations to come.

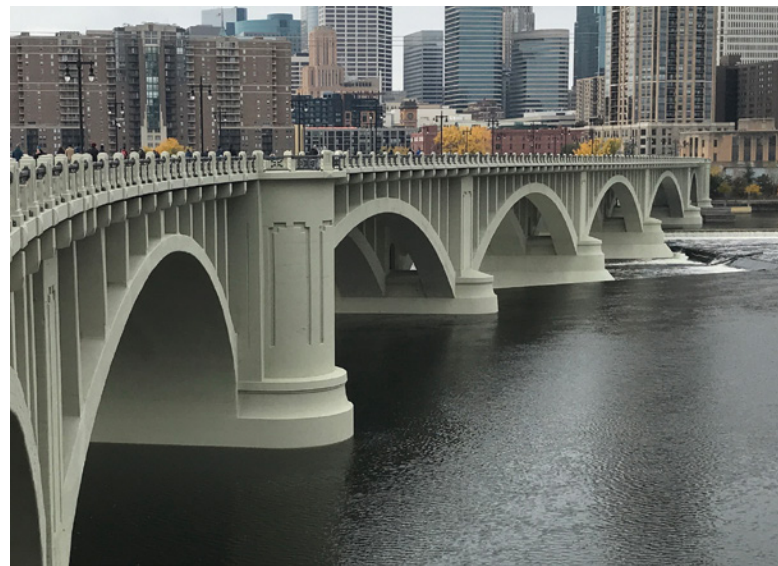
Image 14: "After" photograph along upstream of bridge, showing repaired arches and pier bases with new coating, along with replaced columns, cap beams, and railings above

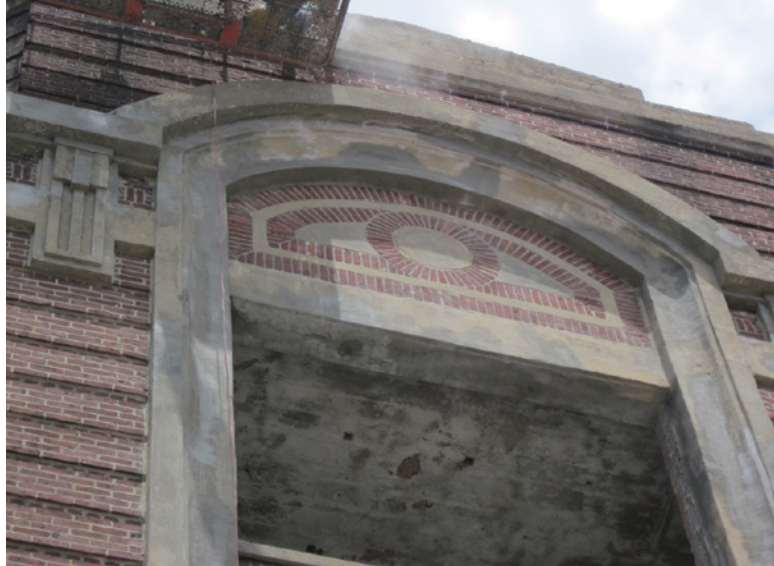
Image 8: Hand-applied mortar in 2014

- Any surviving smooth rebar in the repairs were thoroughly cleaned and coated with a corrosion-resistant primer that also increased adhesion with the repair material. However, there was a great deal of reinforcement throughout the structure that was terminally corroded and had to be replaced with new rebar or complemented with additional strengthening. New reinforcement was required for all the spandrel beam repairs.
- The hand-applied method was chosen for both the smaller more isolated repairs on columns and ceilings, and for the more complicated architectural features such as with the exterior arches (Image 8, Image 9).
- Machine-applied repair mortar was used to repair some large ceiling sections. This method was selected to improve production while providing a very dense material (Image 8, Image 9).

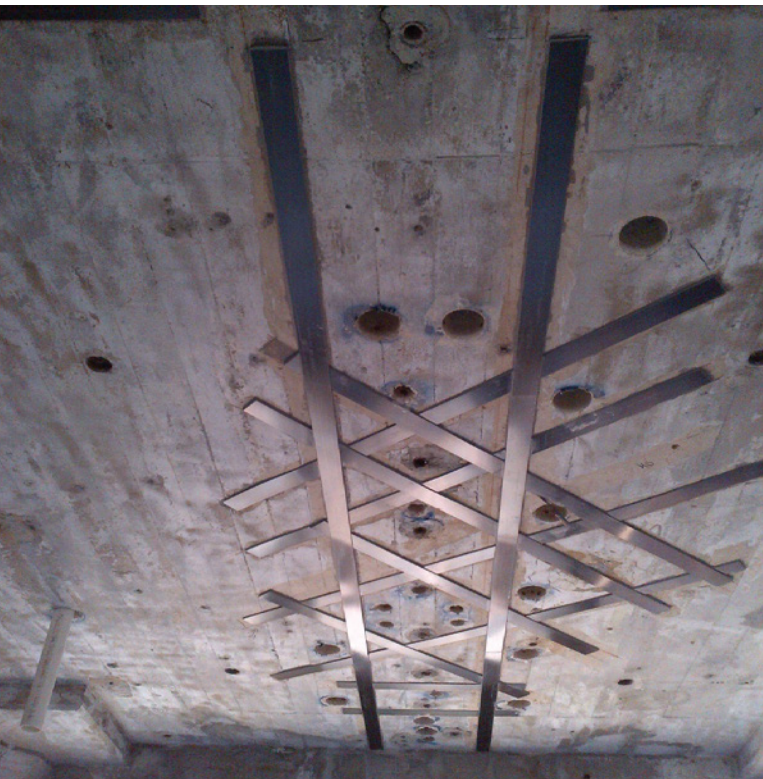
Image 10: Carbon fiber plates

Roof slabs of the building had extreme section loss requiring new reinforcing. Supplemental reinforcement was also used to bring slabs back to their safe load bearing capacity. Carbon fiber plates were installed for strengthening these areas along with strengthening locations of new cut outs for conduits, pipes, ducts, and vents and for the new HVAC system (Image 10).

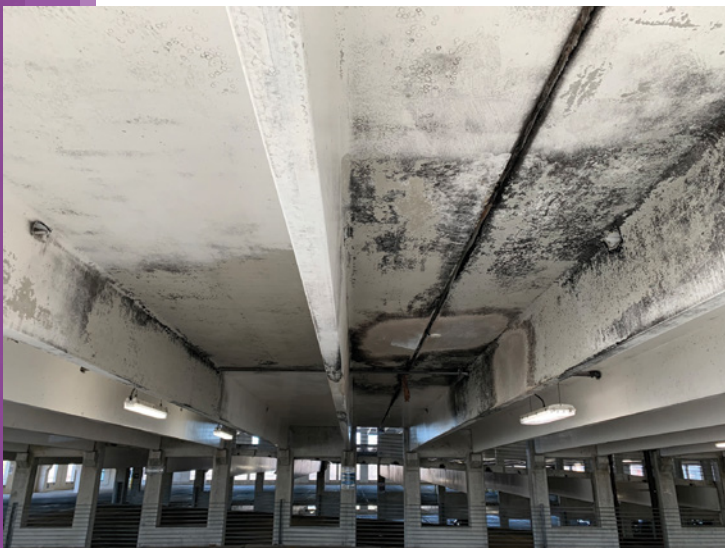
Image 2: Fire damage to the underside of the level four precast double tees

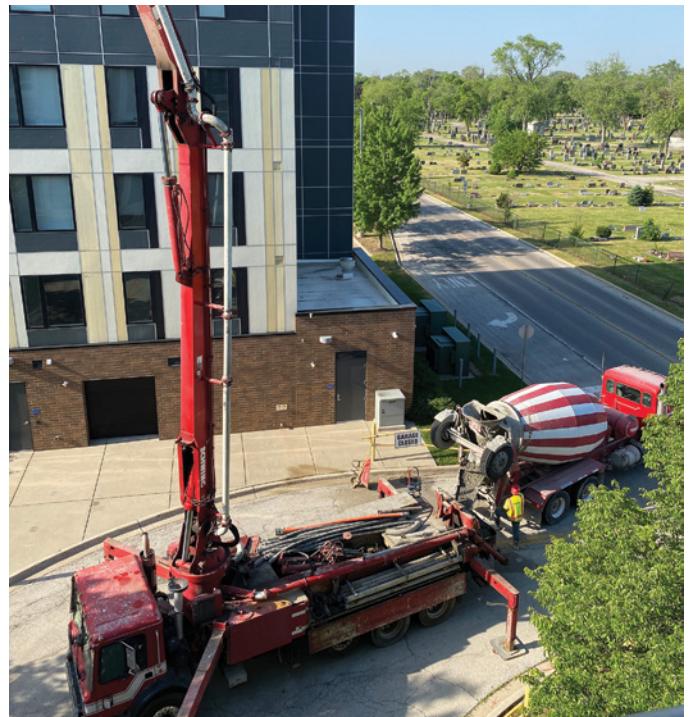
Image 5: Pump truck positioned to pump through opening

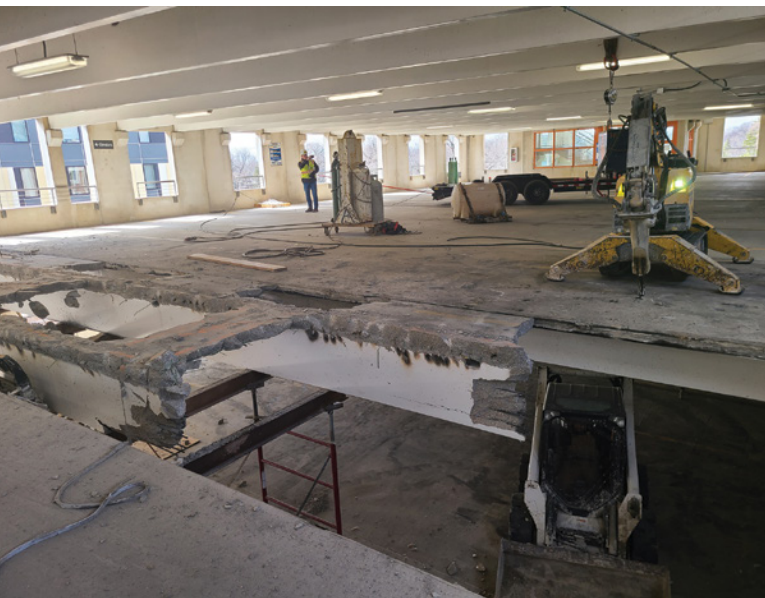
Image 6: Remote controlled demolition

Before demolition could begin, all welded connections around the fire-damaged double tees had to be severed. The contractor chose to implement a remote-controlled demolition machine equipped with a hydraulic breaker to chip away the concrete into more manageable pieces for removal from the parking structure (Image 6). To protect the double tees below from damage, loose concrete was collected on the level beneath using tires and plywood to dissipate the impact load, ensuring the deck remained undamaged. A skid-steer loader was then used to gather the loose concrete debris and safely transport it out of the parking structure.

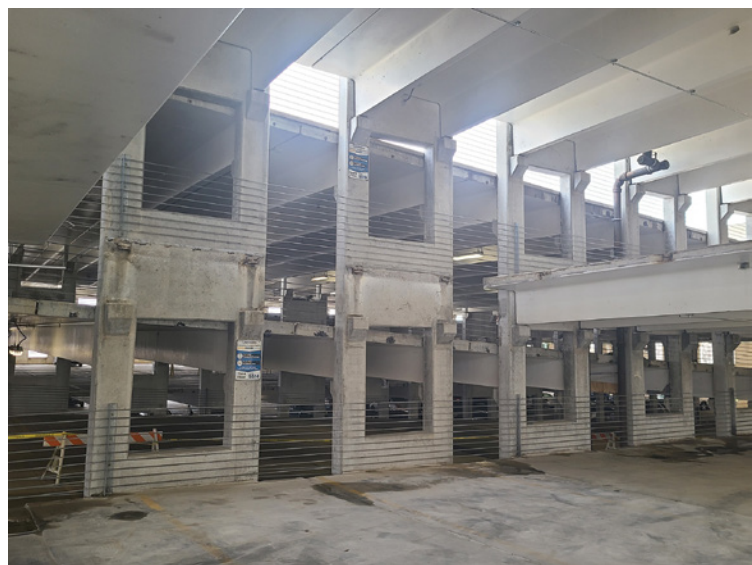
Image 8: Double tees removed

After demolishing the damaged double tees, all exposed flange connectors between the existing double tees became visible (Image 8).

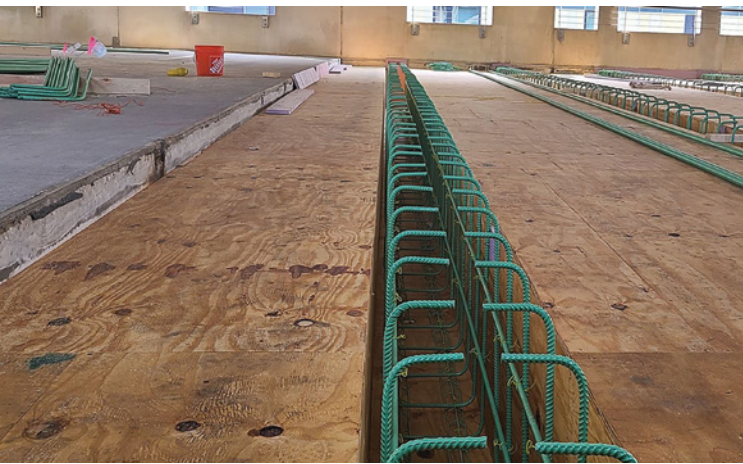
Image 9: Partial rebar detail with formed repair

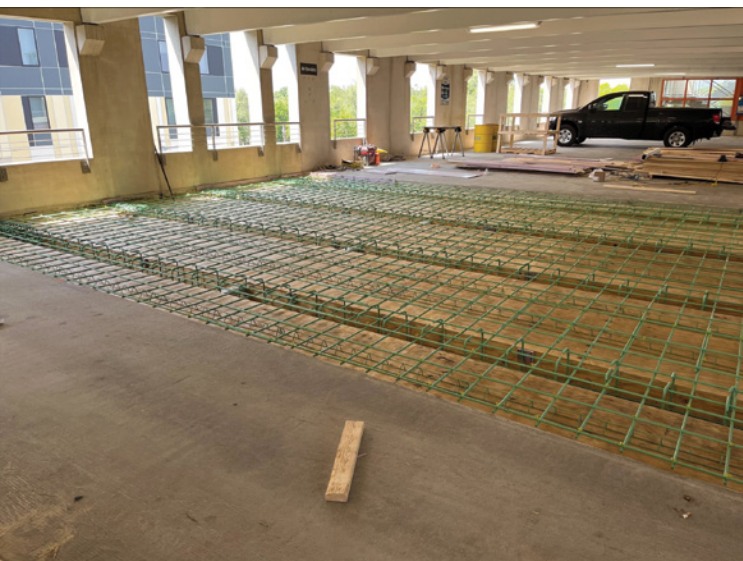
Image 10: Reinforcement for monolithic pour

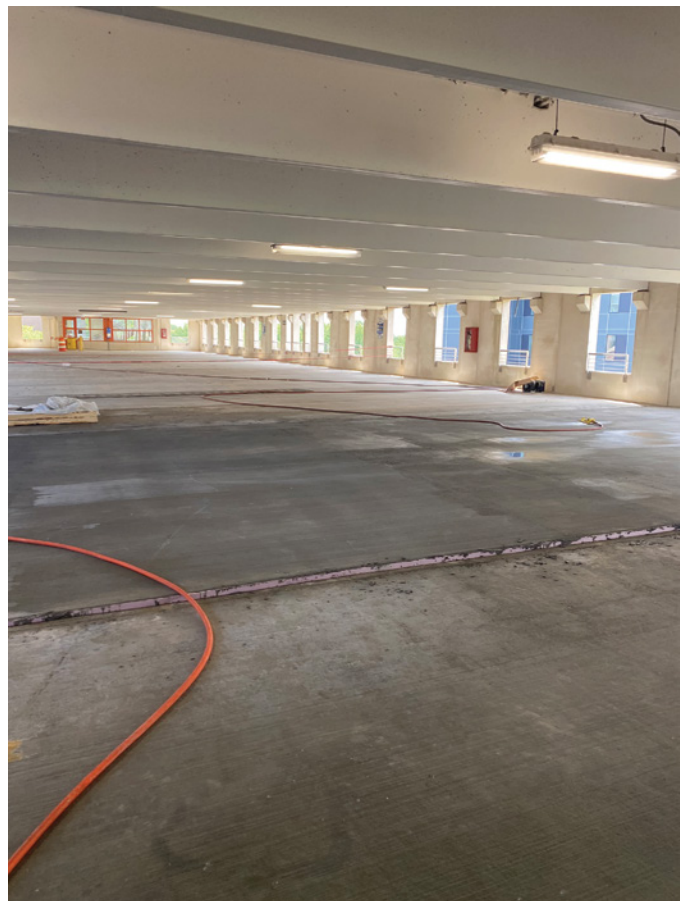
Image 11: Precambered form edge after concrete placement

The precambered cast-in-place system performed exceptionally well. Leading up to the scheduled concrete pour date, there were multiple meetings between contractors and designers. Initially, the concrete contractor expressed doubts about the precamber value, expecting it to be less than the calculations showed. However, precise calculation of the precamber from the designer was used, which was crucial to ensure that the new cast-in-place slabs deflected into position as the contractor lowered the shores and started to align with the adjoining precast. The design utilized a T-section analysis to calculate the deflection at the different stages. The dropped beams and slabs were cast monolithically, with reinforcement detailed to tie them together and form the composite section (Image 9, Image 10). After removing the shores, immediate inspection revealed no visible cracks in the new cast-in-place concrete beams and slabs components (Image 11, Image 12). Site visits were periodically performed to visibly inspect the new cast-in-place concrete.

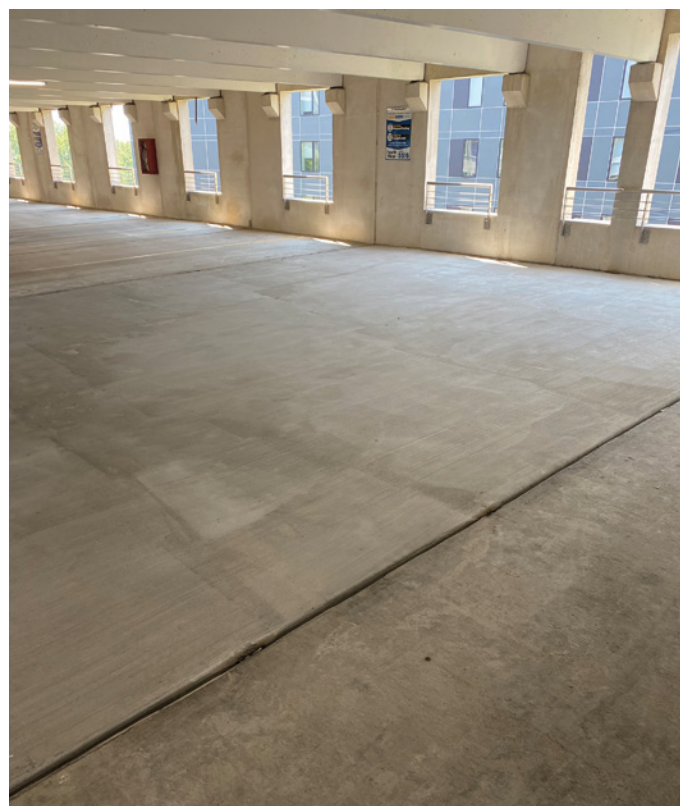
Image 12: Concrete system after shores were lowered

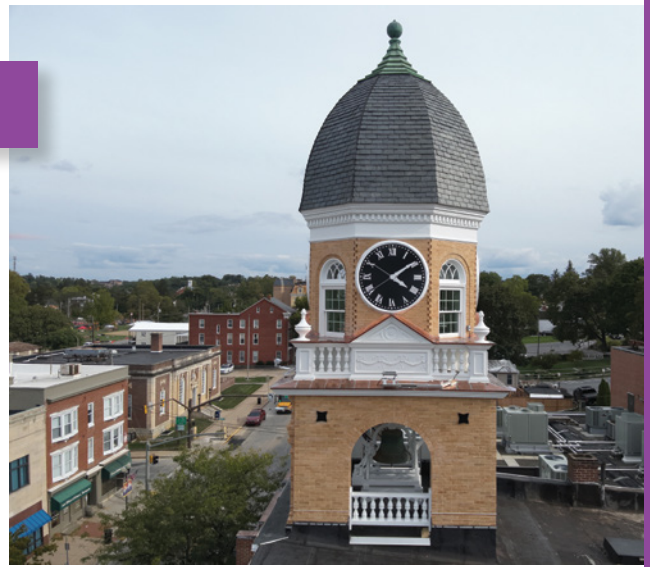
Image 2: Deficiencies in the tower base

The clock tower sits in plain view and signs of distress were recognized by the city with the primary concern in the clock tower base (Image 2).

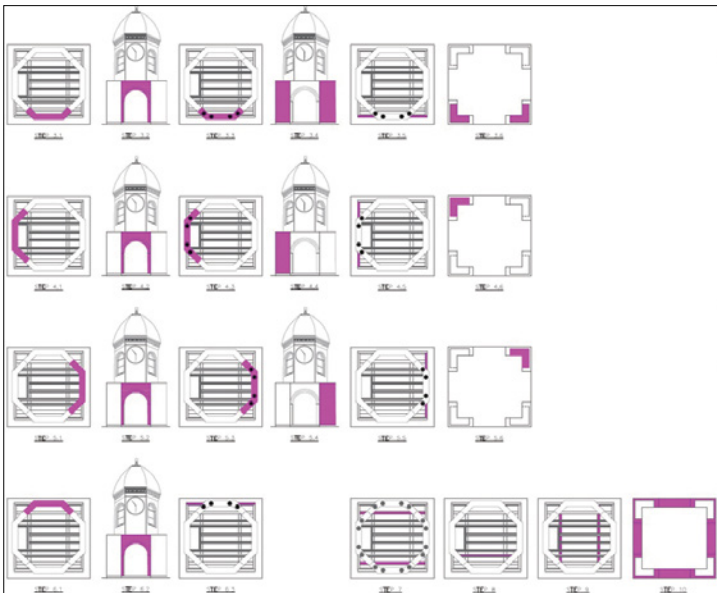
Image 3: Graphic illustration of the sequencing

The sequence of deconstructing/reconstructing the entire masonry tower base, while temporarily supporting the tower attic and roof above, was a herculean effort. Image 3 graphically illustrates the sequencing of shoring, demolition, masonry installation, structural steel installation, and wood framing installation in a phased manner (Image 4, 5).

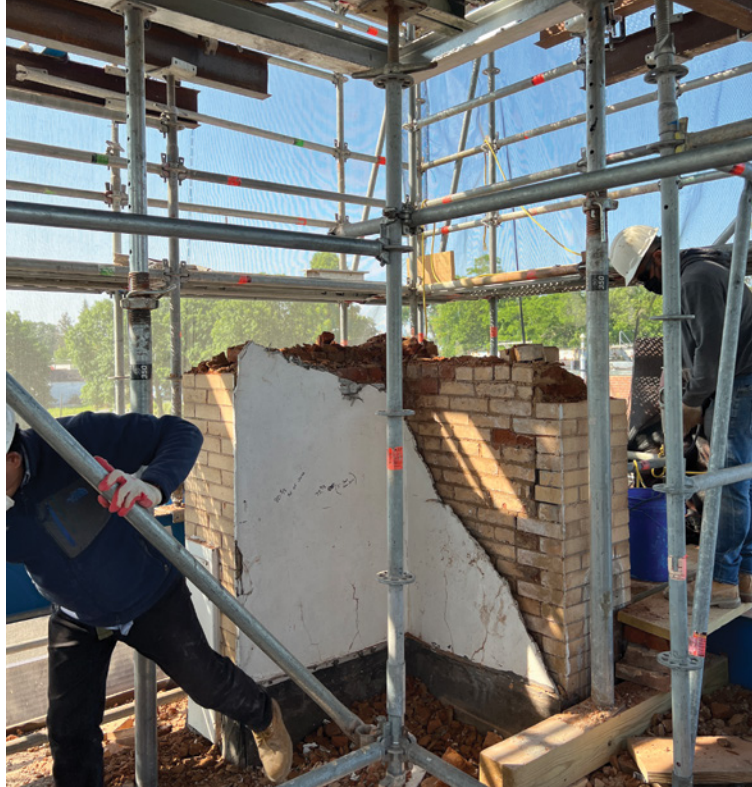
Image 4: Demolition of the tower base with shoring

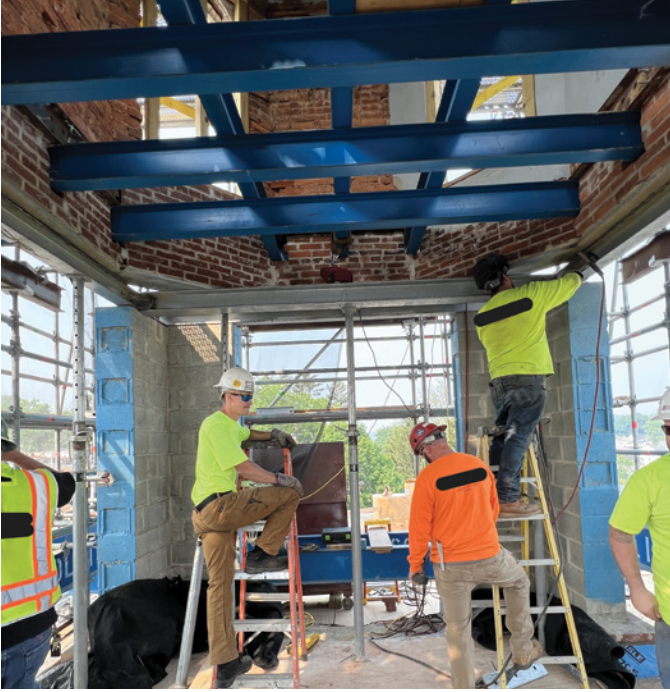
Image 5: Tower base reconstruction with structural steel installed

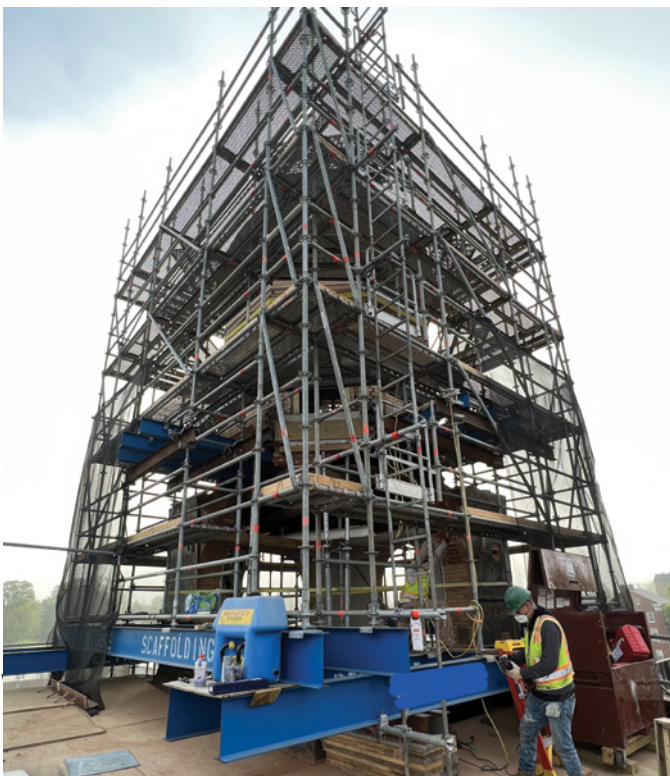
Image 6: Suspension of the upper two-thirds during reconstruction of the base

During rehabilitation, the upper two-thirds of the tower (approximately 75,000 lbs.) was suspended in the air while reconstructing the base section. Often overlooked, the temporary shoring/bracing system utilized state-of-the-art methods (Image 6). Needle beams supported steel angles which “sandwiched” the tower attic walls while the Contractor simultaneously deconstructed/reconstructed the tower base in quadrants.

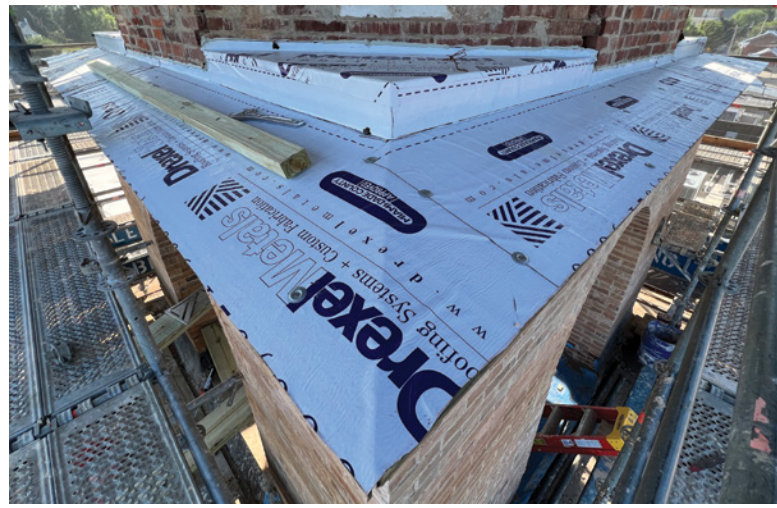
Image 7: Waterproofing and flashing materials installed

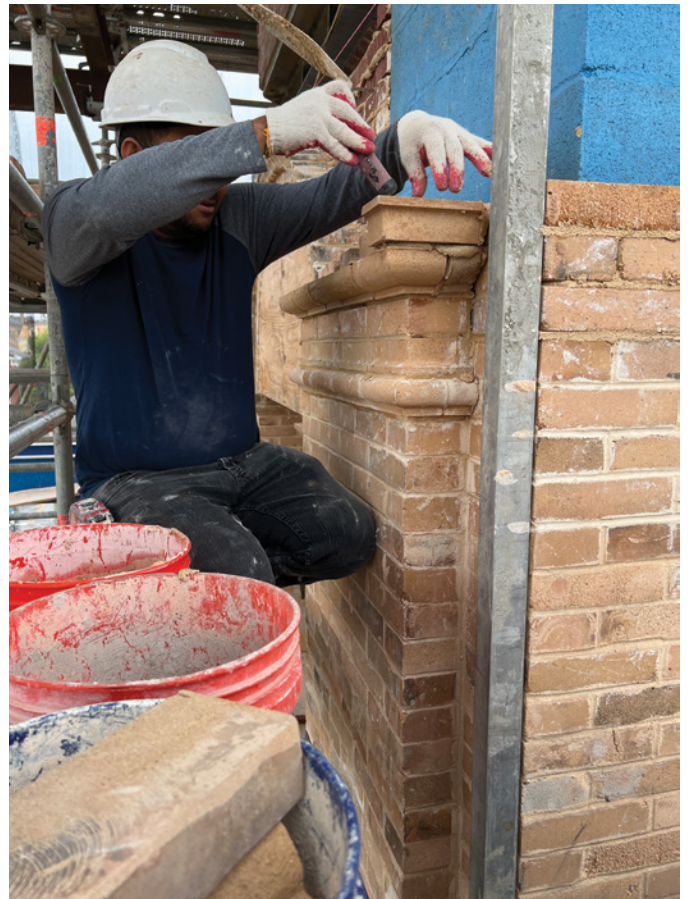
Image 8: Salvaged brick veneer installation

One key example of this is the reconstruction of the tower base veneer (Image 8). Although the tower base was converted from a multi-wythe brick masonry wall to a grout-filled, reinforced CMU wall, a salvaged brick veneer was used so there was no noticeable change to the clock tower aesthetics.

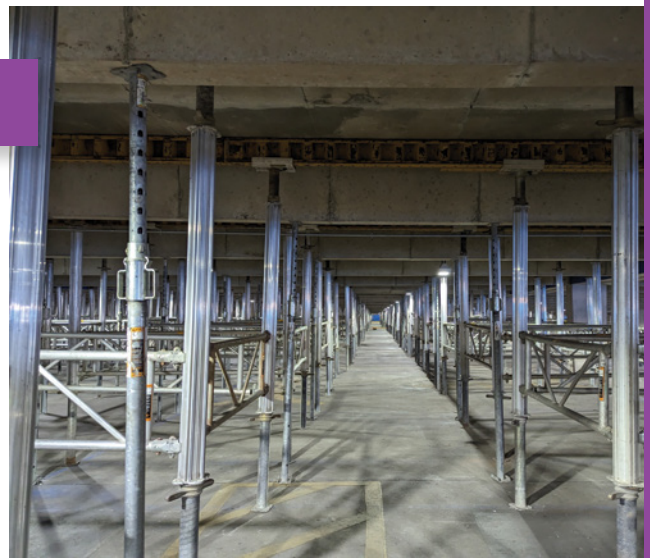
Typical shoring layout for slab strengthening slot installation

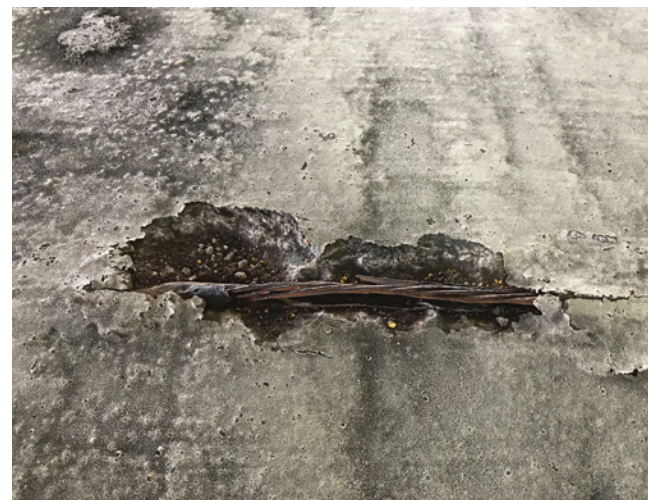
Failed PT tendon with multiple broken wires protruding from the top of the slab

While the original structure's thin slabs were constructed with limited conventional mild-reinforcement that corrode more slowly than the high-strength PT tendons, we found that significant loss of the PT tendons would result in loss of a viable load path for the slab system. Therefore, significant slab strengthening in the original structures would be required to achieve safe operation of both structures for the desired remaining service lives in addition to significant routine maintenance repairs for the expansion structures.

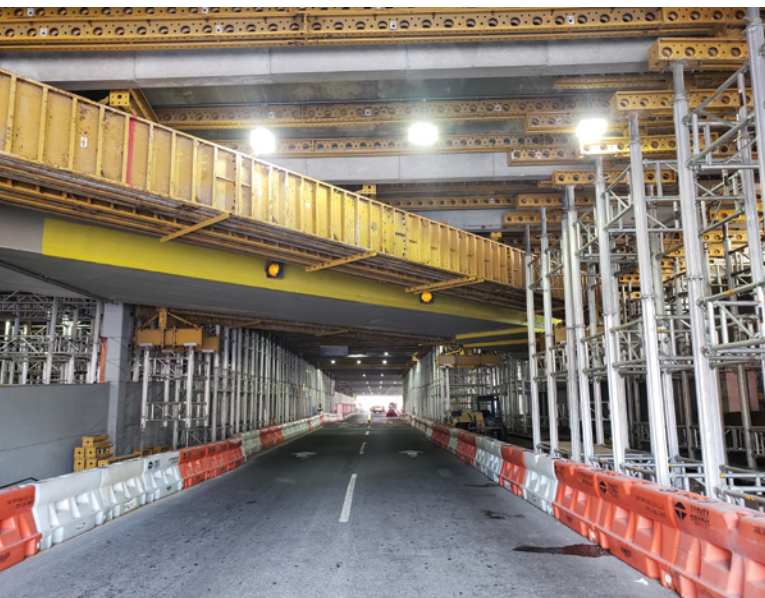
Shoring layout on Terminal Parkway to maintain partial use of the roadway during construction

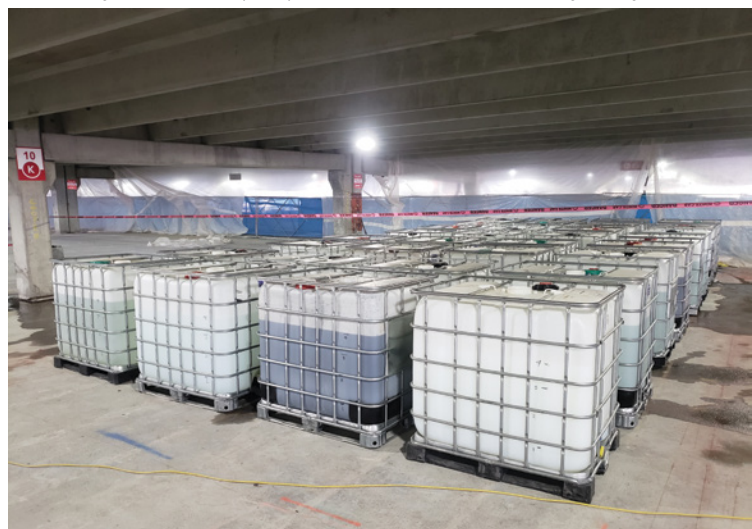
Load testing the slab to verify the performance of the new slab strengthening slots

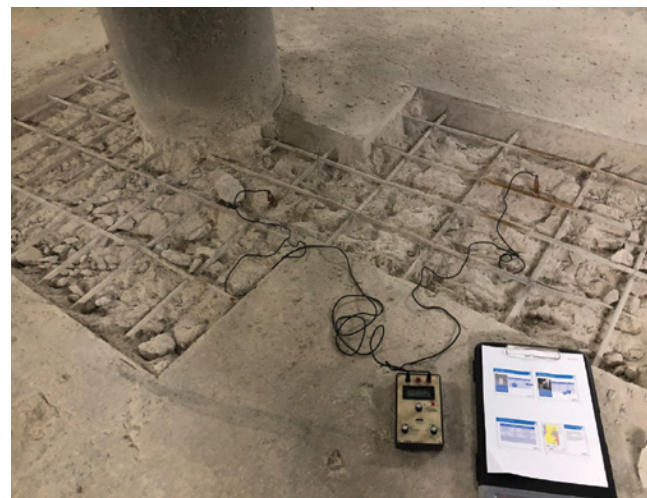
- Concrete laboratory analysis (Figure 1) indicates the chloride contamination levels in the floor slabs are 2 to 15 times higher than thresholds needed to initiate corrosion of embedded reinforcing steel.
- In spite of the very high levels of chlorides in the concrete, the extent of concrete deterioration was modest.

Figure 1: Chloride Laboratory Analysis

During the evaluation of the structure's condition and the effectiveness of the CP system, there were three major key findings related to the CP system (Fig. 1):

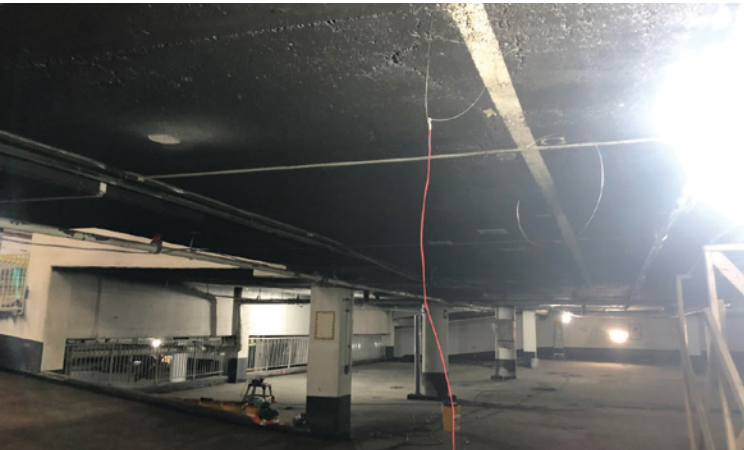
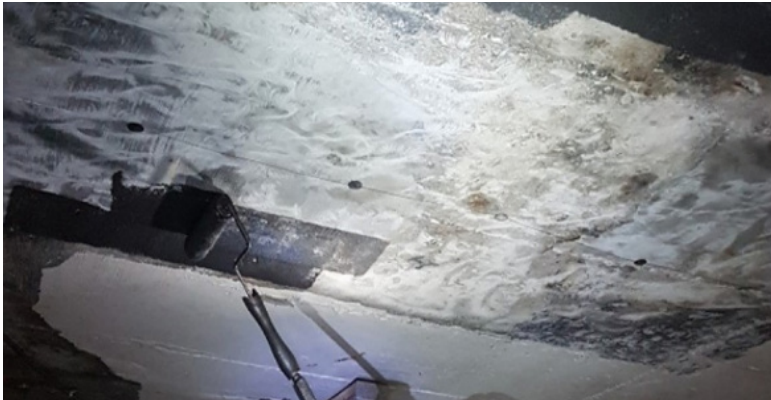
Installing bare platinized niobium wires embedded within the conductive coating

Applying the highly conductive coating (carbon rich coating that looks like black paint) to the soffit fully

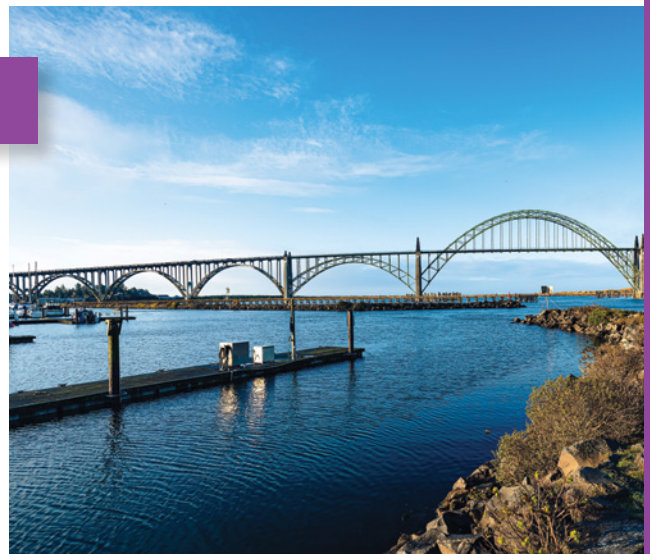
The Yaquina Bay Bridge, a testament to architectural brilliance, is not just a functional structure but a piece of history. Standing tall at 130 feet and stretching over 3,200 feet, this bridge blends concrete and steel, featuring concrete curved t-beam spans, concrete deck arch spans, steel deck arch spans, and a main steel through-arch span. The bridge's steel members are strategically placed over the 130-foot navigational channel to facilitate maritime traffic. The construction of this historic bridge involved a massive 30,000 cubic yards of concrete and 3,100 tons of steel.

Yaquina Bay Bridge

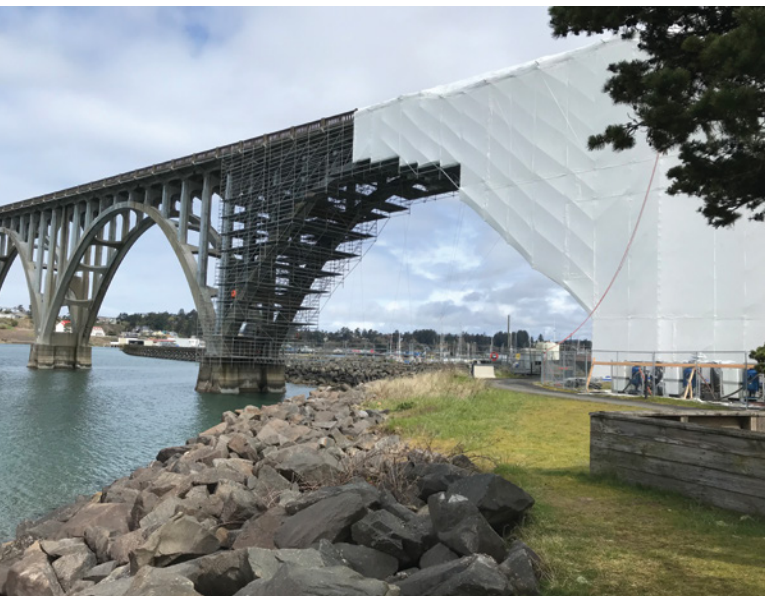
Scaffold with containment

Six hundred tons of abrasive media was used to remove the previously installed zinc in addition to cleaning and profiling the concrete surface to accept the new zinc anode. After the abrasive blasting stage, delaminated or spalled concrete was identified for removal and replacement.

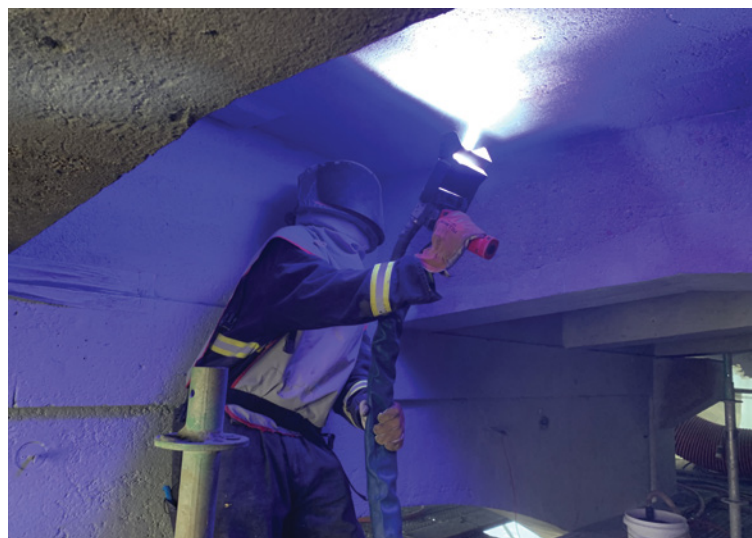
Installing thermally sprayed ICCP system

Brass terminal plates were installed on the concrete surface and eventually connected to the zinc (anode), while structure connections were made to the reinforcing steel (cathode). The anode and reinforcing steel were checked and confirmed to be non-continuous.

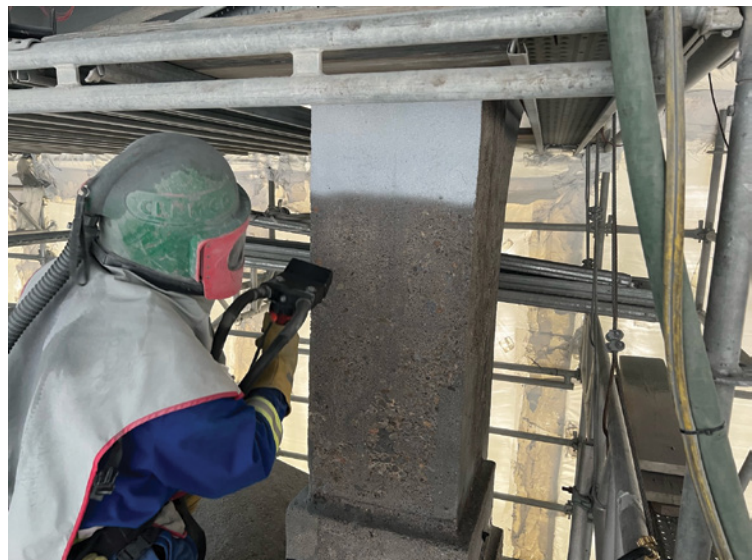
Metalizing on a properly prepared concrete surface

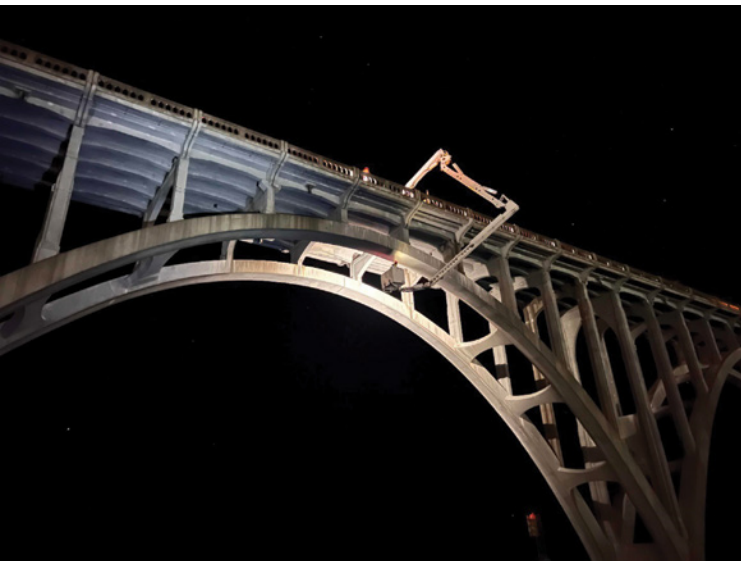
Metalizing from Snooper Truck
