November/December 2024  
Vol. 37, No. 6

CONCRETE REPAIR BULLETIN

## ICRI PROJECT, SAFETY, AND SUSTAINABILITY AWARDS

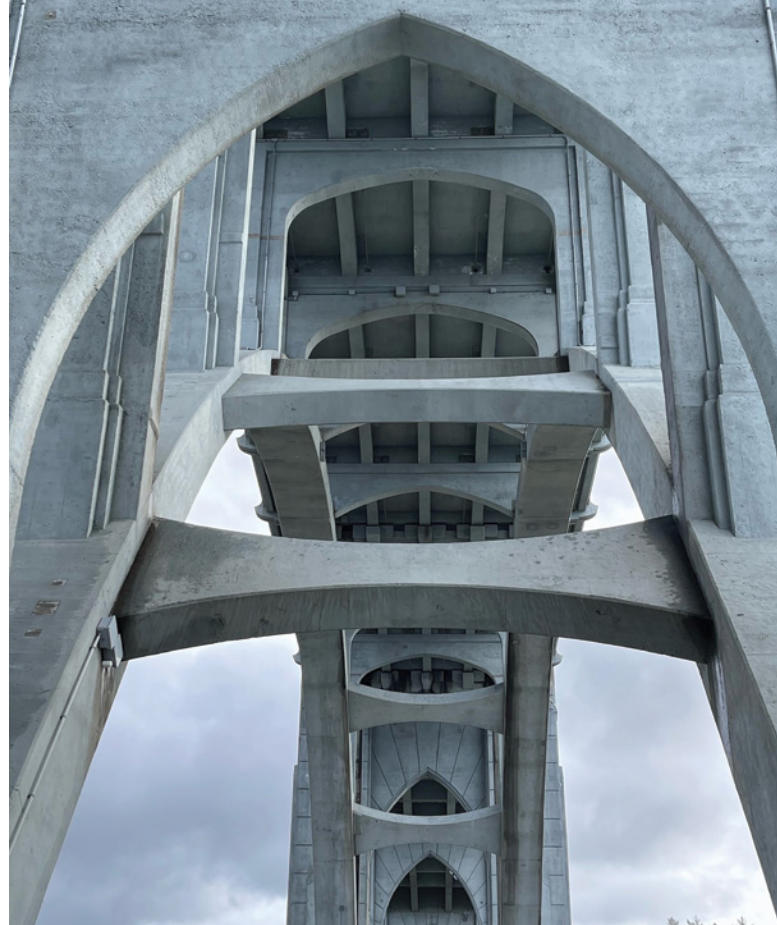
Completed cathodic protection installation

Opting for cathodic protection over costly removal and replacement saved significant time and resources and ensured the bridge's structural integrity in a challenging coastal environment. This project, involving removing and replacing 320,000 square feet of zinc anode and addressing 160 square yards of concrete repairs, stands as one of the most significant ICCP undertakings in history.
