2025SPRING CONVENTION

NAVIGATING CHALLENGES IN WHARF PILE REHABILITATION

Esteban Zecchin, PhD, EIT Staff Engineer Pivot Engineers

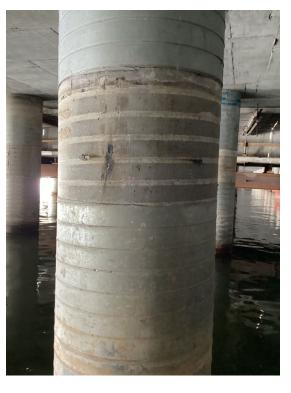
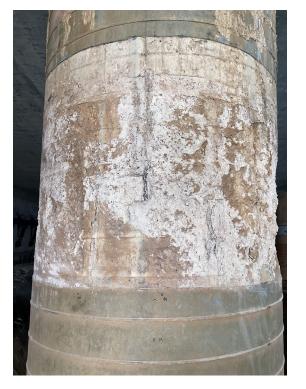
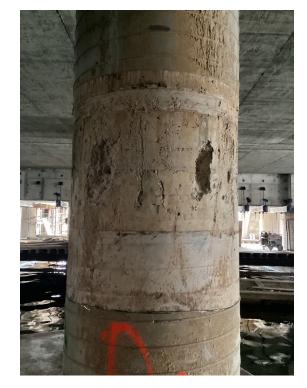
Rebound Hammer Test (ASTM C805)

- Spring-loaded hammer impacts the concrete surface with a predetermined amount of energy
- Assess in-place concrete uniformity, delineate regions of poorer quality, and estimate in-place strength
- Correlated with core strengths at corresponding locations

>50

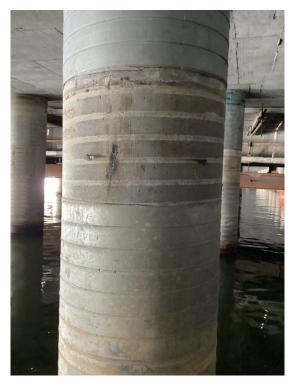
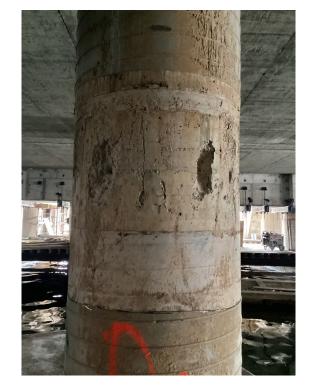
Ultrasonic Pulse-Velocity – UPV (ASTM C597)

- Evaluate quality and integrity of concrete, and identify defects
- Sends sound waves through the material being tested

4100 m/s

3800 m/s

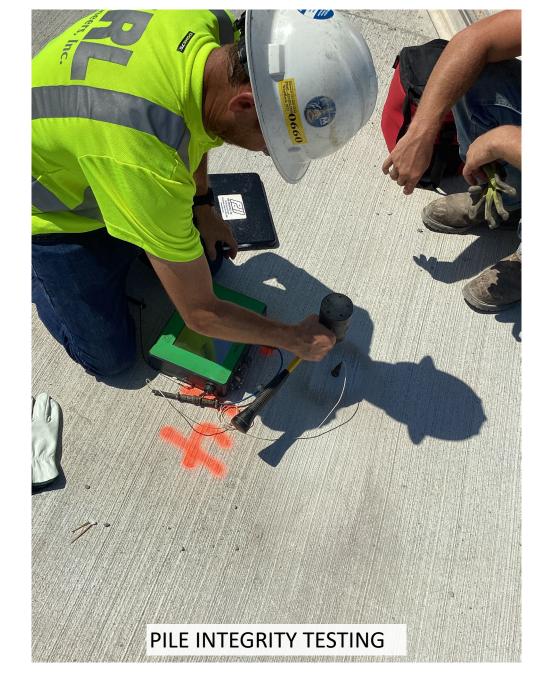
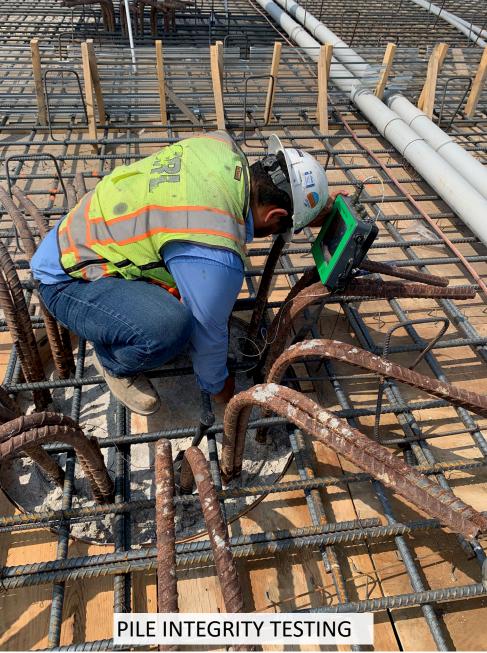
$Wave \ Velocity = \frac{Distance \ Traveled}{Travel \ Time}$

• Velocity is related to the modulus of elasticity

(E), the Poisson's ratio (v), and the density (δ)
