2025 SPRING CONVENTION

RETURN OF THE HORSES

Conservation Challenges of Nivola's Play Horses

Mary Jablonski
Jablonski Building Conservation, Inc.

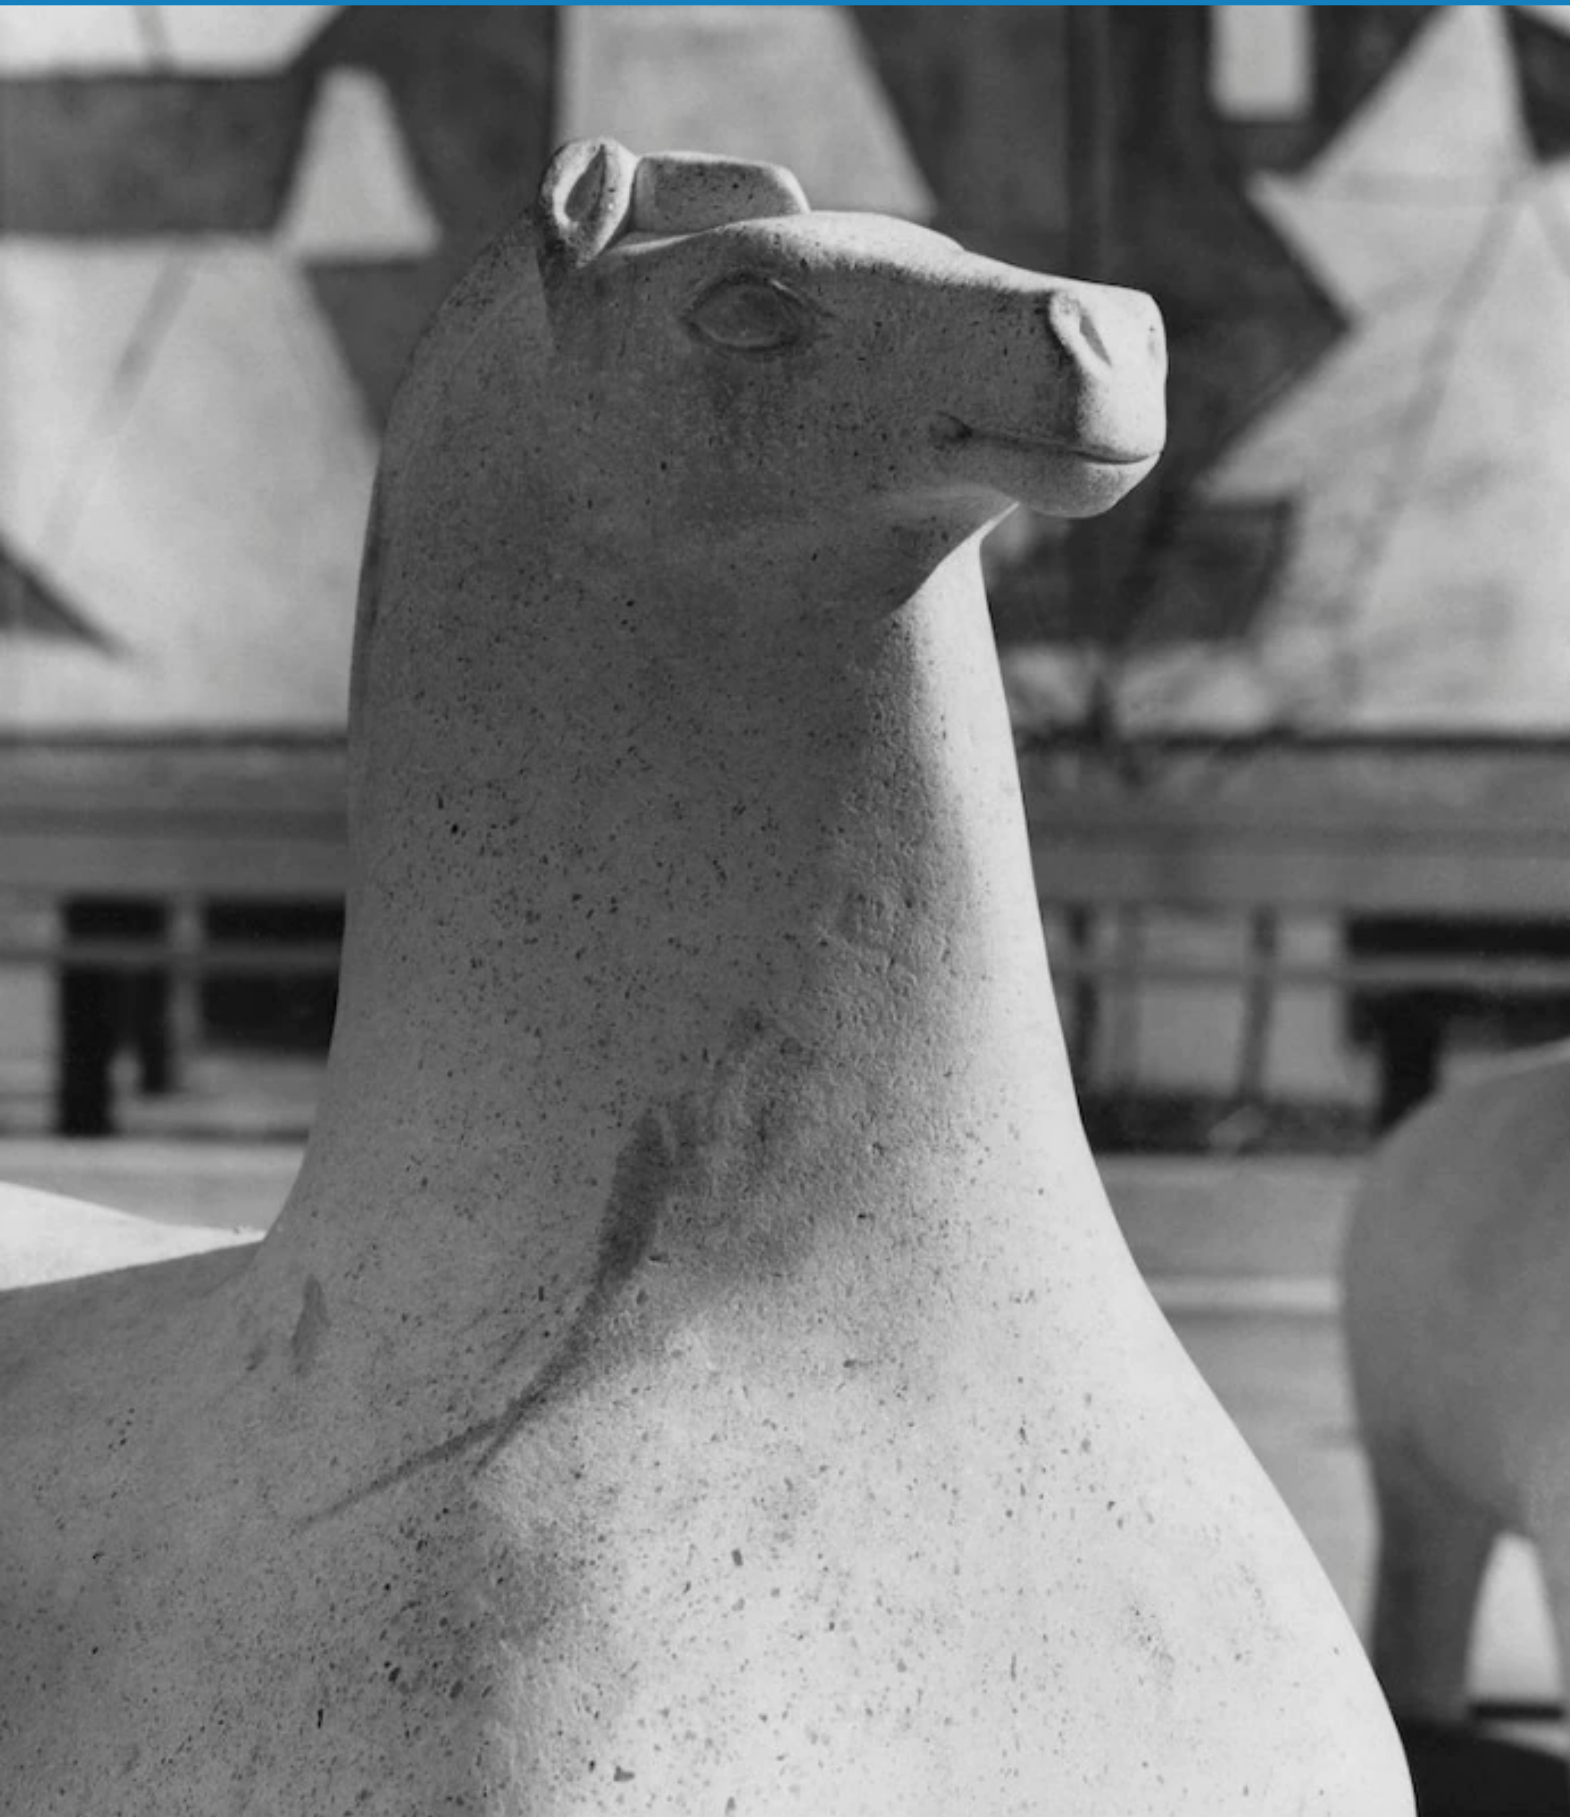
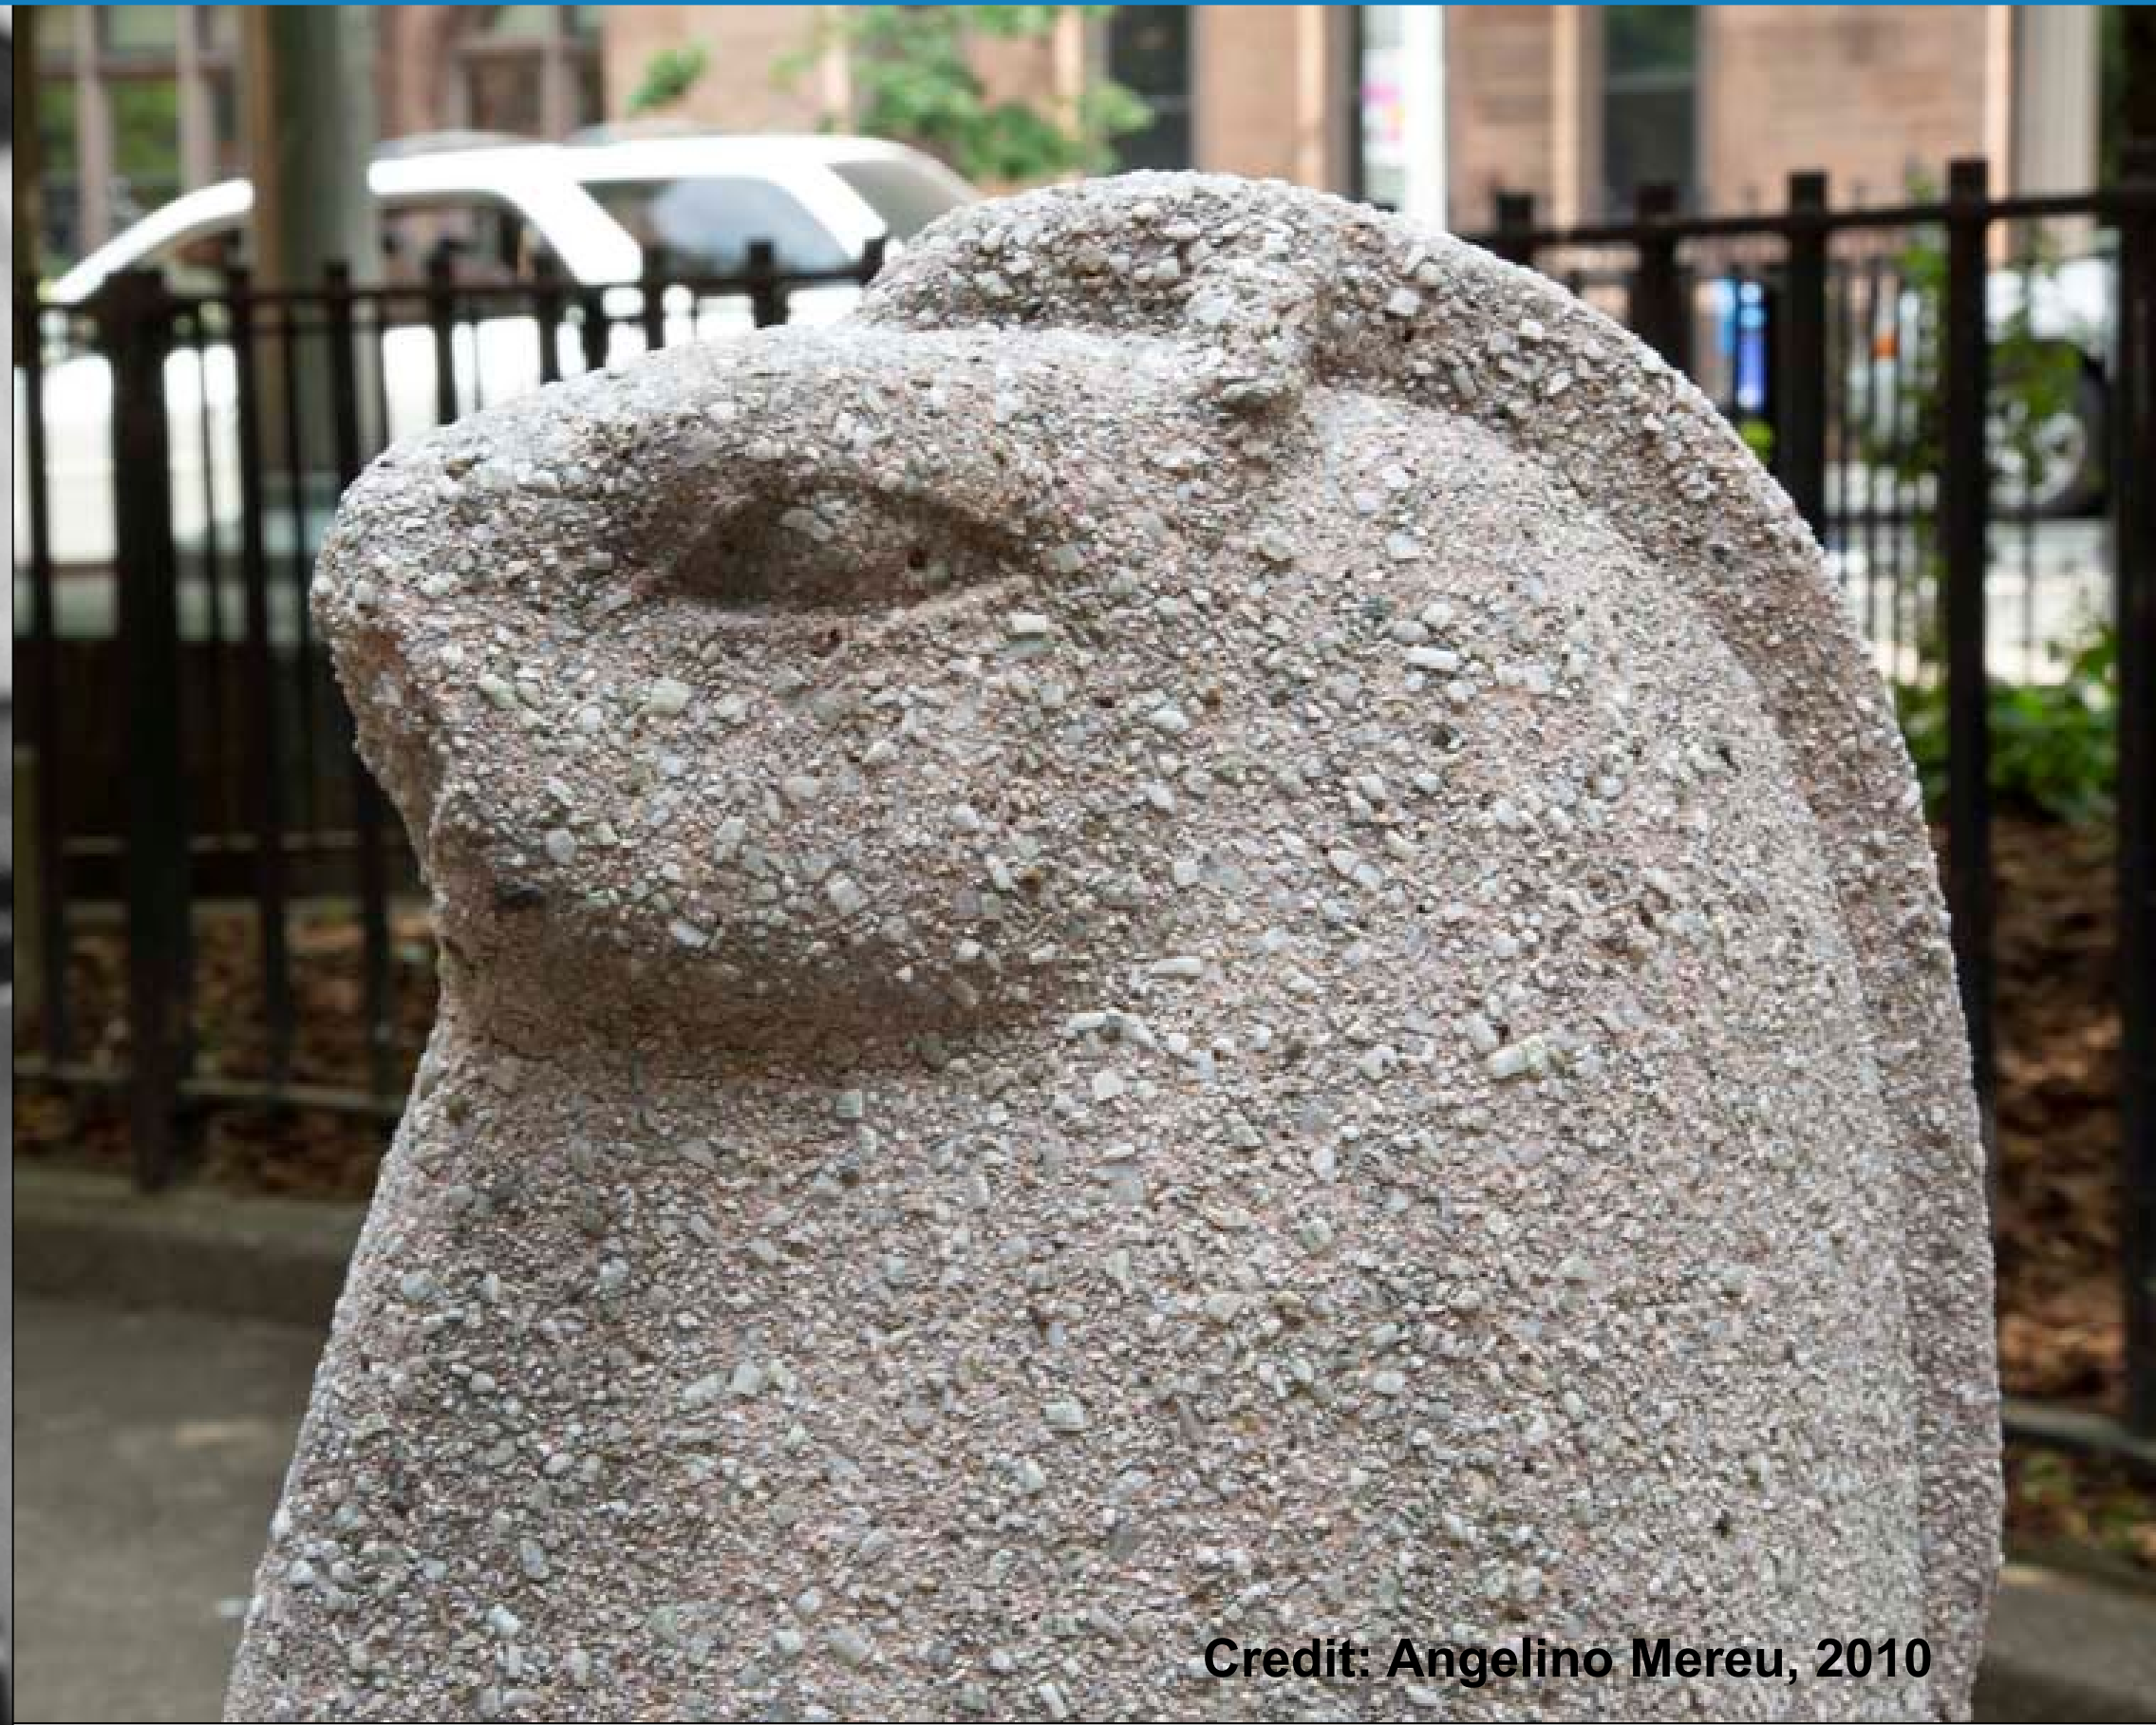
Vandalized Muzzles

Submerged hooves, missing muzzles and damaged tails (2010)

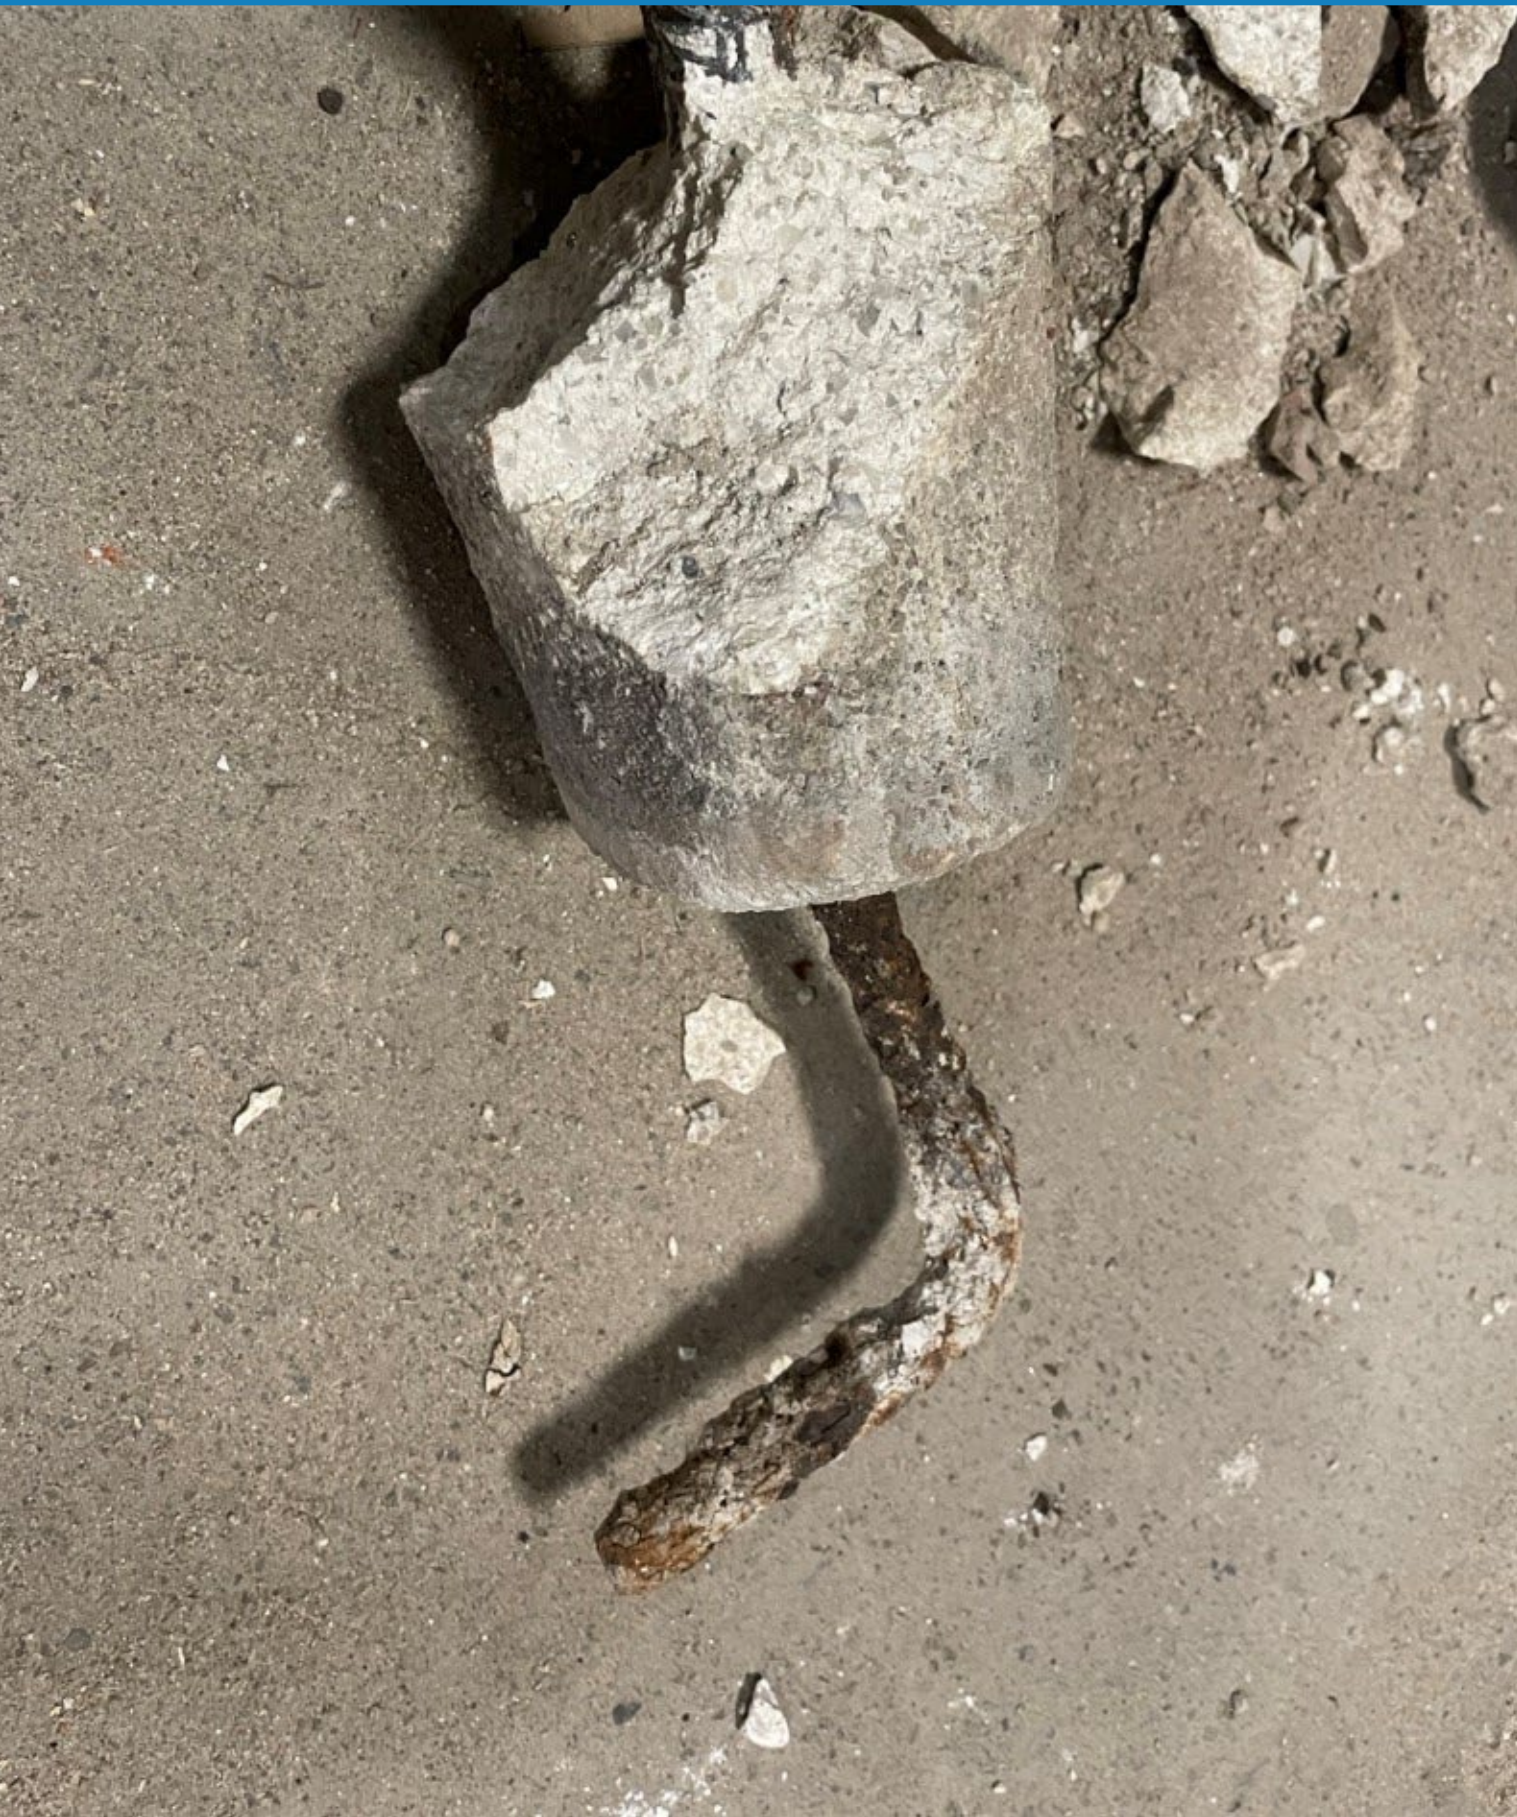
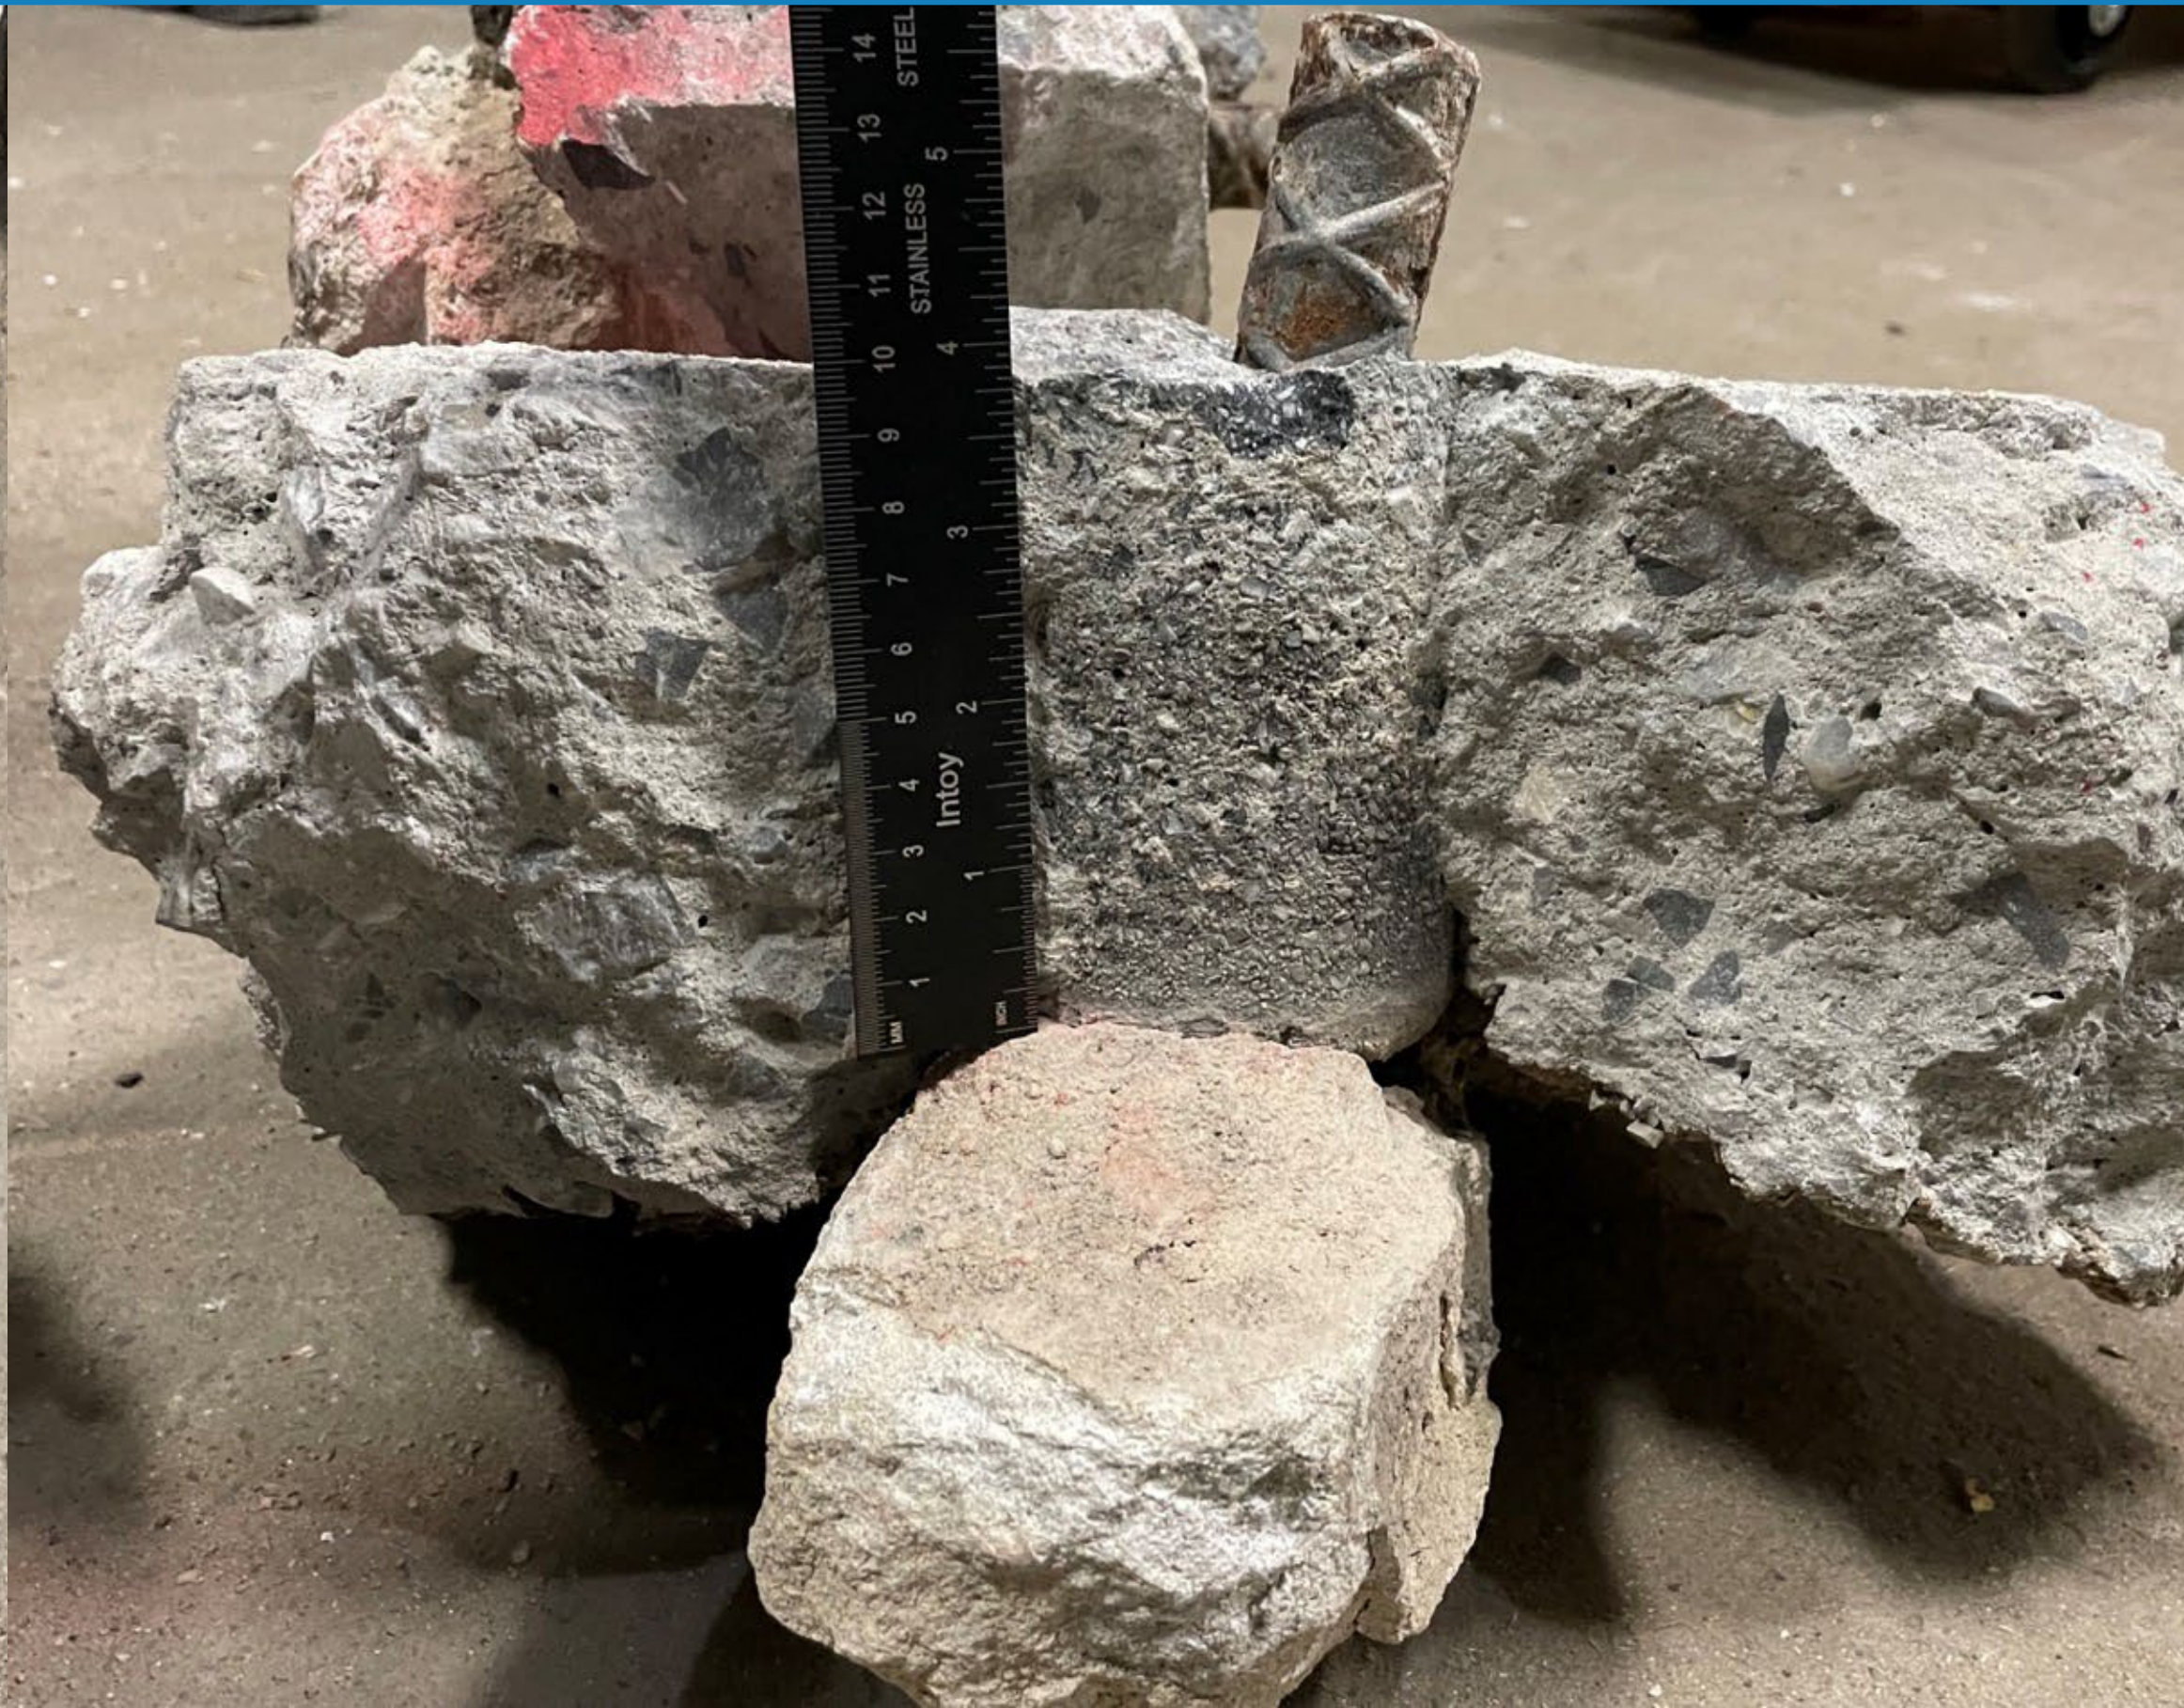
Documentation: Nothing to Reuse and Legs Different Lengths

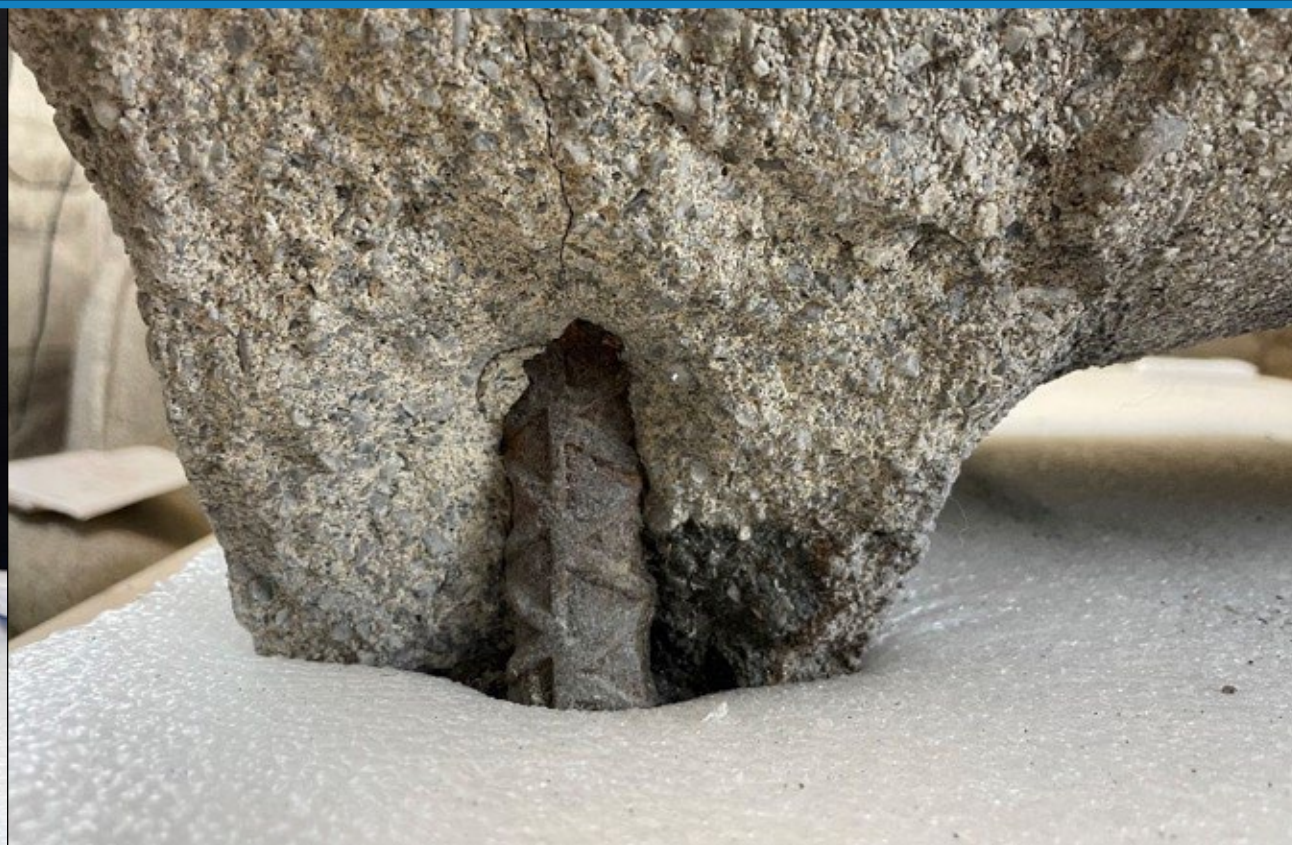
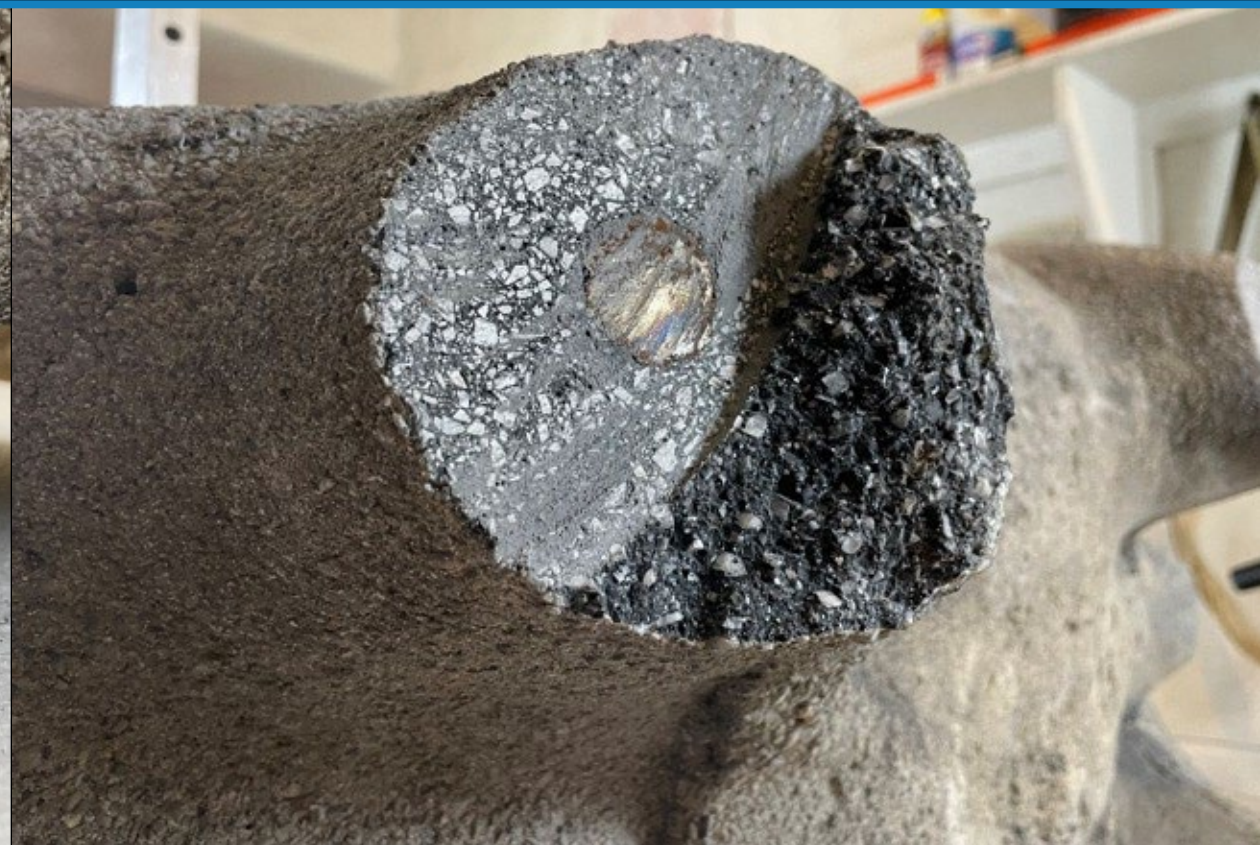
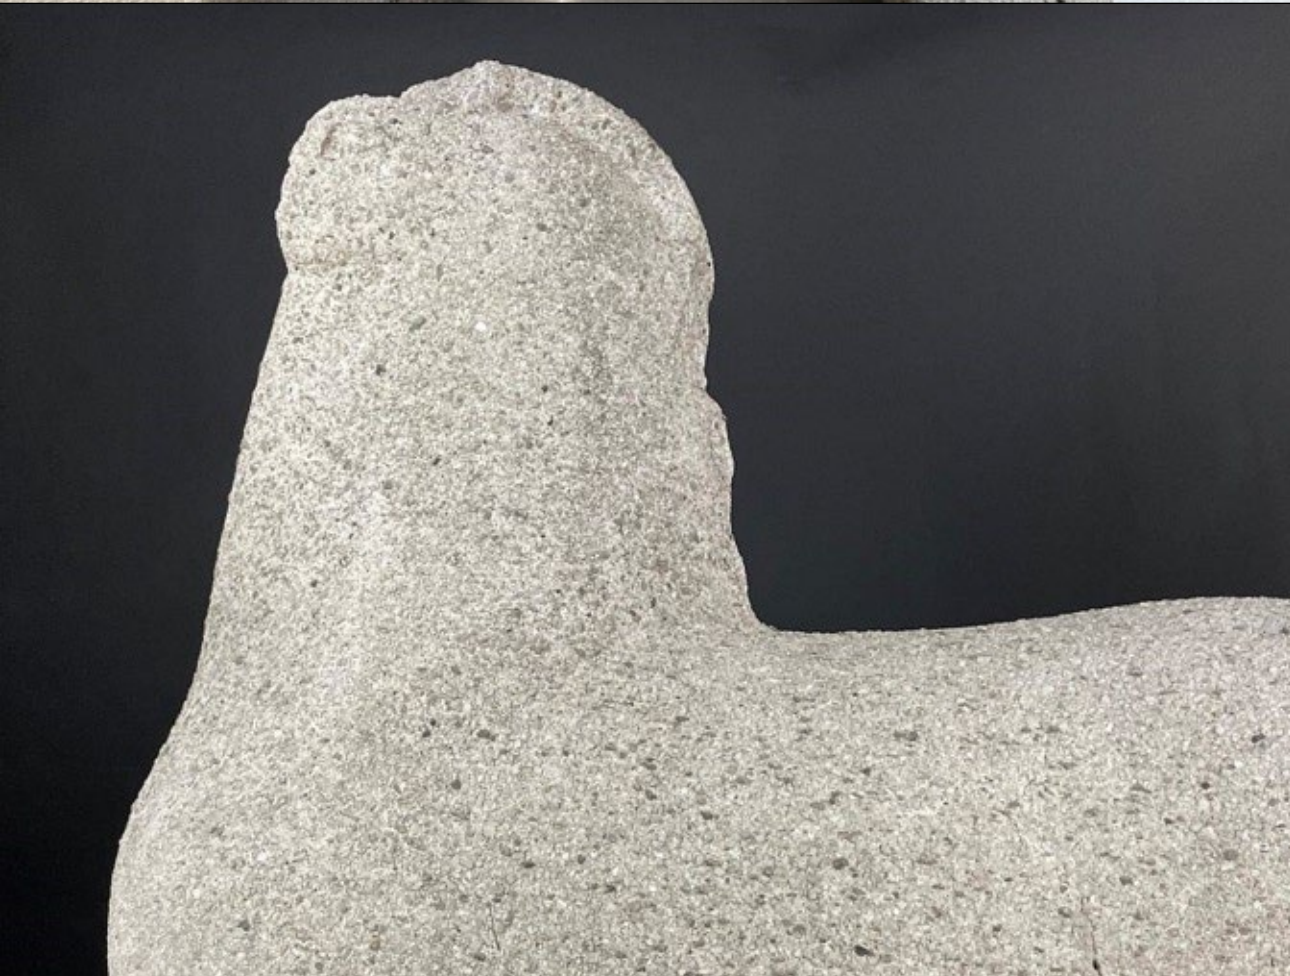
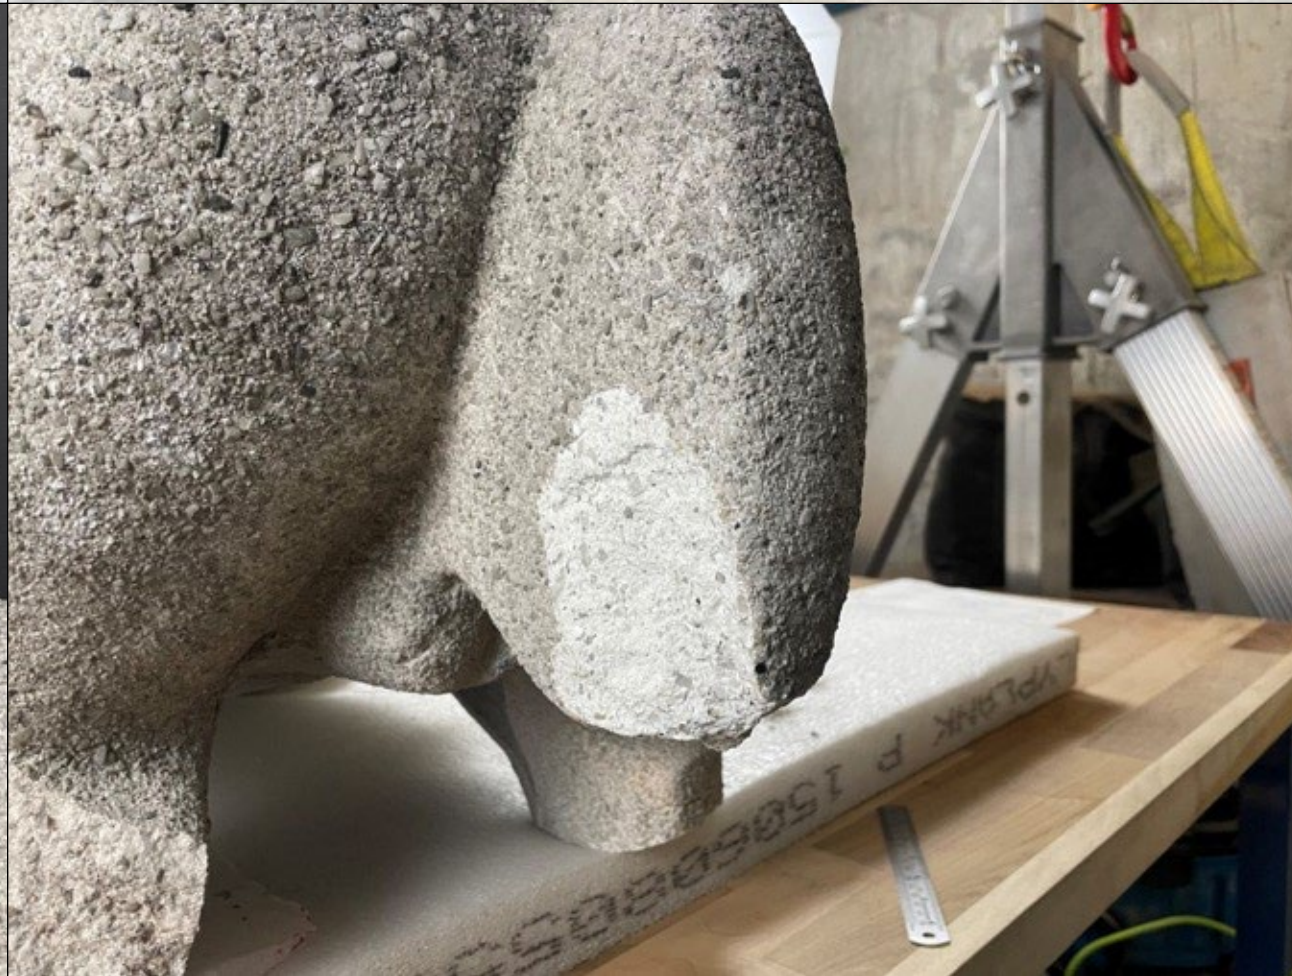
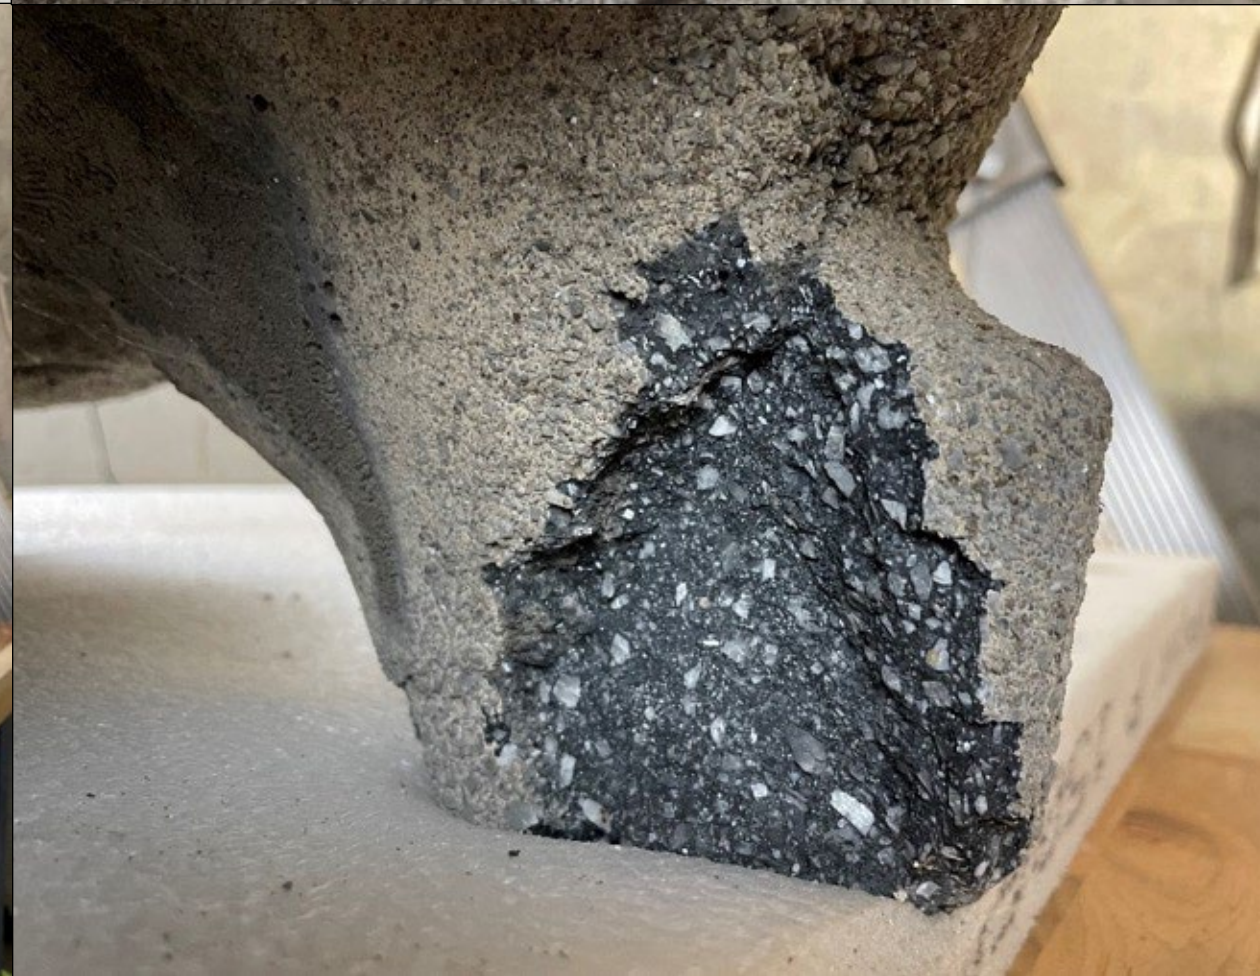
Conditions: Losses
