2025 SPRING CONVENTION

RETURN OF THE HORSES

Conservation Challenges of Nivola's Play Horses

Mary Jablonski
Jablonski Building Conservation, Inc.

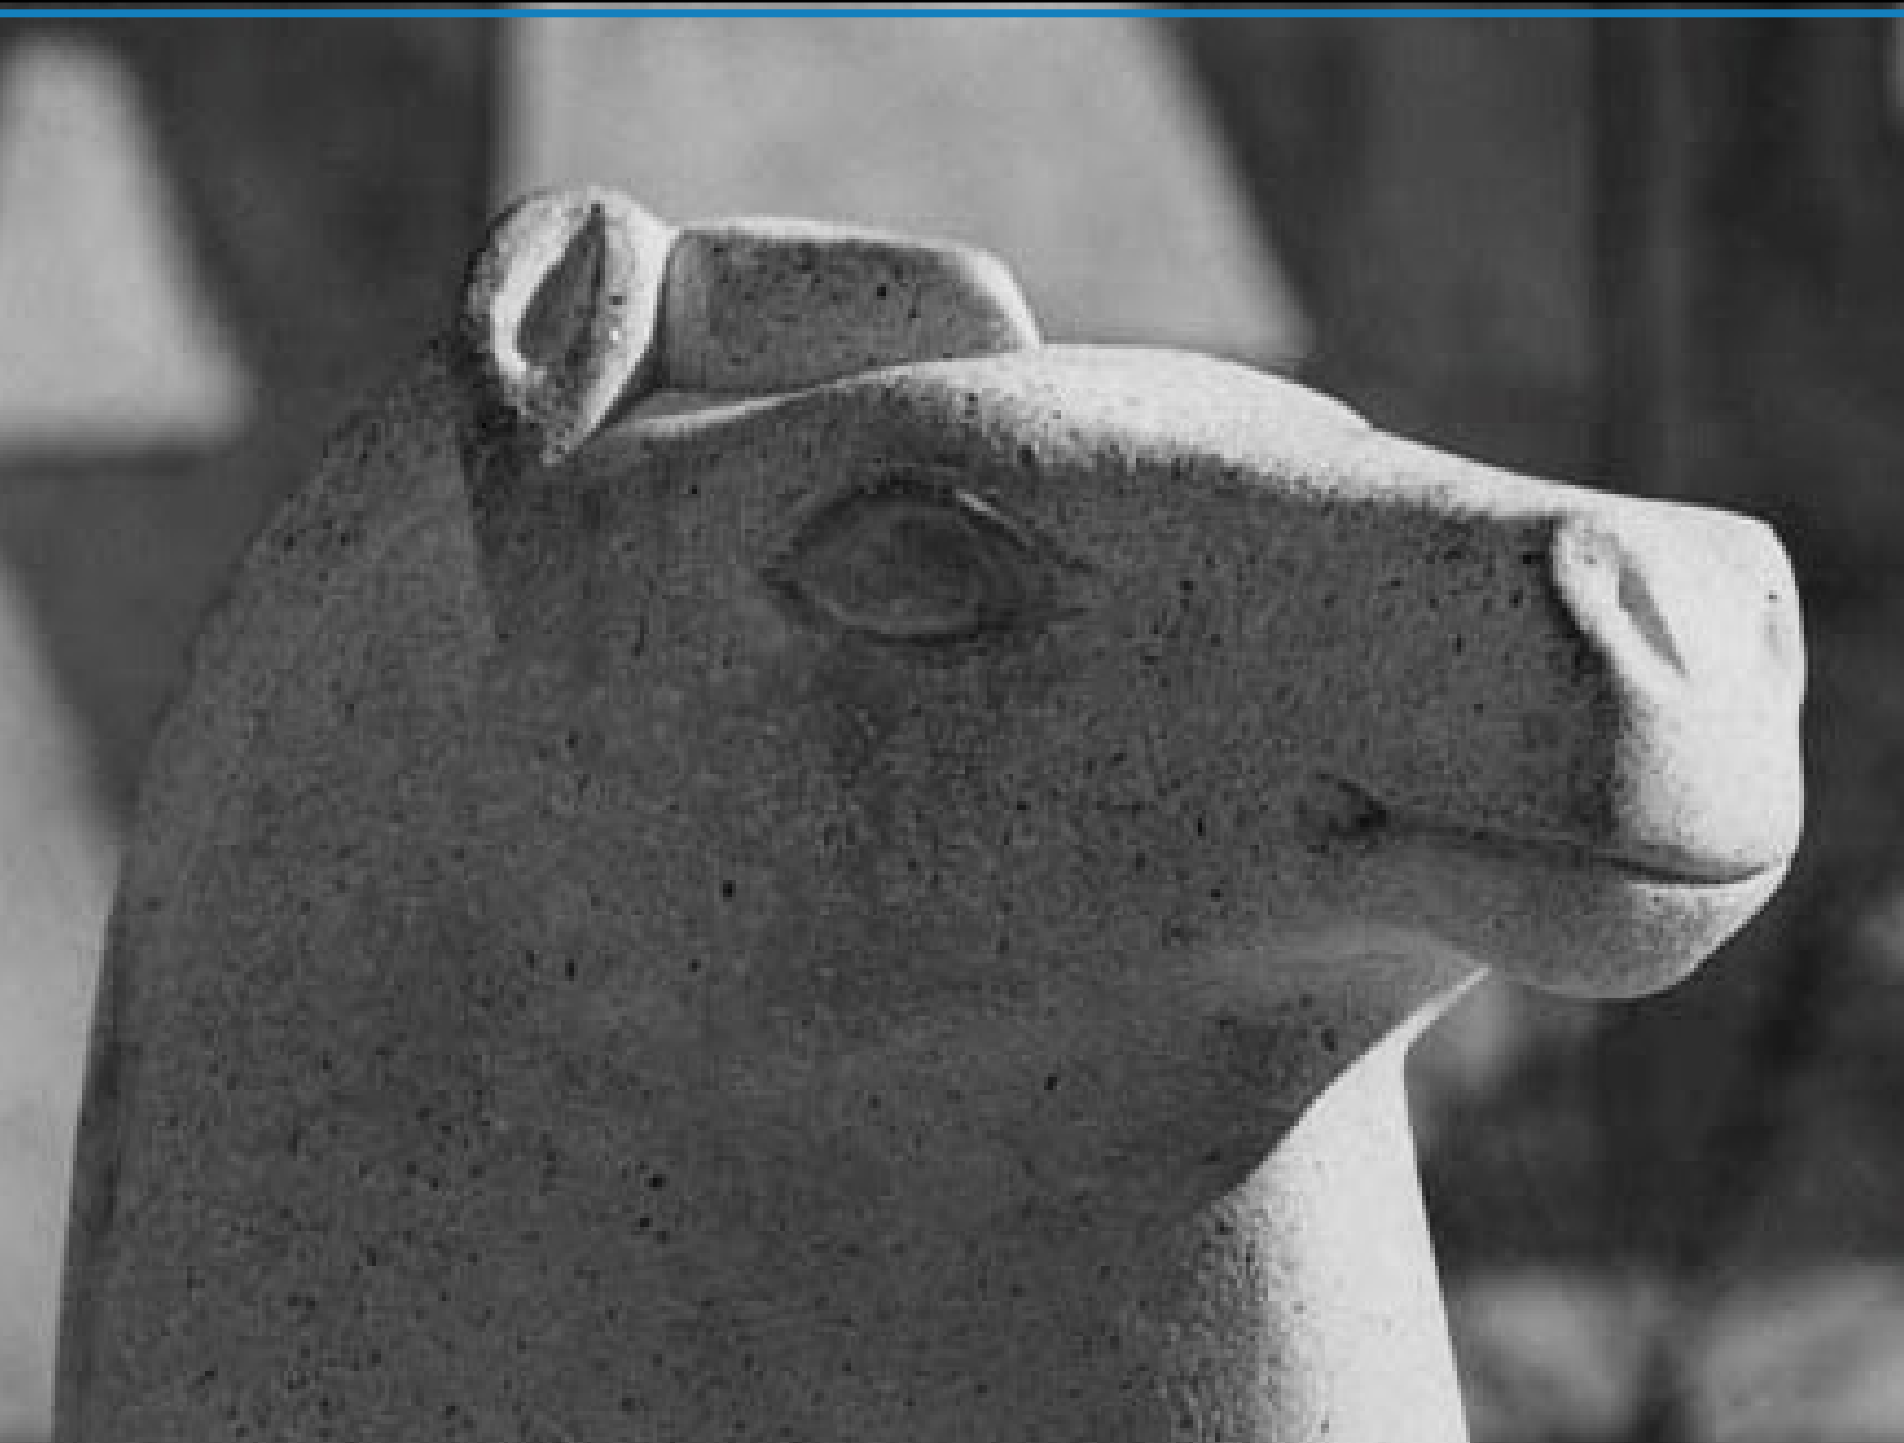
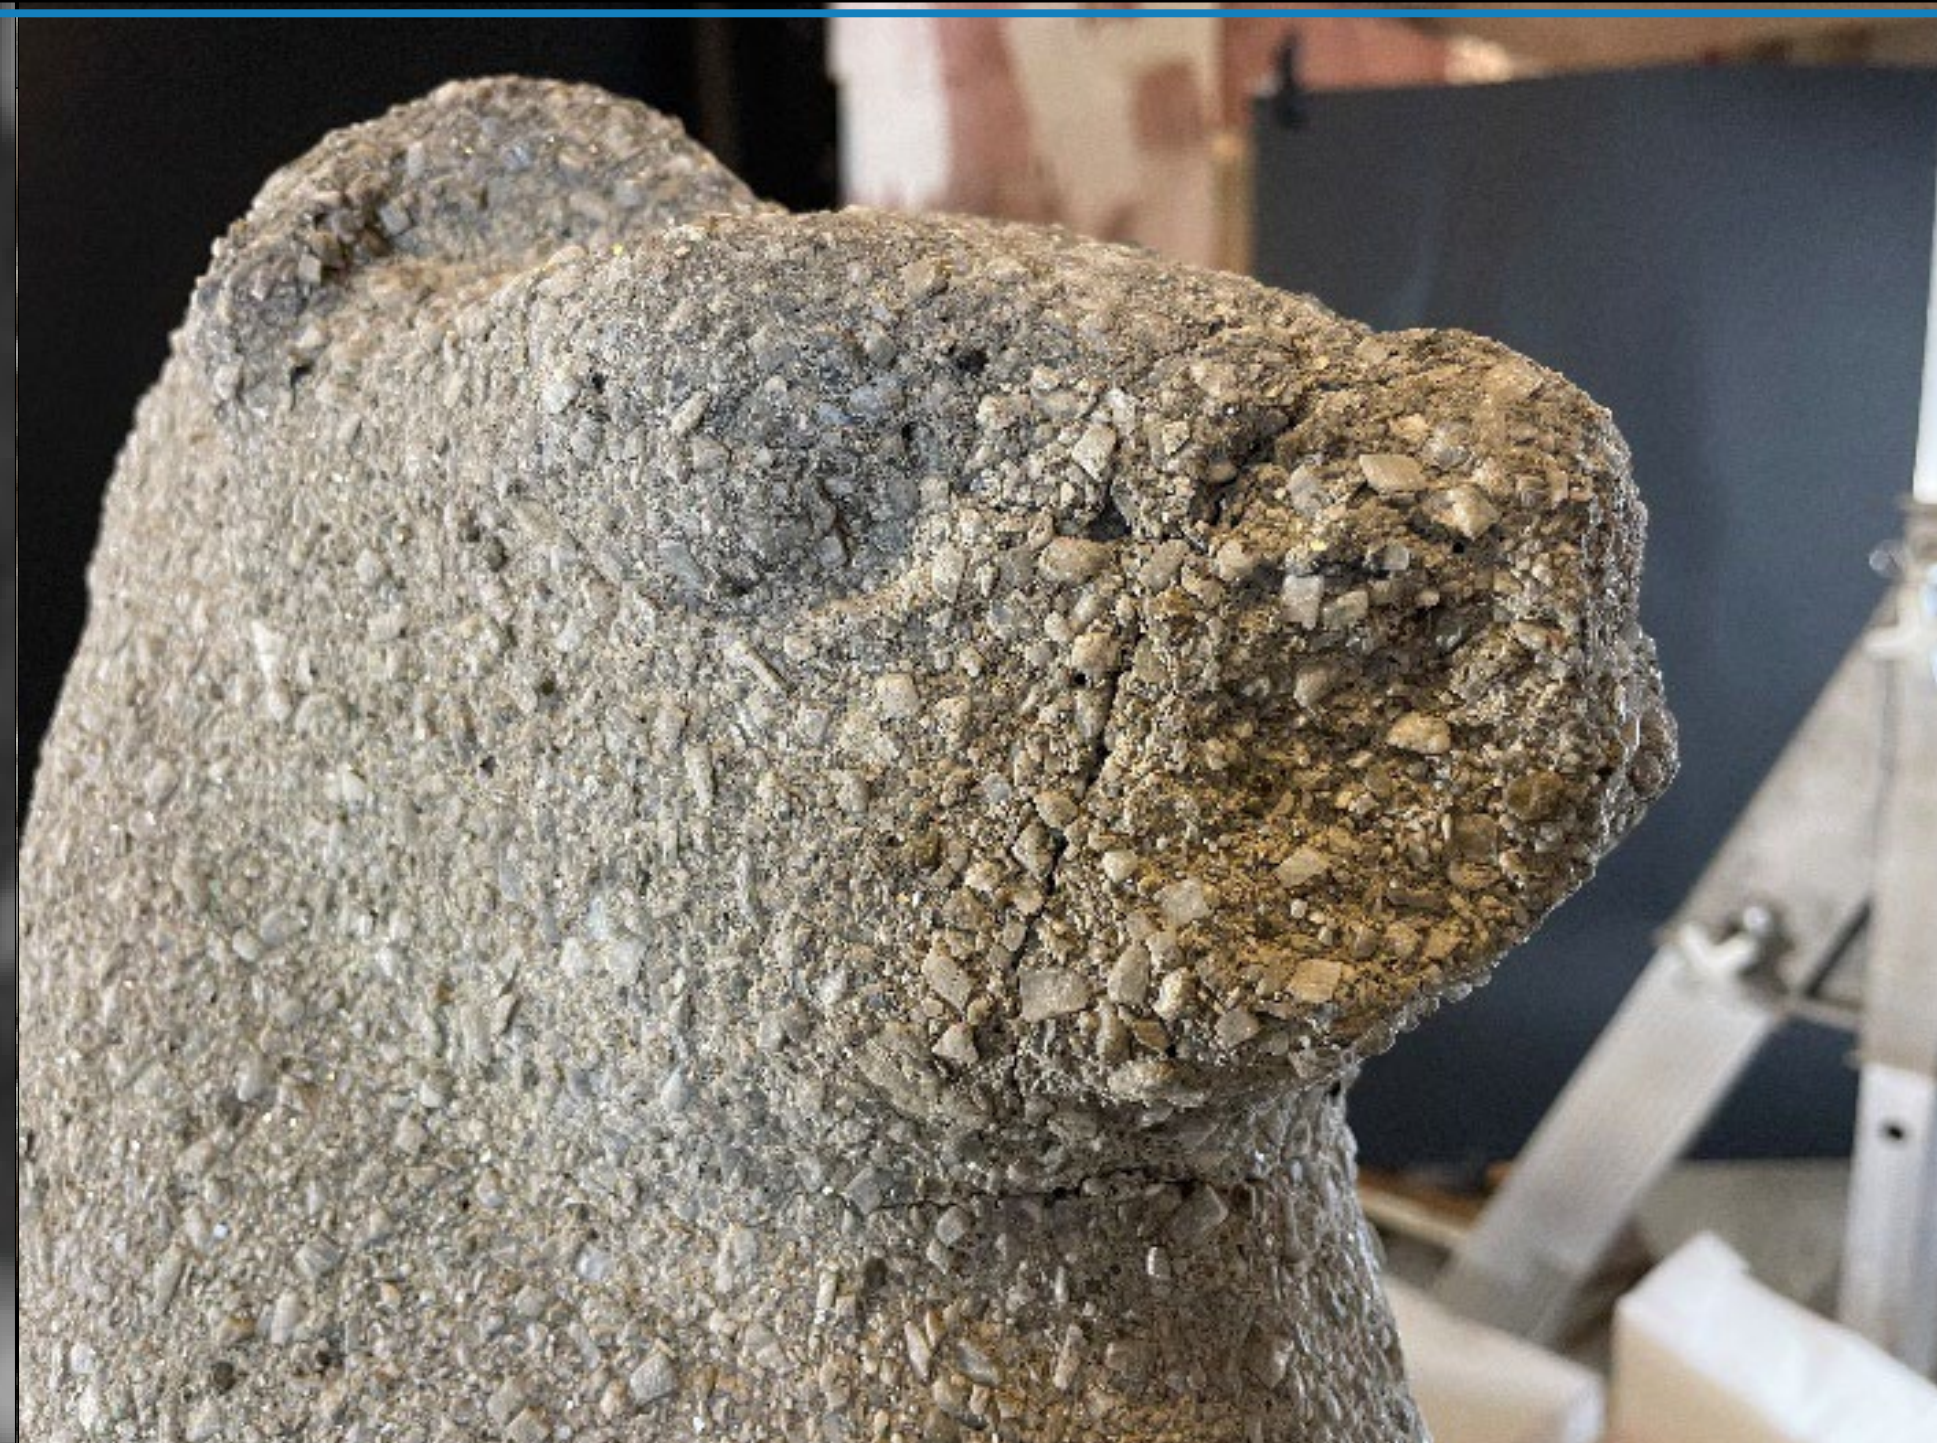
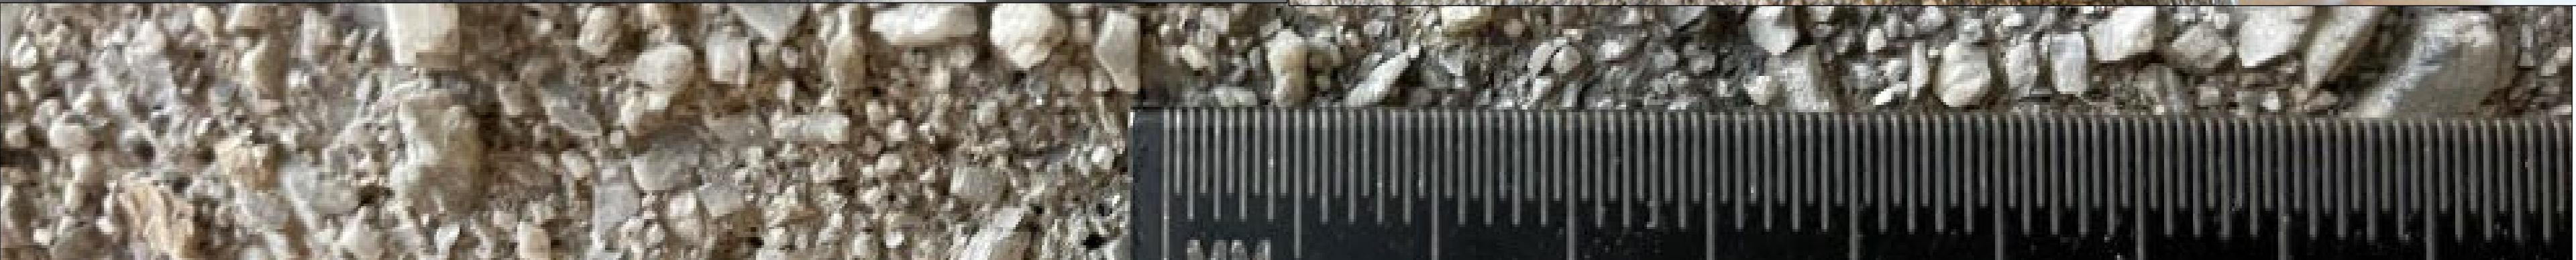
Conditions: Erosion

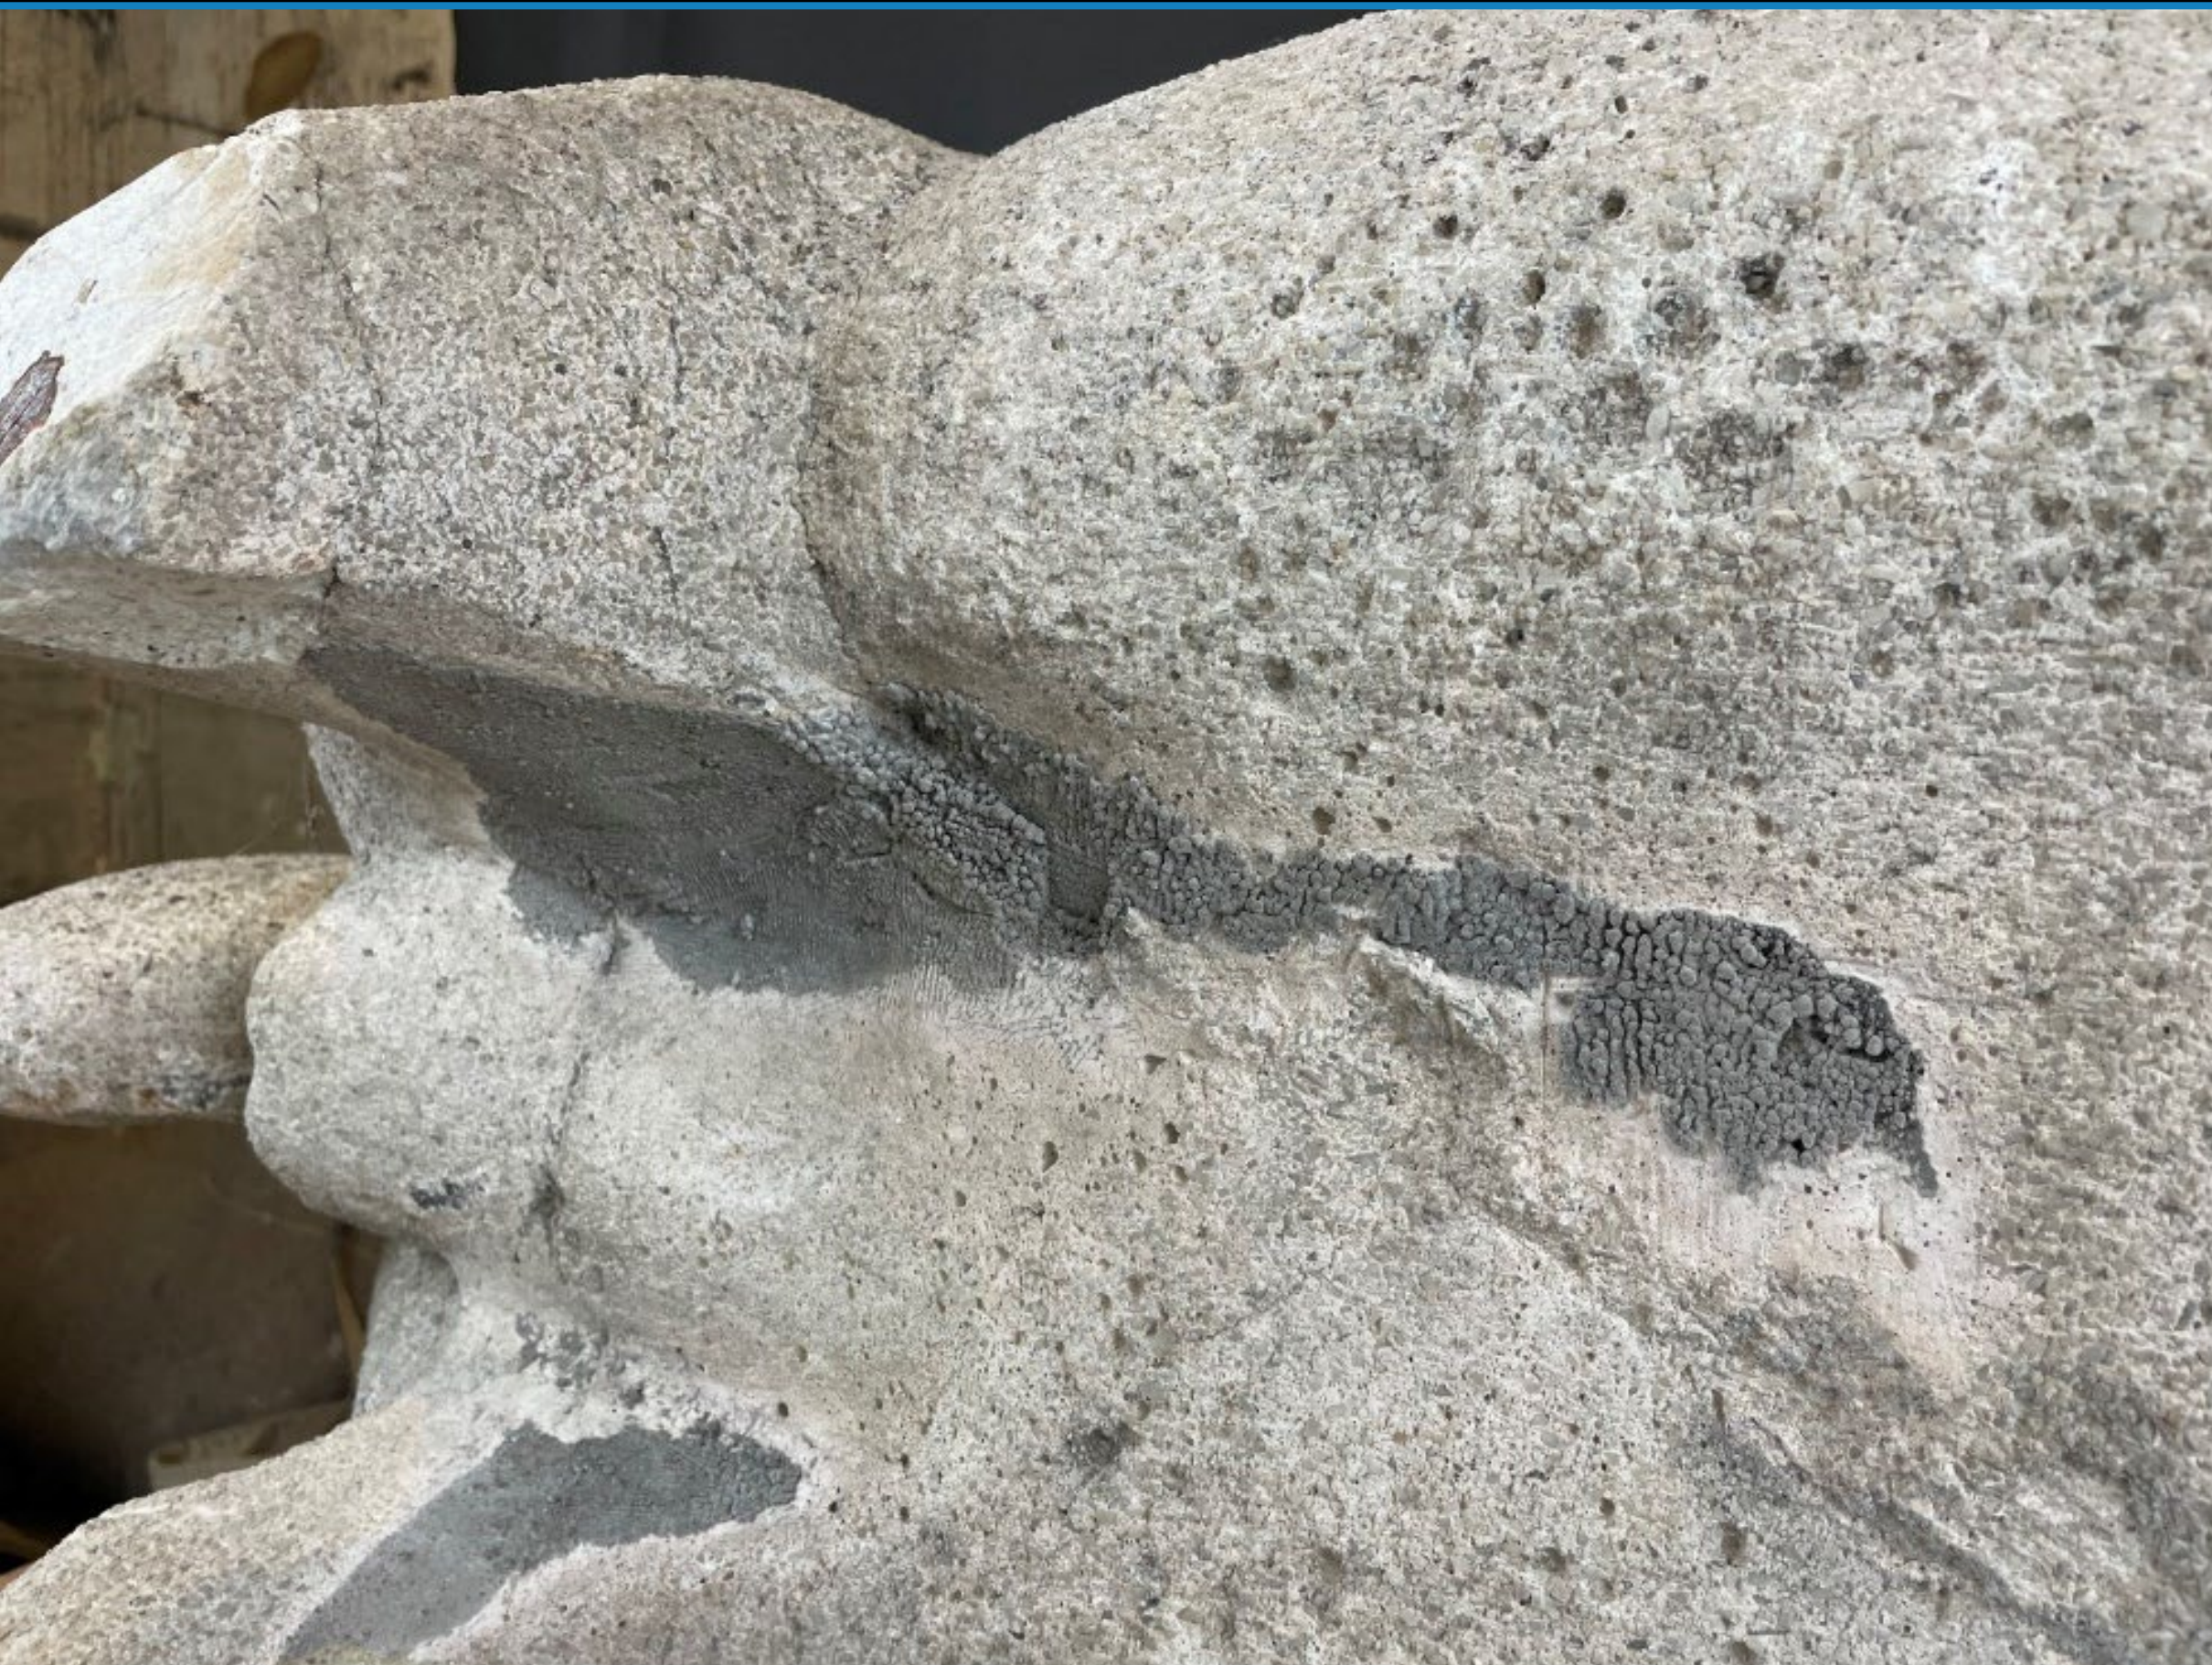
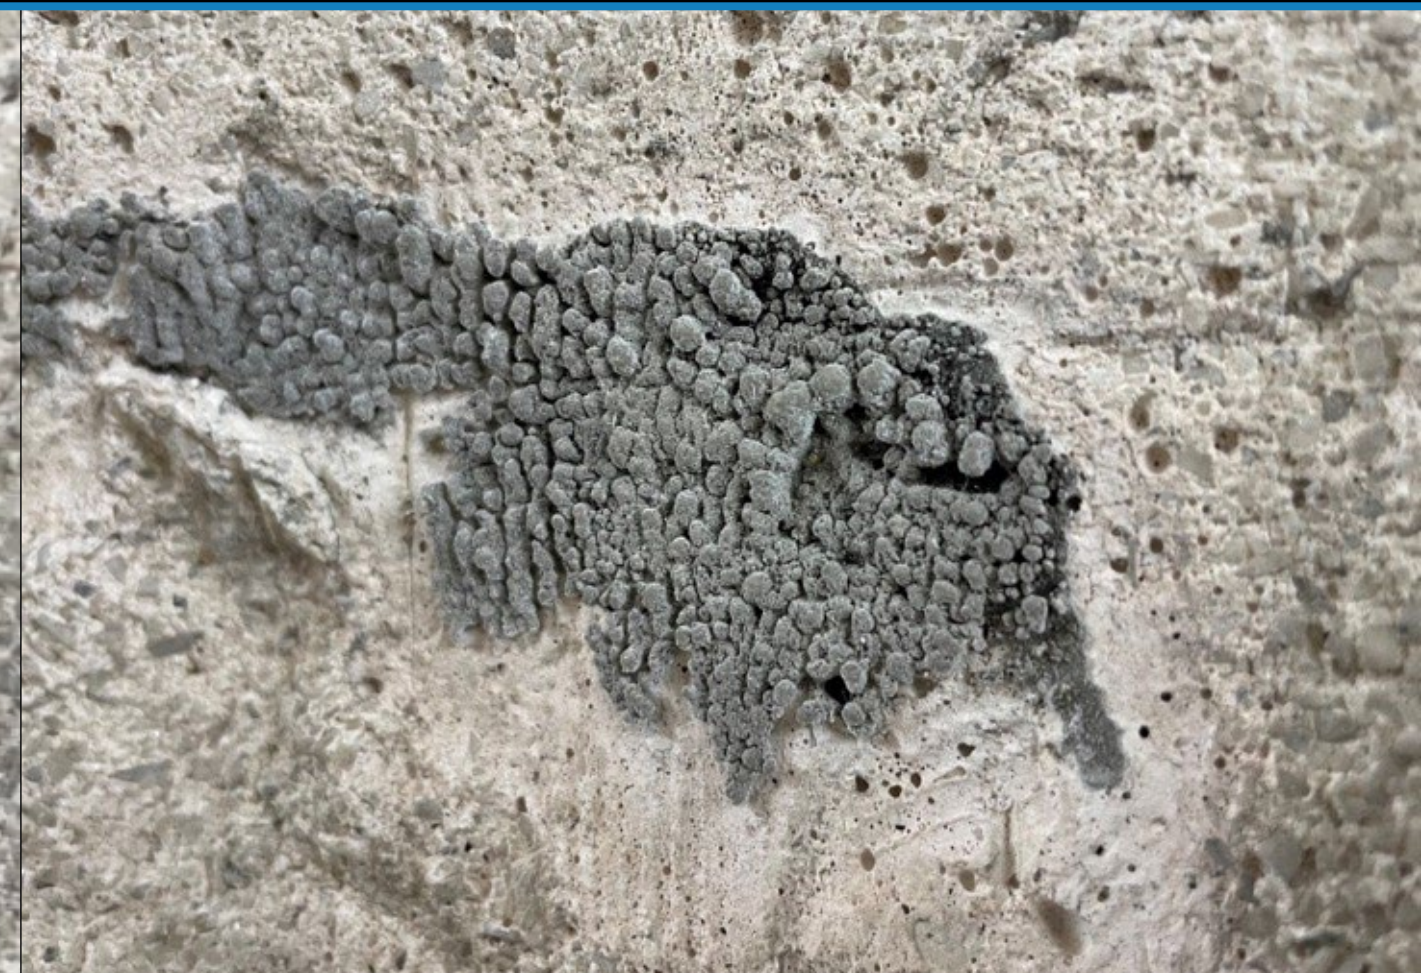
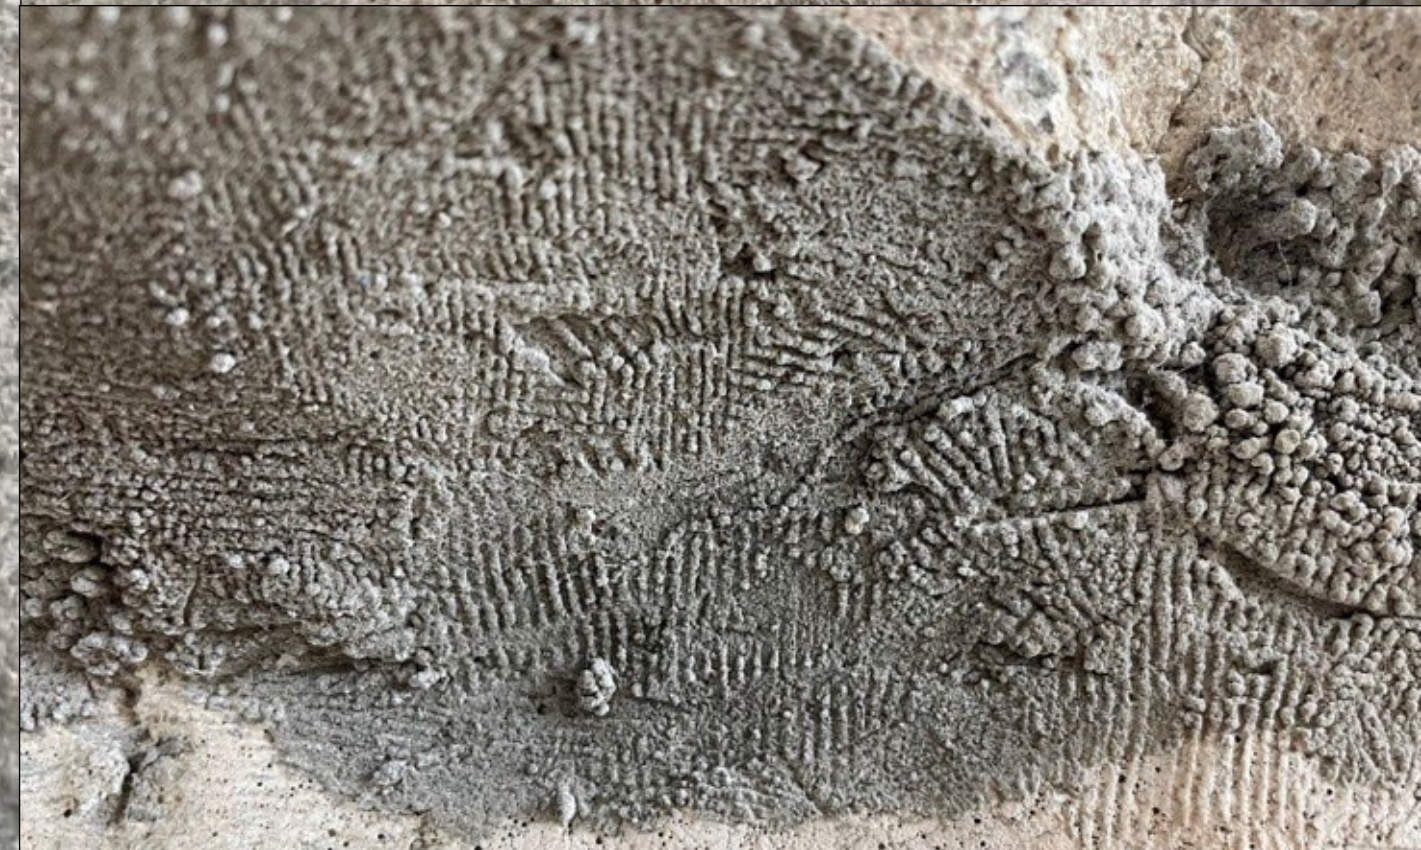
Conditions: Gypsum Crusts

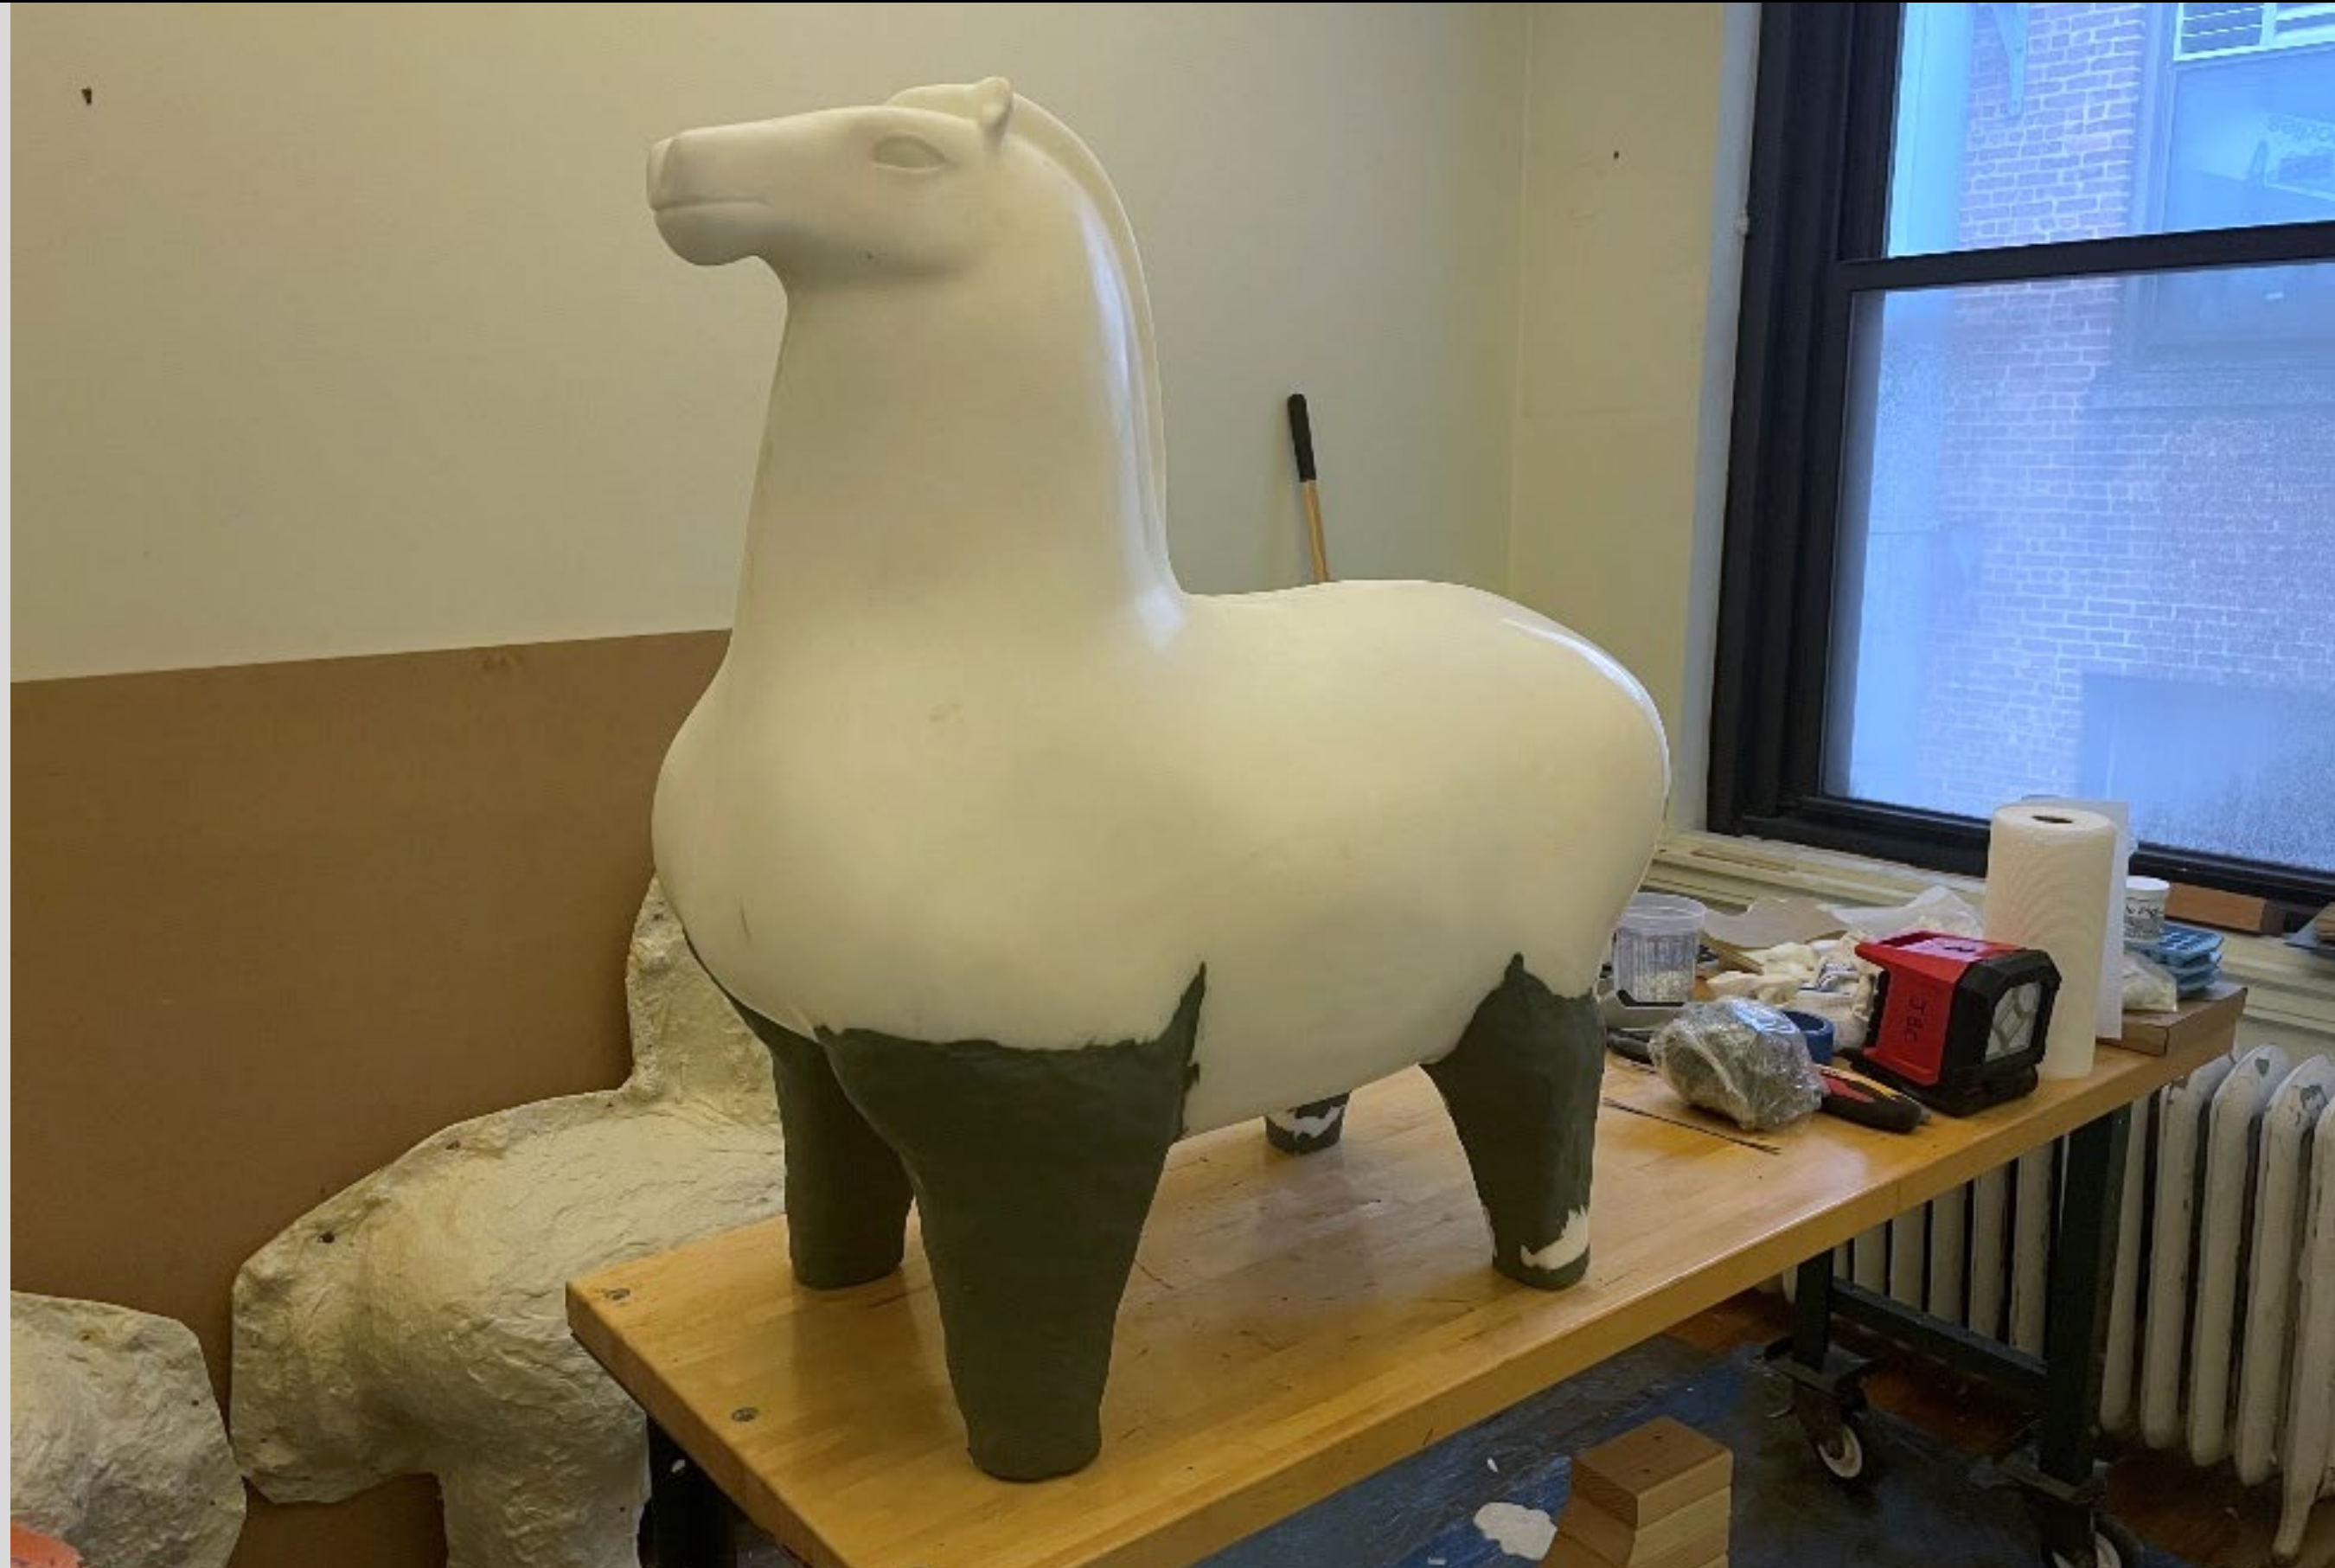
Modification of the Legs
