2025 SPRING CONVENTION

RETURN OF THE HORSES

Conservation Challenges of Nivola's Play Horses

Mary Jablonski
Jablonski Building Conservation, Inc.

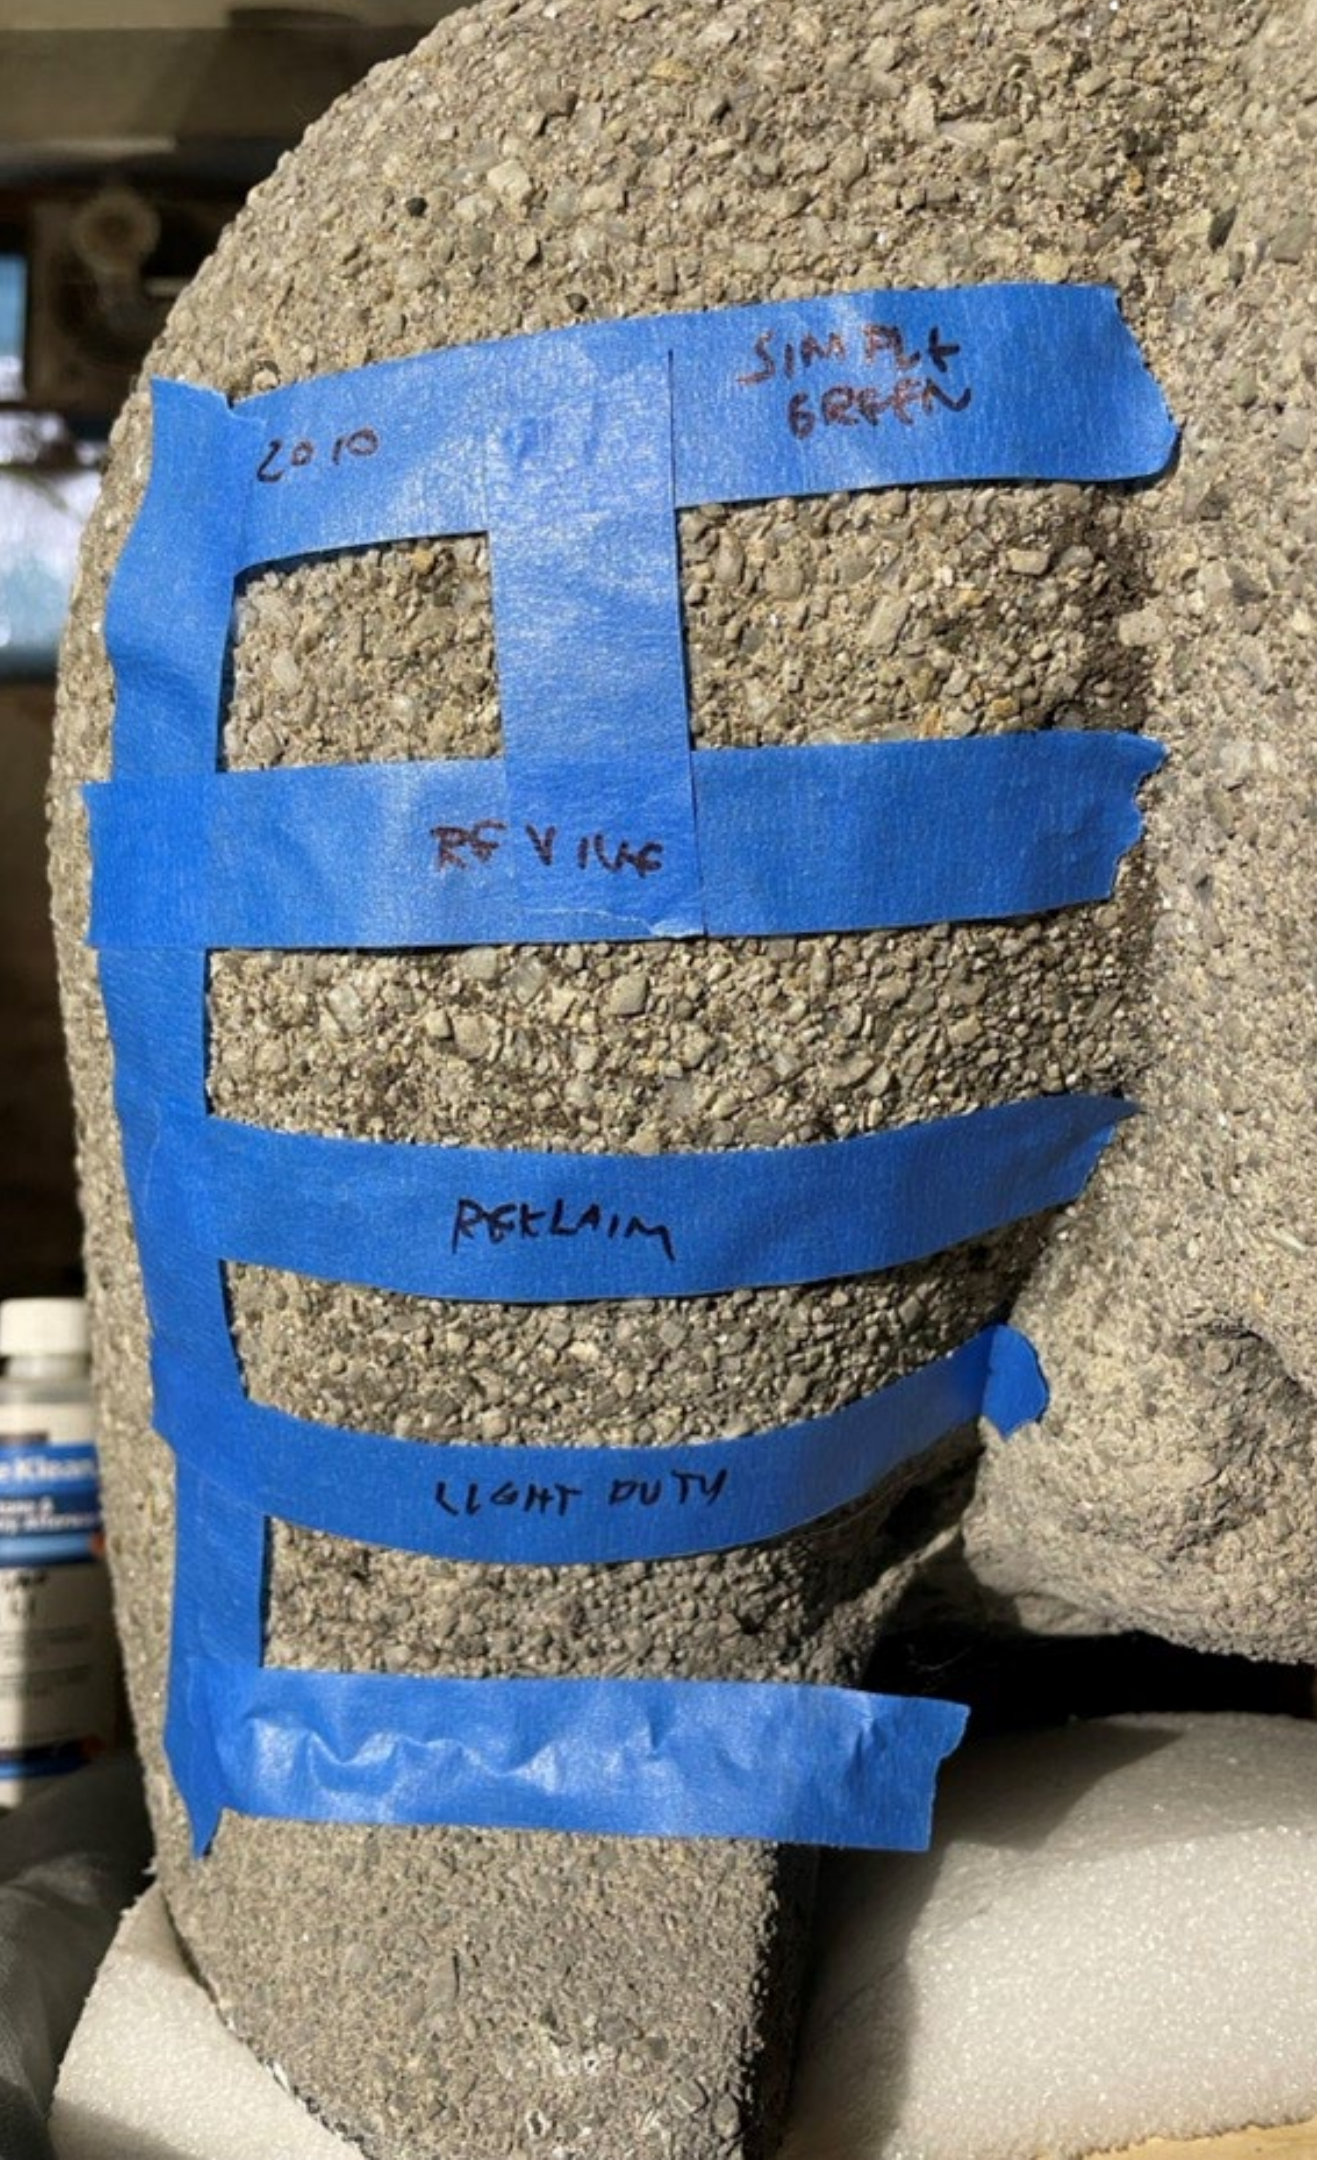
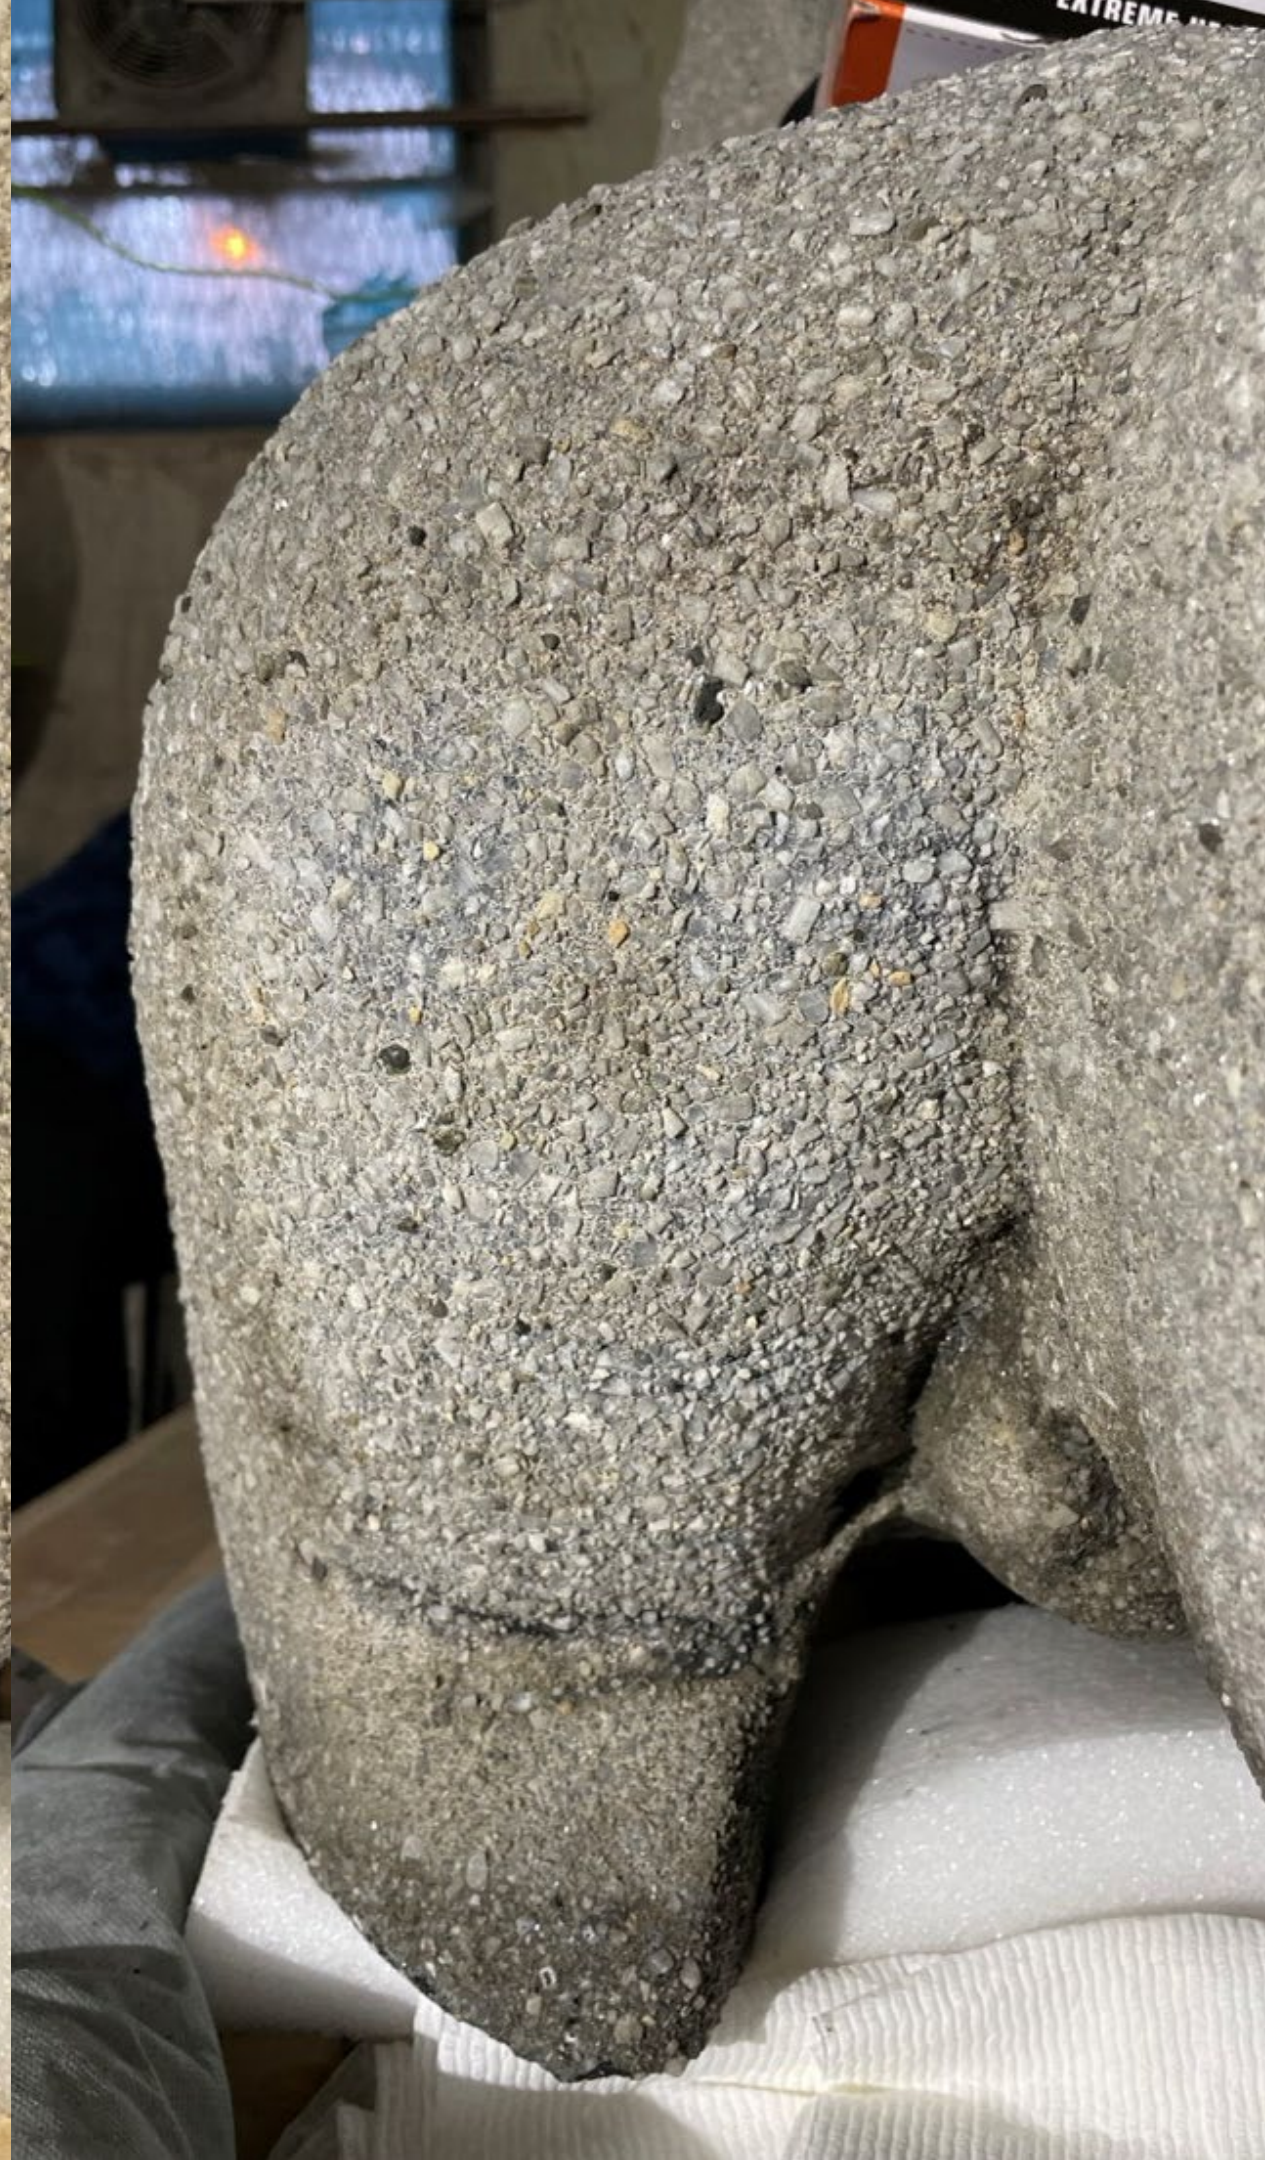
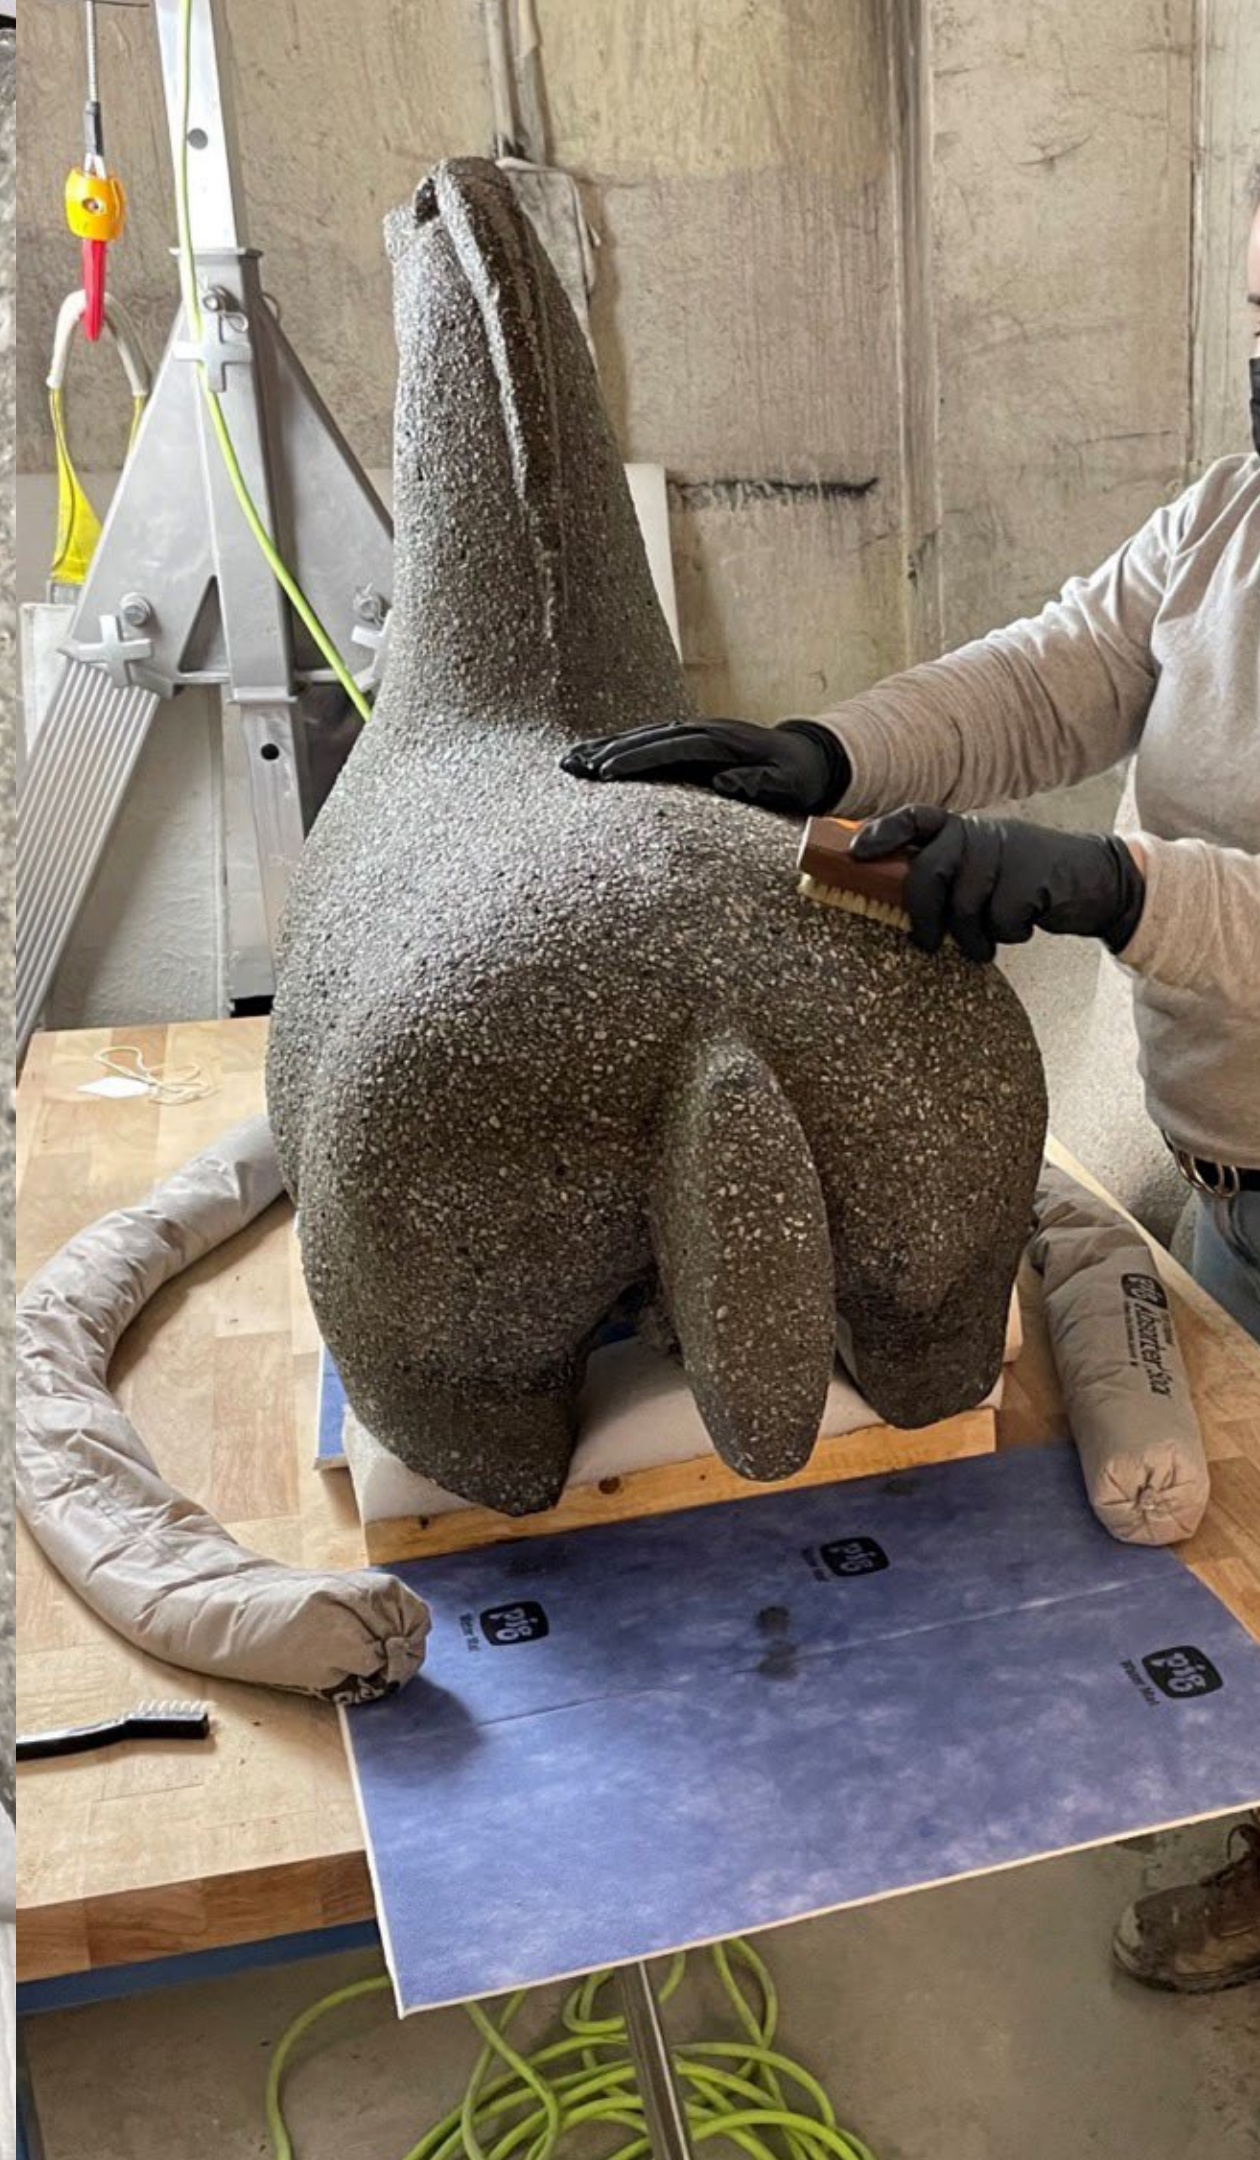
Investigation of Color Change

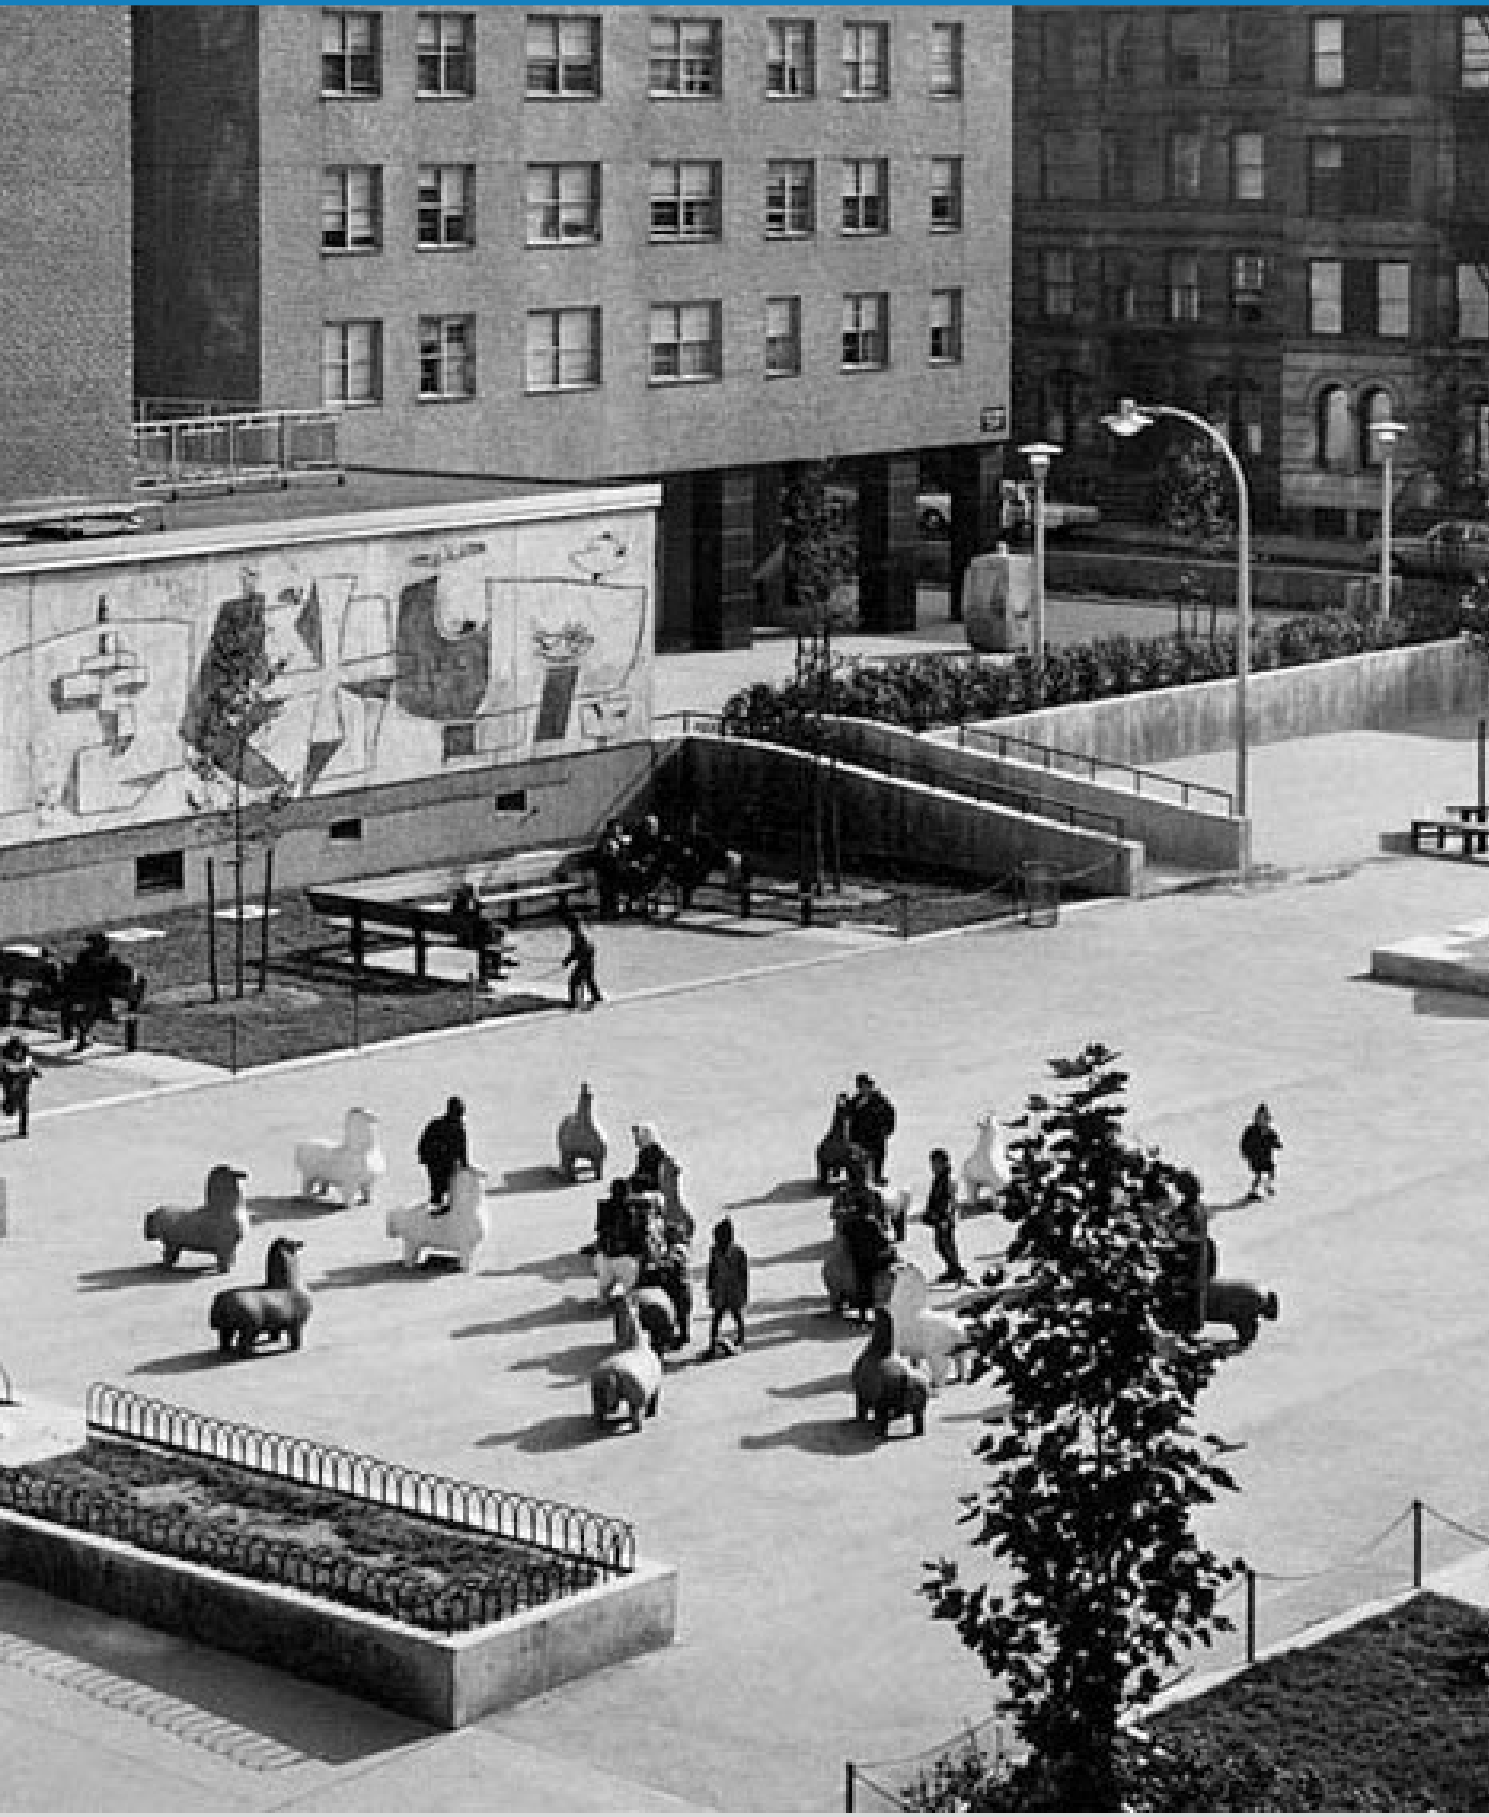
Nivola Horses Sculptures Approx. Original Location

Installation Plan
