CONCRETE REPAIR BULLETIN

2019 ICRI PROJECT OF THE YEAR AWARD WINNER

The Île-aux-Tourtes Bridge Rehabilitation

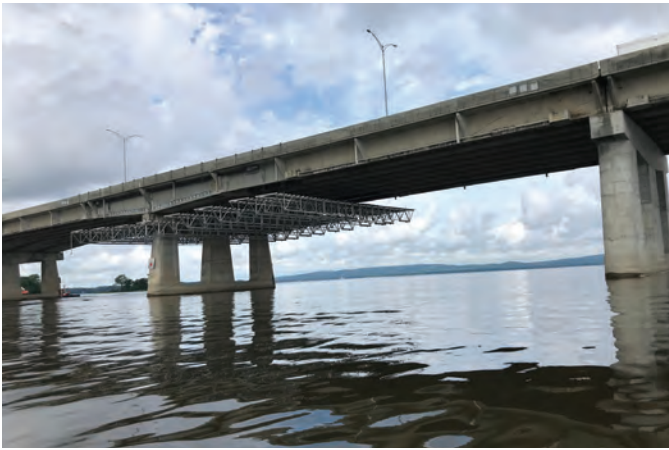
Fig. 1: Working platforms over the maritime corridor

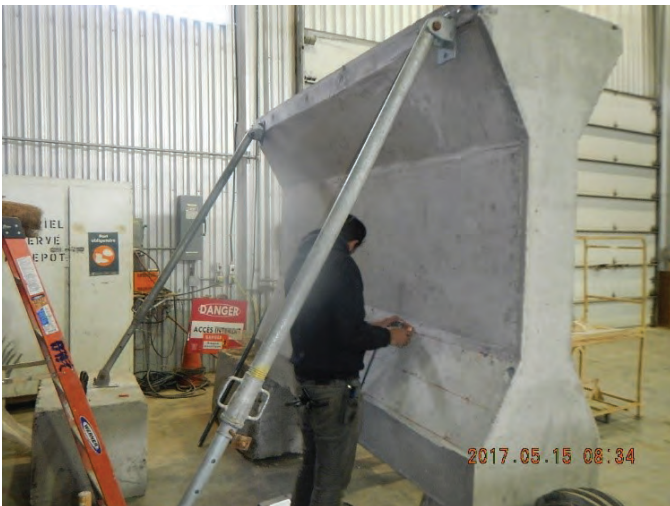
Fig. 2: Test beam

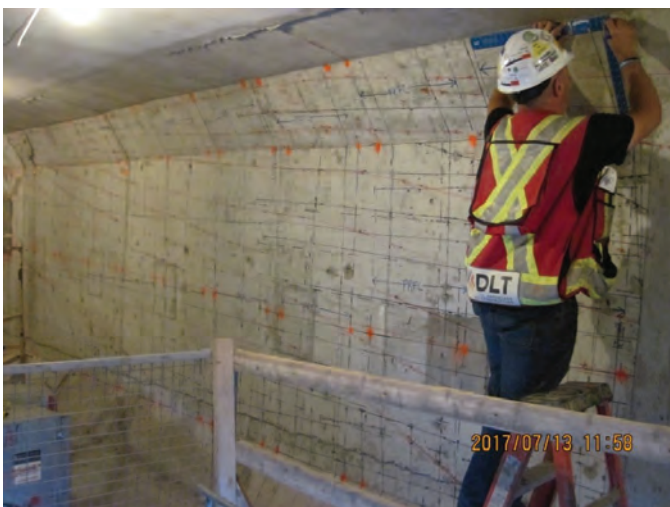
Fig. 3: Rebar and strand identification

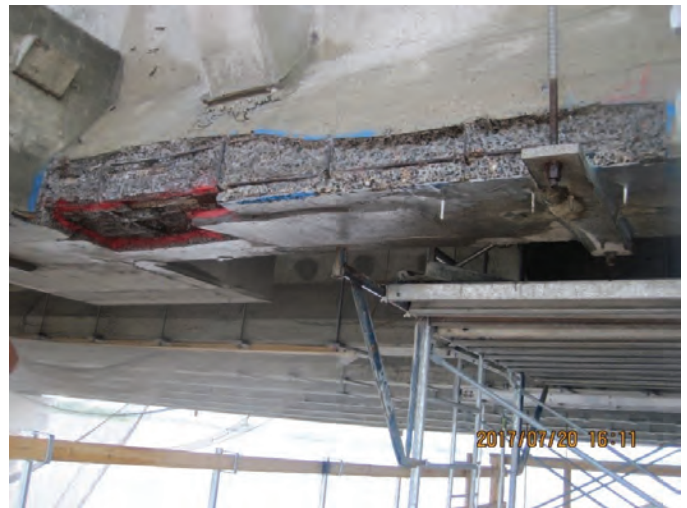
Fig. 4: Typical lower flange girder concrete demolition

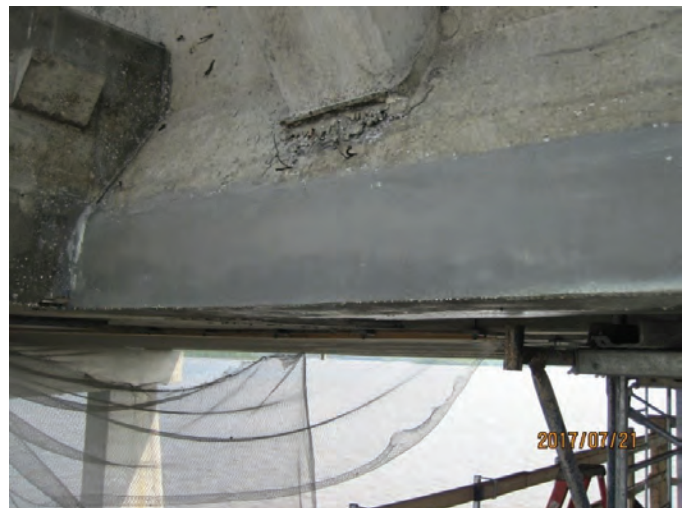
Fig. 5: Repaired girder using mortar concrete

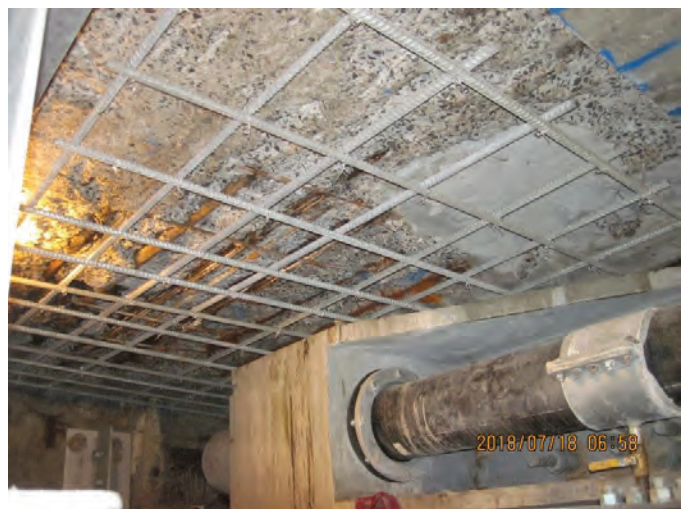
Fig. 6: Underside heavy duty slab repair prior to adding forms, concrete and steel deck and transverse beams

Heavy-duty slab repair utilized ultra-fast hardening self-leveling concrete placed from the top of the deck. This limited the bridge lane closure at night to about 30 minutes. Several areas of the slab had to be repaired by creating an extra thickness on the underside of the slab (Fig. 6). Cracks in the bridge slab and girders had to be repaired before the low-viscosity epoxy crack injection (Fig. 7).

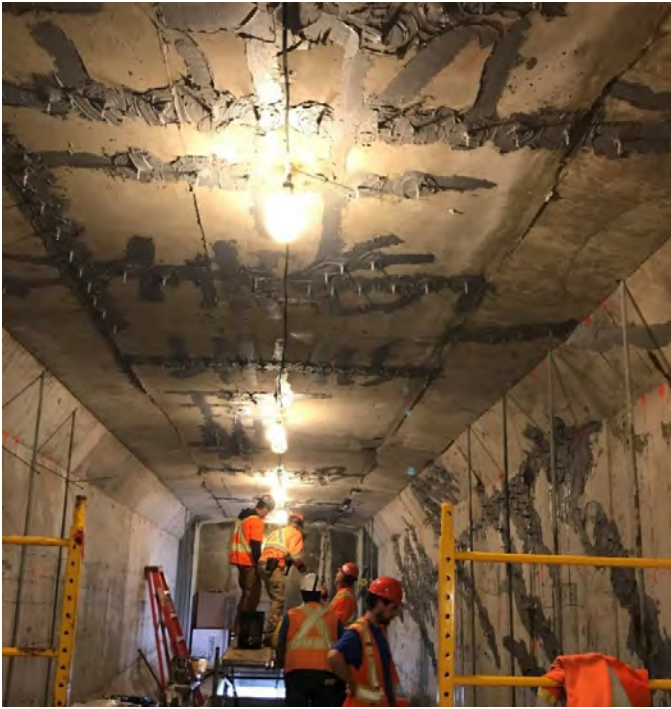
Fig. 7: Crack injection preparation

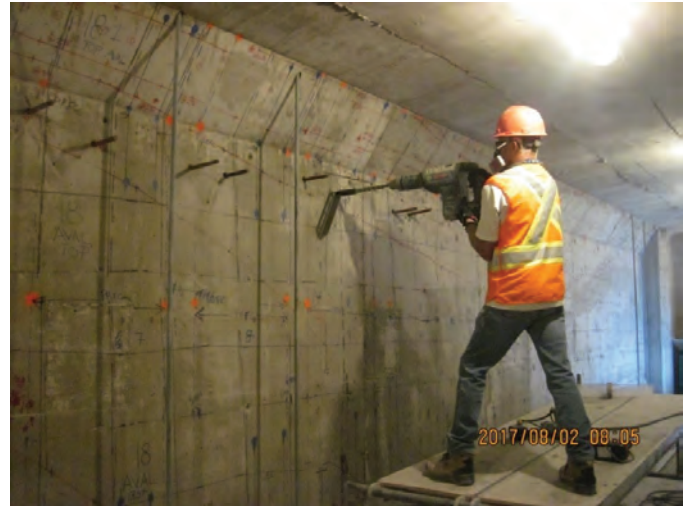
Fig. 8: Steel CFRP anchor plate horizontal hole drilling

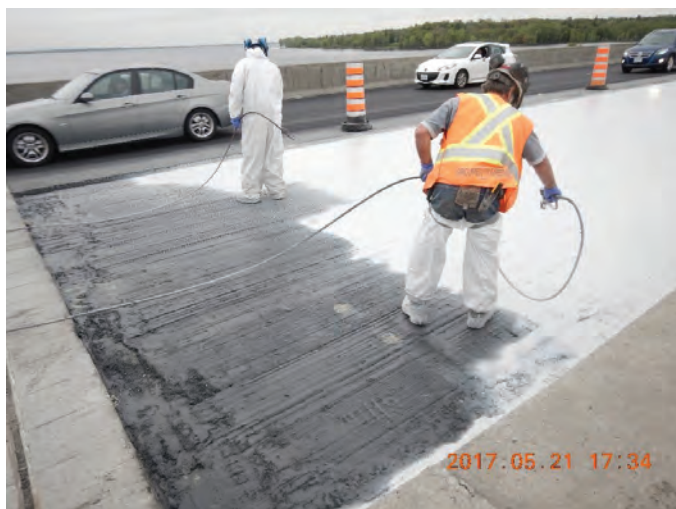
Fig. 15: Spray applied waterproofing deck membrane application

A liquid waterproofing membrane (Fig. 15) and new pavement was added to protect the new girder rehabilitation and avoid having de-icing salts from penetrating the new CFRP repair from deck cracks and preventing premature concrete delamination and additional internal prestressing cable corrosion. This assures the required dry surface condition for the CFRP installation on the girder webs and near the top slab location.

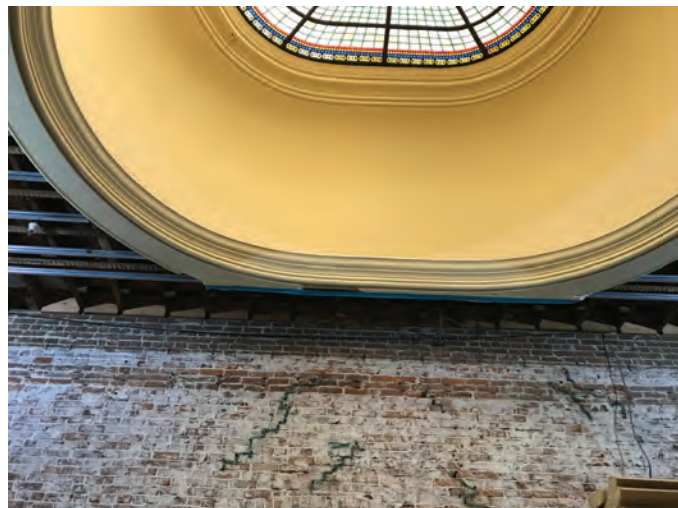
Fig. 2: The unreinforced masonry walls crumbled while the glass from the vaulted glass dome on the second floor was undamaged

The Courthouse suffered extensive damage after a 6.0 magnitude earthquake struck the region on August 24, 2014. The load bearing masonry walls, plaster, and wood trim exhibited severe damage from the excessive movement (Fig. 2). Shear cracks ran through many of the exterior and interior walls, coupled with diagonal cracking through many of the window spandrels. A gaping hole was visible at the southeast corner roofline, and portions of the interior walls were in danger of collapsing. HVAC, fire sprinklers, and electrical systems were also impacted.

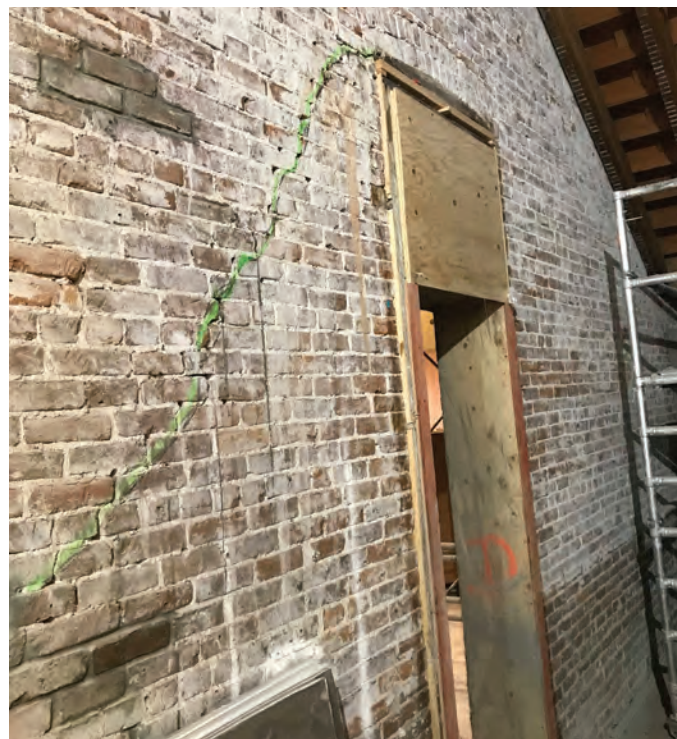
Fig. 3: The unreinforced masonry walls crumbled while the glass from the vaulted glass dome on the second floor was undamaged

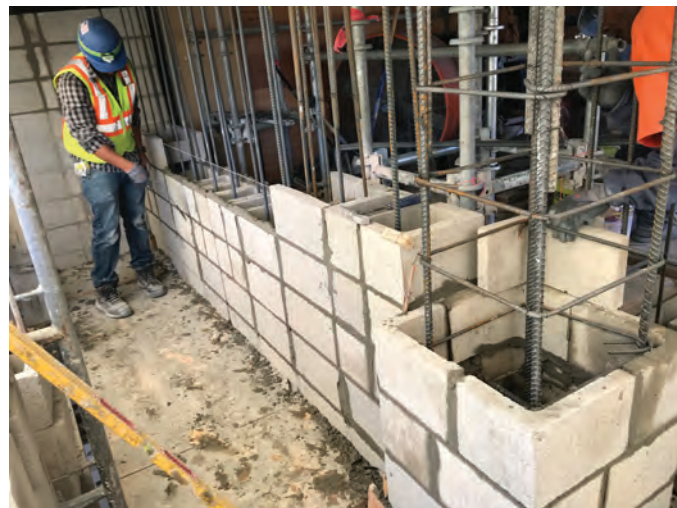
Fig. 4: The versatile building block enabled reconstruction in areas that were completely destabilized

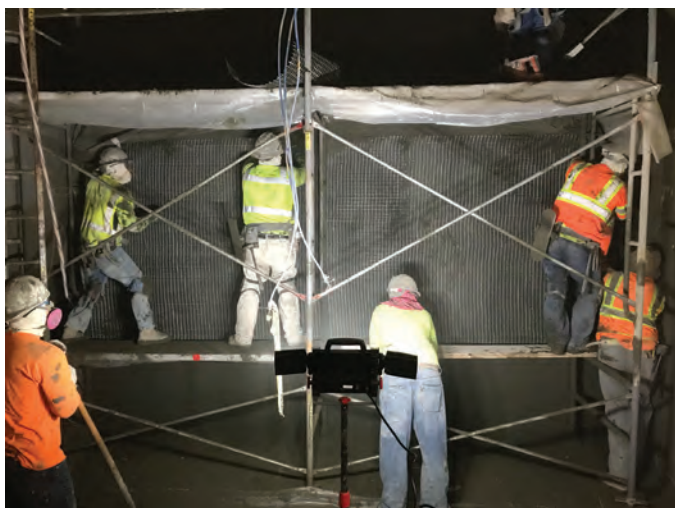
Fig. 5: Reinforcing a wall with the FRCM system

To implement the FRCM application, the bricks were brought to the correct moisture content and nominal 1 in (25 mm) thickness for FRCM to properly adhere. Teams

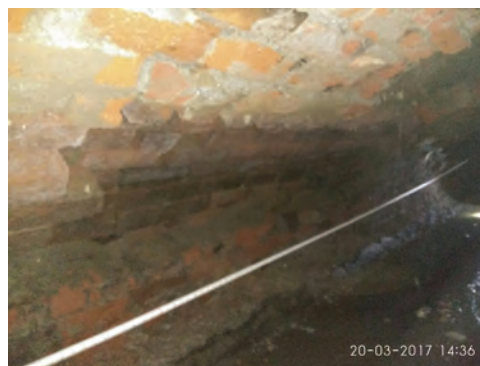
Fig. 2: Delaminated and spalling of brick lining

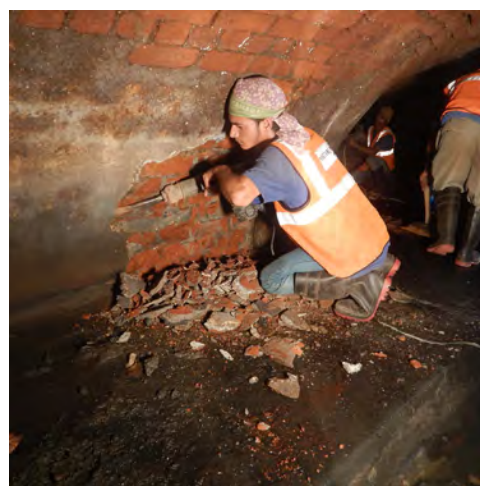
Fig. 5: Demolition of deteriorated brick lining with lightweight breaker

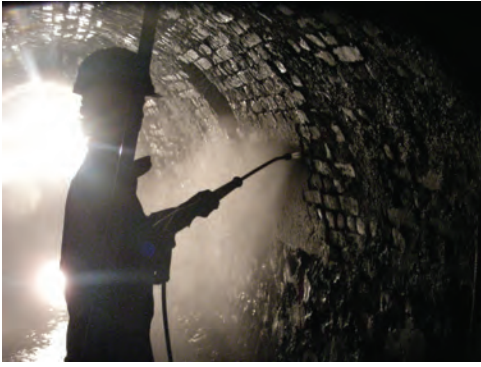
Fig. 6: High-pressure waterjet washing

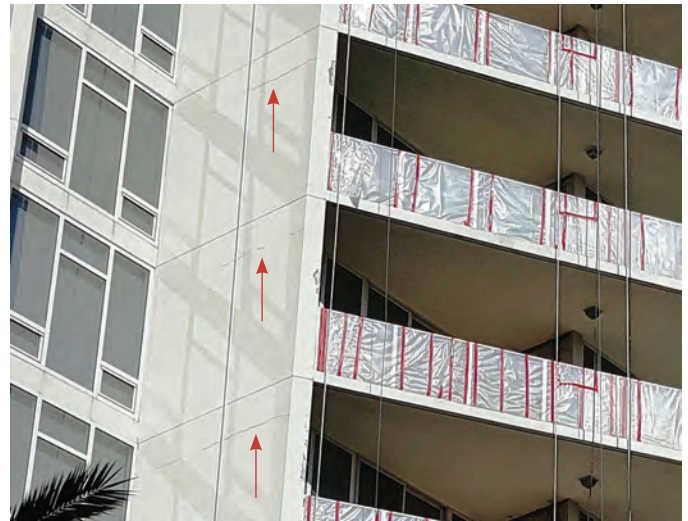
Fig. 2: Cracks in stucco on every floor at bottom of turndown beam to top of wall

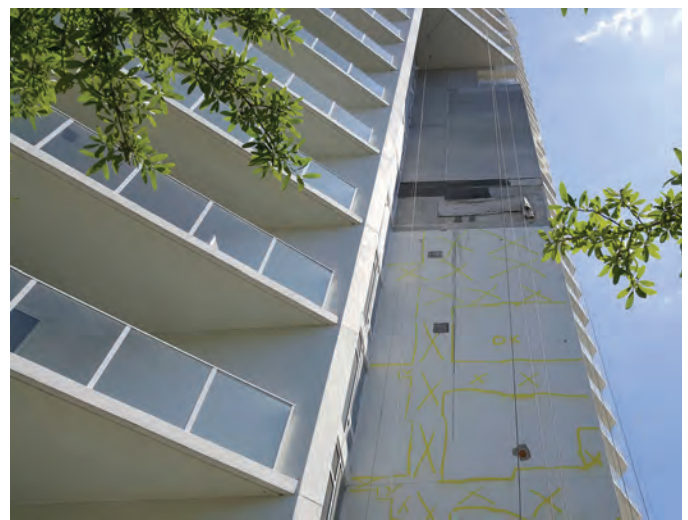
Fig. 3: Stucco marked up for removal after sounding

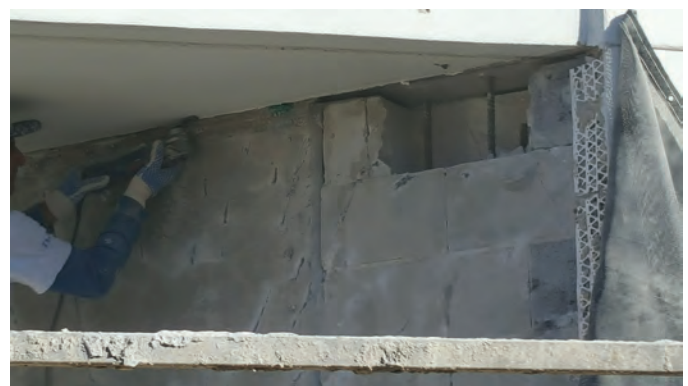
Fig. 4: CMU reinforced cells missing grout

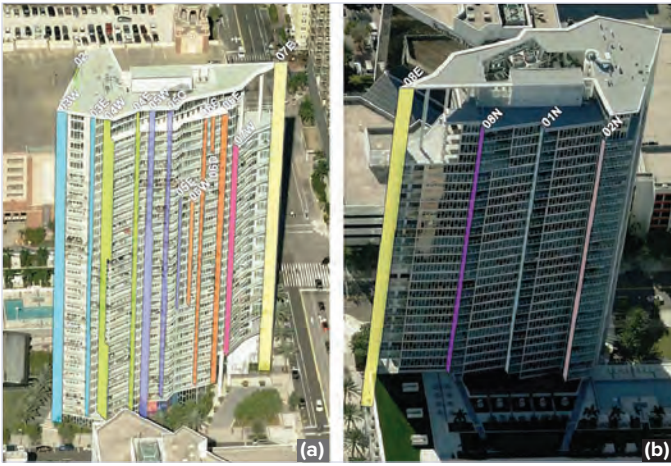
Fig. 5: Graphics showing shear wall elevations planned for repair – (a) south elevation, and (b) north elevation

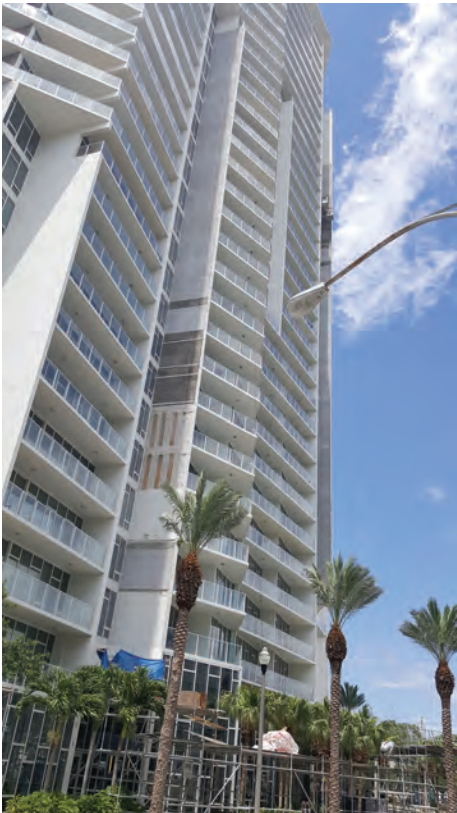
Fig. 6: Shear wall under various phases of repair

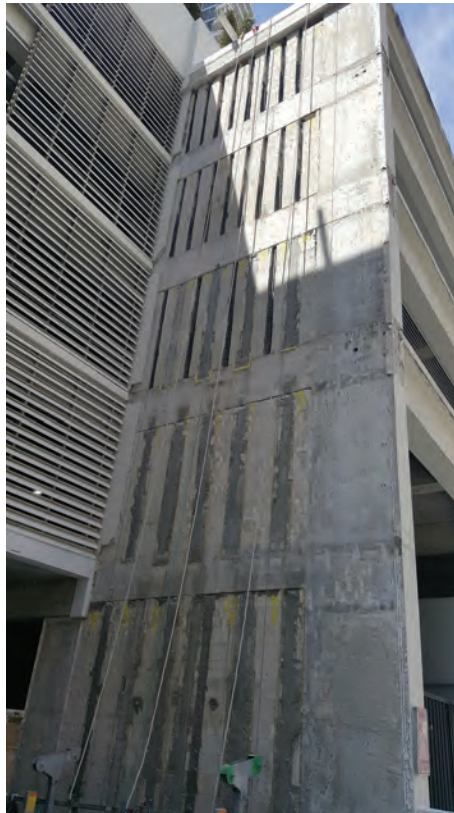
Fig. 7: Parking garage shear wall/barrier wall being reinforced

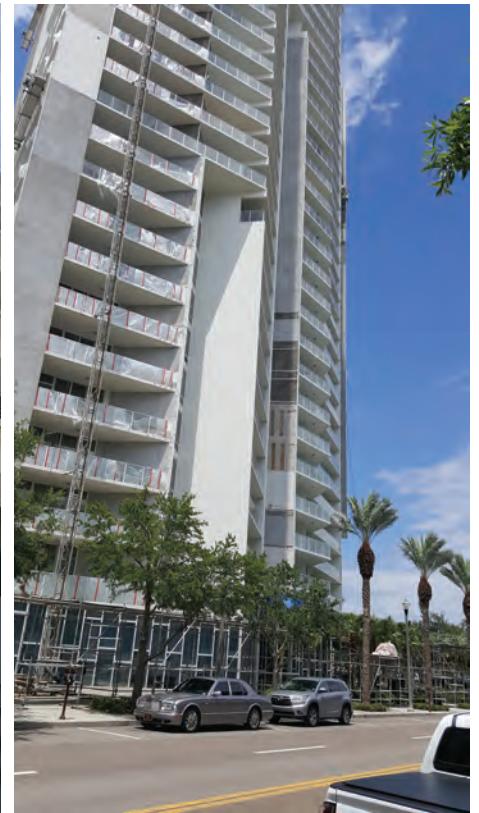
Fig. 8: Stucco replacement, CMU grouting, guardrail protection, overhead protection, and mast climber/swing stage access

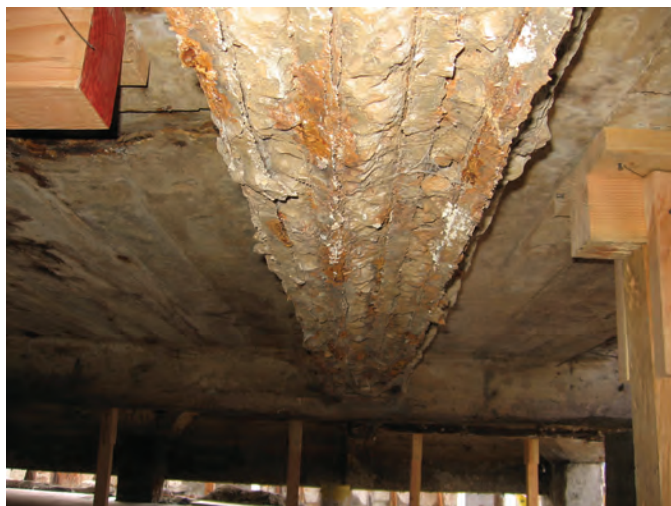
Fig. 2: Extensive spalling of the beams, girders, and slabs caused by severe corrosion of the reinforcing steel

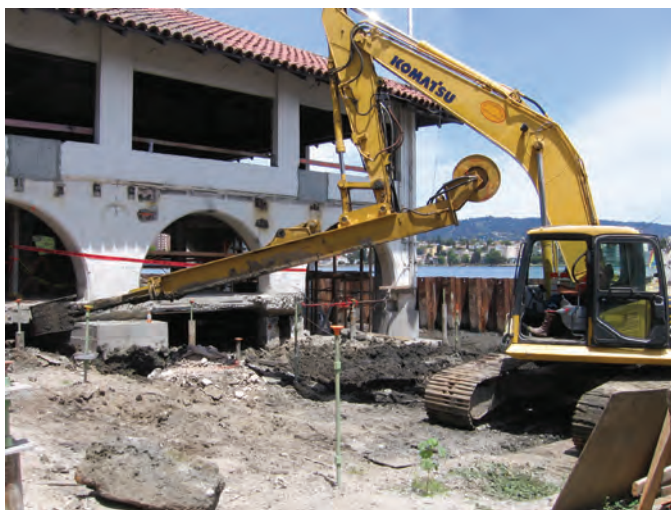
Fig. 3: Modified excavation equipment to remove the mucky soil under the supported slab

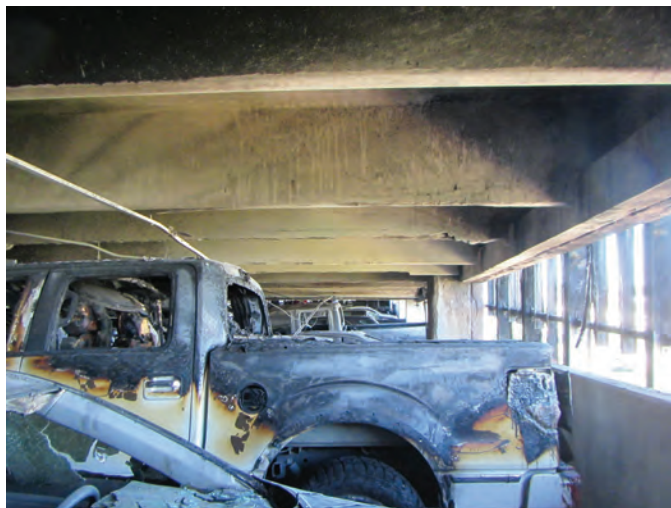
Fig. 2: Fire damage on Level 3 of parking garage

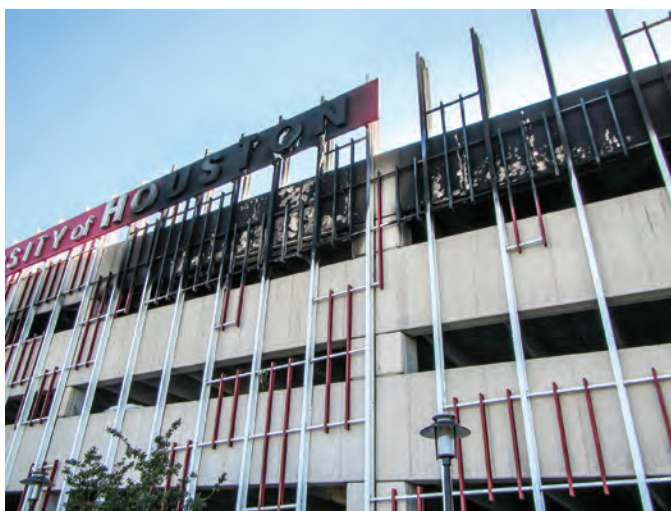
Fig. 3: Fire damage at exterior of garage

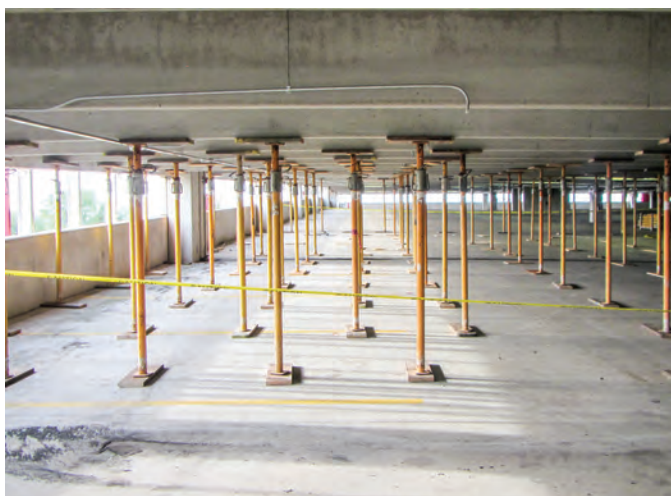
Fig. 4: Shoring installed in affected area

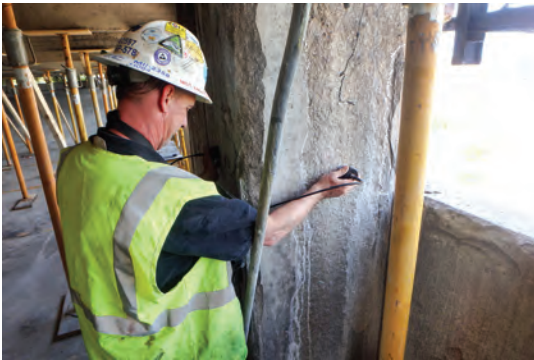
Fig. 5: Nondestructive testing performed at damaged column

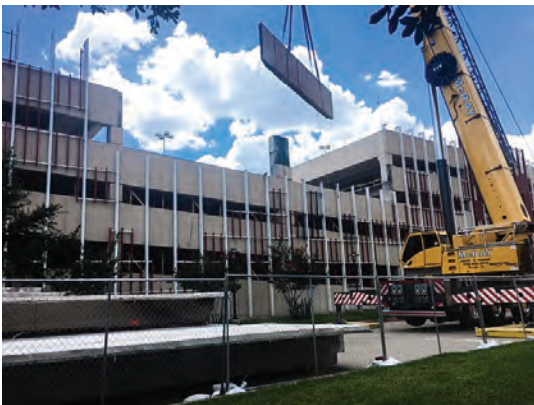
Fig. 6: Spandrel beam replacement

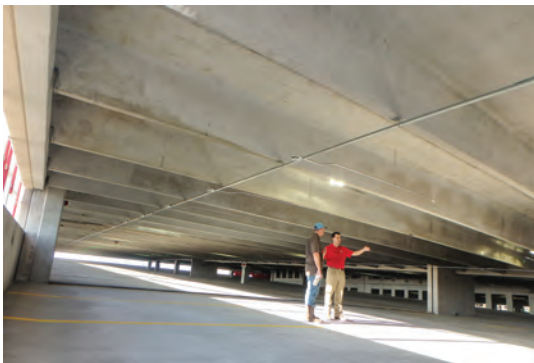
Fig. 7: New double tee beams

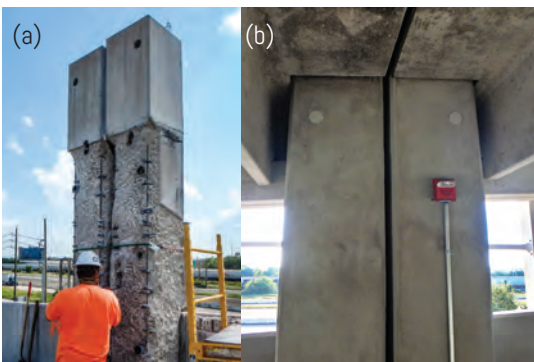
Fig. 8: Column repair (a and b)

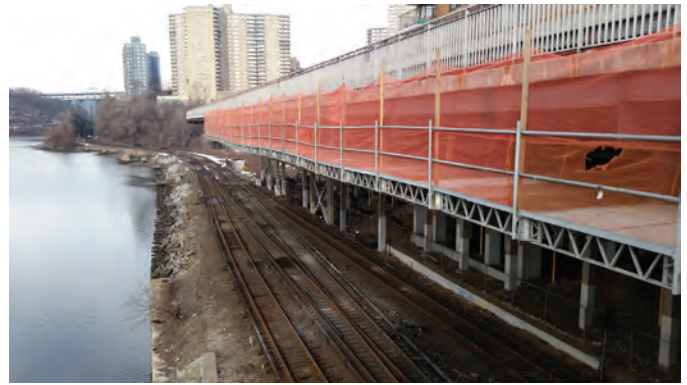
Fig. 2: Work platform suspended under the building

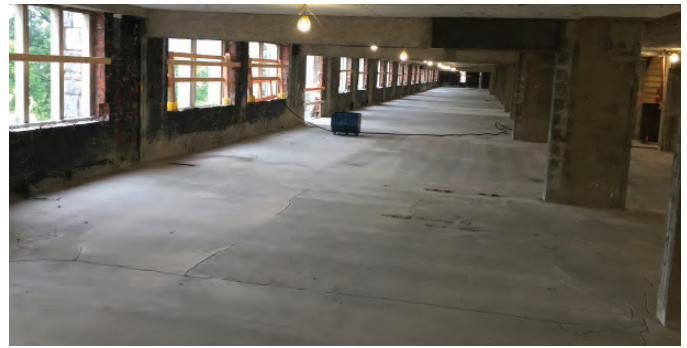
Fig. 2: Barrack slabs prepared by shotblasting before installing the crack infills and CFRP

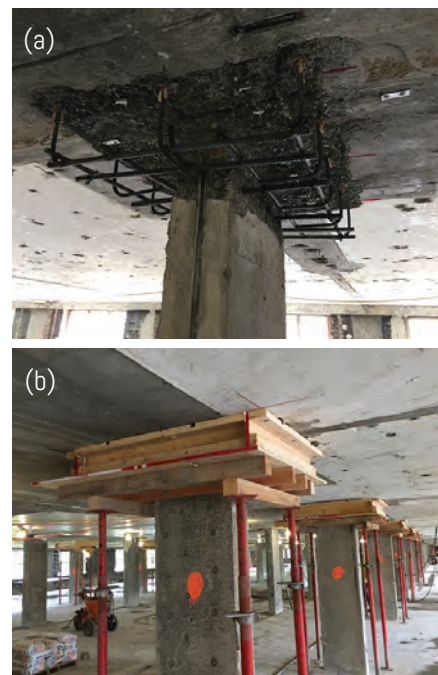
Fig. 4: Shear capital repair - (a) preparing and reinforcing the concrete surface, and (b) installed formwork prior to concrete pumping

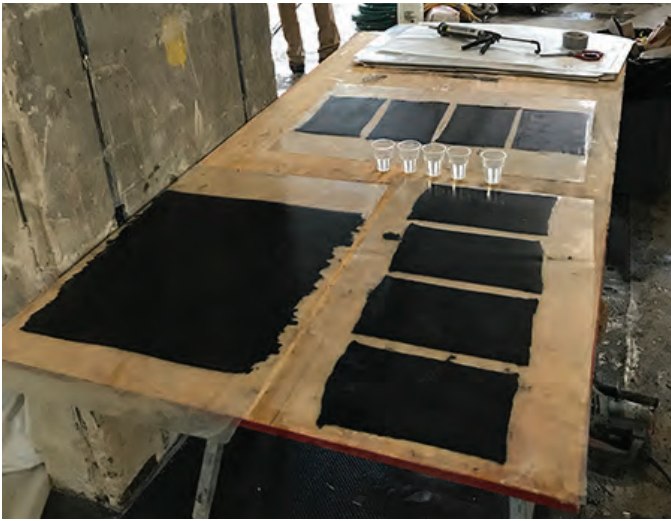
Fig. 5: Witness panels and epoxy resin cups for the QA/QC plan
