# CONCRETE REPAIR March/April 2018 Vol. 31, No. 2 BULLETIN

A Bimonthly Publication of the International Concrete Repair Institute

## DOCKS, LOCKS AND CANALS

## To Repair or Replace: Structural Assessment of Damage at the Steeplechase Pier

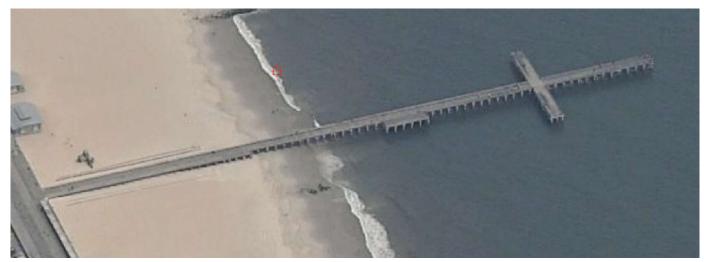
Fig. 1: Aerial view of Steeplechase Pier, Coney Island, Brooklyn, NY @ 2003 Pictometry (Reproduced with permission)

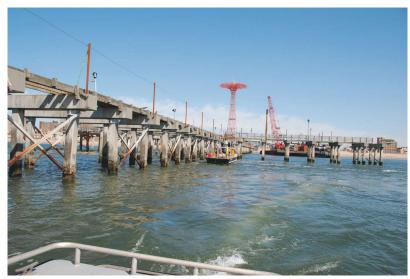
Fig. 2: Overview of pier construction (some existing wood decking and framing remains)

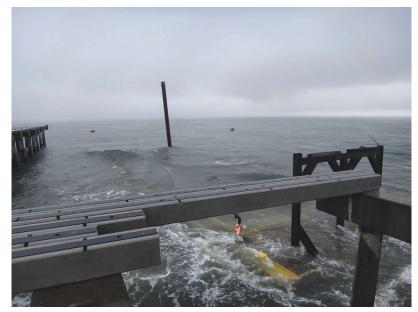
Fig. 3: View of completely-submerged barge (the submerged barge came to rest away from the pier)

On April 12, 2013, a construction barge that was stationed adjacent to the southern tip and west extension of the pier suffered a failure of the "spud" mooring system and began to take on water in rough seas. The barge began to sink and rotate horizontally on the water surface and list (tilt), with the southern end of the barge sinking and the northern end raising up. By April 14, 2013, the majority of the barge had submerged. The sinking, rotating, and listing combined with wave action from rough seas caused the barge to impact the pier at two locations—one at the southern tip and one at the west extension. By April 17, 2013, the barge had completely sunk away from the pier and came to rest on the mudline below (Fig. 3).

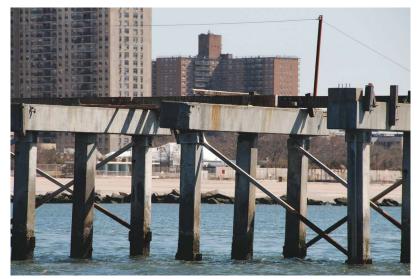
Fig. 4: View of rotated beam at southern tip of pier

southern tip), the entire frame assembly was displaced at the top (as seen with the naked eye) from its original position. At all three locations, the impact of the barge imparted large lateral forces on the frames, resulting in lateral displacement and shear failures of the piles in a zone directly below the beam. Large horizontal cracks running completely through the pile cross-section, along with associated concrete spalling and lateral displacement across the pile axis, provided evidence of shear failures. The condition of the piles below the waterline remained unknown (Fig. 4 through 6).

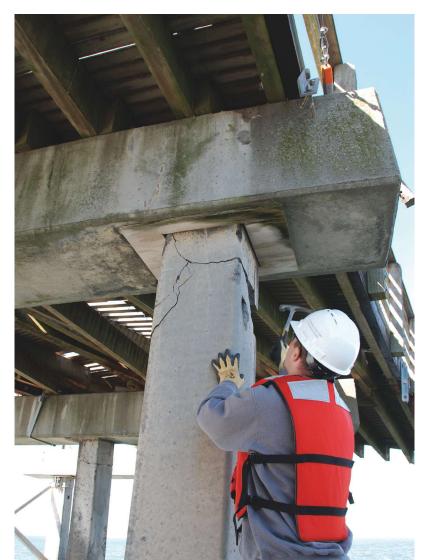
Fig. 7: Sounding at affected piles

Poor weather and difficulty finding an appropriate boat that could navigate between the piles delayed the investigation until April 25, 2013. While on site, the boat was positioned between and against the piles, making hands-on surveys possible from the deck of the boat. Ground penetrating radar (GPR) determined the locations and typical configurations of reinforcement. GPR results were confirmed, along with the sizes of reinforcement, at the concrete spalls caused by the barge impact. Portions of the piles accessible above the waterline were also sounded to survey for damage or delaminations not visually apparent. This hands-on survey from a boat indicated that significant distress to the piles above the waterline was only at the plainly-visible distressed zones (Fig. 7 and 8).

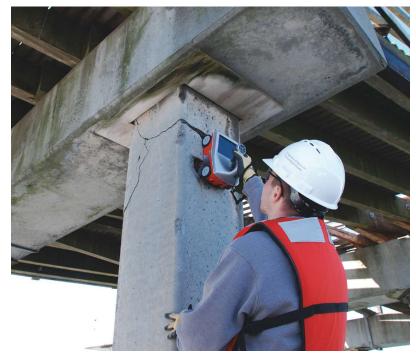
Fig. 8: Ground-penetrating radar (GPR) at affected piles

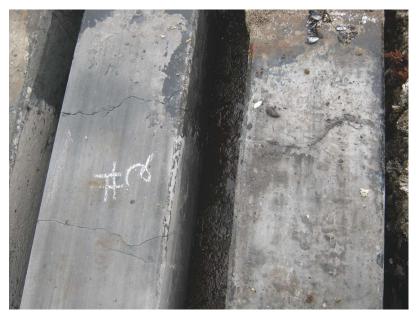
Fig. 9: View of damage to affected piles, after removal, below mudline

of the existing piles would be selectively demolished and the stub piles would be connected to the existing piles to transfer only shear and axial loads. This initial repair design would effectively shorten the length of the existing piles and upgrade the pile-beam connection from a pinned connection to a full-moment connection. Development of this repair design stopped shortly after an existing pile tipped following removal of the beam. Following the pile failure, and as directed by the owner, the contractor removed and surveyed the affected piles on a barge. At previously-unseen areas below the mudline, the piles exhibited notable damage, such as cracking through the full cross-section, further confirming that the initial repair design would not correct all of the damage (Fig. 9).

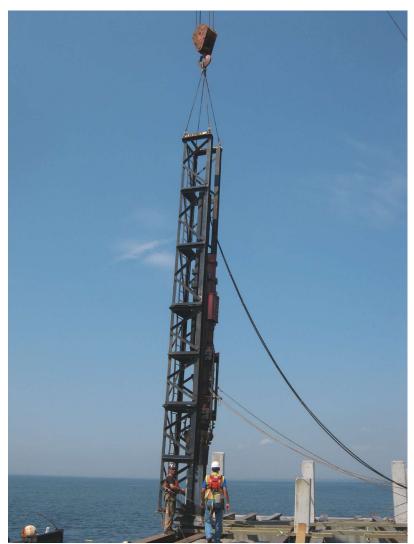
Fig. 10: Overview of driving new replacement pile

Over the course of the project, multiple repair options were designed for various and constantly evolving scenarios. The final design replaced the prestressed concrete piles and precast, conventionally reinforced beams in-kind. However, because of the development of other repair options, improved detailing was implemented and resulted in the final design.

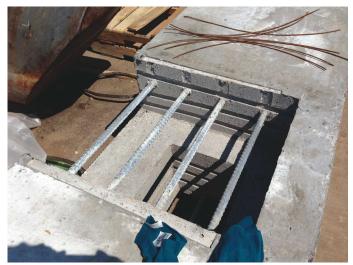
Fig. 11: Pile-beam connection prior to assembly

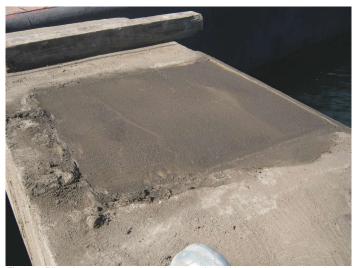
Fig. 13: Pile – beam connection after grouting with rapid-strength-gain repair mortar

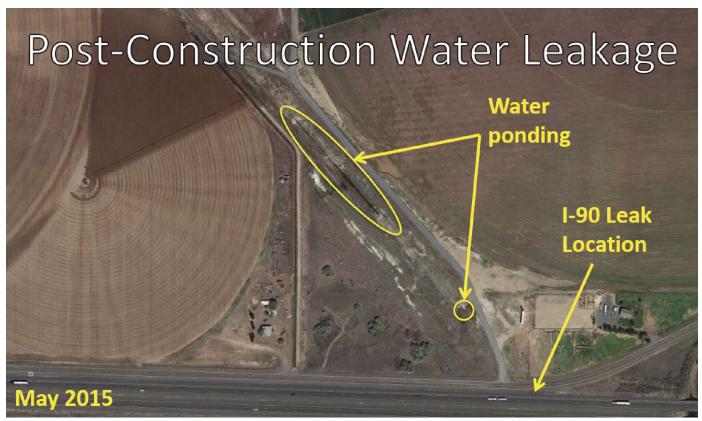
Fig. 1: Water leakage above the Weber Coulee Siphon after construction of the new barrel section

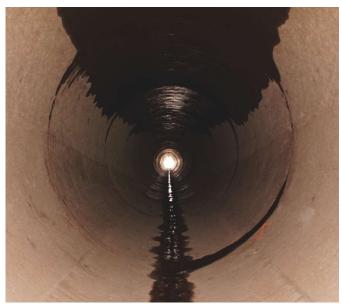
Fig. 3: Looking upstream from inside the siphon. Due to the slope of the siphon, condensation and leakage water also collects on the crown of the siphon

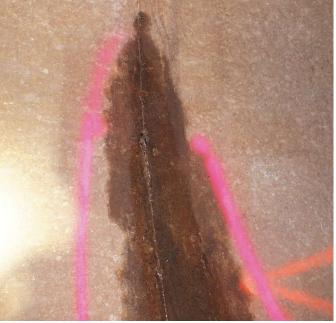
Fig. 4: Water leakage through a joint in the siphon barrel

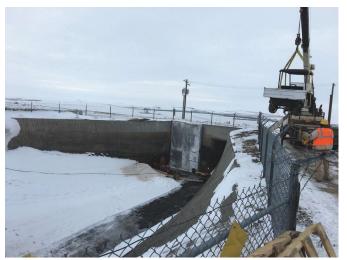
Fig. 6: Lowering materials and equipment to siphon entrance after clearing snow and ice

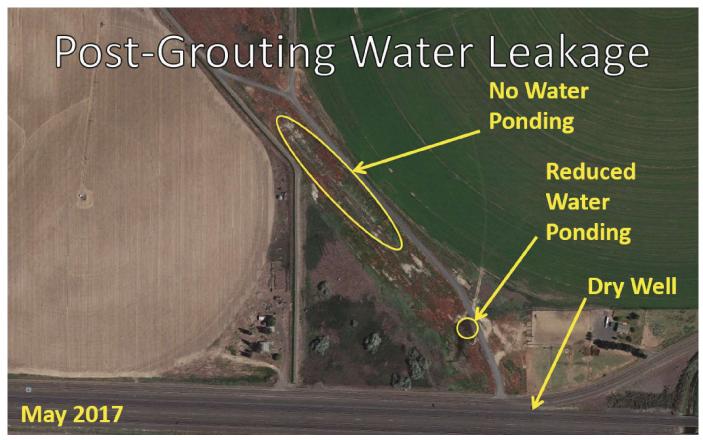
Fig. 8: Site conditions after completing Phases 1 and 2 of the repair plan

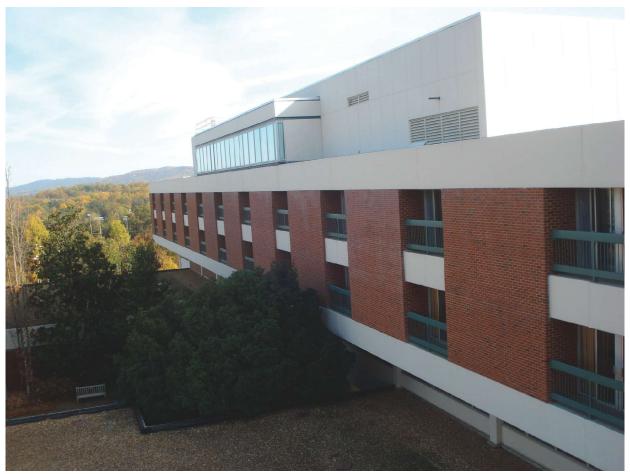
Fig. 1: Building north elevation prior to repair

fter a preliminary evaluation of the building revealed severe material deterioration with the exterior walls and structural frame of the building, the owner embarked on a major renovation program to replace the exterior wall systems and to rehabilitate the structural framing. Balancing the exterior repairs with the concurrent interior renovations and full occupancy, while taking into account the needs of both the owner and the tenant, resulted in several challenges to overcome throughout the course of the project (Fig. 1 and 2).

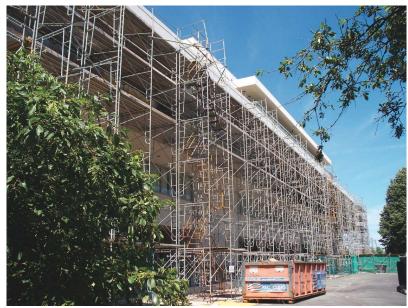
Fig. 2: Building south elevation during construction

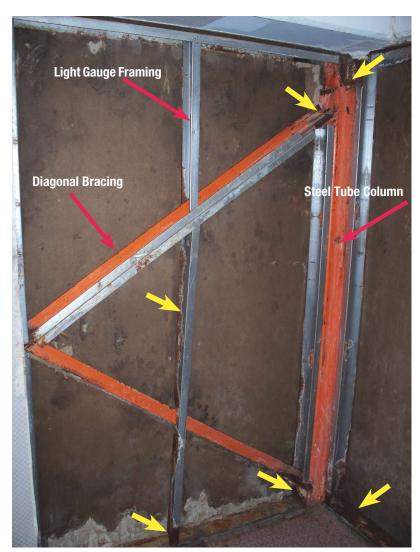
Fig. 3: Steel stud framing corrosion

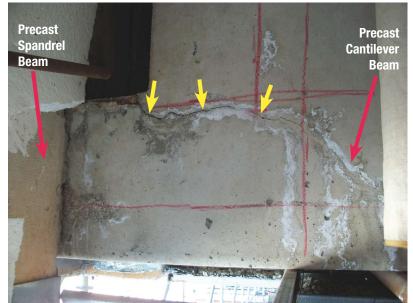
Fig. 5: Original design detail at cantilever beam dapped end

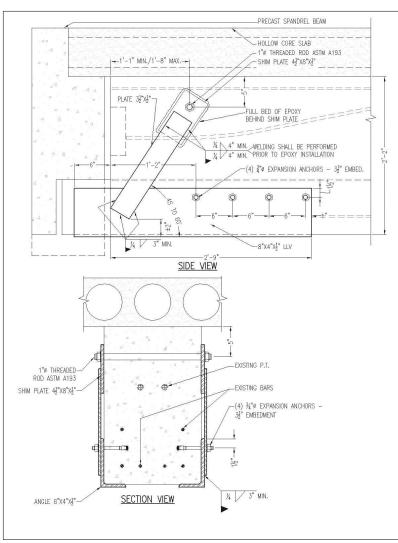
Fig. 6: Supplemental steel frame details at dapped end of beam

The supplemental steel frame incorporated steel plates and angles to act as tension and compression members with a 1 in (25 mm) diameter throughbolt and expansion anchors to transfer loads into the beam (Fig. 6 and 7). The first conceptual repair

design included expansion bolts instead of the through-bolt at the top of the beam, but the final design adopted the through-bolts. The value in using a through-bolt at the top of the beam at each repair was four-fold:

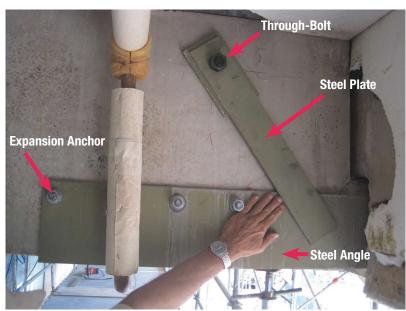
Fig. 7: Supplemental steel frame installed at dapped end of beam

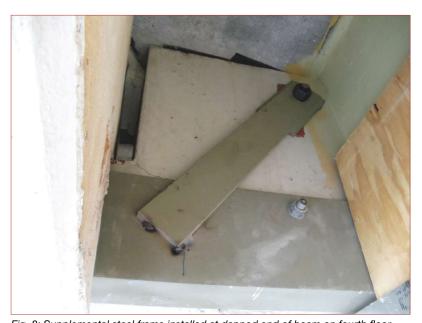
Fig. 8: Supplemental steel frame installed at dapped end of beam on fourth floor

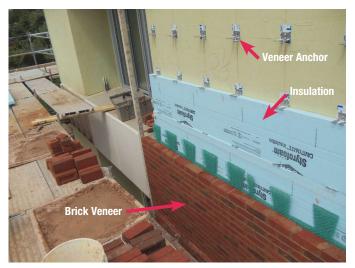
Fig. 9: Brick veneer installation with new veneer anchors

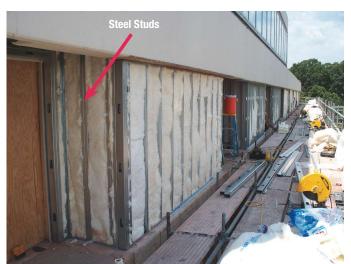
Fig. 10: Exterior wall replacement

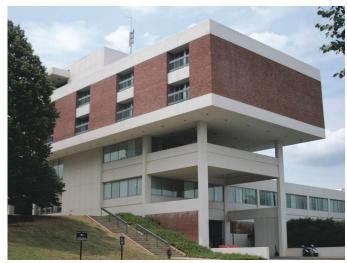
Fig. 12: Completed southeast elevation
