CONCRETE REPAIR

November/December 2018
Vol. 31, No. 6

Project of the Year:

THE EDISON BATTERY BUILDING

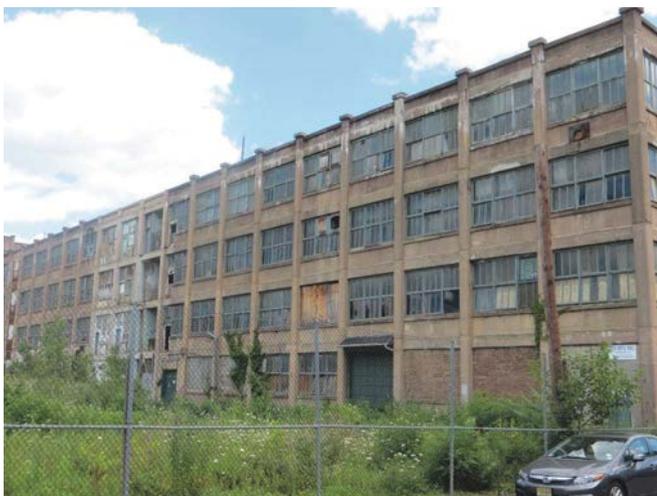
Fig. 4: Existing building façade prior to repairs

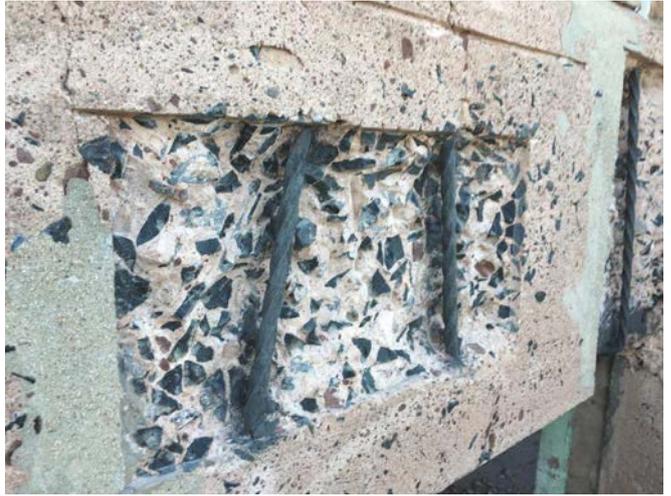
Fig. 5: Hand-applied repair

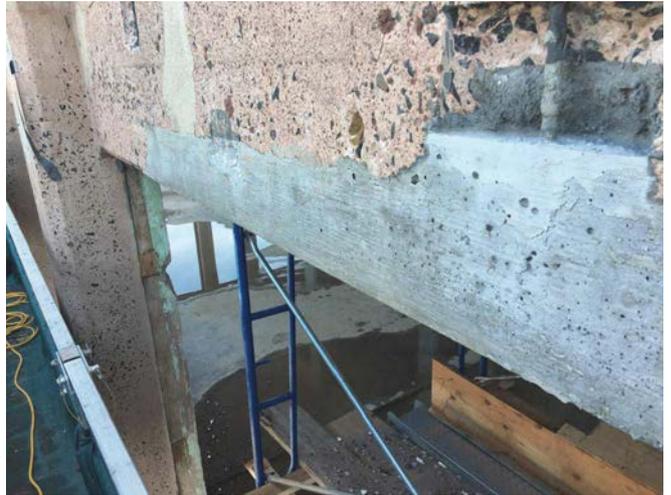
Fig. 6: Form and pour repair

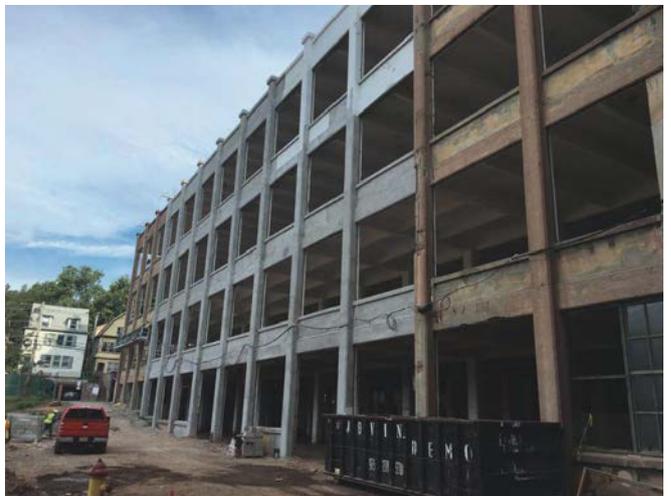
Fig. 7: Section of the building that received a parge coat

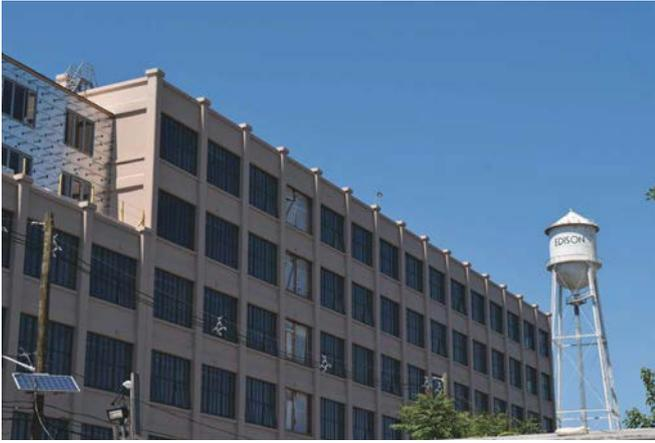
Fig. 8: Finished exterior with the iconic Edison water tower in the background

After the leveling coat, a waterproofing coating was installed for aesthetics and protection (Fig. 8). A coating with crack bridging was selected to coat the entire building façade. To meet the requirements of the historical commission, a textured base coat was selected to cover the blemishes and maintain some of the look of the old concrete. No less than twenty color samples were installed on the building as mock-ups for approval by the historical commission. The selected final color, Capitol Tan, also happened to be the first color that was installed as a sample.

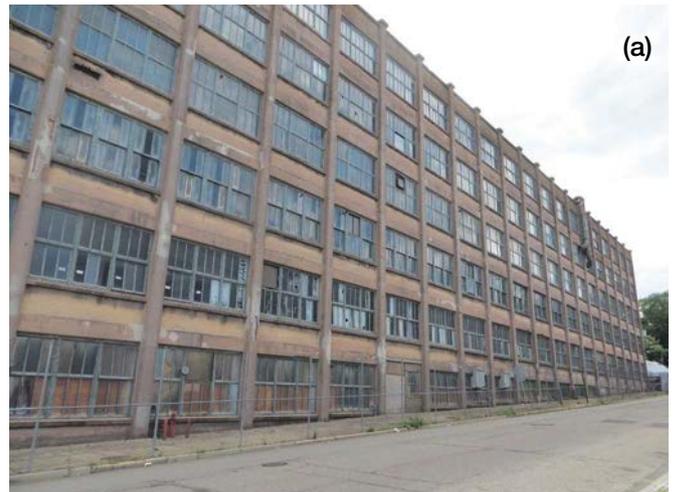
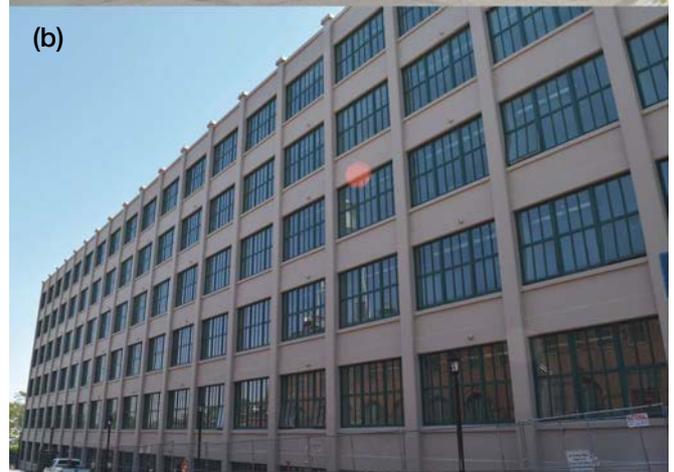
Fig. 11: The Edison Battery Building before repairs (a) and after repairs (b)

For quality assurance, a third-party oversight consulting firm was engaged to keep track of progress and make recommendations to the project team on unforeseen conditions during repair. This control helped deliver quality repairs with recommendations that were adequate for non-standard details. This iconic structure was restored in 30 months and completed on time and on budget (Fig. 11).

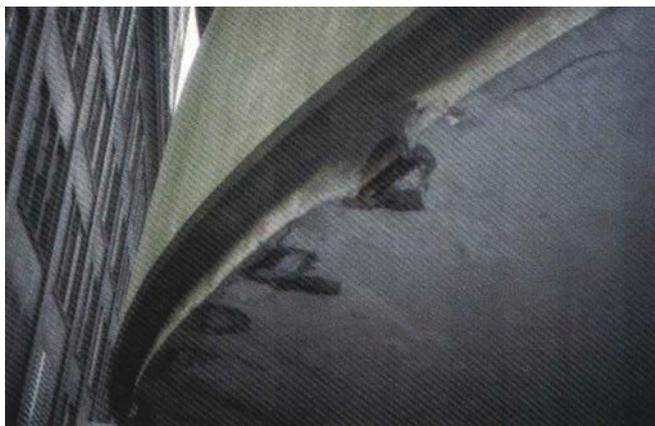
Fig. 2: Original slab edge deterioration

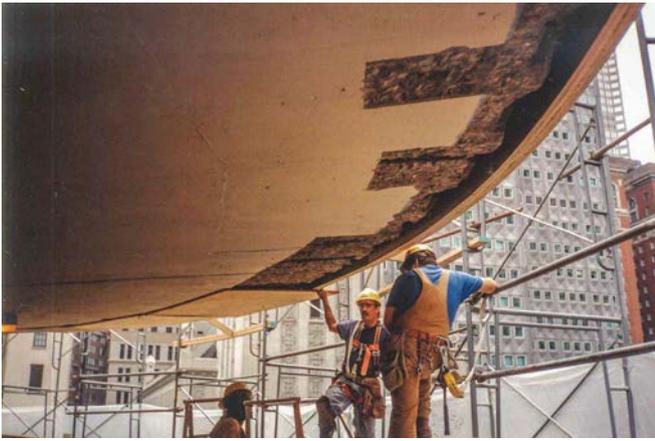
Fig. 5: Slab edge soffit demolition and formwork

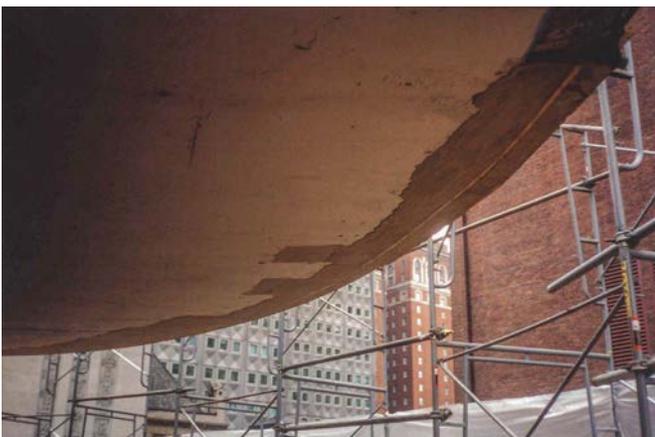
Fig. 7. Completed slab soffit repair with integral drip edge

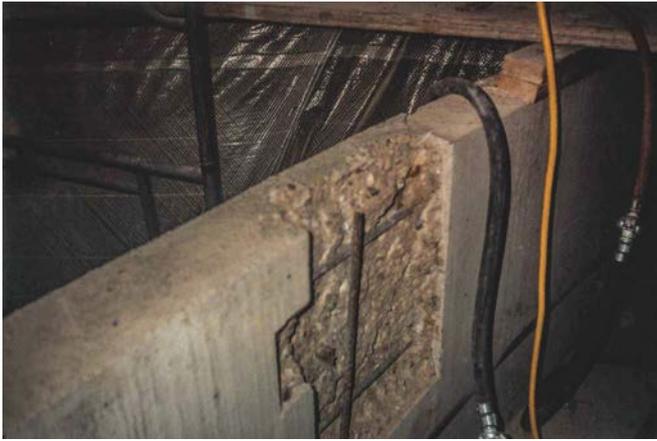
Fig. 8: Knee wall vertical repair demolition

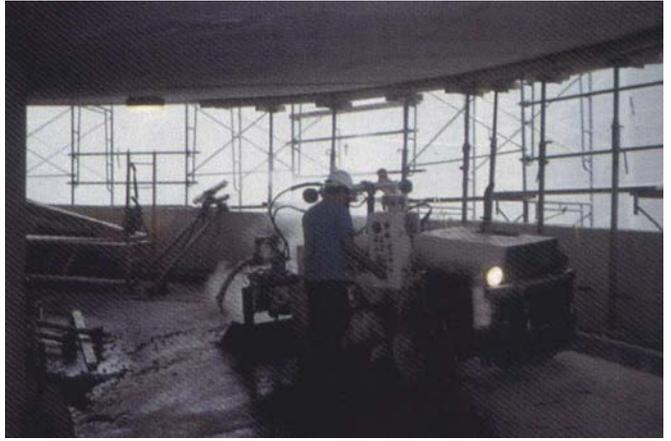
Fig. 9: Hydrodemolition of upper concrete layer at ramp slab

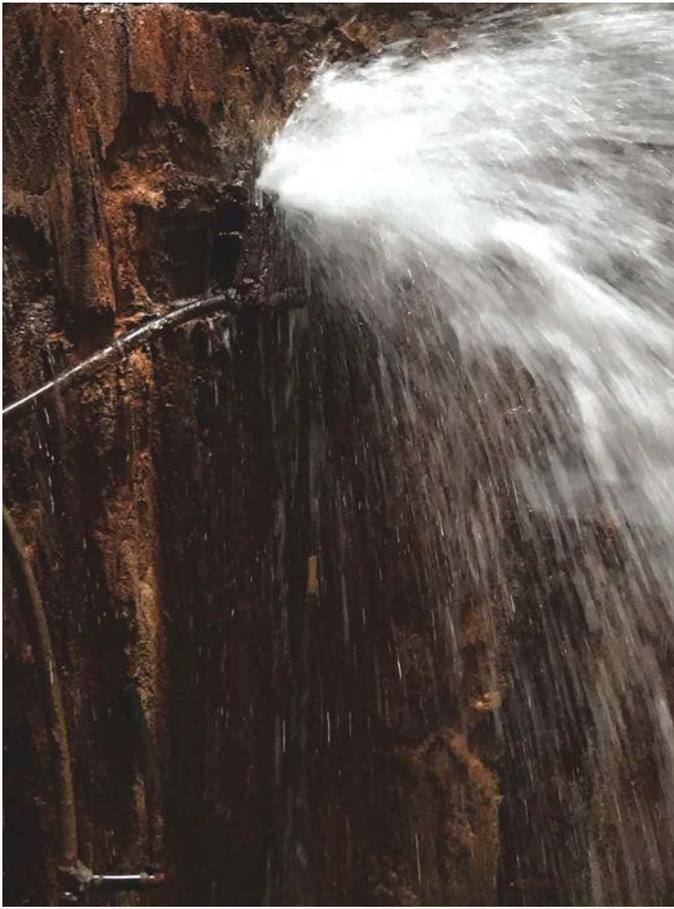
Fig. 2: Major water penetration points were blasting masses of water 12 in (300 mm) wide across the 23 ft (7 m) diameter of the shaft. The extreme pressure of the water was causing damage to the shaft structure and made the repair a very dangerous project.

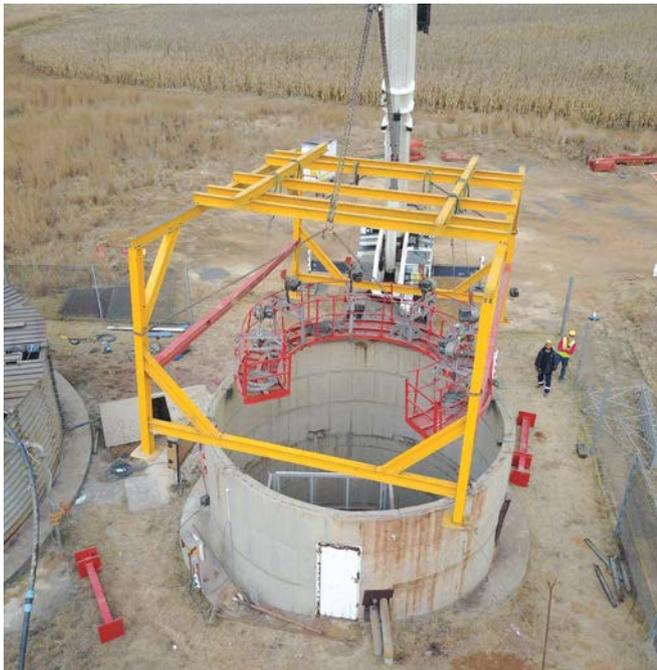
Fig. 3: Access to the shaft was a huge safety and logistical concern. The access specialists were able to supply a custom-built cradle to lower workers into the shaft. This cradle was anchored to the sides of the shaft to ensure no movement during the high-pressure cleaning and sandblasting.

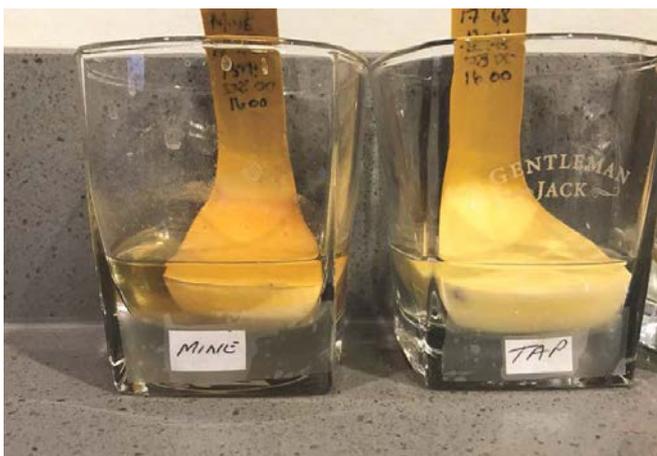
Fig. 4: Swelling waterstop being tested with shaft water vs tap water.

With information gathered by visuals, a swelling waterstop had to be introduced to the positive side to reduce the water flow to a manageable condition (Fig. 4 and 5). In order to prepare the site for the application of crystalline waterproofing products, the damaged sections of concrete had to be cleaned and prepared using dustless sandblasting and ultra-high pressure cleaning. Concrete cutting machines and chisels were used to chip chases along the entire length of all water ingress points, construction joints and cracks. Running water was stopped by the use of a rapid-setting hydraulic cement and a swelling waterstop (Fig. 6). Chased cold joints were filled with a repair grout (specially mixed dry-mix).

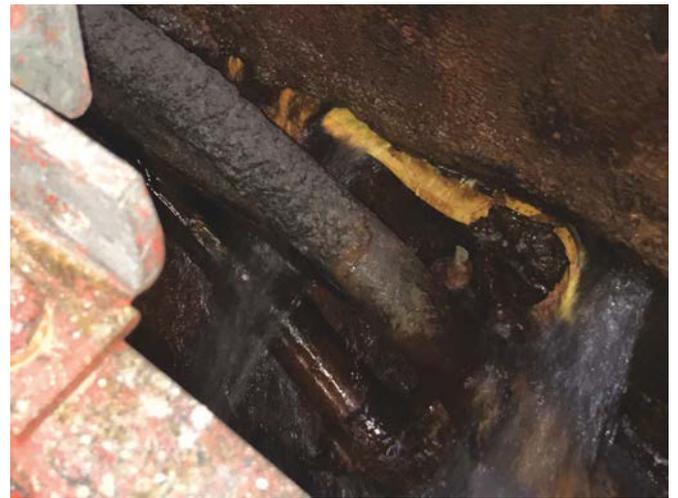
Fig. 5: The waterproofing specialists tested the swelling waterstop on the ingress points to ensure the waterstop would swell to its maximum capacity to alleviate water pressure to continue with the crystalline leak repair system.

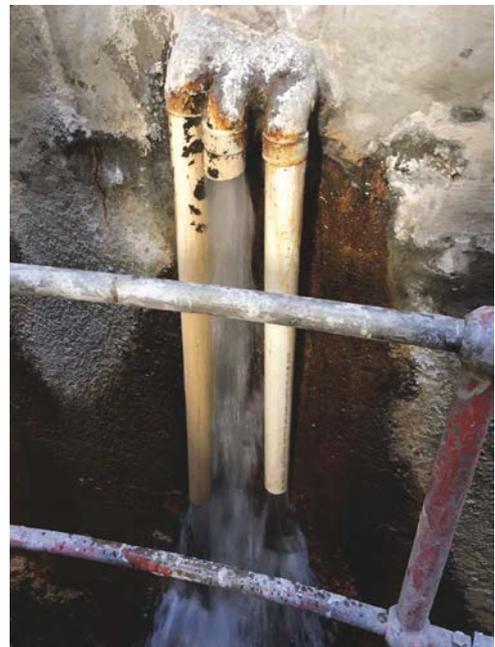
Fig. 6: Using a rapid-setting hydraulic cement and a swelling waterstop, the waterproofing specialists were able to successfully contain the flow of water to a single access point, thus making the water more manageable.

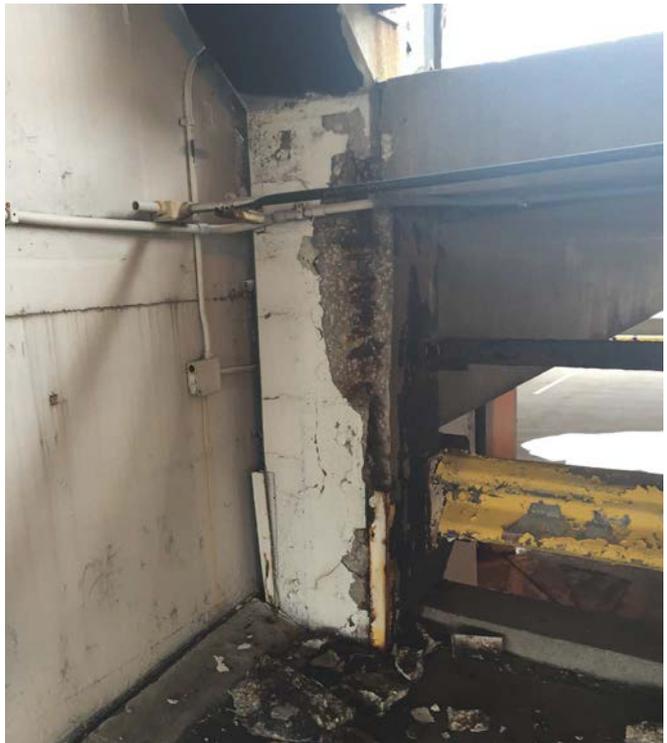
Fig. 2: Existing condition discovered at an interior column

Unsound grout pockets in the beams were opened for inspection, and the unbonded wires were often found to be severely corroded, with a large proportion of wires completely failed. In-situ deflections of the beams were measured to correlate the condition of the tendons to the measured deflections of the beams. Based on the developed correlation, sound grout pockets at beams that exhibited a measured deflection exceeding the developed critical deflection threshold were opened for inspection, as well as beams that were next to slab drains (i.e. likely often exposed to ponding water), and beams that were located to adjacent distress. As a result, emergency shoring was provided for 20 beams and a total of 32 beams were repaired due to significant tendon section loss. The beam repair design was subject to multiple constraints, including structural integrity requirements at beam-column connections, fire-protection, and construction accessibility

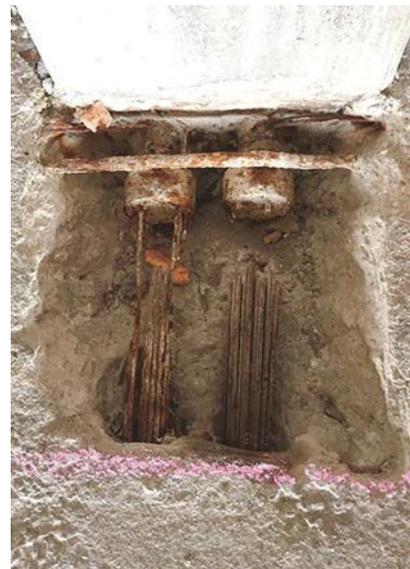
Fig. 3: Many beams were observed to have completely corroded through tendons

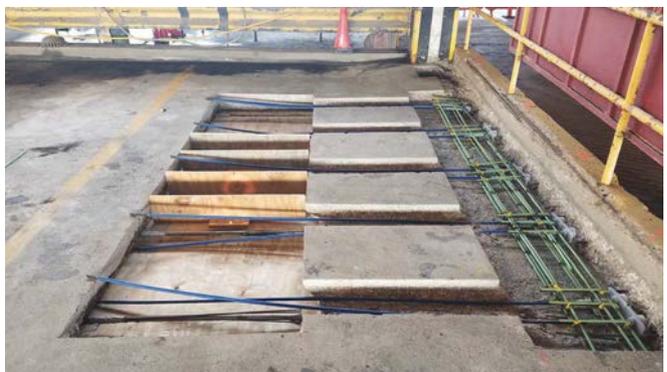
Fig. 4: Placement of new PT anchors

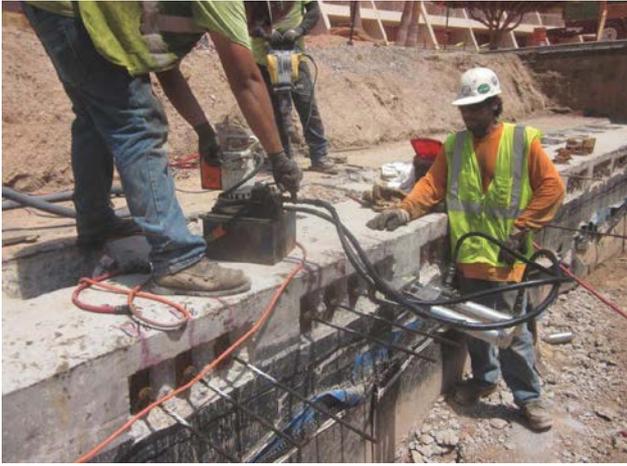
Fig. 5: Post-tension repairs in progress (stressing end)

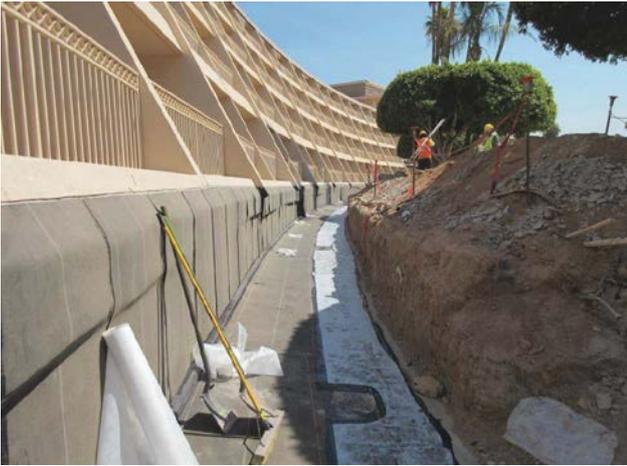
Fig. 6: New membrane and flashing along the expansion joint and building wall
