CONCRETEREPAIR

November/December 2017 Vol. 30, No. 6

BULLETIN

A Bimonthly Publication of the International Concrete Repair Institute

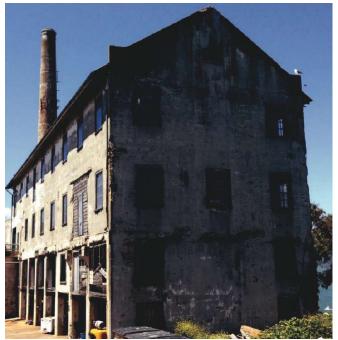
Fig. 4: Deteriorated Quartermaster Building, circa 2013 (prior to restoration)

By 2010, deterioration was visible at nearly all concrete elements, including large spalls and exposed corroded reinforcing steel at the walls, beams, columns, and floor slabs (Fig. 4, 5 and 6). Deterioration was most severe at the exterior walls, but also visible throughout the interior. In many cases, rebar was observed very close to the surface at cracks and spalls.

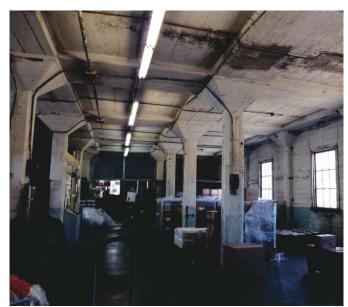
Fig. 7a: Interior area before restoration

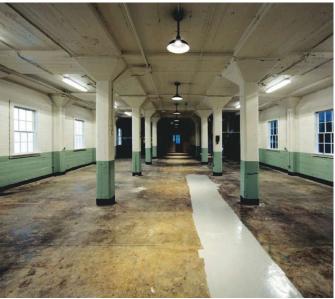
Fig. 7b: Interior area after restoration

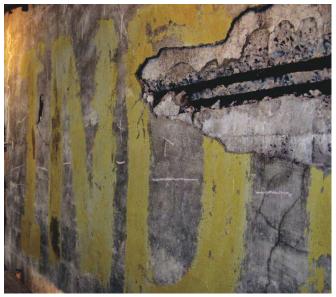
Fig. 10: Deteriorated conditions at locations of political statement in 2014 (prior to repairs)

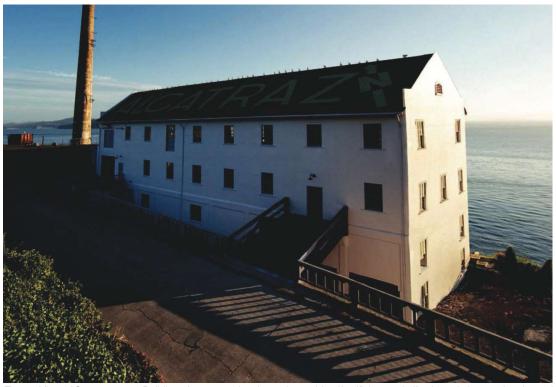
Fig. 13: View of Quartermaster Building after restoration the project to identify efficient and effective solutions to the planned repairs and unforeseen conditions

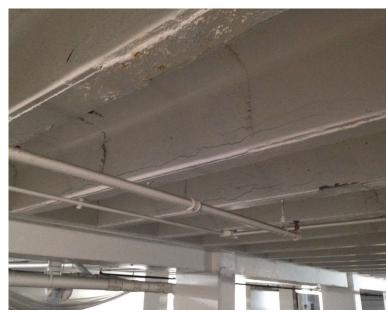
Fig. 1: Concrete deterioration at existing concrete joist.

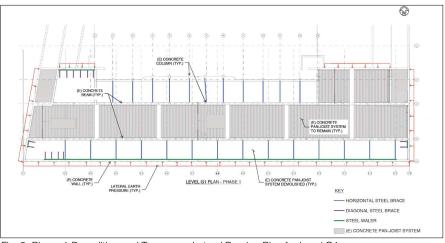
Fig. 3: Phase 1 Demolition and Temporary Lateral Bracing Plan for Level G1

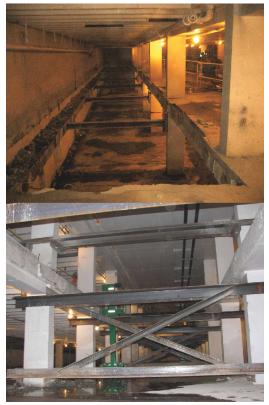
Fig. 4: Demolition and temporary lateral bracing in Phase 1

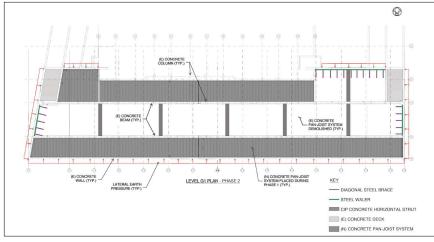
Fig. 5: Phase 2 Demolition and Temporary Lateral Bracing Plan for Level G1

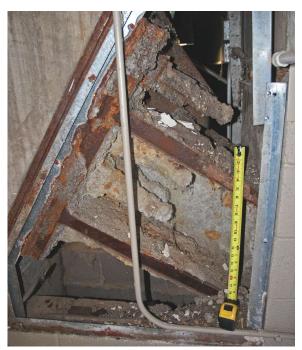
Fig. 3: Raker truss tieback anchor—connection between steel raker truss and concrete frame with sixteen 1-3/8" (35mm) diameter high strength threaded rebar anchor rods. Connection is completely hidden between two masonry walls in a dead space with leaking precast joint directly above. Spray-applied fireproofing absorbs water and never dries out.

The upper seating level has 32 tieback connections. All locations were investigated, prioritized, and 19 locations have been repaired. None of the anchor rods had experienced enough corrosion yet that repairs were required to restore the rod's tensile strength. Severely corroded nuts required replacement.

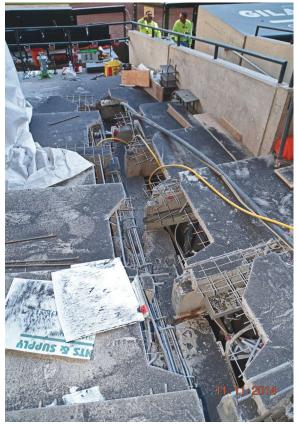
Fig. 7: Precast joint repairs—typical example of demolition required to repair the joints between the precast seating sections. Seismic restraint plates have been completely removed for replacement. Bearing repairs for stems have not started. Nearly every row was affected.

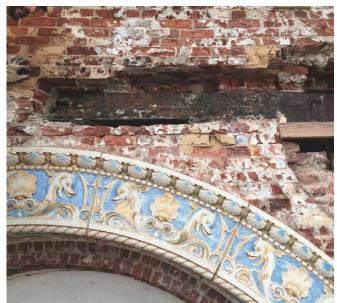
Fig. 3: Steel deterioration near window openings

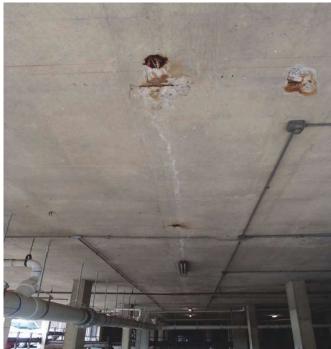
Fig. 3: Cracking of the concrete slab aligned with the electrical conduits at mid-span

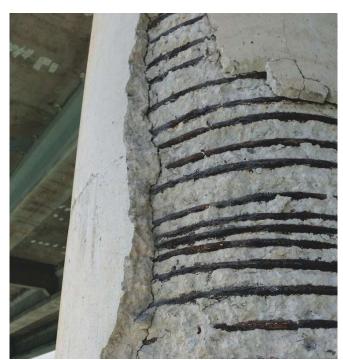
Fig. 2: Column deterioration during the bridge inspection

The original design called for encapsulation of all columns from the pier cap to a height of 20 ft (6 m) and individual spall repairs on deteriorated concrete areas above that height. A sprayapplied migrating corrosion inhibitor was also specified to help protect the column areas that were not being repaired. Soon after construction began, it was agreed that more value could be gained by totally encasing the columns above the 20 ft (6 m) height. As a result, most of the trowel-applied column spall repairs and the migrating corrosion inhibitor were eliminated from the project and instead the columns were totally encased with new, corrosion resistant concrete from top to bottom. This revised approach saved time, provided significant strengthening of the columns, and provided full protection for the column against corrosion by increasing concrete cover by 6 in (152 mm)

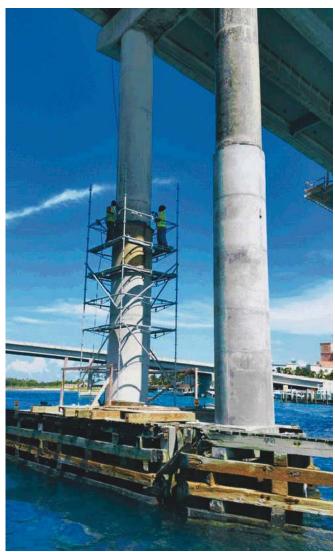
Fig. 3: Repair work at one of the columns

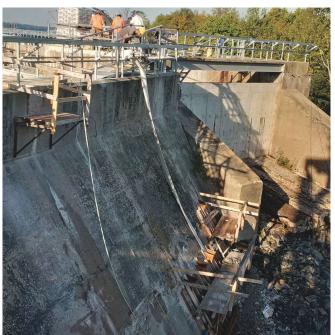
Fig. 3: Placing concrete into wall forms

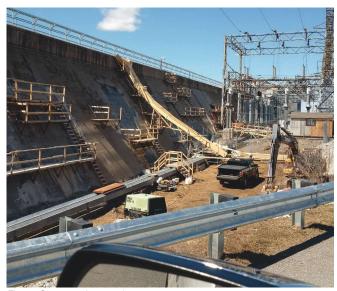
Fig. 4: Concrete formwork

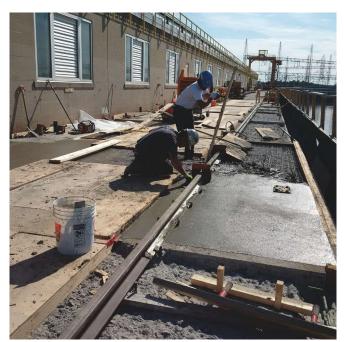
Fig. 5: Finishing deck concrete

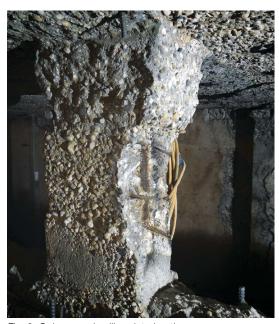
Fig. 2: Column and ceiling deterioration
