# CONCRETE REPAIR BULLETIN

July/August 2017  
Vol. 30, No. 4

## SPORTS FACILITIES

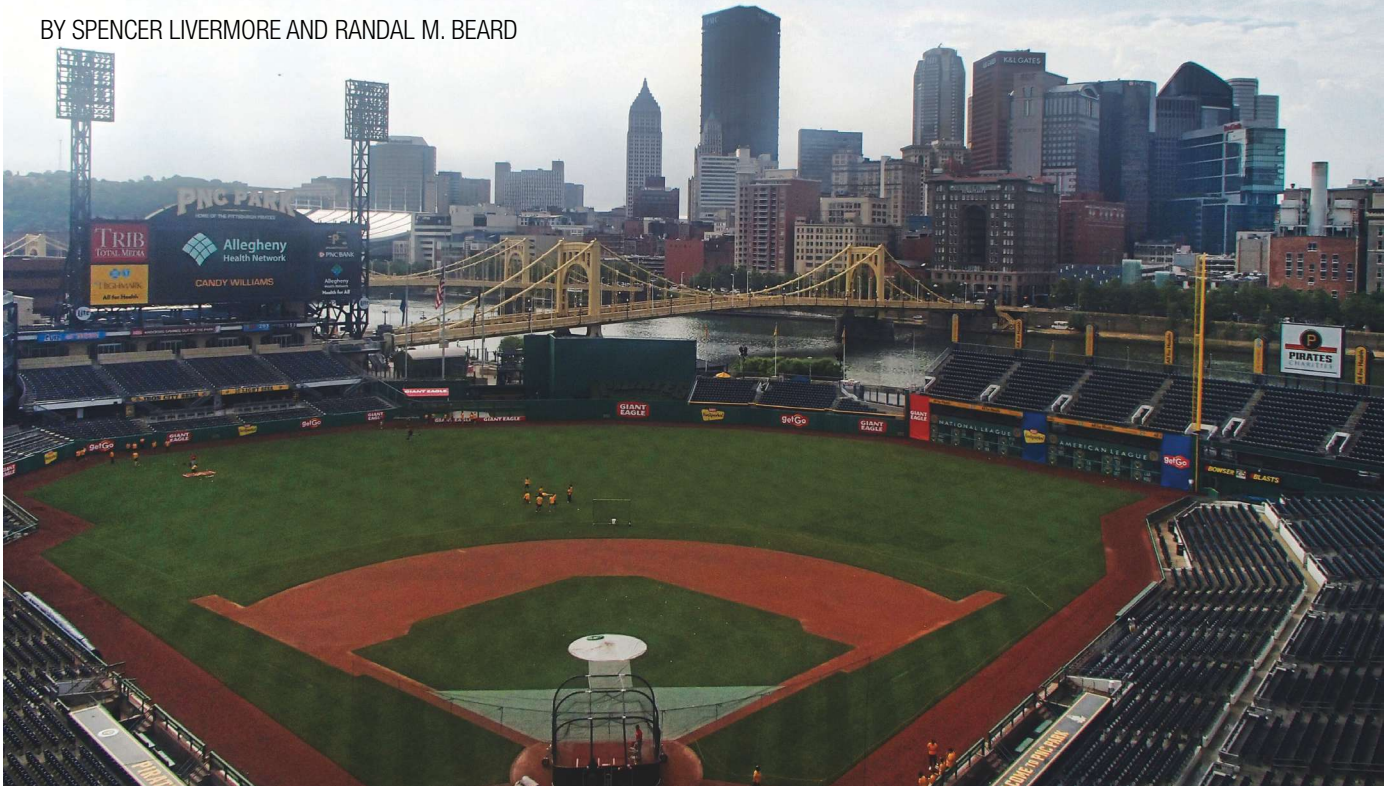
Fig. 1: View of ballpark along riverfront

In 2016, three structural assessments were conducted in Pittsburgh, Pennsylvania involving a football stadium—Heinz Field, a ballpark—PNC Park (Fig. 1), and PPG Paints Arena. Conditions common to stadiums, ballparks and arenas were observed, evaluated, and prioritized into a long-term capital asset management plan (CAMP) for use by each facility. The assessments included both visual and nondestructive

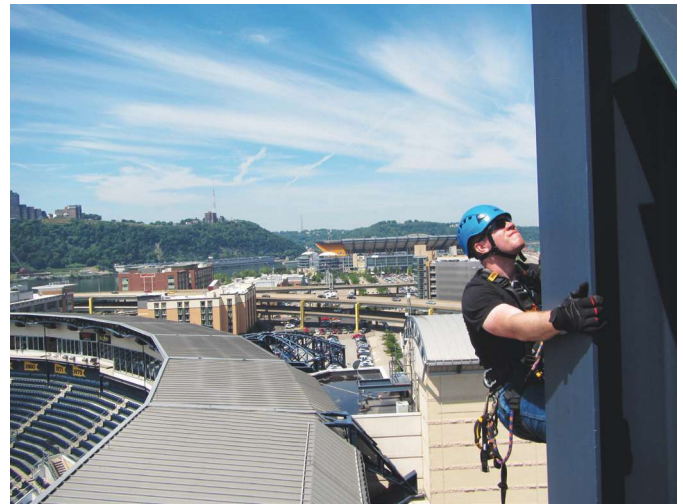
Fig. 2: Rope access was used to visually review lighting mast steel connections close up

testing of typical conditions affecting structural elements such as concrete and structural steel, through the use of traditional assessment methods and much more challenging non-traditional techniques such as rope access (Fig. 2 and 3). Rope access techniques involve the use of rope and rigging systems to access portions of the structure otherwise inaccessible or costly to access by typical methods such as swing stage, power climbers, man-lift, and frame scaffolding. During the assessments, existing distress conditions were documented and prioritized for immediate and future repair/maintenance, and budgets were established for short-term and long-term future planning purposes. Sports venue assessments and capital planning reports are considered a road map to effective planning and fiscal management of sports venues, thereby keeping them in great condition for future seasons to come.

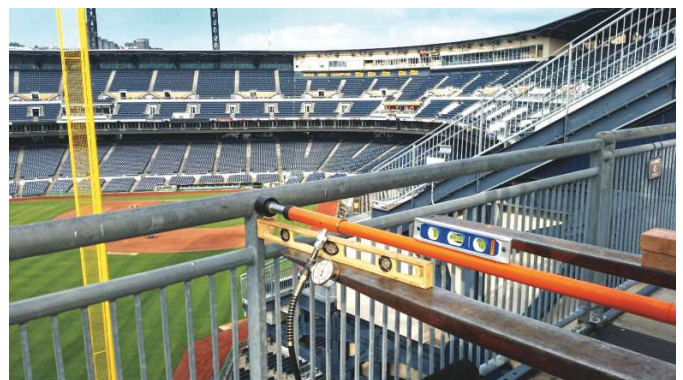
Fig. 4: Load testing of typical handrail

The use of NDT on handrails exemplifies the importance of NDT (Fig. 4). It can be difficult to visually determine if existing handrails can resist the code prescribed forces. However, this can be verified through NDT by testing handrails in locations that visually appear to have some evidence of distress, or testing handrails in locations throughout the facility that are most susceptible to degradation or damage over time (Fig. 5). Some areas that are susceptible to damage may include

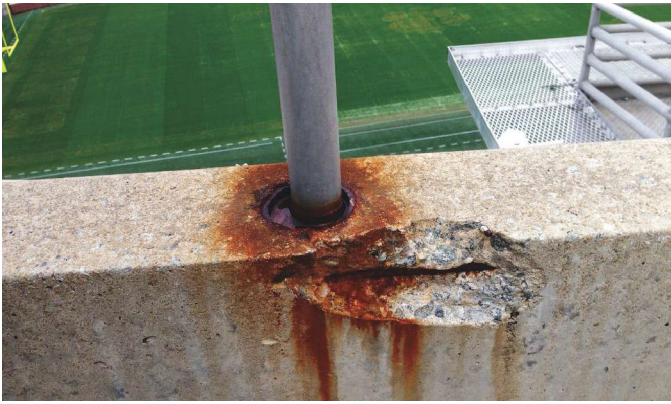
Fig. 5: Typical concrete and handrail damage that occurred over time

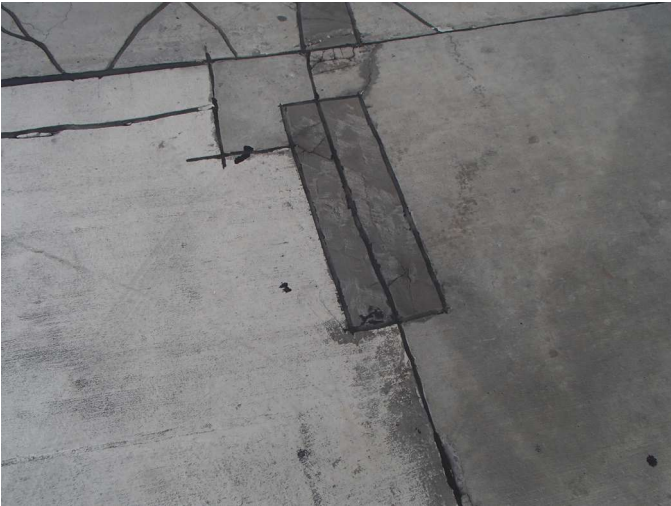
Fig. 6: Example of monitoring for replacement of deteriorating concrete repair where past repairs are critical to extending the long-term service life of the structure

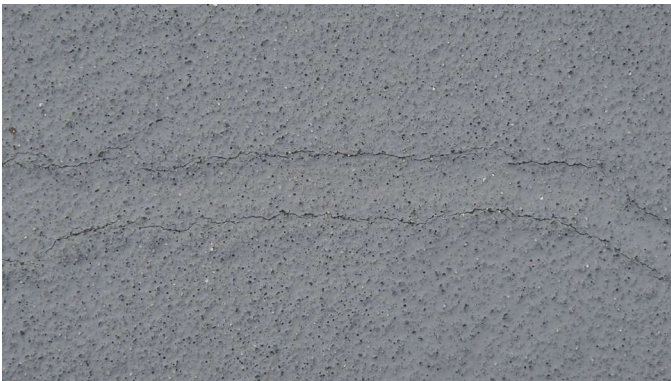
Fig. 7: Example of failing traffic coating spanning over a crack that when identified promptly for repair will improve the performance of this critical protective system

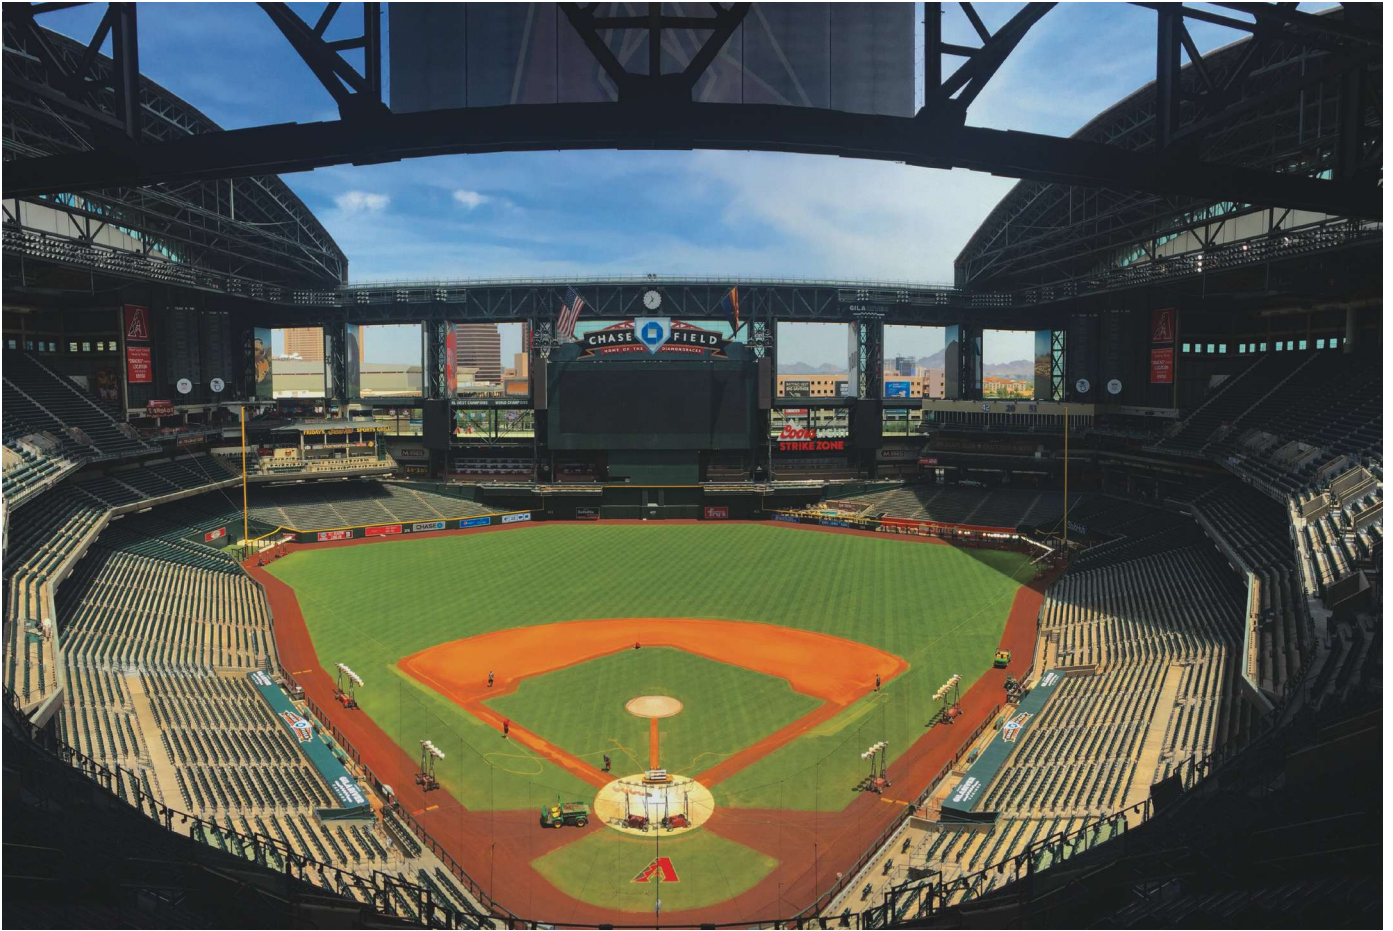
Fig. 1: Interior view of Chase Field

Chase Field (Fig. 1), owned by the Maricopa County Stadium District and managed and operated by the Arizona Diamondbacks Major League Baseball team, has undergone annual structural repair programs from 2011 through 2017. The vast majority of the repairs have been the result of corrosion damage due to frequent cleaning wash-downs after events during its 19-year existence since construction in 1998. The Stadium was built without any type of waterproof protective membrane in seating areas. However, an extensive gutter system, intended not to protect structural elements but to prevent nuisance water damage to ceilings/floors, was installed under the precast concrete joints. As a result, corrosion damage has occurred to the structure as water leaks through the joints, traveling across structural members before entering the gutters.

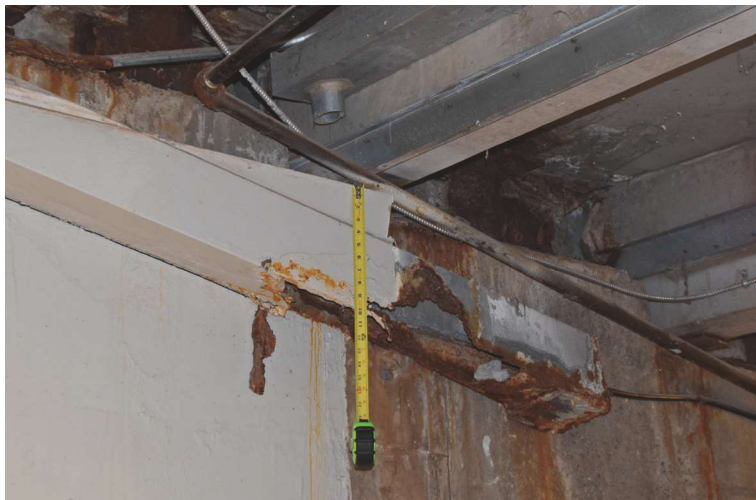
Fig. 2: Bottom side of seating riser at support—seating riser bearings and seismic restraint plates are visible on the bottom side. Moisture penetration through building expansion joint into mineral wool (each side of L-shaped plate) resulted in severe corrosion. Rain gutter system completely corroded through as it enters uninhabited space.

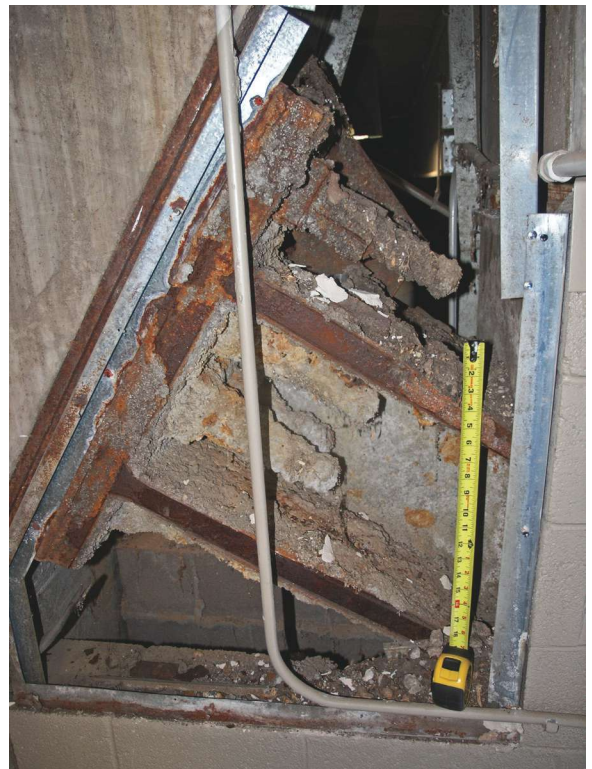
Fig. 3: Raker truss tieback anchor—connection between steel raker truss and concrete frame with sixteen 1-3/8" (35mm) diameter high strength threaded rebar anchor rods. Connection is completely hidden between two masonry walls in a dead space with leaking precast joint directly above. Spray-applied fireproofing absorbs water and never dries out.

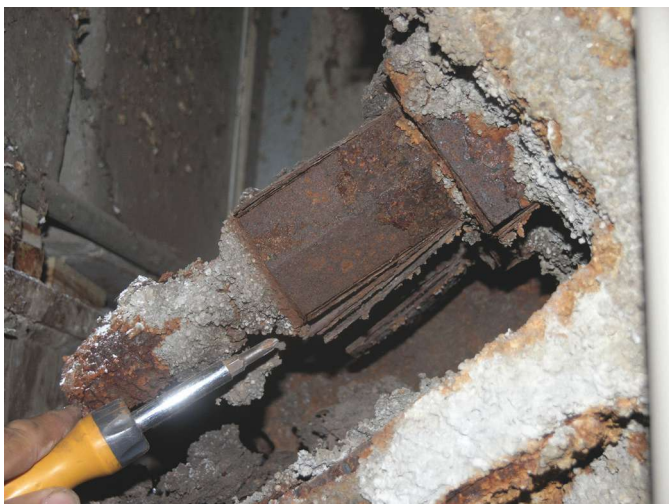
Fig. 4: Threaded rebar anchor nut—Severe deterioration of the nut. Corrosion of the threaded anchor rod is not visible due to fireproofing and debris.

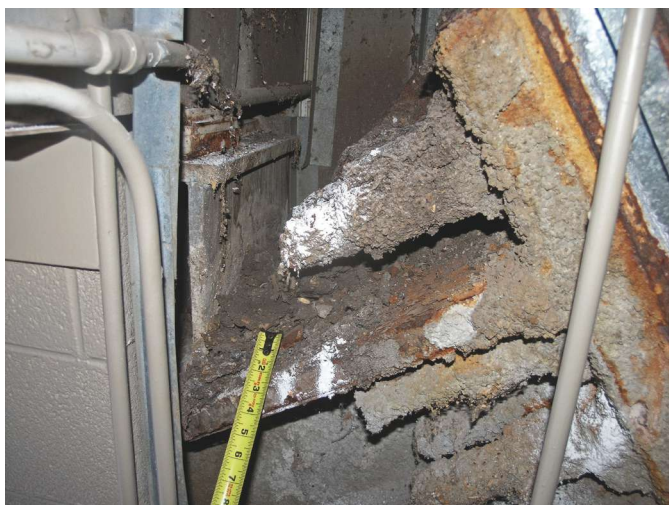
Fig. 5: Threaded rebar anchor—large mound at end of tape measure is peanut shells and debris washed through failed joint above.

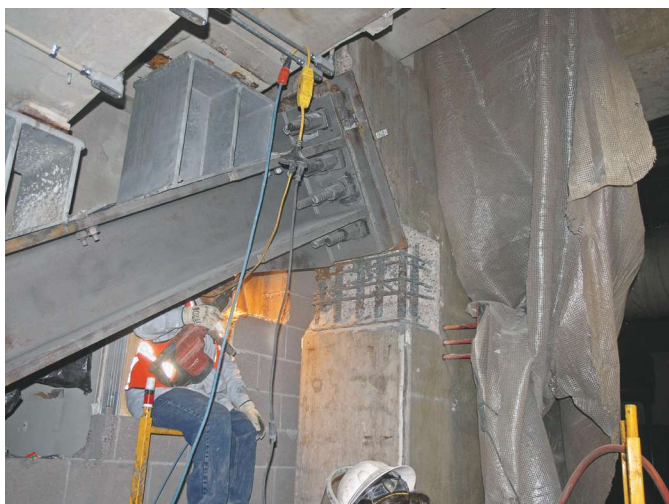
Fig. 6: Raker truss tieback anchor connection—overall view of the threaded rebar anchor assembly after initial sandblasting.

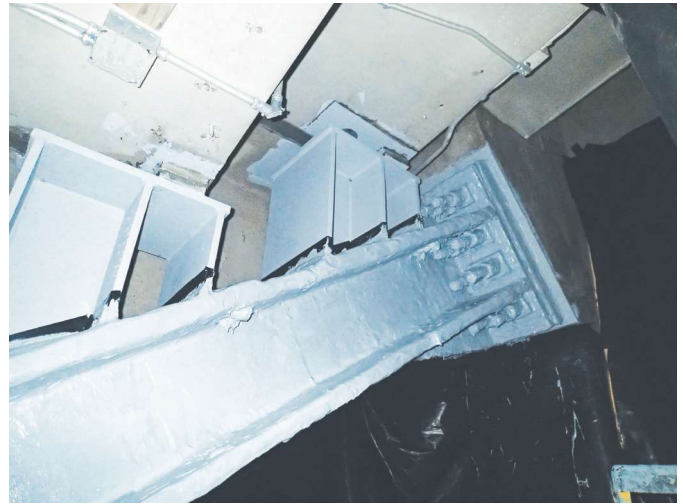
Fig. 7: Raker truss tieback anchor connection—completed repair with epoxy intumescent fireproofing to achieve 3 hour fire rating and provide corrosion protection to the beam and threaded rebar anchors.

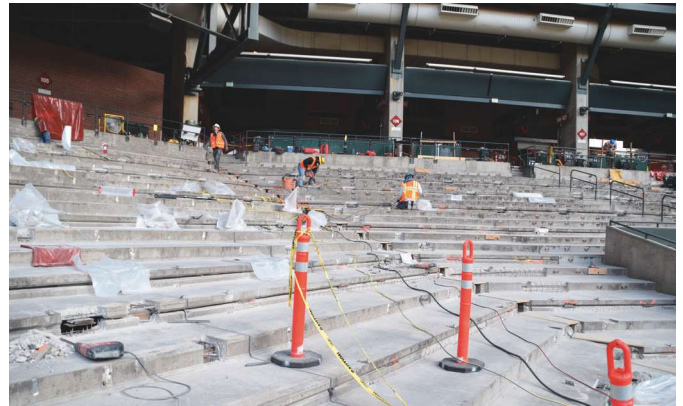
Fig. 8: Repairs to precast seating risers

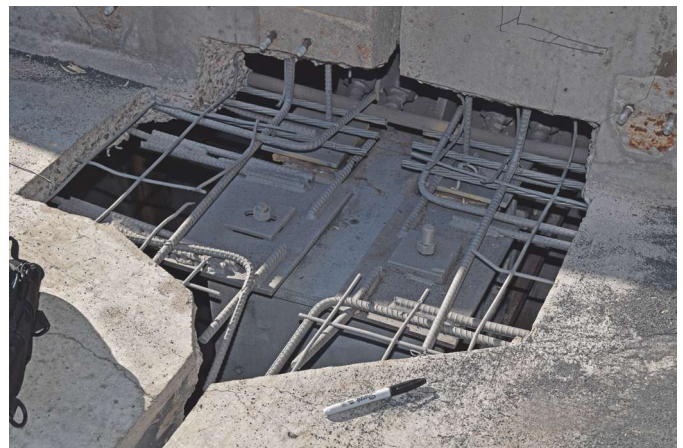
Fig. 9: Typical precast joint repairs—seismic restraint plate (embed with bolt) and precast bearing seat assembly (below prestressing strands) after existing plates replaced, rebar welded back, and sandblasted prior to epoxy coating and pour back.

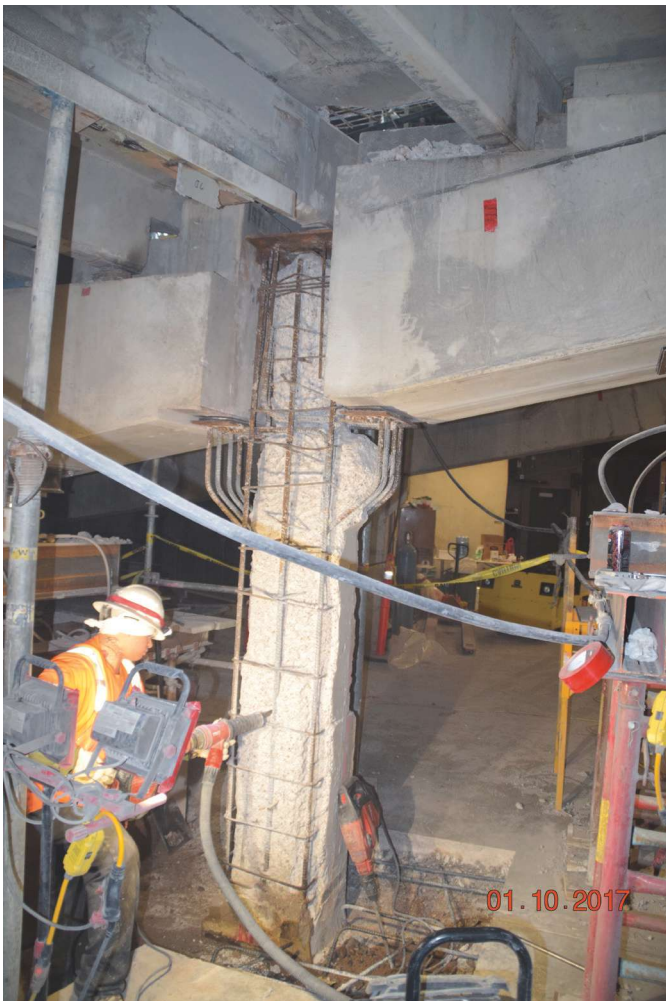
Fig. 10: Concrete column repairs—due to placement logistics, the contractor elected to repair this column rather than replace it.

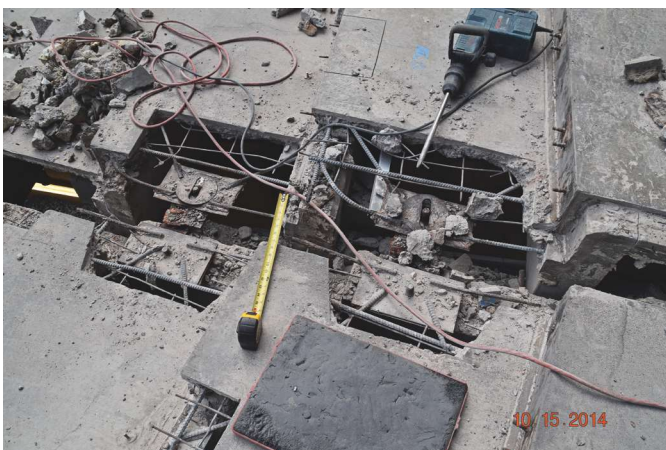
Fig. 11: Typical Precast Joint Repairs - Water leaking through building expansion joint between precast seating sections was absorbed by mineral wool fireproofing in the joint, resulting in severe deterioration. Large steel plates are seismic restraints.

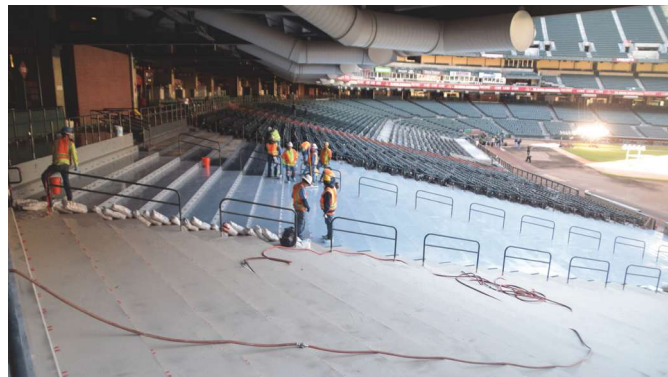
Fig. 13: Deck coating application at precast seating risers.

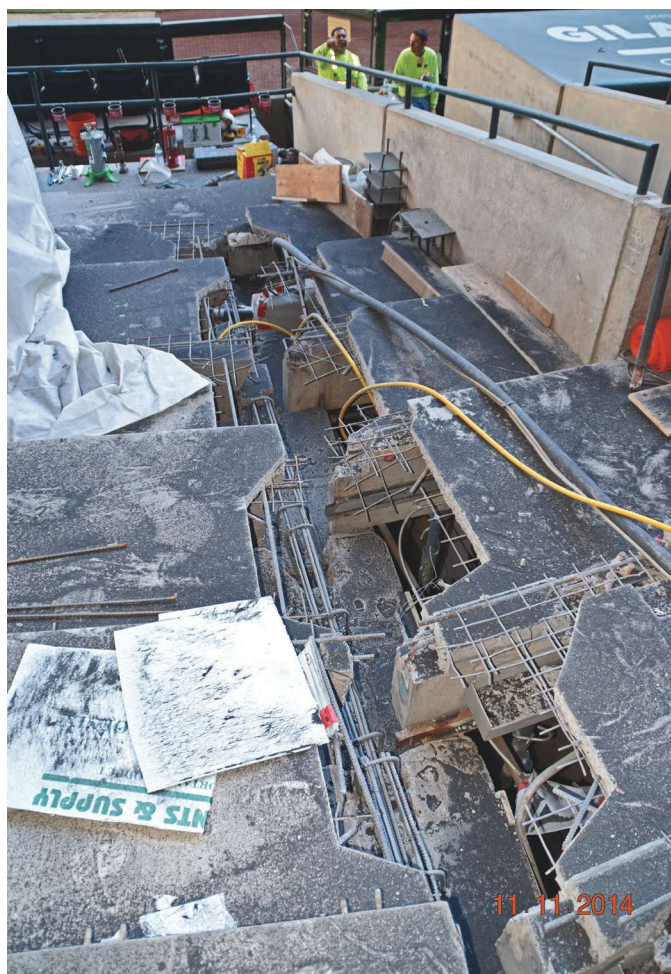
Fig. 12: Precast joint repairs—typical example of demolition required to repair the joints between the precast seating sections. Seismic restraint plates have been completely removed for replacement. Bearing repairs for stems have not started. Virtually every row was affected.

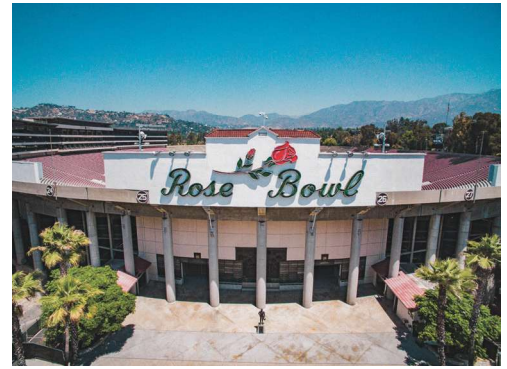
Fig. 2: The exterior entrance to the Rose Bowl Stadium

When one thinks of iconic sporting venues in the US, there are few larger or more historic than the Rose Bowl Stadium (Fig. 1 and 2) in Pasadena, California. Originally built in 1922, the Rose Bowl Stadium was designed by Myron Hunt, a distinguished local architect whose design was influenced by the Yale Bowl in New Haven, Connecticut. The Rose Bowl game, known as “The Granddaddy of Them All” is the oldest of all college football bowl games.

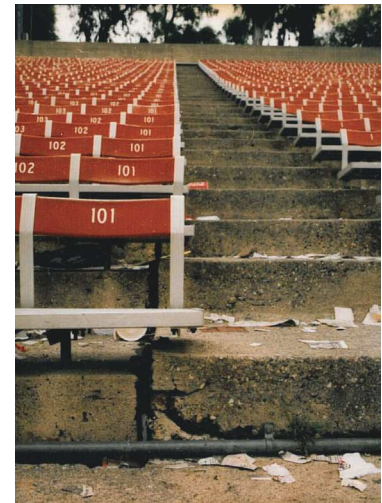
Fig. 3: Large areas of damaged concrete

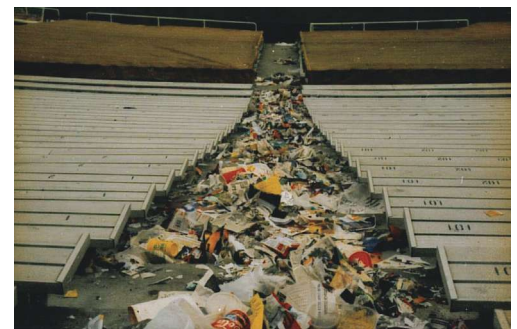
Fig. 4: Waste left on concrete risers during a football game (stadium cleaned after every event)

The stadium, which has hosted countless events over the years with millions of people in attendance, was starting to show its age. The primary issue to be addressed was the eroded concrete surfaces at the treads and bleachers. There were also large areas of exposed aggregate surface leaving a rough non-uniform concrete surface at these locations (Fig. 3). This condition was partly due to poor consolidation of the concrete when it was originally placed. The second major issue involved corrosion damage of the concrete that had resulted in cracking and spalling of the concrete. The corrosion was partly caused by the lack of concrete cover over the 60-year-old steel reinforcing steel, which was measured at a ½ inch (13 mm) depth in most areas. This low cover did not provide enough long-term protection to the reinforcing steel. Another issue that added to the concrete damage was years of exposure to acids, fats and other by-products from food and beverages that are consistently spilled at sports stadiums (Fig. 4).

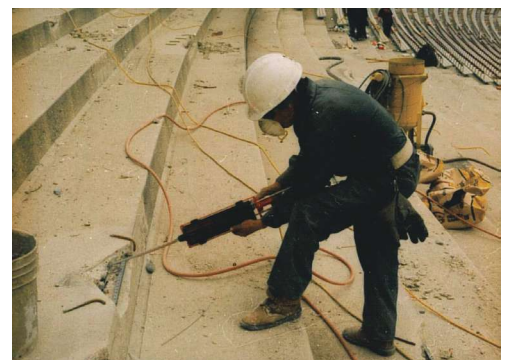
Fig. 5: Removing damaged concrete with chipping hammer

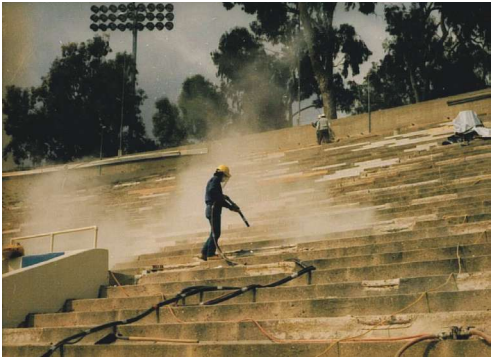
Fig. 6: High-pressure water blasting to clean and prepare concrete surface

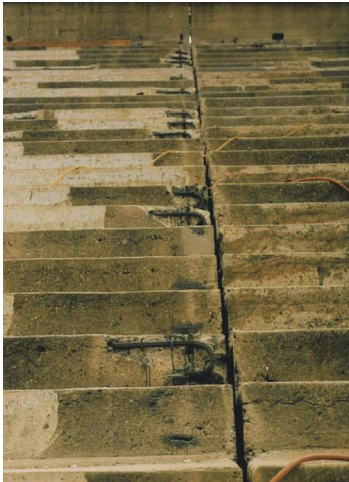
Fig. 7: Areas of prepared and un-prepared concrete

In areas of the stadium where the concrete surface had already degraded, leaving large areas of exposed aggregate, the concrete was prepared by using high-pressure water blasting (Fig. 6), a nondestructive method that adequately prepared the substrate for the repair (Fig. 7).

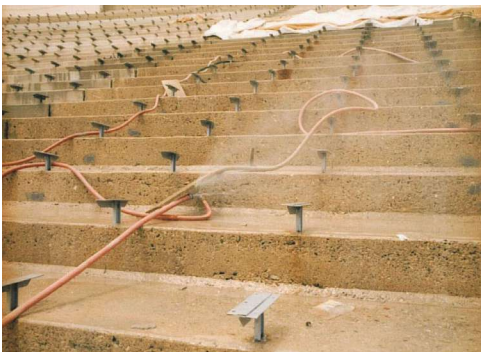
Fig. 8: The required substrate moisture conditions were achieved by soaking for 24 hours

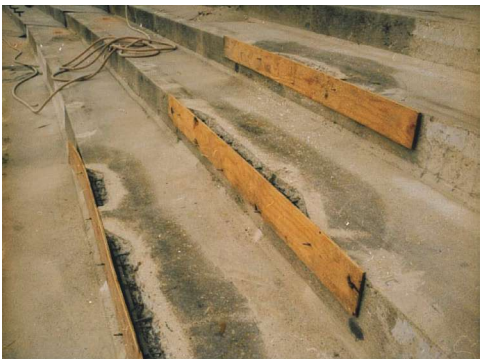
Fig. 9: Forming concrete risers for repair material installation

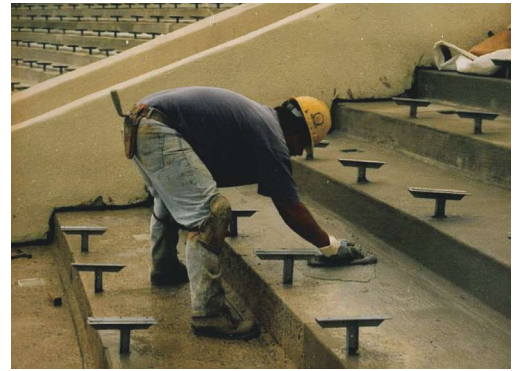
Fig. 10: Resurfacing concrete

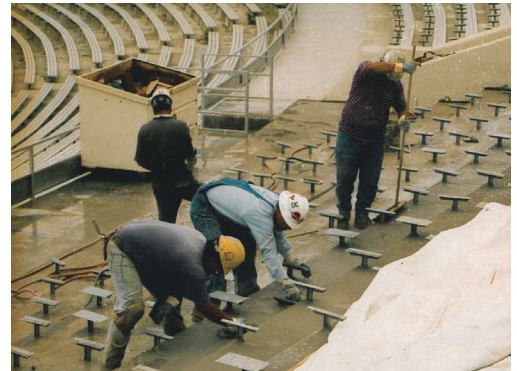
Fig. 11: Team approach—resurfacing, finishing, and curing

With this repair team approach, the resurfacing/overlay material was applied at  $\frac{1}{8}$  in (3.2 mm) to  $\frac{1}{2}$  in (12.7 mm) thick with trowels and sponge floats (Fig. 10), then the next team would broom finish the application as the initial team moved up to the next riser in the stadium (Fig. 11). In other areas where there was concrete spalling on the tread riser interface, a form and pour approach was used for the repair.

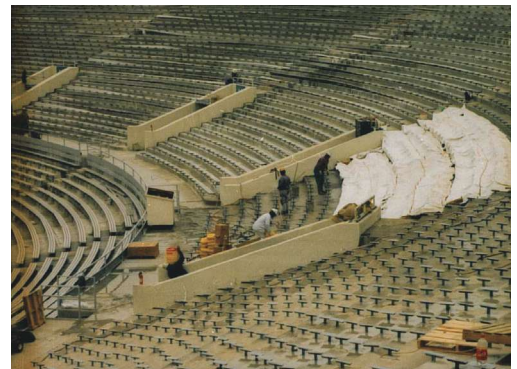
Fig. 12: Large repair areas were cured with saturated curing blankets

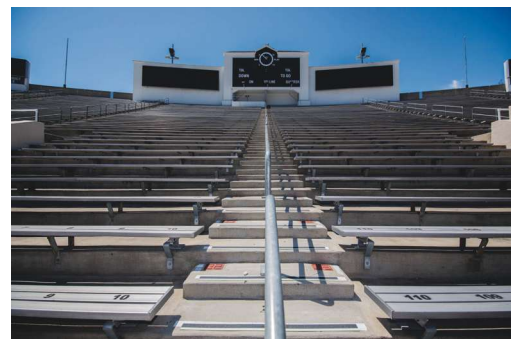
Fig. 13: The Rose Bowl Stadium today—repairs performing after 19 years
