CONCRETE REPAIR BULLETIN

September/October 2026 Vol. 39, No. 5

**AMPLIFYING  
DURABILITY**  
THROUGH INNOVATIVE REPAIR

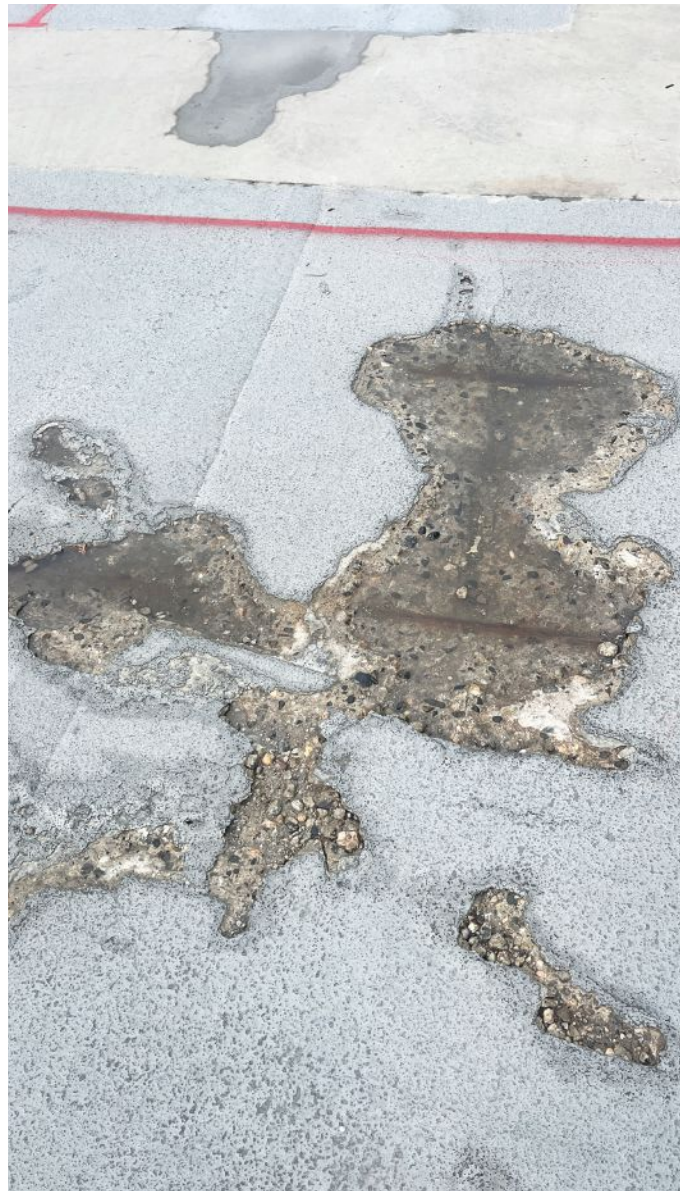
Figure 1: Suspected area of delamination.

Parking structures are particularly vulnerable to deterioration caused by moisture ingress, chloride contamination and repeated freeze-thaw cycles. These mechanisms can initiate corrosion of reinforcing steel, leading to cracking, spalling and delamination of the concrete surface. When such deterioration becomes visible, determining its full extent can be difficult, particularly when the affected area spans several thousand square meters (Figure 1).

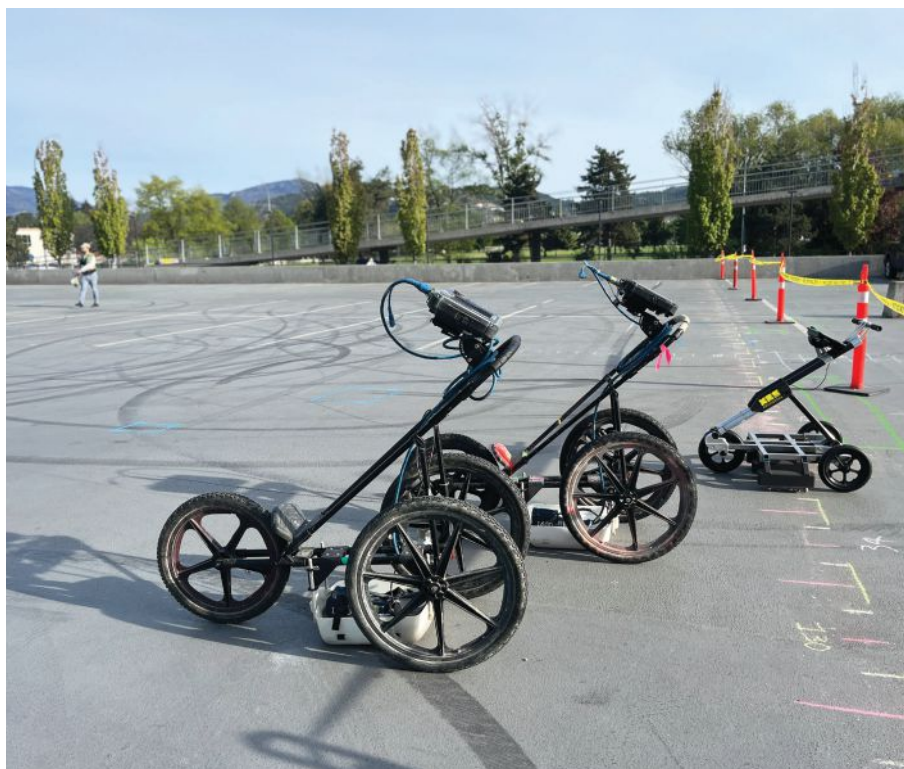
Figure 2: Ground-penetrating radar (GPR) and objective acoustic sounding system.

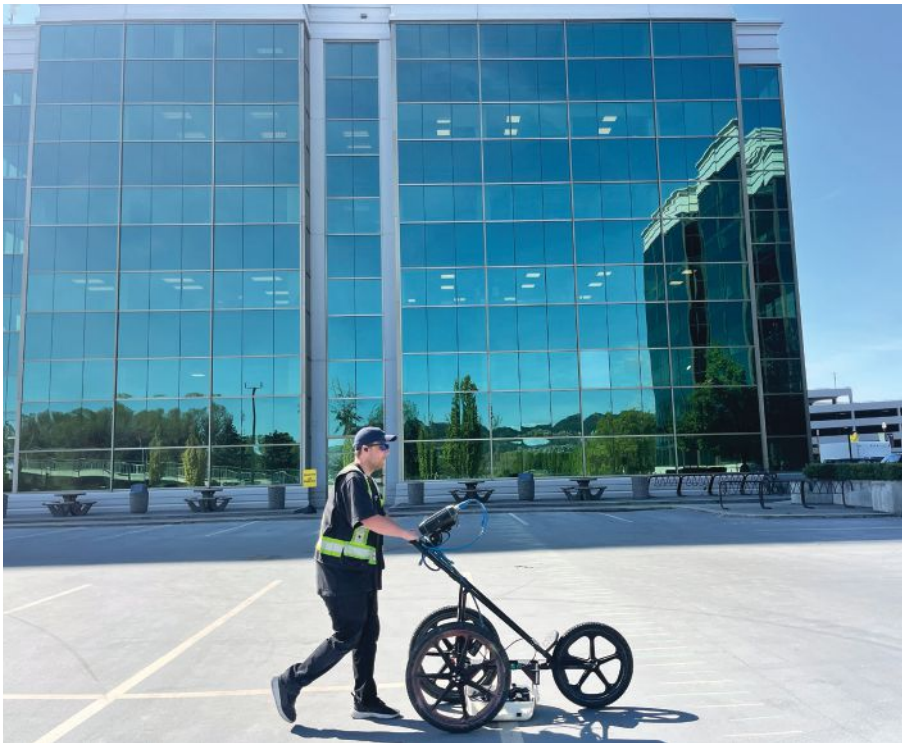
Figure 4: On-site GPR survey.

This dual-orientation approach reduces the likelihood that isolated corrosion affecting individual reinforcing bars will be overlooked and provides additional confidence in interpreting corrosion patterns (Figure 4).

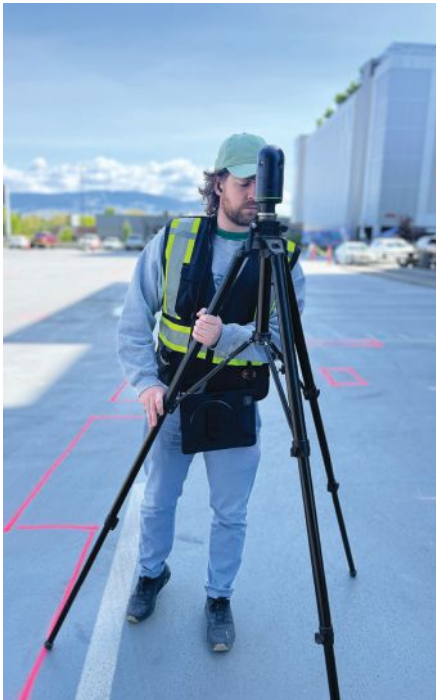
Figure 8: Laser scanning.

To ensure accurate spatial positioning, a 3D laser scan of the site was also performed. The scan generated a scaled point cloud and mesh model representing existing conditions. Photographic imagery captured during scanning recorded the survey grid lines and surface features, allowing results to be accurately positioned within the model (Figure 8).

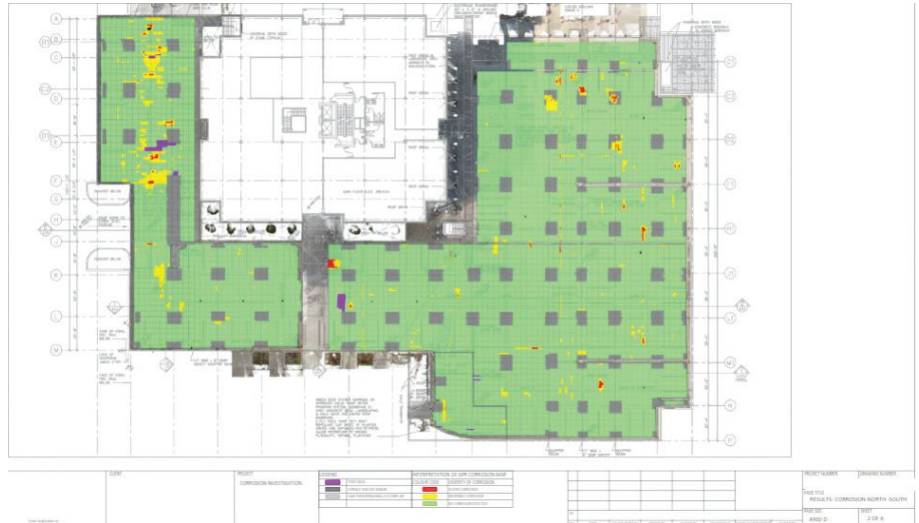
Figure 9: On-site GPR corrosion results.

The most concentrated deterioration zones were located near the western entrance of the parkade and in portions of the northern parking area. Corrosion patterns identified in the two orthogonal radar surveys correlated well in several locations, suggesting deterioration affecting reinforcement in multiple orientations (Figure 9).

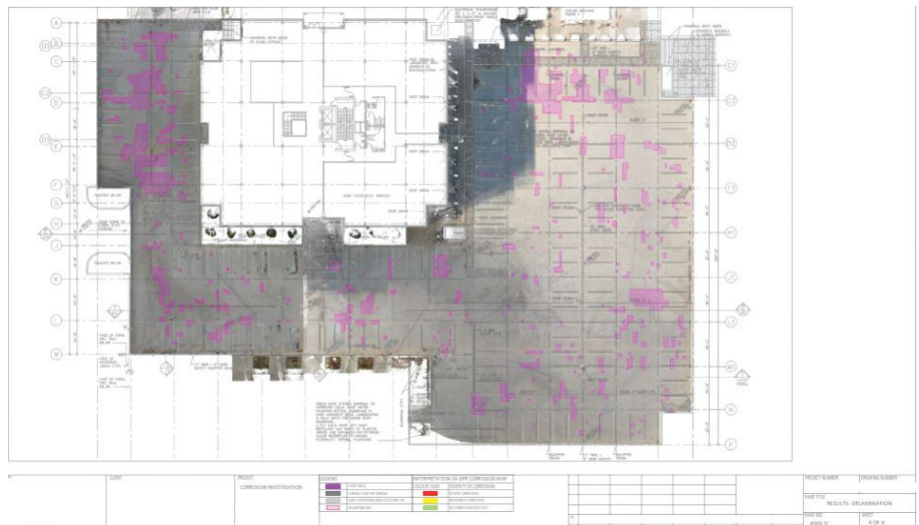
Figure 10: On-site sounding delamination results.

Delamination was detected across multiple areas of the slab and was generally more extensive than the areas identified as containing corrosion indicators. This outcome is common because delamination may propagate beyond the immediate location of corroding reinforcement. In addition, acoustic sounding methods are sensitive to separation within surface coatings or shallow concrete layers (Figure 10).

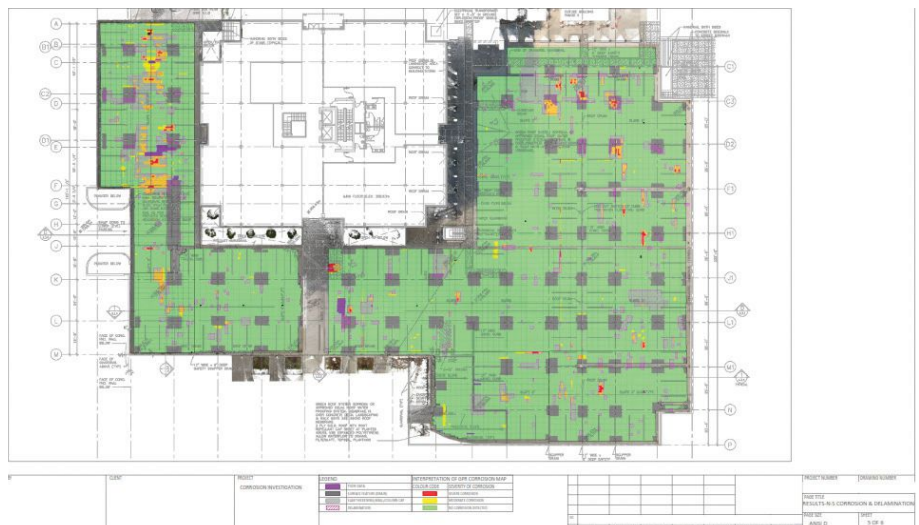
Figure 11: Combined results of GPR and sounding results.

Despite these differences, many of the largest delaminated areas corresponded closely with regions showing strong corrosion indicators in the radar data (Figure 11).

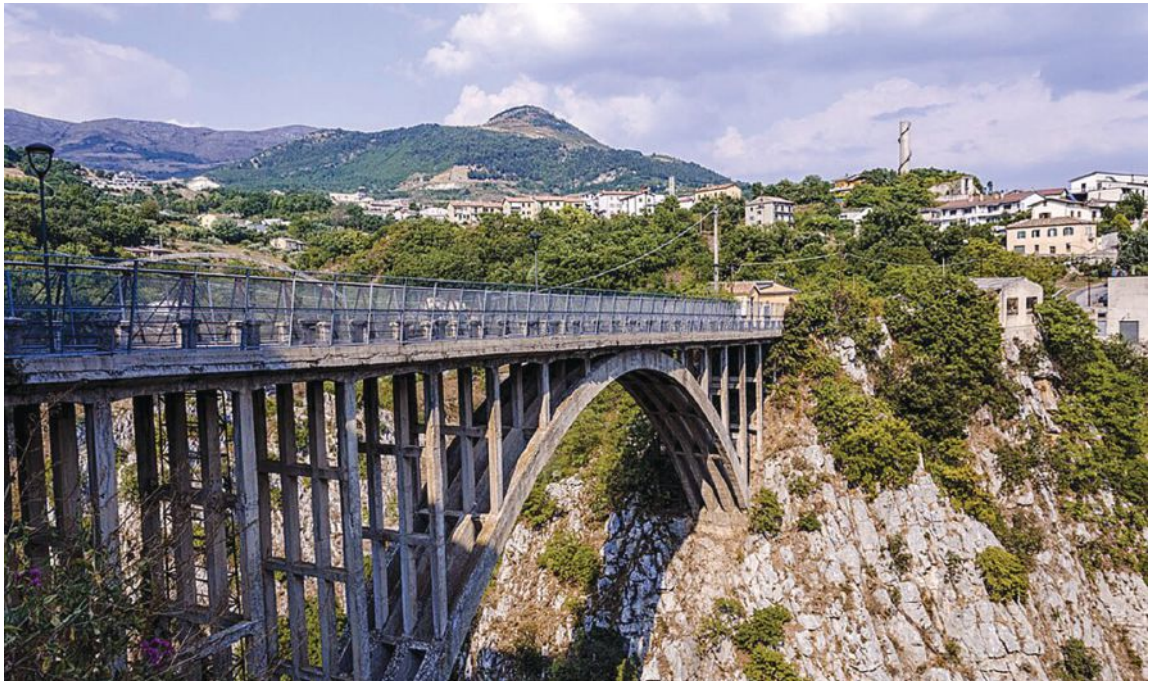
*Image 1: Over the years, the bridge has shown significant deterioration of the reinforced concrete, particularly in the support areas; it therefore became necessary to take action to reinforce and secure the structure.*

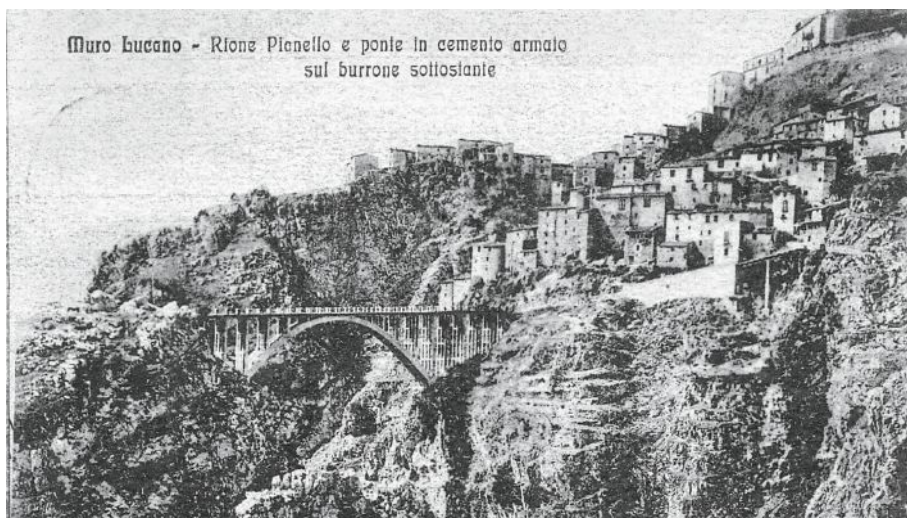
Image 2: The Pianello Bridge on a vintage postcard. Built between 1916 and 1918, it is one of the first reinforced concrete structures built in Southern Italy.

Constructed between 1916 and 1918, Ponte Pianello is recognized as the first reinforced concrete bridge built in Europe (Image 2). The structure connects the Borgo Pianello area with the Capodigiano area, approximately 1.9 miles (3 km) from the urban center, and crosses a deep valley that has made the bridge a recognizable feature of the local landscape. Its construction took place when reinforced concrete was still an innovative material, giving the bridge architectural and heritage value beyond its transportation function. Due to its age, structural configuration and visibility, the project required a rehabilitation strategy

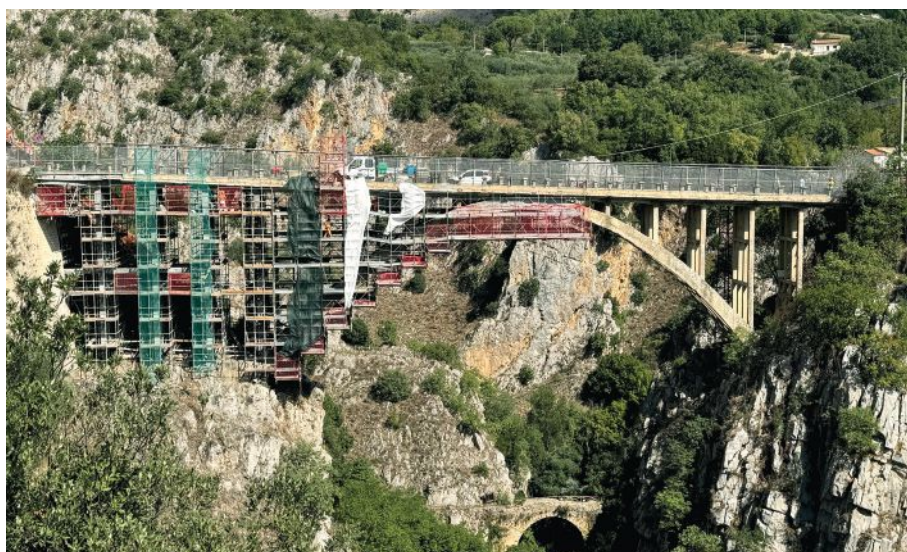
Image 3: The restoration of the Pianello Bridge in Italy using FRCM has secured one of the earliest reinforced concrete structures in Europe.

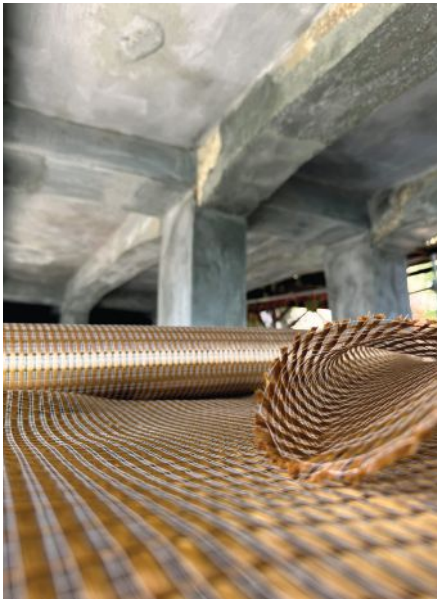
Image 4: The PBO-FRCM system, based on a bidirectional mesh combined with the inorganic matrix, installed on the bridge.

Strengthening systems that were not thin and lightweight were excluded from the beginning, both to preserve the bridge's appearance and because it was not possible to install adequate conventional scaffolding. The entire jobsite and all work activities were carried out using suspended scaffolding anchored directly to the bridge structure.

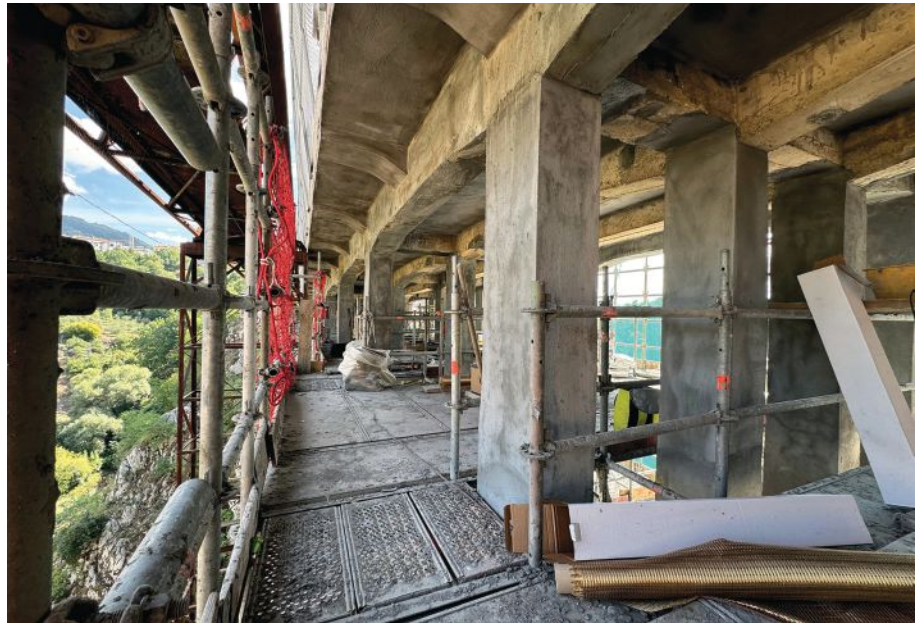
Image 5: View of the bridge's structural elements addressed by the reinforcement work using the FRCM system.

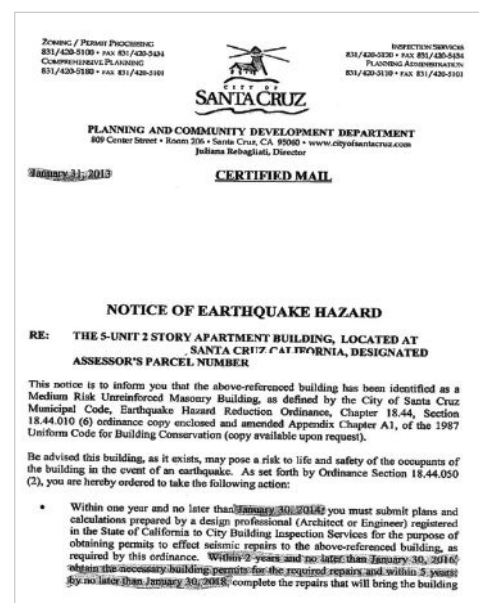
Figure 1: Notices of noncompliance.

Weeks later, as California cities moved under state law to assess their URM inventories, the City of Santa Cruz mailed a notice to the owners of a modest two-story, five-unit apartment building from 1935 (Figure 1) that it was exactly the kind of structure that, in the city's words, "historically has exhibited little resistance to earthquake motion." It was the first of two earthquake-hazard notices the building would receive — the second arriving in 2013 — and the start of a path that would, decades later, lead to an innovative repair.

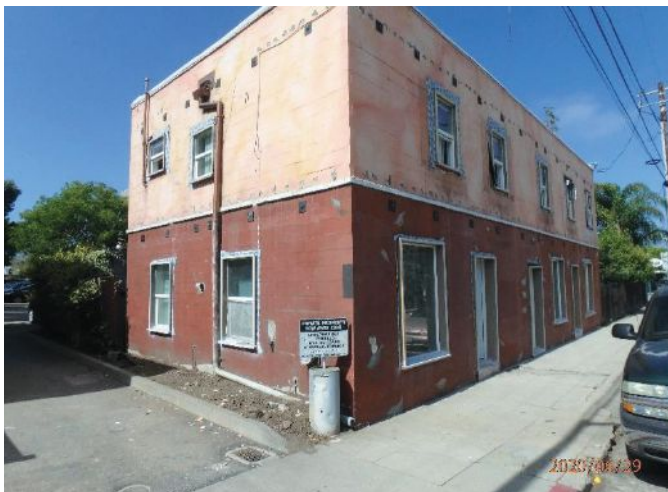
Figure 2: Structure exterior — before.

The path following the second noncompliance notice led to a full structural rehabilitation of the building (Figure 2). The project included assessment, design and repair efforts with complexities beyond expectation because the original assessments proved inaccurate. A project that appeared to be a routine URM retrofit turned out to be a hidden hybrid repair when it was discovered that the building's load path threaded unpredictably through masonry, wood and concrete. This article offers a useful template for evaluating and strengthening the many aging, irregularly built masonry structures still in service today.

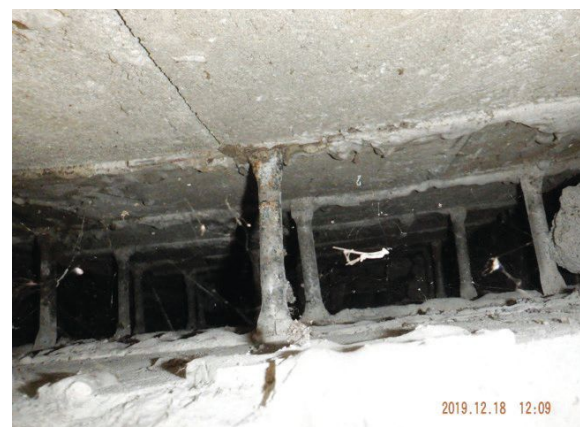
Figure 4: Exterior wall cavity with railroad track and ties.

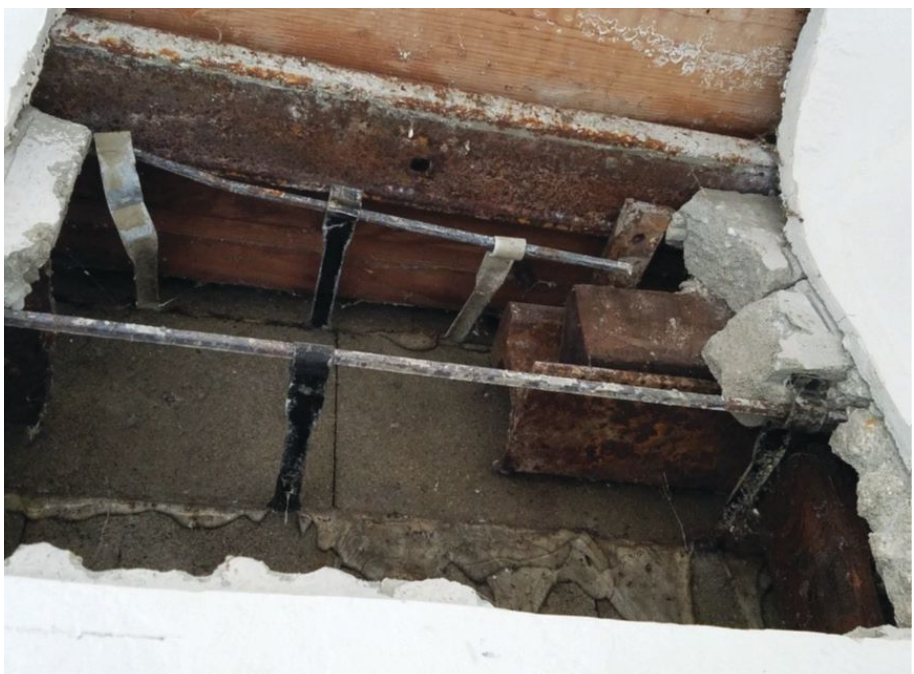
Figure 5: Wall interior — mixed materials.

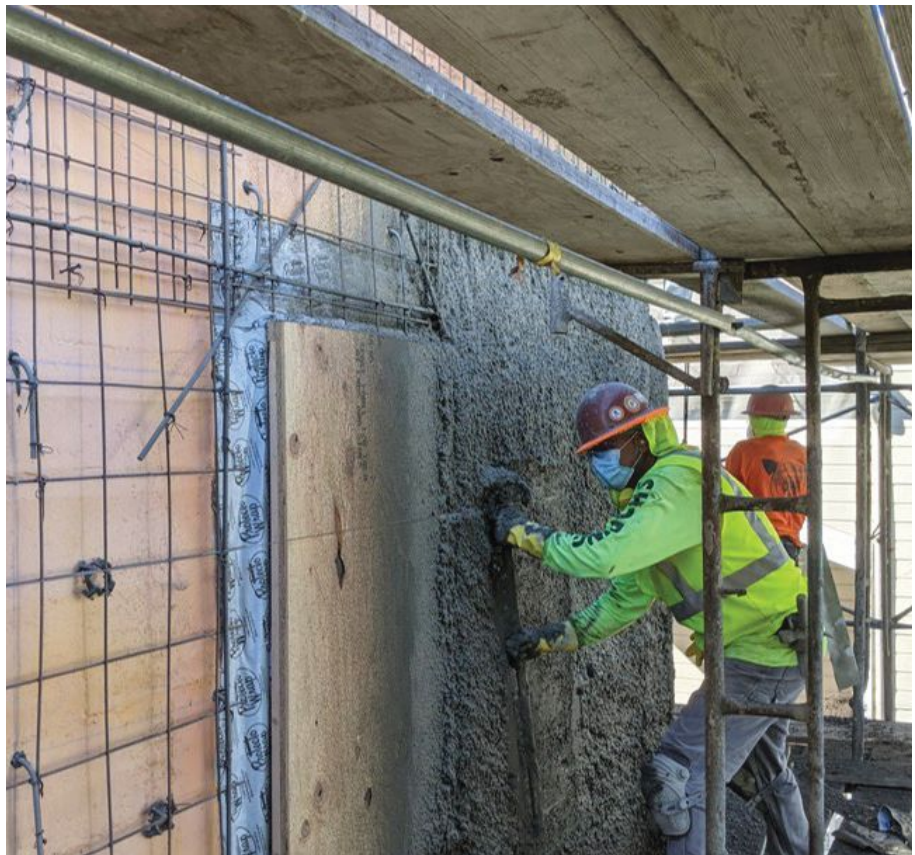
Figure 8: Structural shotcrete curtain construction.

Several attributes made the curtain the right fit for a hidden hybrid. It could be detailed to form genuine structural connections across the building's mixed masonry, wood and concrete elements, knitting a discontinuous load path back together. It required minimal temporary shoring. It was cost-effective given the as-built conditions and far less intrusive than gutting and reframing, preserving the building's footprint and character. And as a proven, durable technology, it gave the owners confidence in its performance over decades.

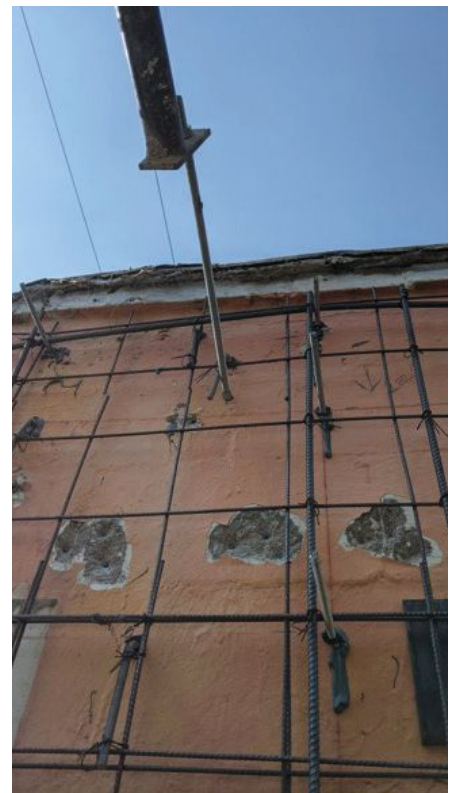
Figure 9: Curtain reinforcement template and installation.

The heart of the design was the wall anchorage that ties the new curtain to the old masonry. Threaded rod anchors were installed into the existing CMU using an injected epoxy adhesive and a screen-tube sleeve sized for hollow masonry, which confines the adhesive within the hollow cell, allowing the anchor to develop its capacity. Detailing was exacting: Rods were hooked around the curtain reinforcement; that reinforcement was centered at the mid-depth of the shotcrete; and each anchor was positioned clear of the centerlines of the bed joints, head joints and CMU webs to seat in sound material rather than a mortar line or void. Anchors

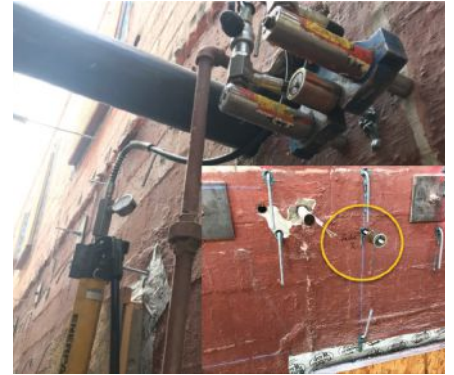
Figure 11: Wall anchor tension test.

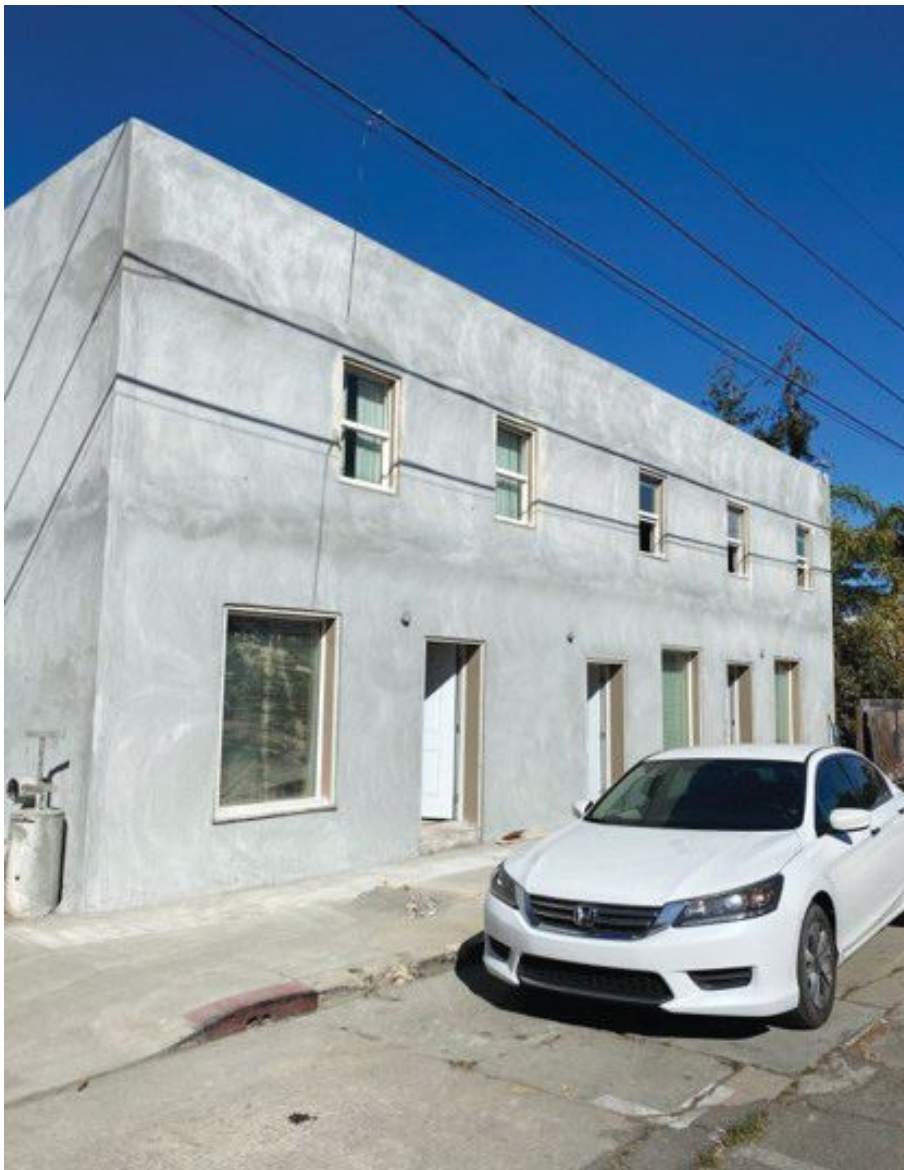
Figure 12: Structure exterior — after.

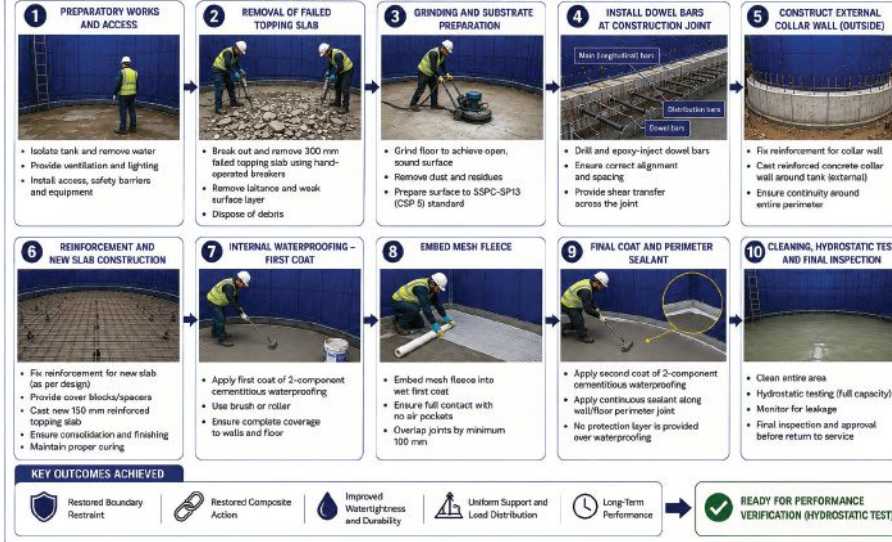
## FIGURE 8 – INSTALLATION OF STEEL DOWELS AND CONSTRUCTION OF THE REINFORCED PERIMETER COLLAR WALL

External reinforced concrete collar wall to restore boundary restraint and prevent water ingress at the base

Figures 6, 7 and 8 illustrate how every stage of the rehabilitation corresponded directly to a verified structural deficiency. The repair became more than a construction exercise; it was the physical implementation of the

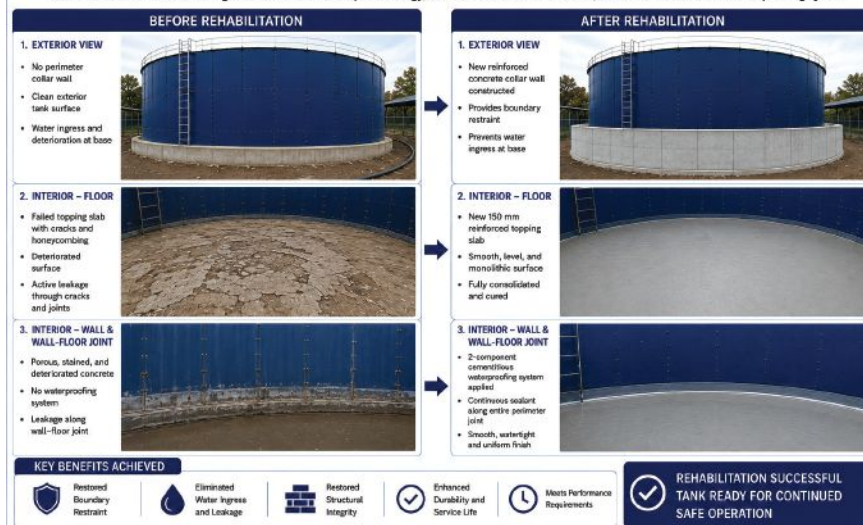
## FIGURE 10 – BEFORE-AND-AFTER COMPARISON OF THE REHABILITATION PROJECT

Transformation achieved through mechanism-based repair strategy, external reinforced collar wall, and internal cementitious waterproofing system

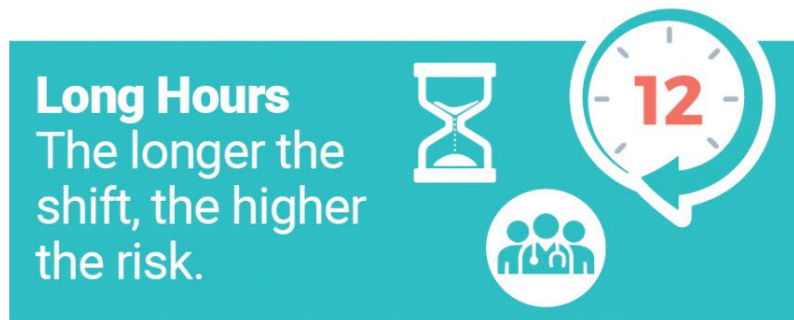
Figure 2: Long work hours contribute to fatigue risks.<sup>4</sup>

- Extended shifts (>10 hours) (Figure 2)
- Consecutive workdays without recovery
- Difficult ergonomic conditions (Figure 3)
- Heavy manual labor required to remove deteriorated concrete

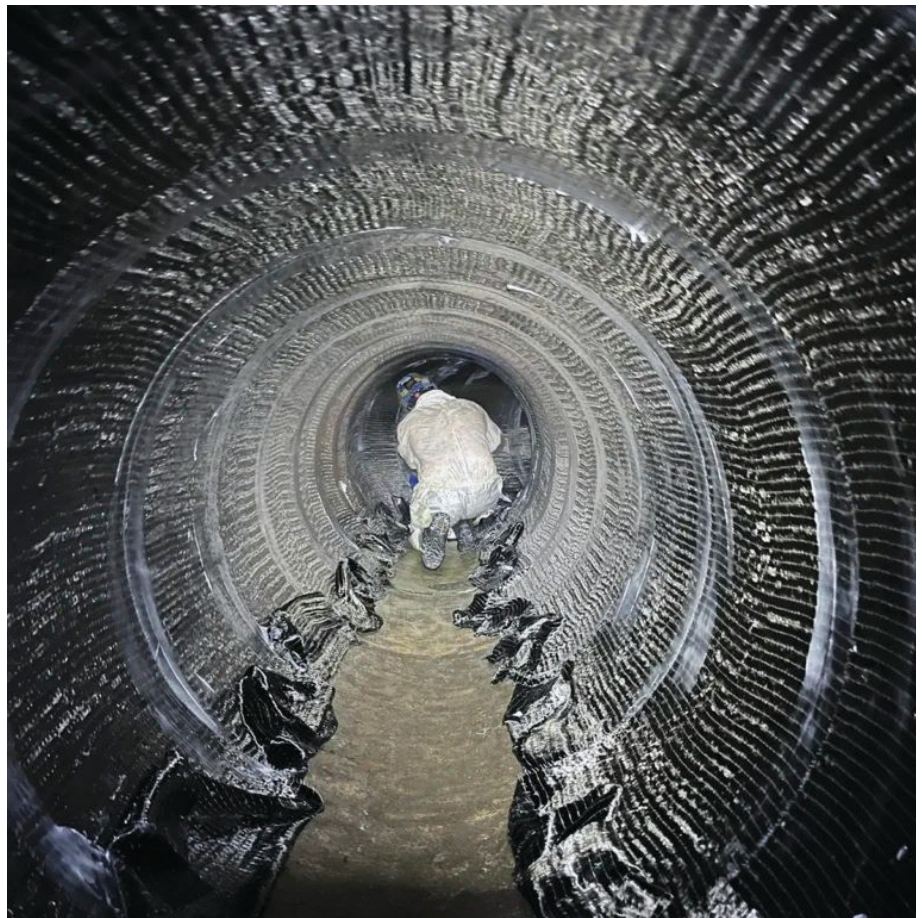
Figure 3: Working in cramped and confined spaces increases worker fatigue. (Courtesy of Structural Preservation Systems)

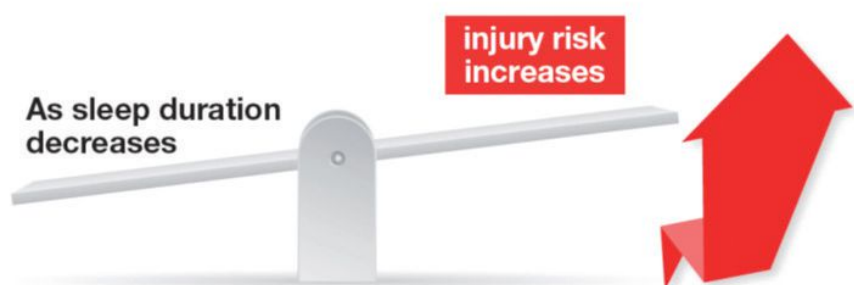
Figure 4: Injury risk increases with sleep deprivation.<sup>3</sup>

Sleep loss and extended wakefulness create a biological drive for rest. Both acute and chronic sleep restriction impair performance (Figure 4).

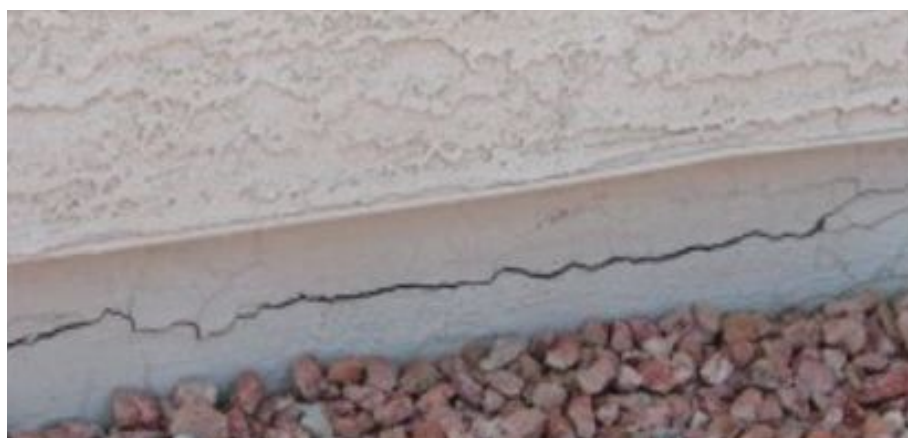
Figure 1: Typical rust jacked stem walls in the Southwest in corrosive conditions. Notice decorative landscape rock.

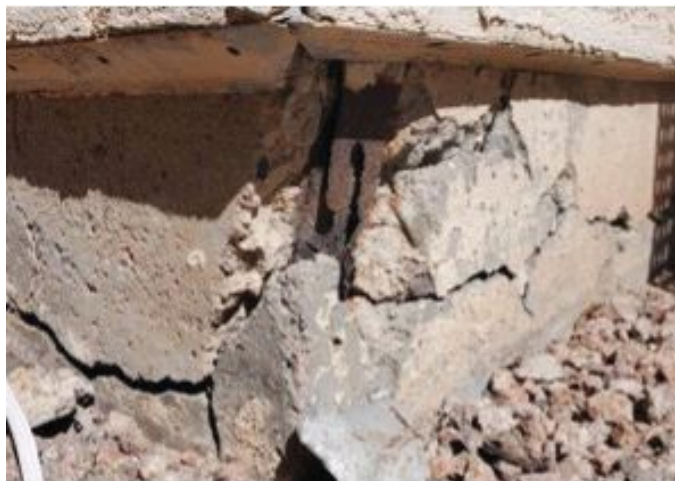
Figure 2: Typical rust jacked stem walls in the Southwest in corrosive conditions. Notice decorative landscape rock.
