Strengthening Category

Structural Reinforcement of Jaime Roldós Aguilera Bus Terminal

Guayaquil, Ecuador

Submitted by BASF Construction Chemicals

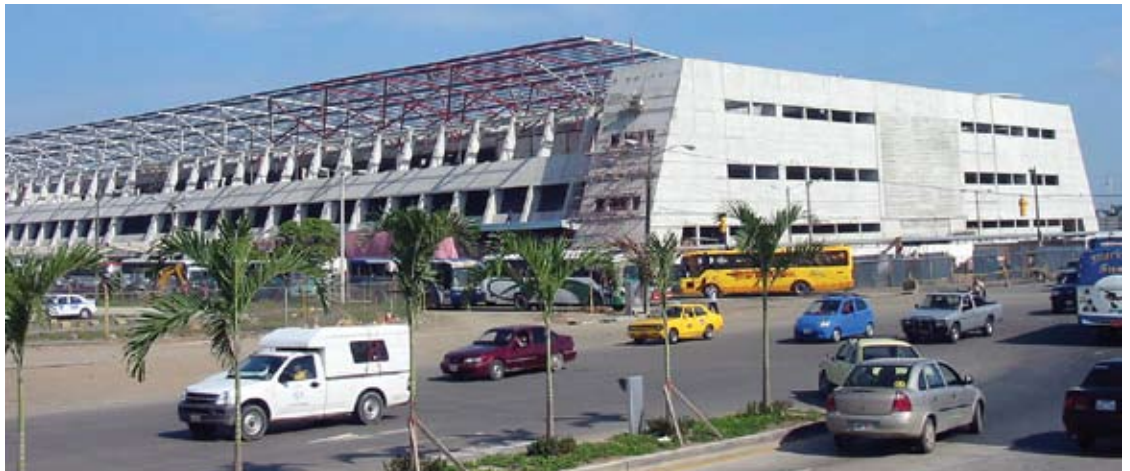
Fig. 1: Overall view of bus terminal

The construction of the Jaime Roldós Aguilera Bus Terminal project in Guayaquil, Ecuador, started in October 1980 and was completed in May 1984 (Fig. 1).
