Unique Solutions for Repair of a Seawall and Lighthouse Structure

By Hamid Vossoughi

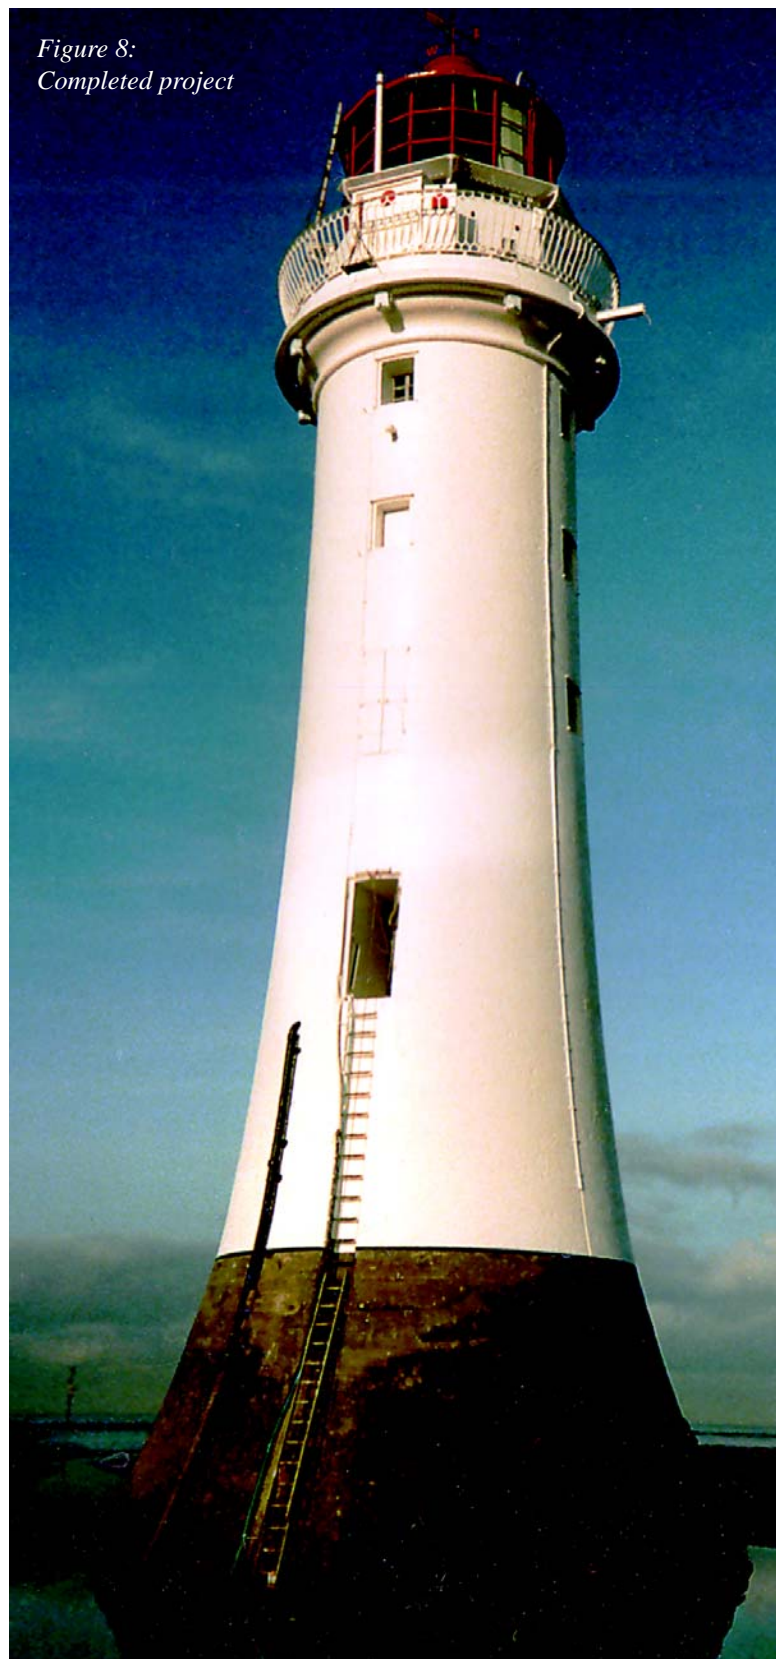
*Figure 8:
Completed project*

Lighthouse—Due to environmental requirements for containing the debris, the lighthouse was shrouded with containment netting (Fig. 7), draped similar to a curtain with steel rings to effectively position the netting along the height of the structure. The delaminated coating was power-washed, stored, and disposed of. Stripping and coating of the lighthouse was performed in five segments. Cracks and uneven surfaces were prepared with pumpable quick-set repair mortar, and minimal patching and dutchman repair of the blocks was required. Silane-based coating was used to coat the surface of the lighthouse (Fig. 8).
