Preserving Winnipeg's Water Supply

Garth Fallis, P.Eng. Vector Construction Group

Repairs to the Winnipeg Aqueduct

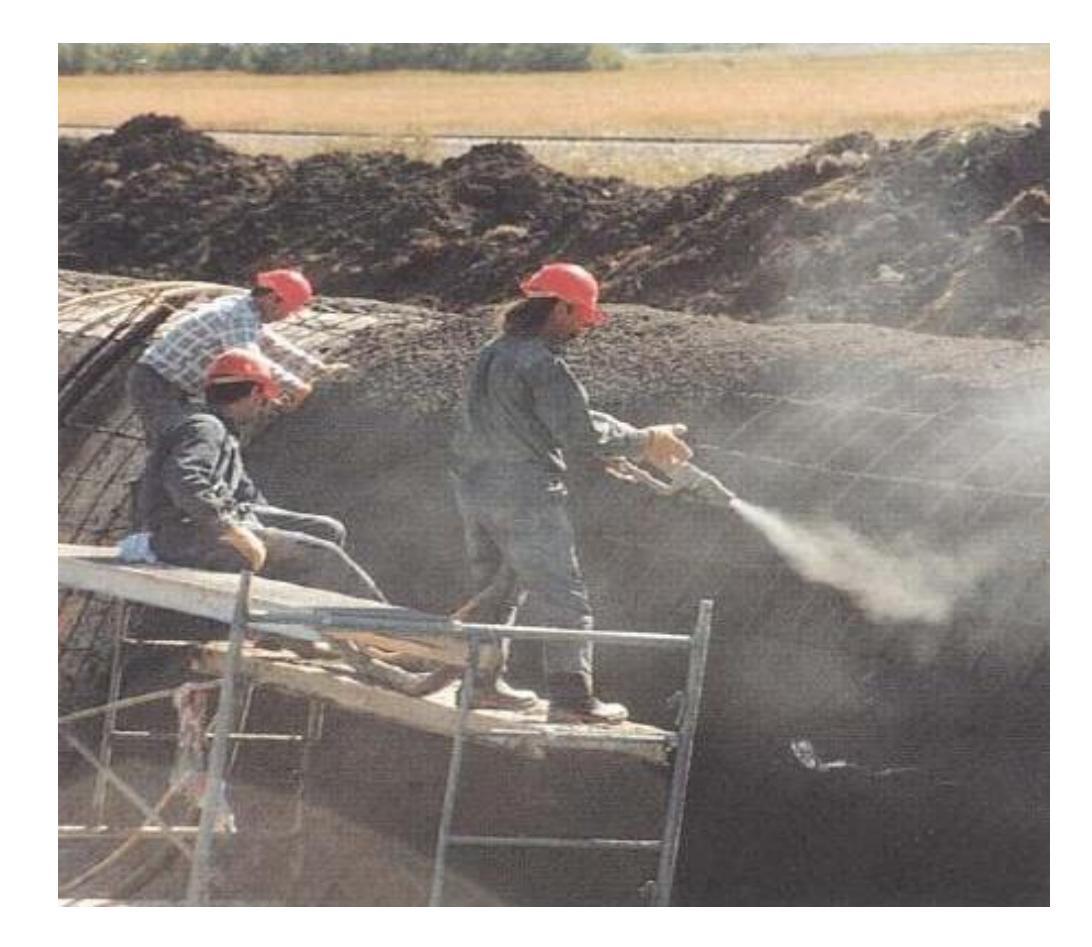
- Some deterioration of the concrete on the exterior of the aqueduct due to sulfate attack in high sulfate soil areas
- Had deteriorated the concrete in some places to a depth of 50%

- Excavate around pipe
- Remove deteriorated concrete
- Add reinforcing steel (even though the original has none)
- Shotcrete new concrete

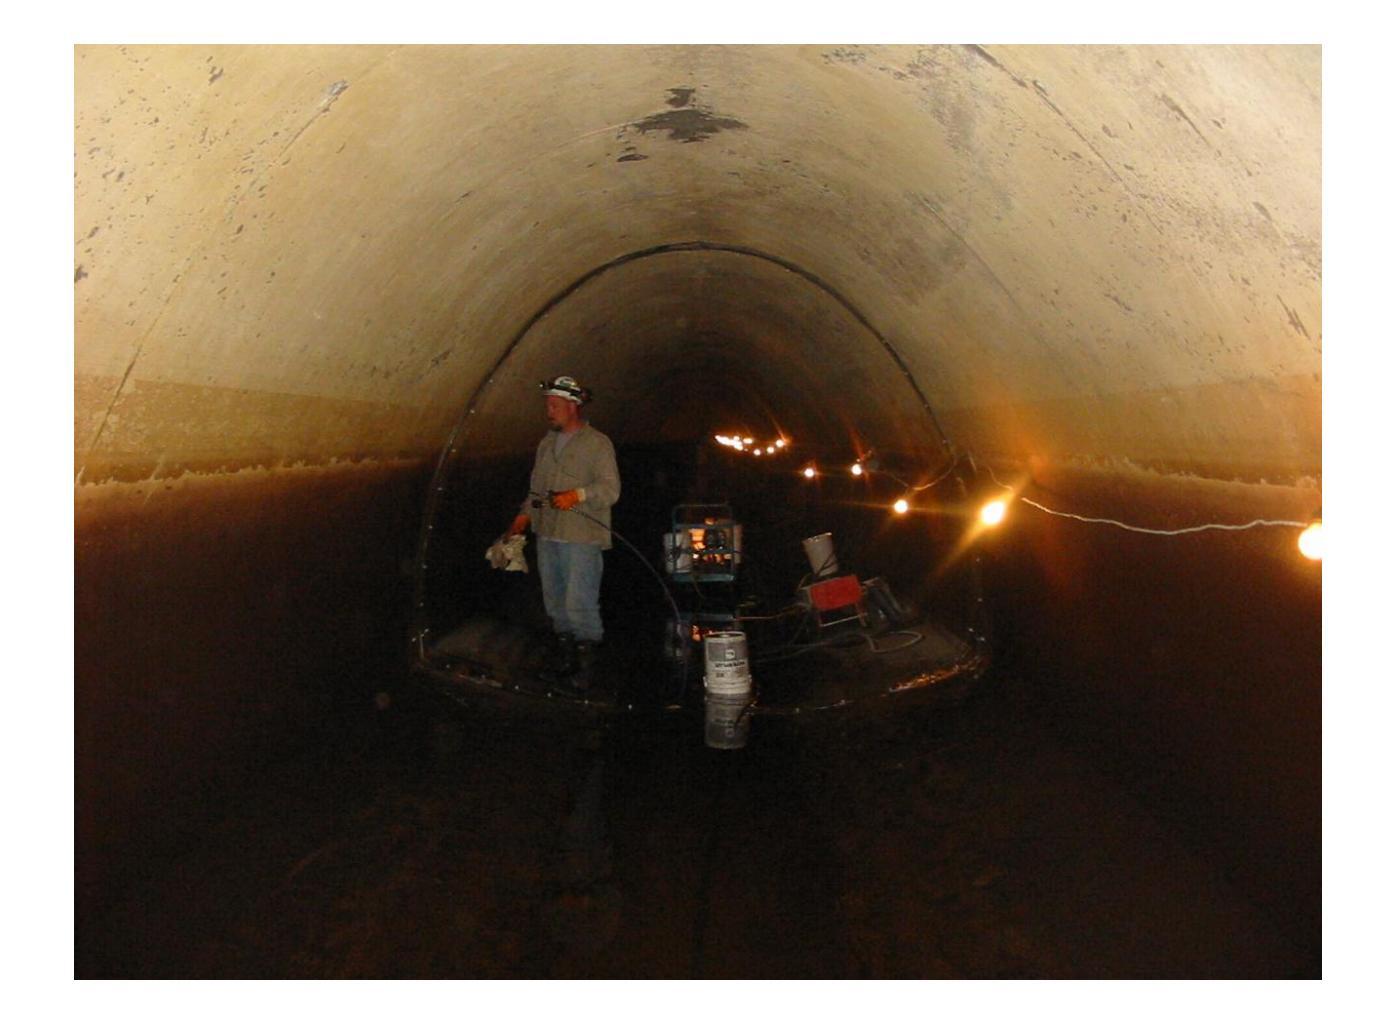
- Internal
 - The Winnipeg water demand was very near the limit of the aqueduct (at 85%)
 - Water was leaking out of the aqueduct at about 15% (thus no additional capacity)
 - The options were considered
 - build an additional aqueduct
 - or to seal leaks

- Seal Crack and Joints to reduce leakage
- Several crack sealing methods were evaluated
 - Route and seal
 - Surface applied sheet waterproofing
 - Epoxy injection
 - Polyurethane chemical grouting

Polyurethane chemical grouting was chosen
