# Evaluation and Repair of Shear Walls of a Parking Garage

Hemant S. Limaye  
Concrete Science, Inc.  
Hayward, CA

# ConRAC

# Concerns

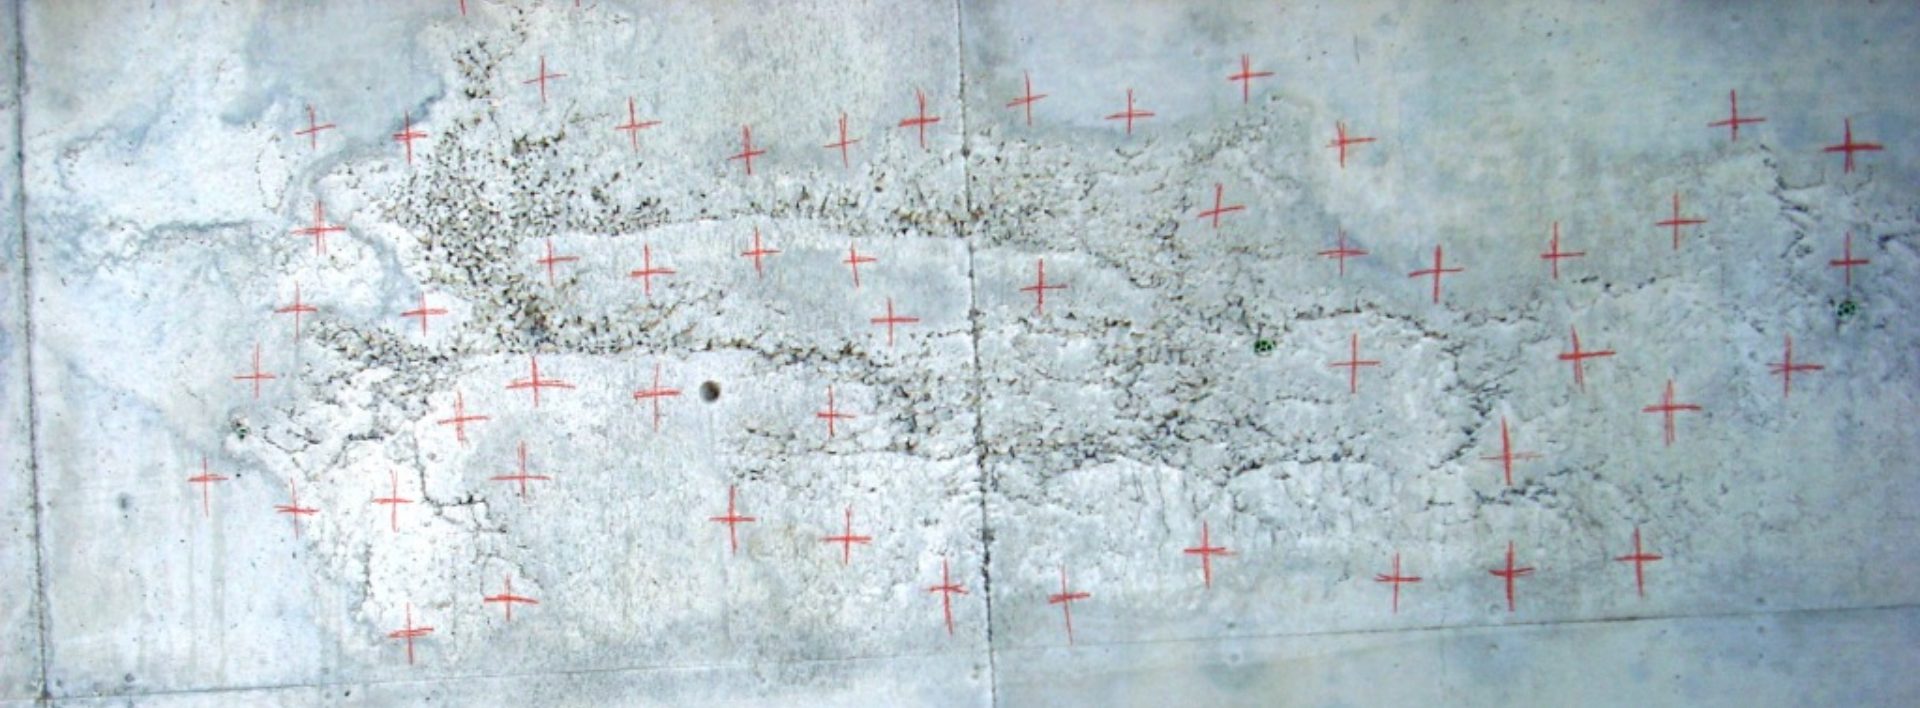
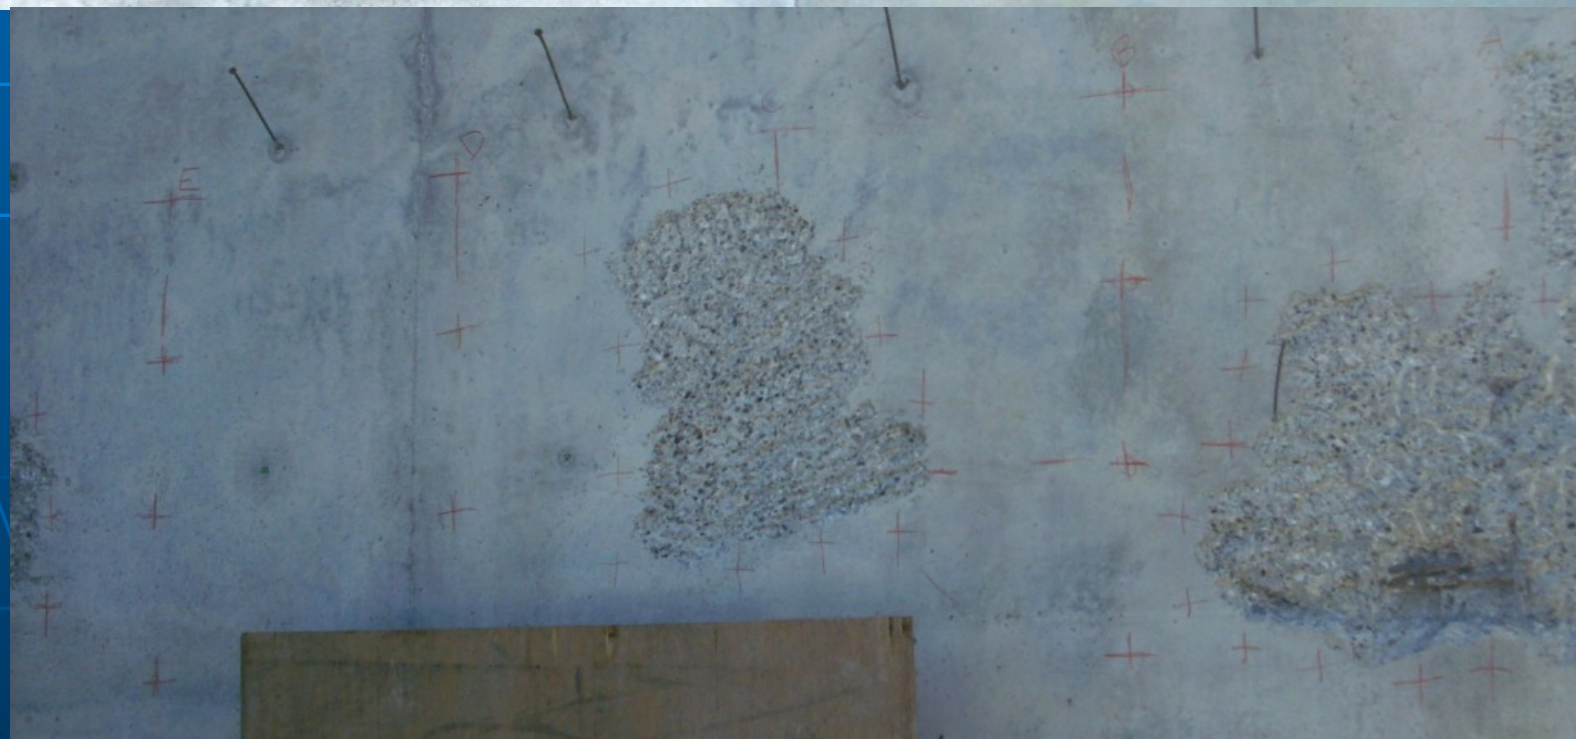
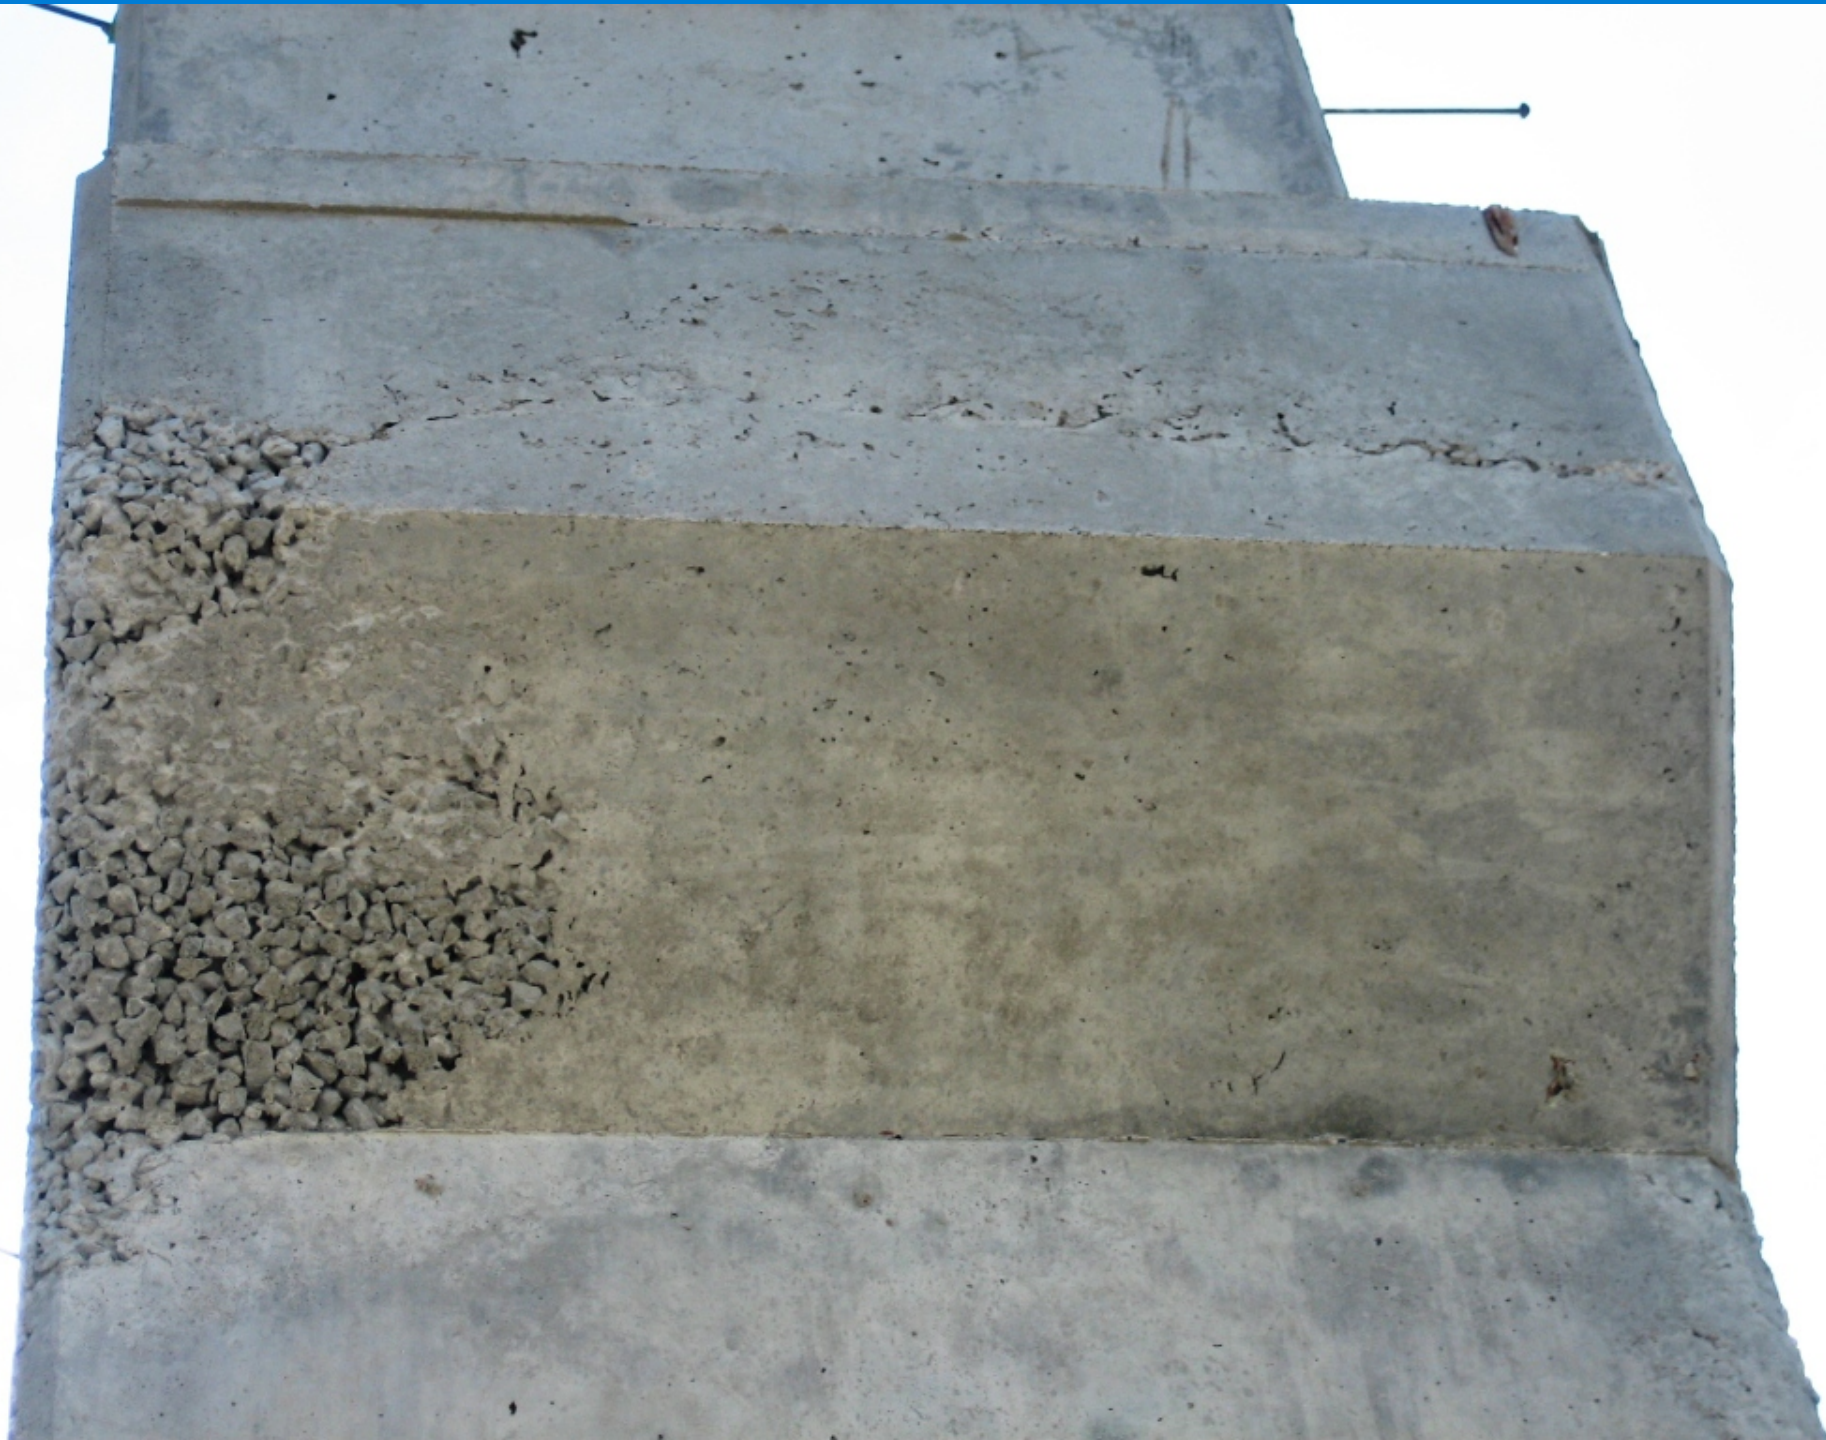
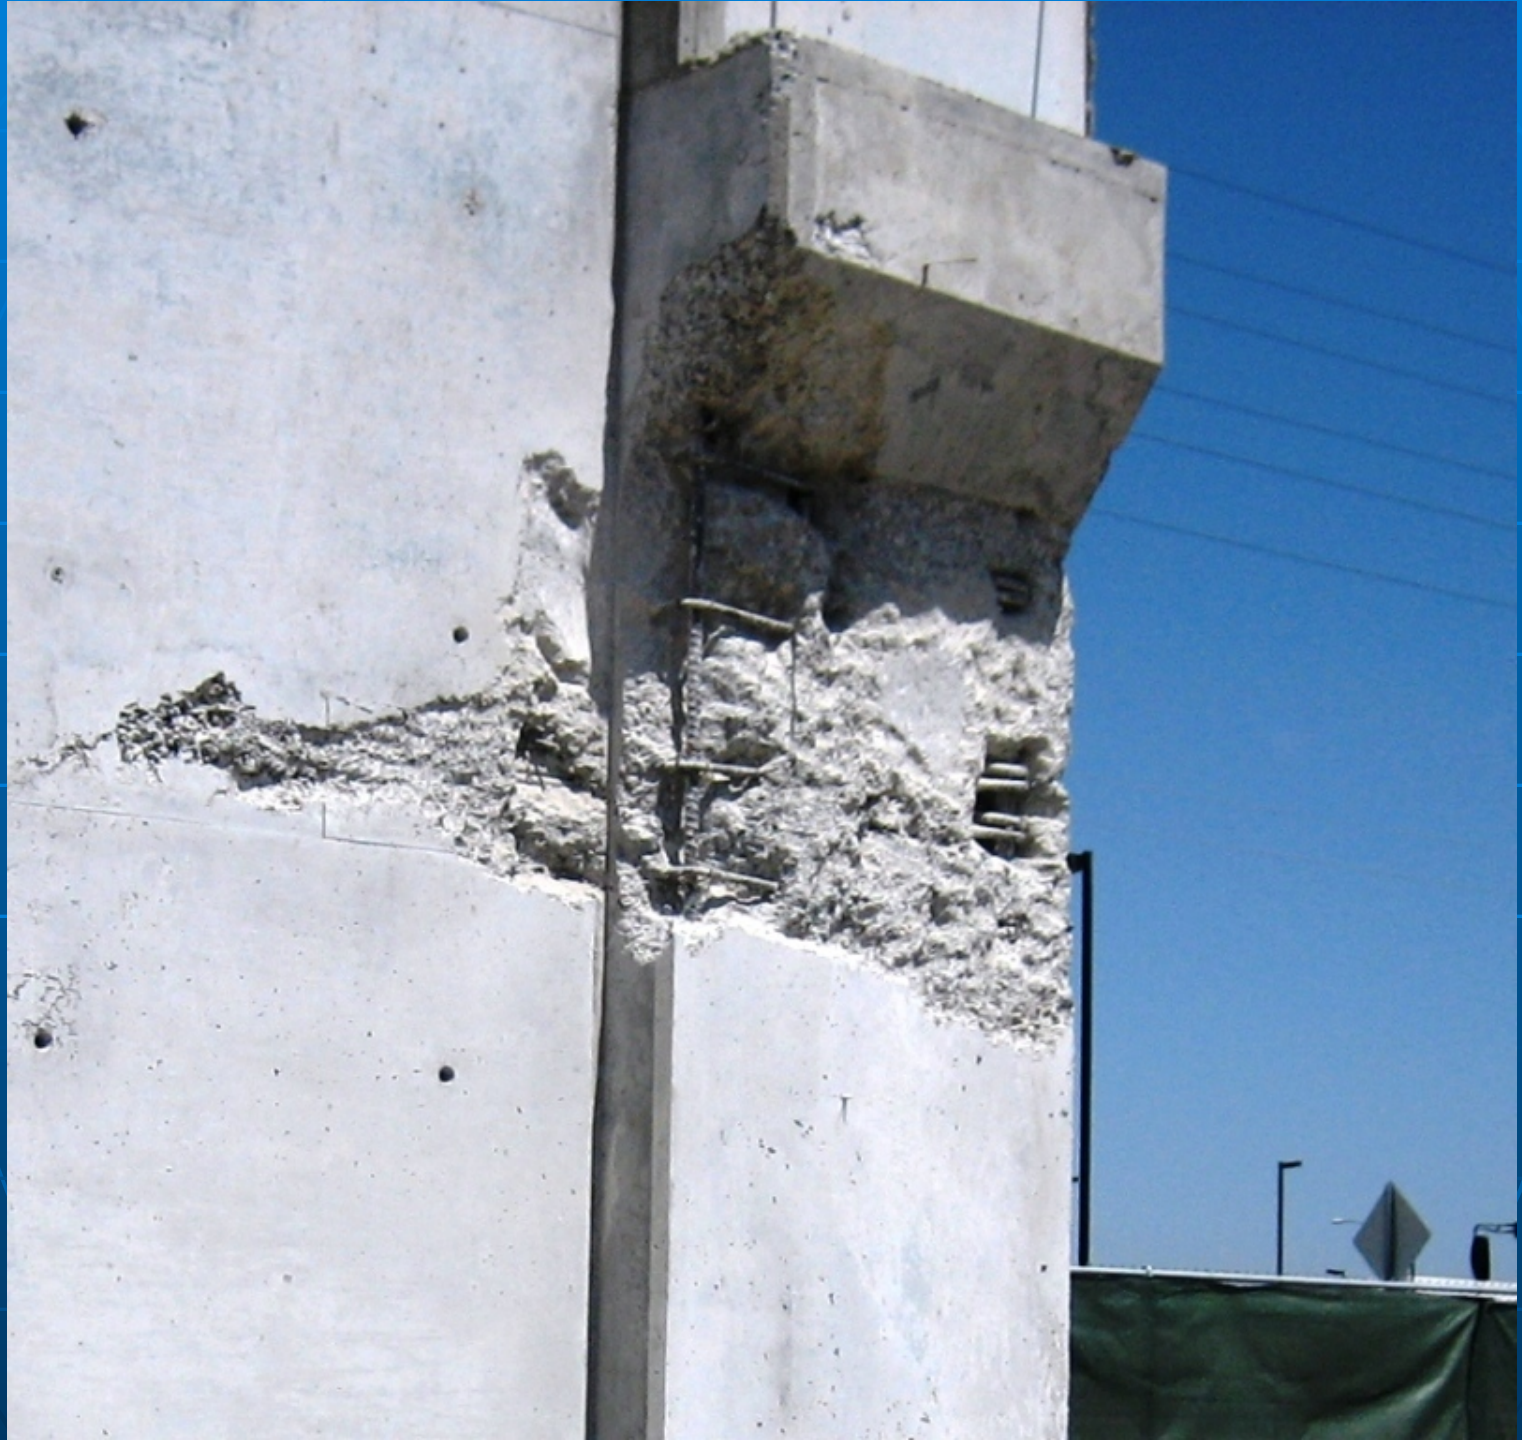
# Honeycombed Concrete

- 32" Thick Shear Walls Between 1<sup>st</sup> & 2<sup>nd</sup> Floor
- After Removal of Forms Revealed Minor to Severe Honeycombing in some of the Walls
- At a Few Locations Unconsolidated Concrete Extended Through the Entire Depth

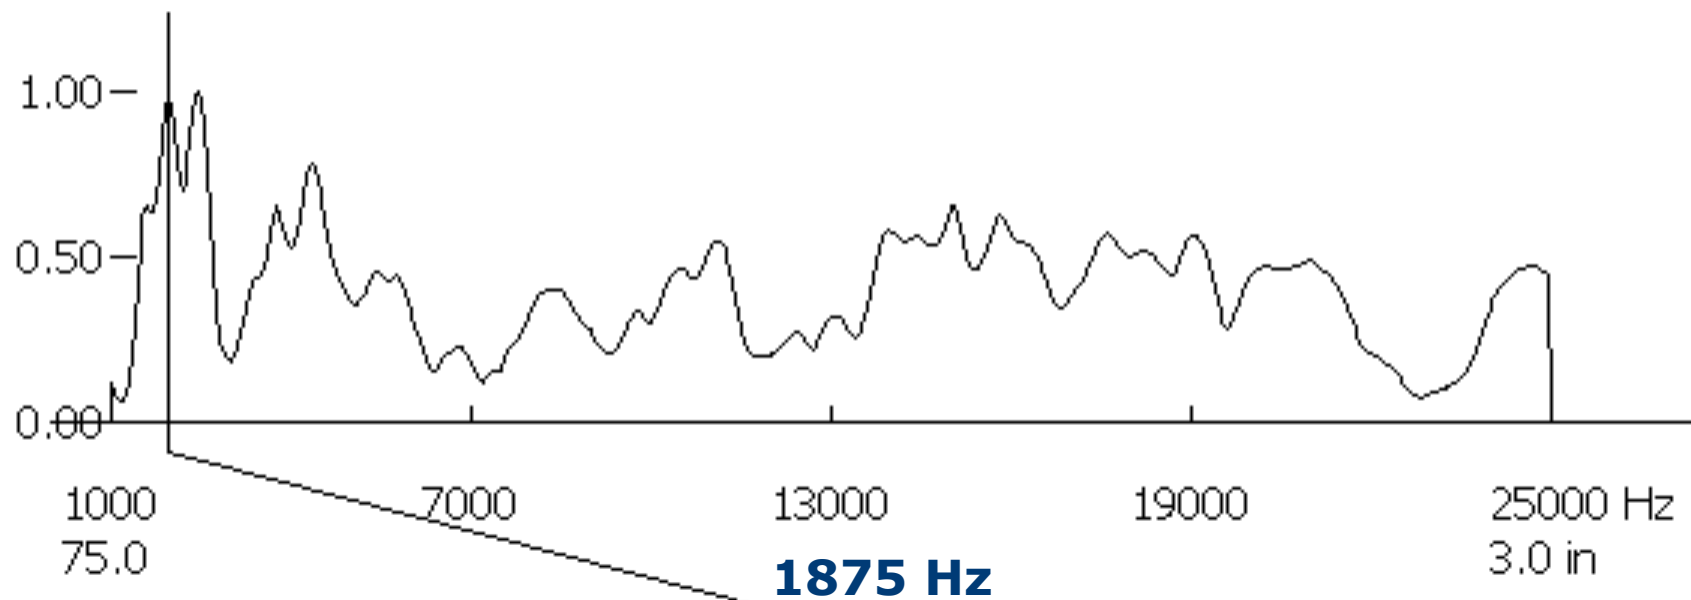
# IE Results-Honeycombed Concrete

- Majority of the Locations Did Not Contain Through the Depth Voids
- A Few Locations Contained Unconsolidated Concrete up to 40% of the Depth

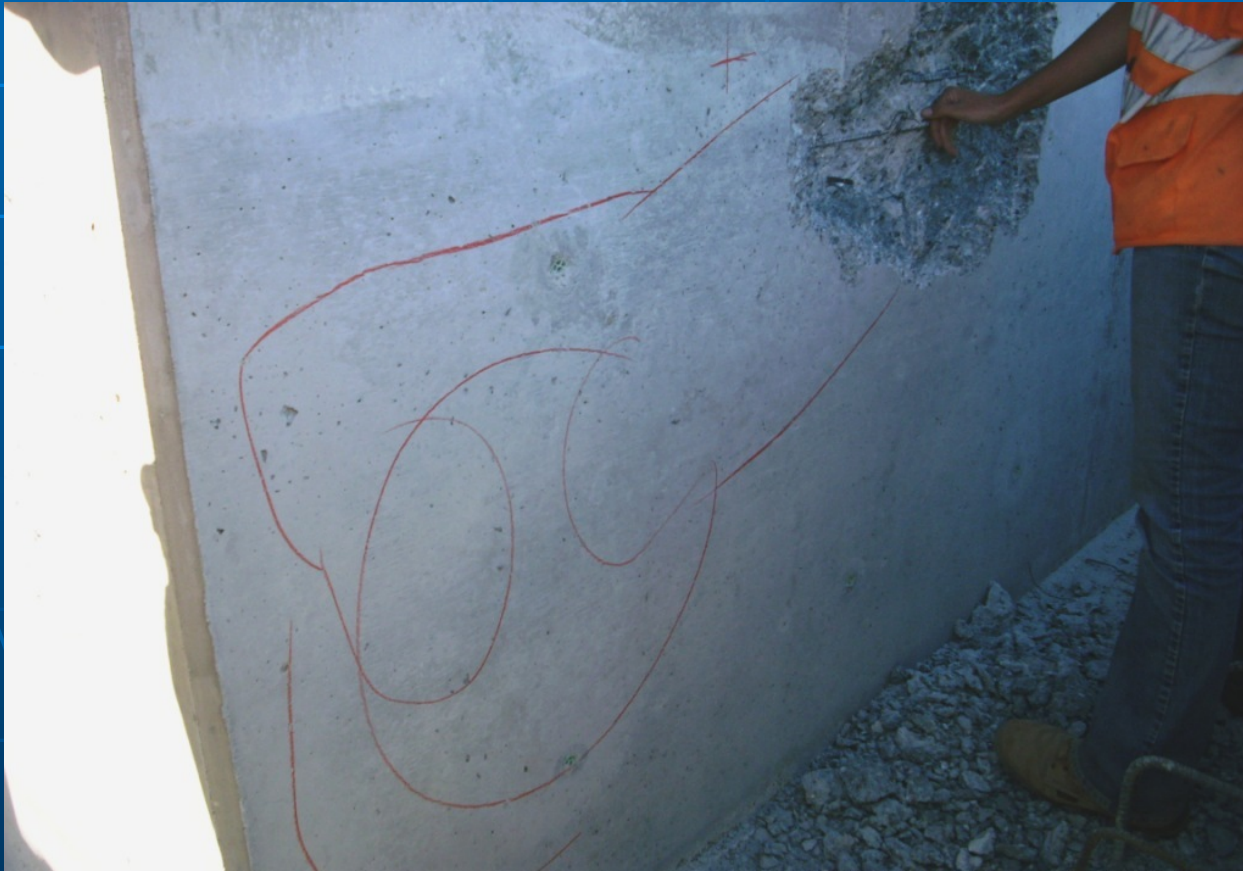
# Shear Wall IE Results

- Showed Inconsistent, Non-Repeatable Signals at Two Adjacent Locations

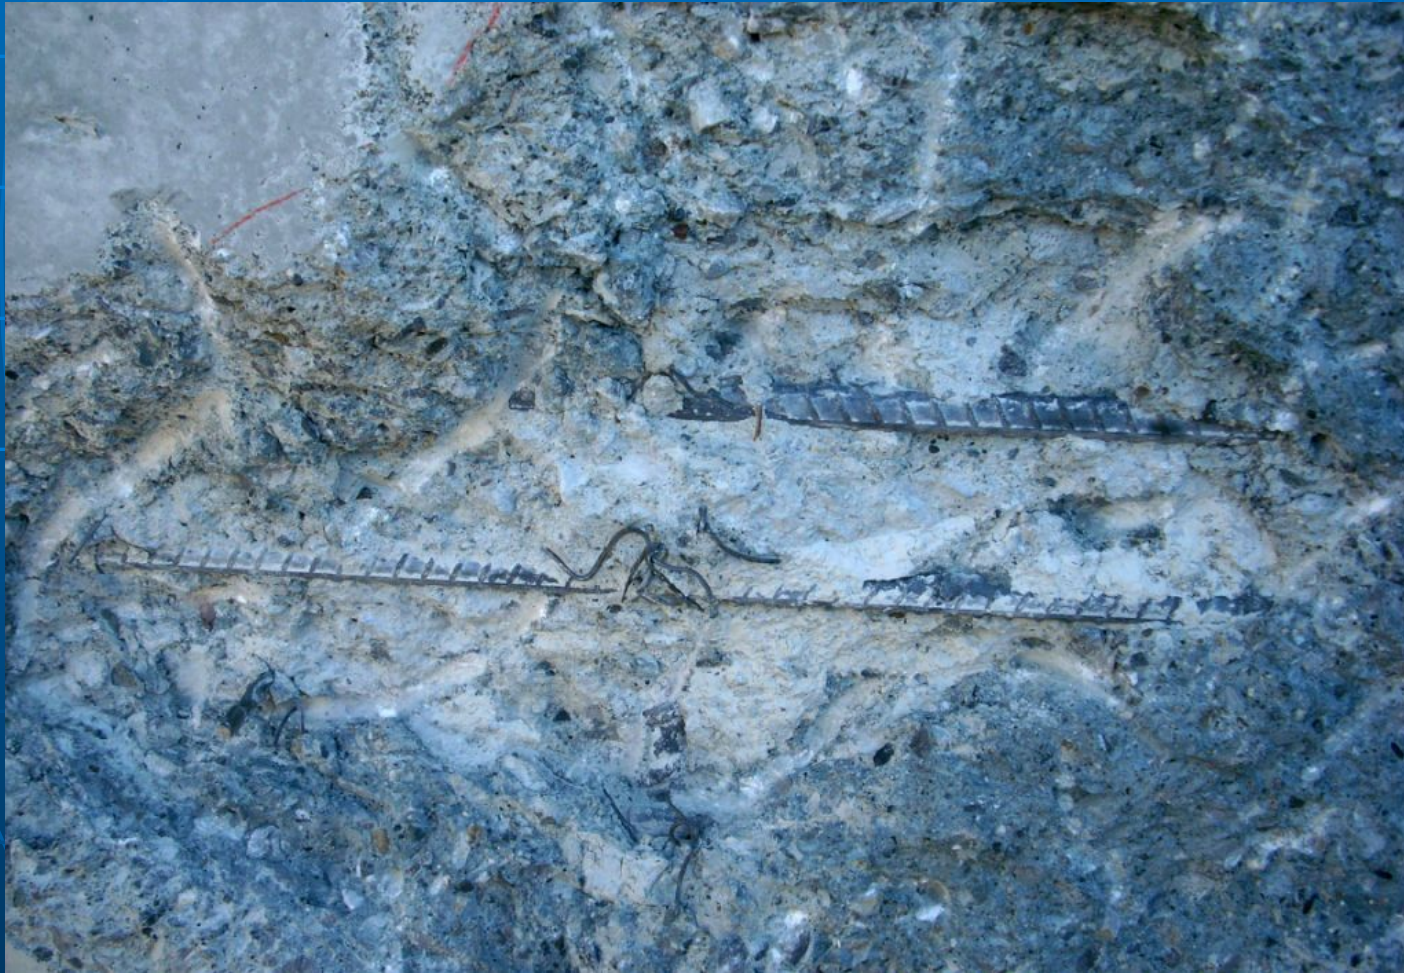
# Shear Wall- Add' L Work

- Chipping of the Concrete Showed Color Variation

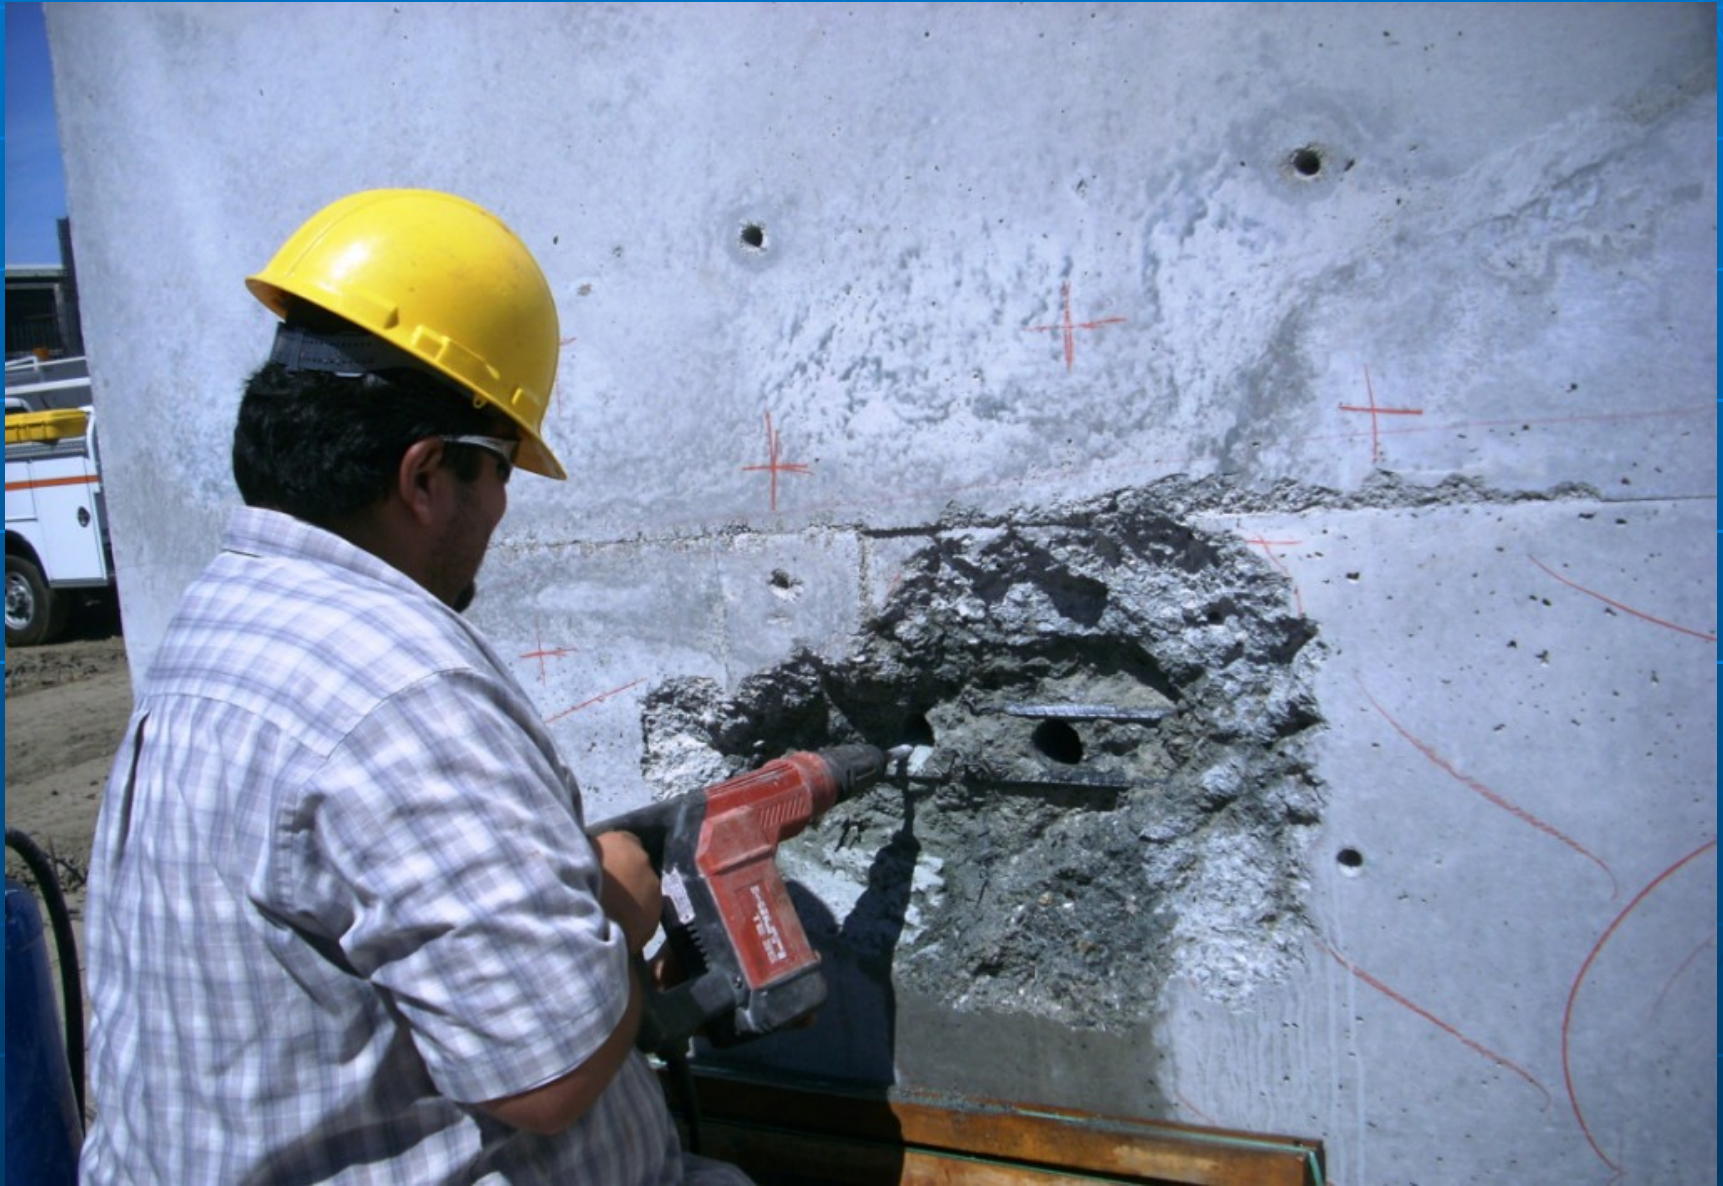
....And then Drilled 5/8" Dia. Holes

- Interior Delamination
- Bug Holes in One Hole, Depth: 8-9"
- Crack in Another Hole; Depth: 9-10", Color Change in Material
- Crack in Third Hole; Depth: ~8", Color Change in Material Starting at 6.5"

- Perform Microscopic Examination to Characterize the Concrete
- Chip the Area Concrete to Examine the Interior Condition

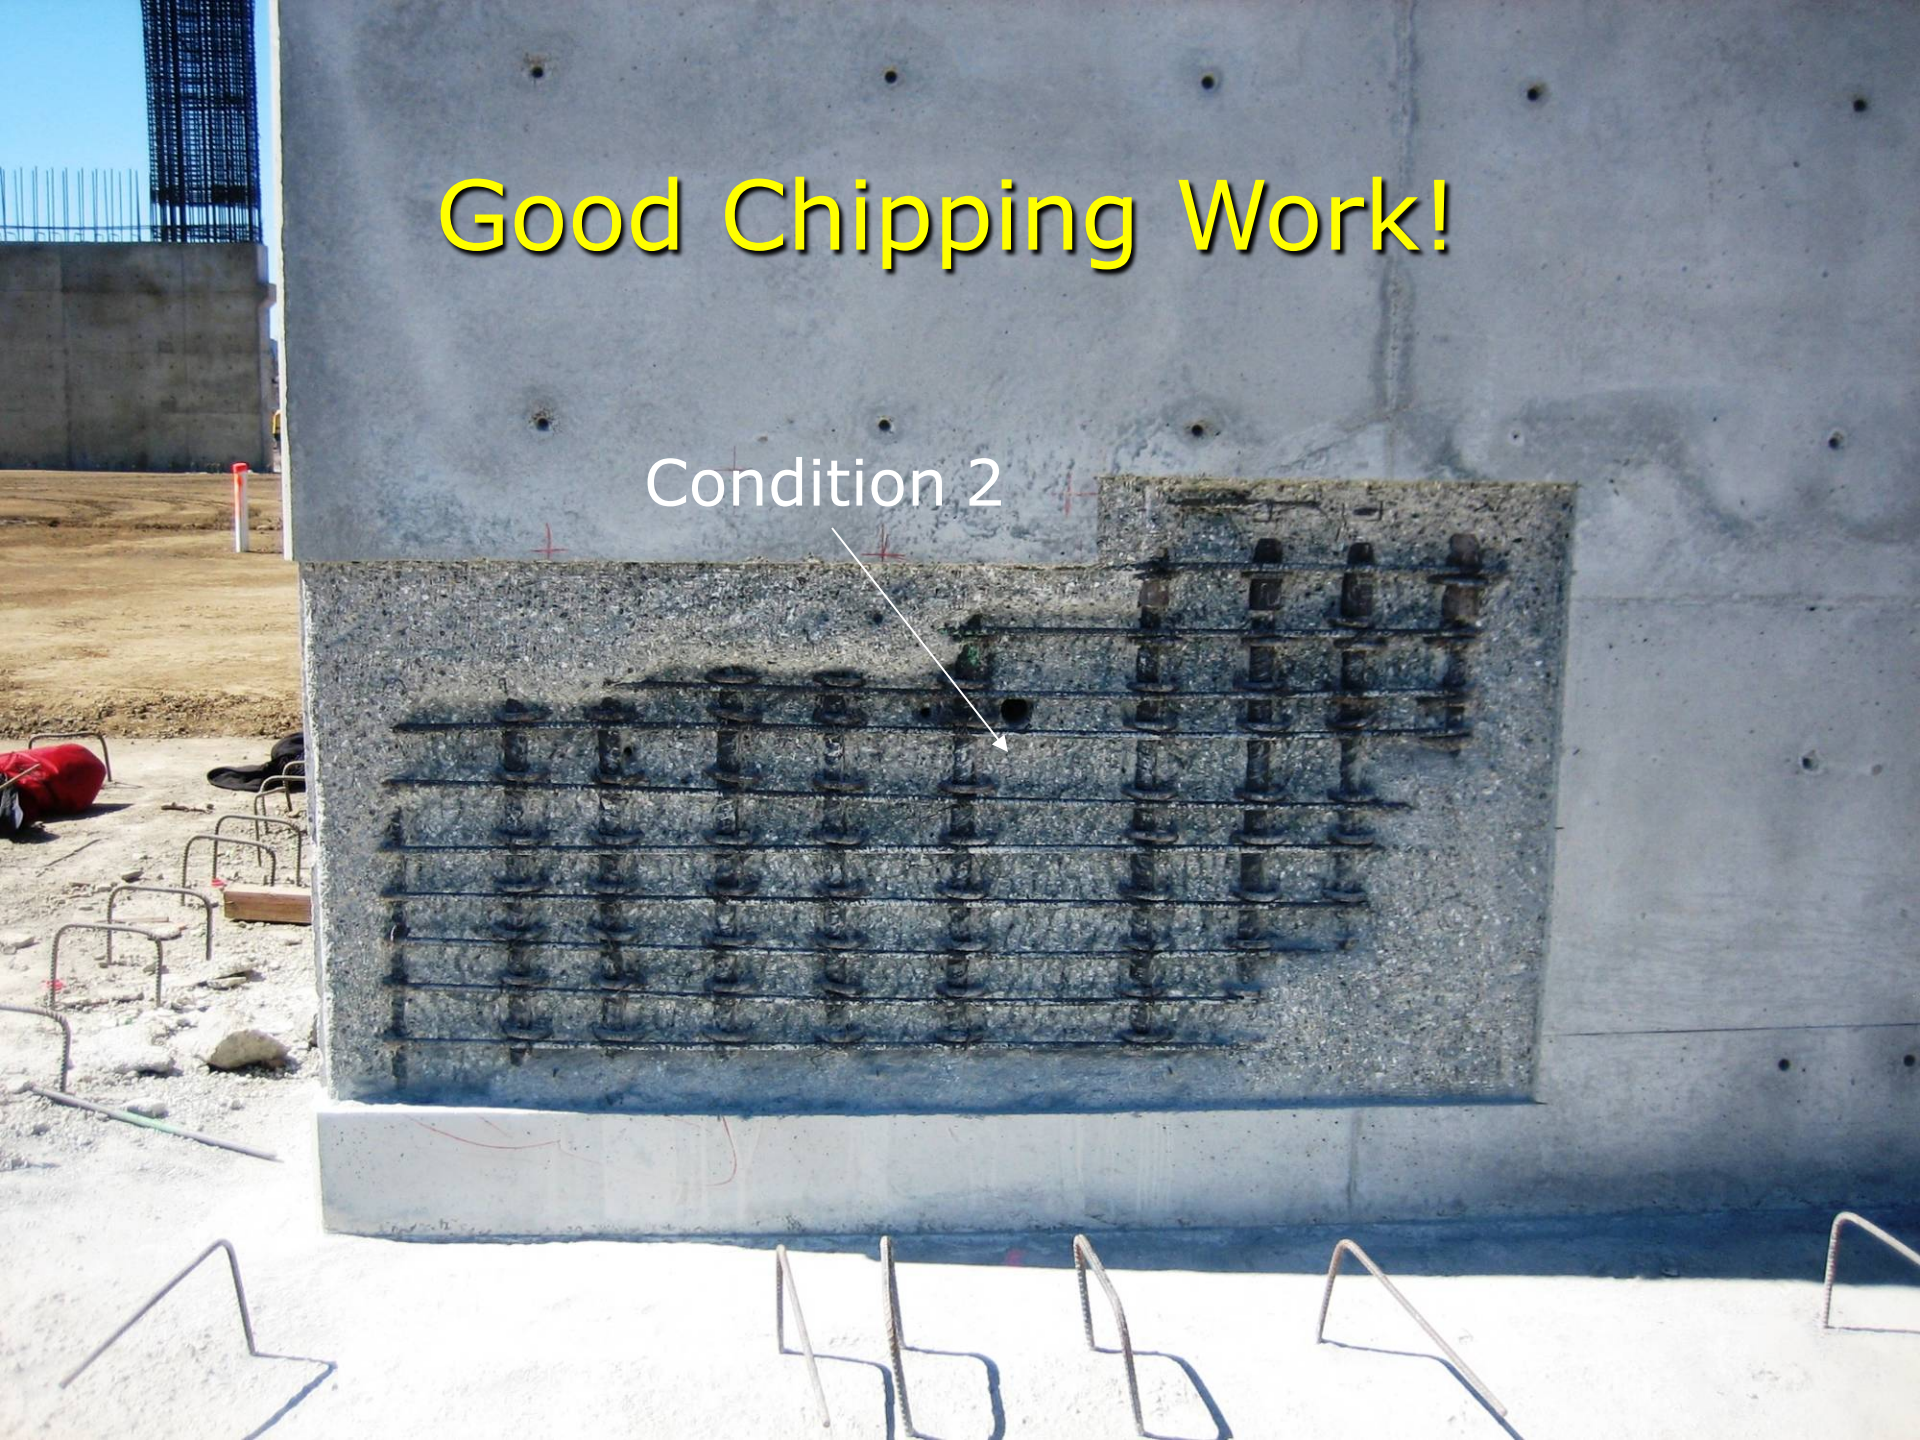
Condition 2

# Good Chipping Work!

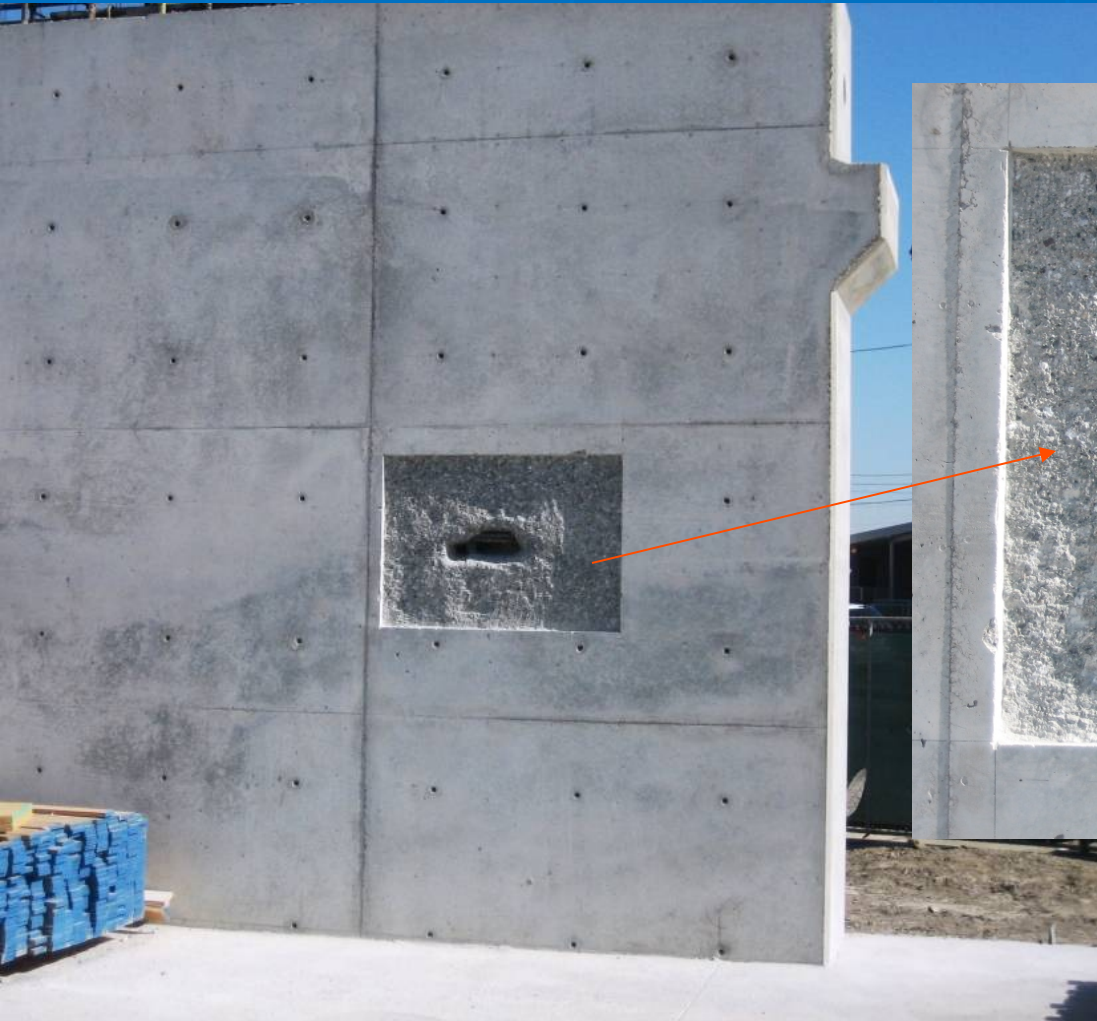
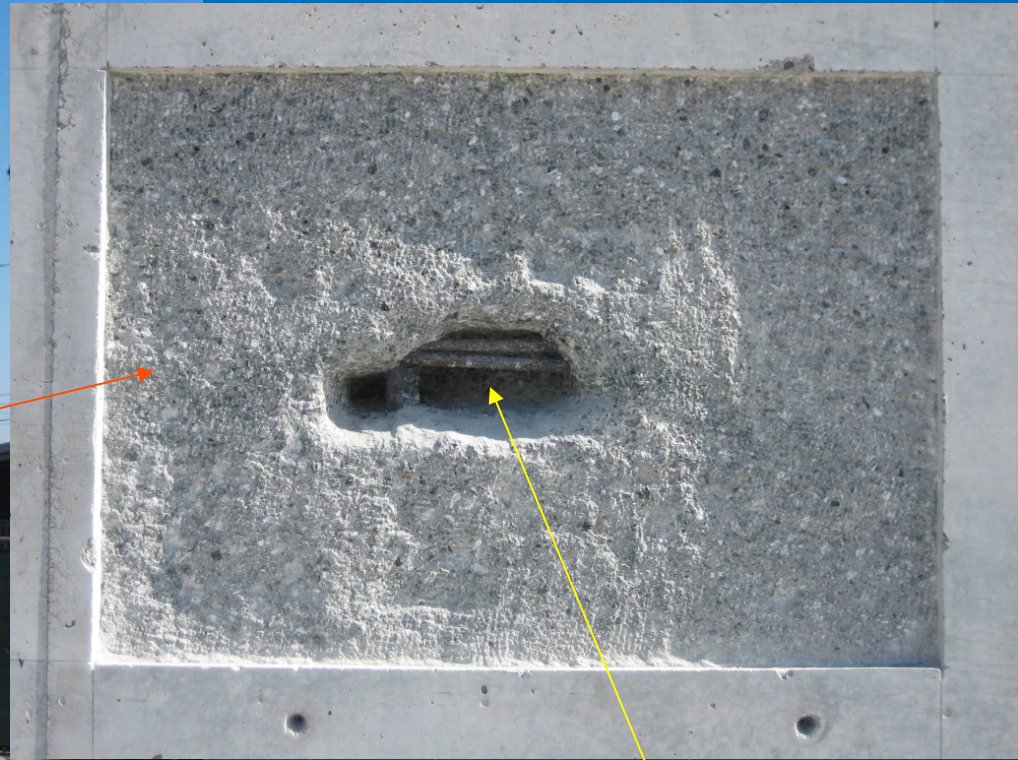
# Good Chipping Work!

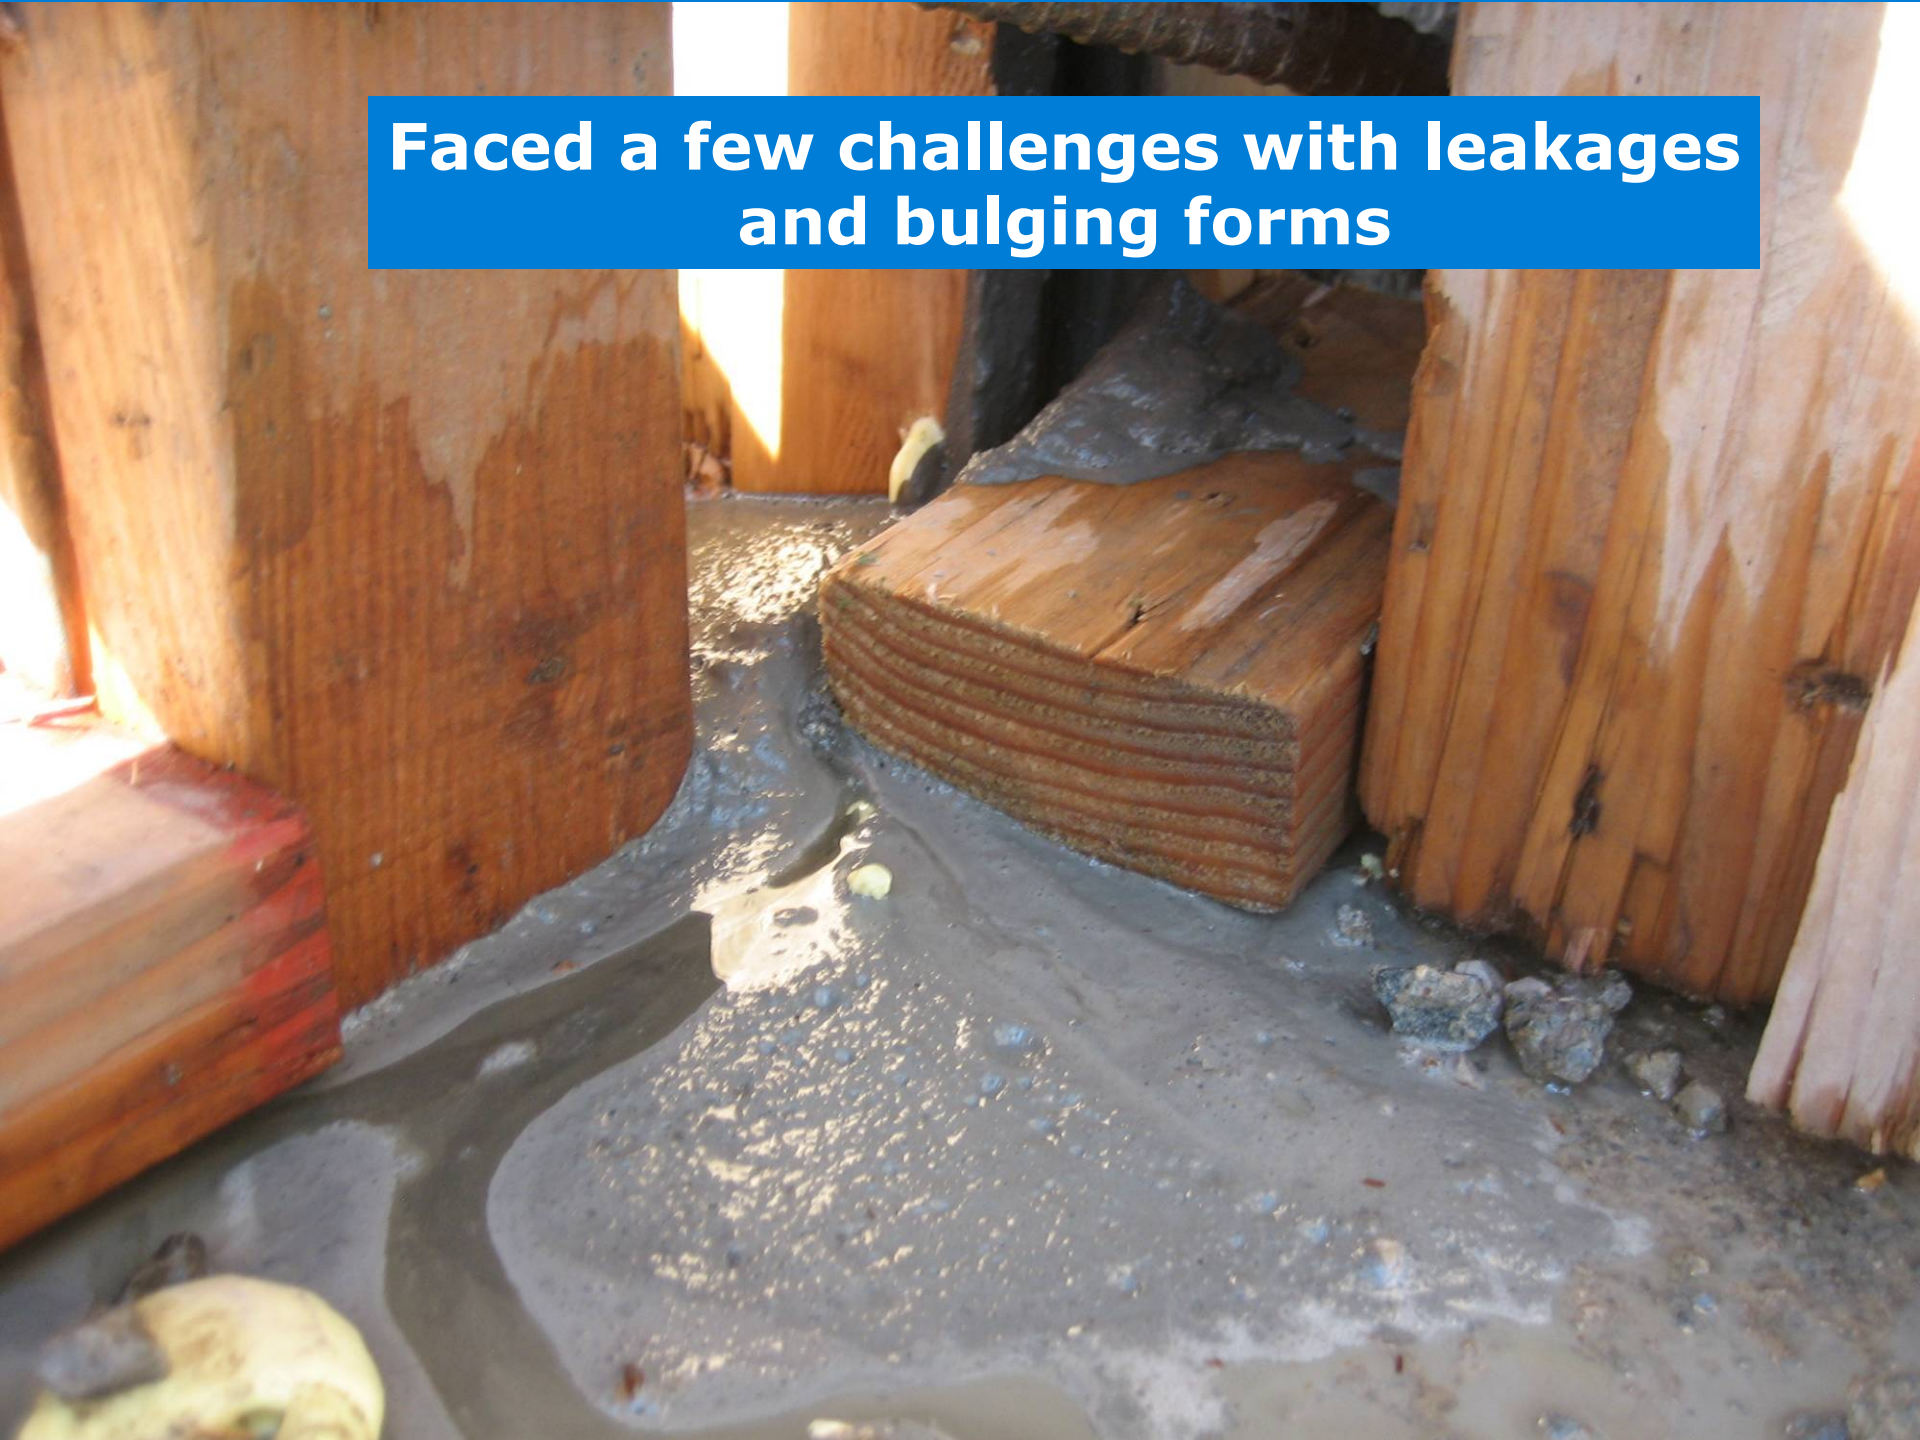
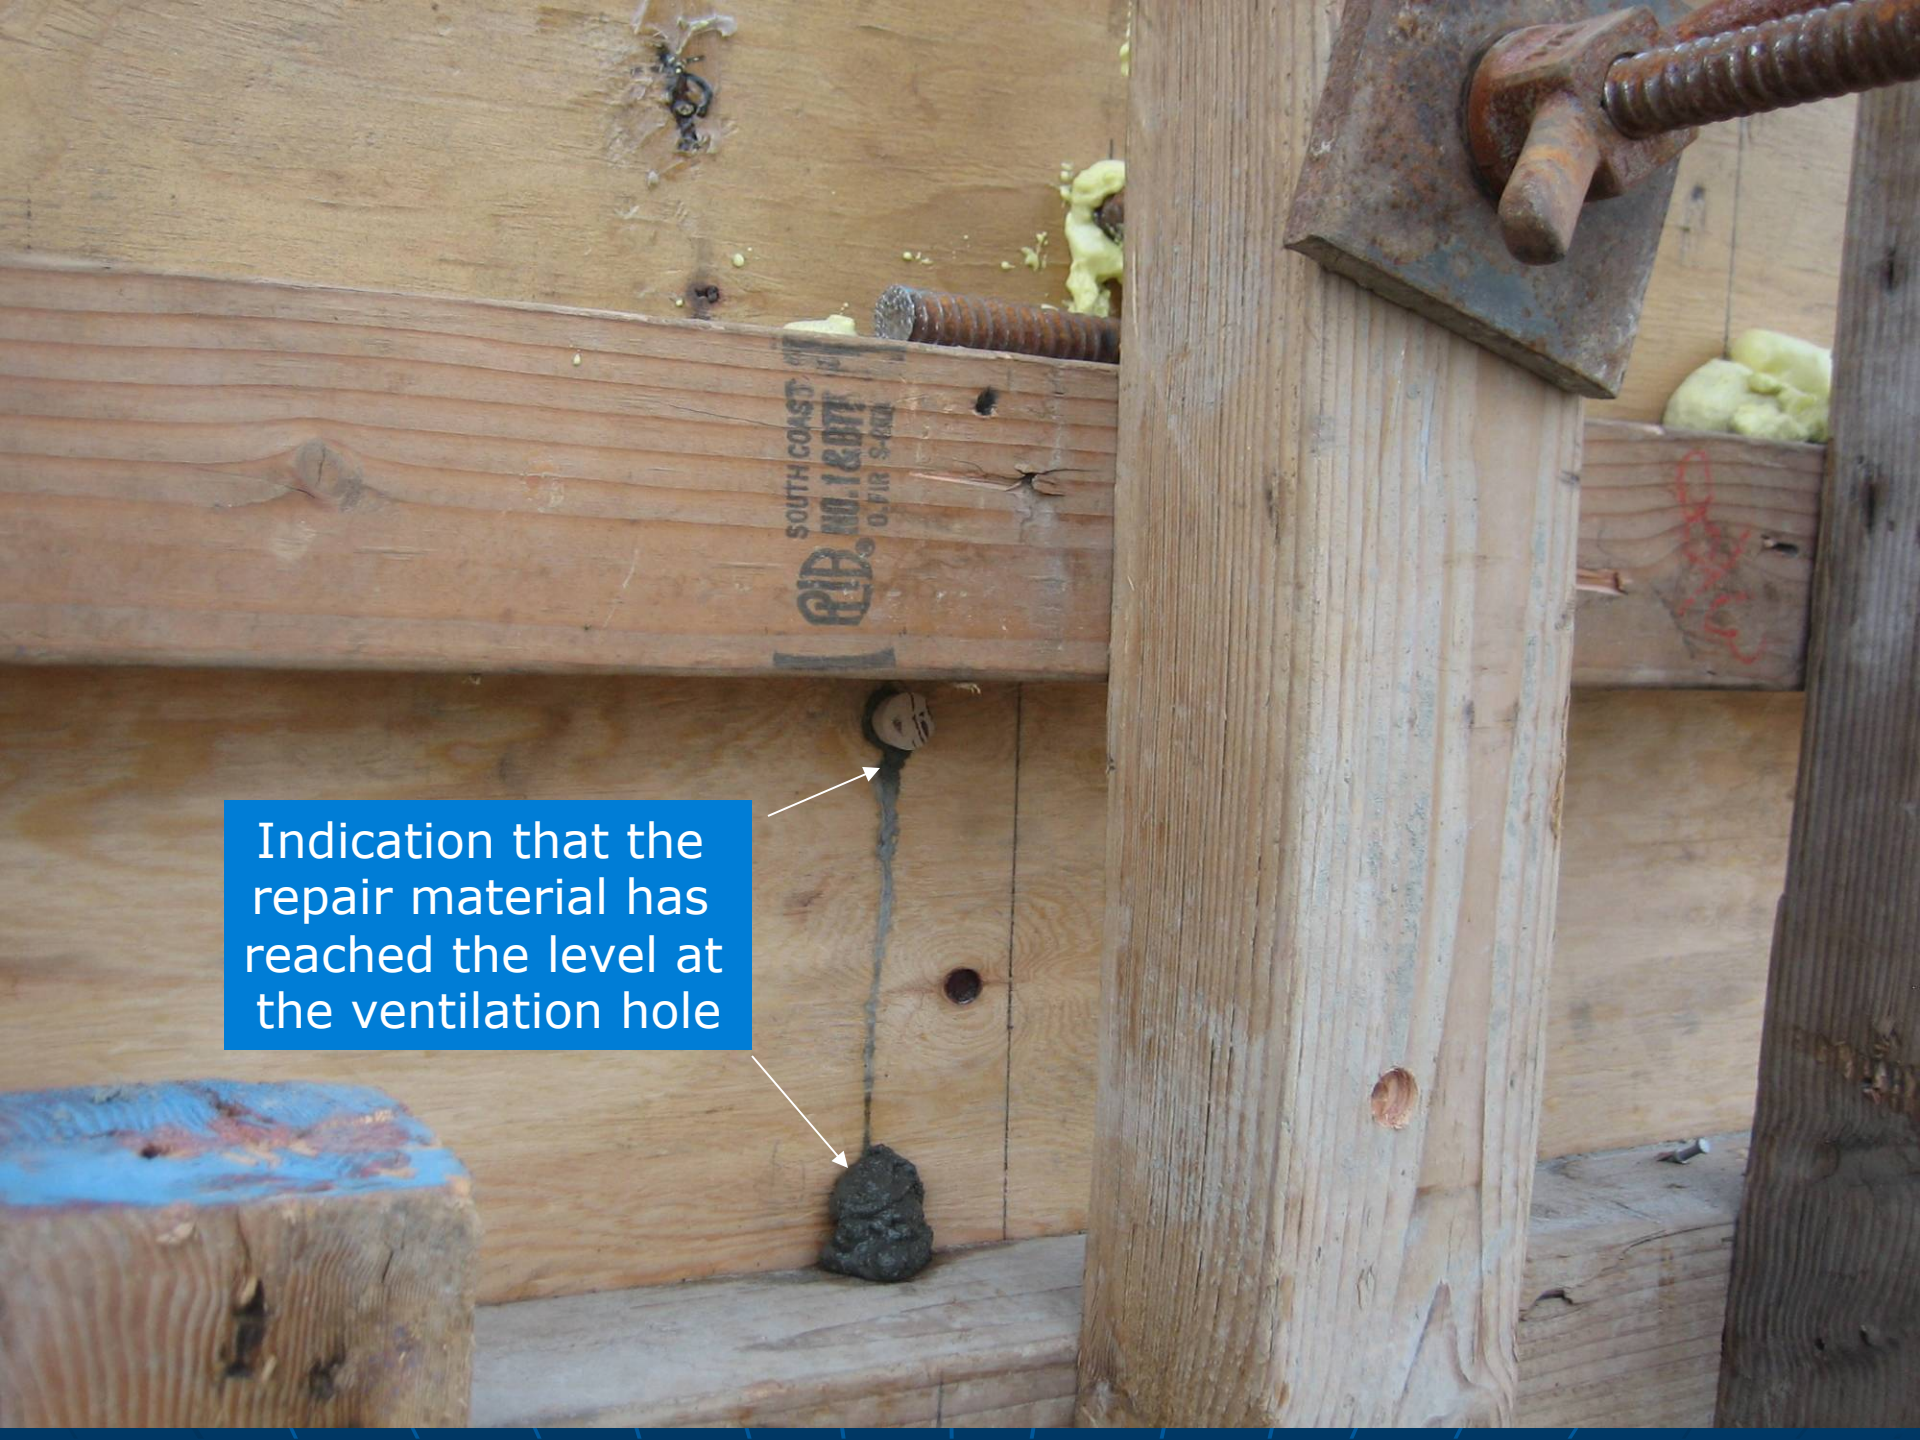
**Faced a few challenges with leakages  
and bulging forms**

Indication that the repair material has reached the level at the ventilation hole
