# Evaluation and Repair of Shear Walls of a Parking Garage

Hemant S. Limaye  
Concrete Science, Inc.  
Hayward, CA

# ConRAC

# Concerns

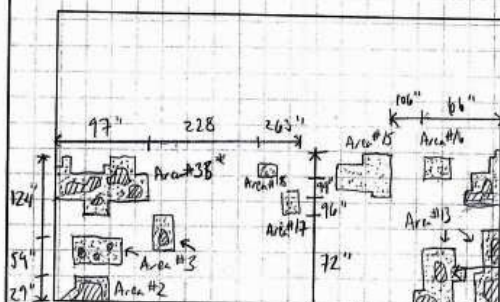
# Shear Wall No. 7 East

\* Area #3B continues onto South face of wall, connects to Area #4 on South. Needs more chipping done tomorrow.  
 Area #2 chipped to a total depth of 7 1/2" at ground level on South side.

A	B	C	D
Horiz. rebar thickness	5/8"	5/8"	5/8"	5/8"
Horiz. rebar depth	2"	2"	2"	2"
Vert. rebar thickness	5/8"	N/A	5/8"	5/8"
Vert. rebar depth	3"	N/A	2 1/4" - 3"	2 3/4" - 3 1/4"
Chipping depth	2" - 12 1/2"	4"	2" - 5"	4" - 6"

Horiz. rebar thickness = 5/8"  
 Horiz. rebar depth = 2"  
 Chipping depth = 3 1/2" - 4 1/2"

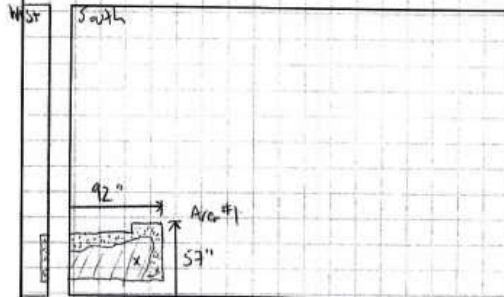
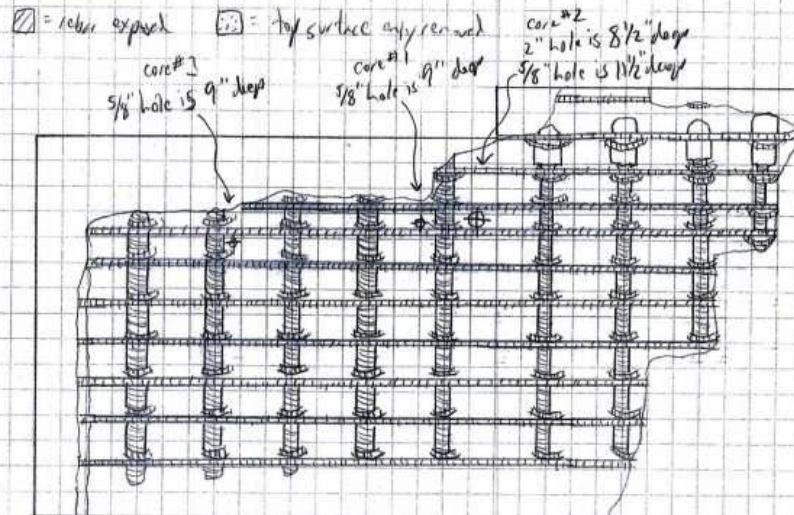
Shear Wall No. 18 South

8-22: hollow sounding sections of wall fell away in large chunks - up to 15" x 6" and 2" thick!  
 8-25: sample of concrete at approx. 3" depth taken (marked with X - 63" from West face and 17" from bottom perimeter of section)  
 8-27: rebar ties cut off

Horiz. rebar thickness = 5/8"  
 Horiz. rebar depth = 2"-2 1/2"  
 Vert. rebar thickness = barich  
 Vert. rebar depth = 3"  
 Chipping depth = 1"-4 1/2"

on 8-26-08 all three core holes were chipped out to their max depths:  
 Core #1 = 10"  
 Core #2 = 12"  
 Core #3 = 9"
