Breathing New Life into a Post-Tensioned Parking Structure

By David A. VanOcker, PE

University of Pennsylvania Parking Structure

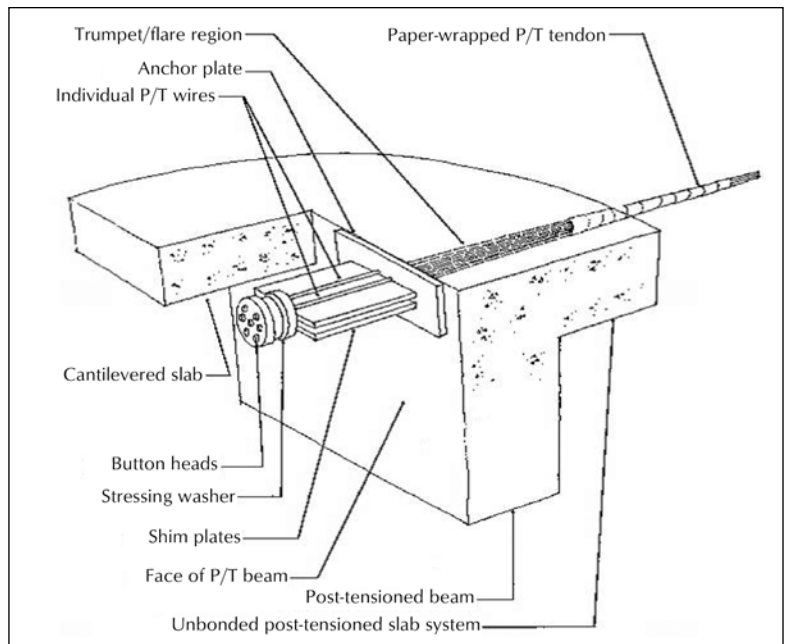
Fig. 3: Isometric of button-headed tendon anchorage

Preliminary probes done on the roof level during the 1996 EJ seal replacement work revealed an extensive amount of corrosion in the P/T anchors. While only a single noticeable tendon anchor rupture had occurred, individual wires were found to have failed in many instances, as evidenced by a differential shortening of certain

wires (Fig. 3). The initial visual examinations of tendon anchors were not completely conclusive, given that many of the wires couldn't be directly inspected. The initial assessment relied heavily on judging the visible concrete deterioration in the anchor regions on a comparative basis, using what was observed at the roof level, and extrapolating this information to visible concrete conditions on lower floor levels. While this method potentially had a wide margin of error, sufficient concerns over the structural integrity of the P/T deck slabs were warranted.
