Manhattan Repair Project Proves Challenging

by Gerald Valente

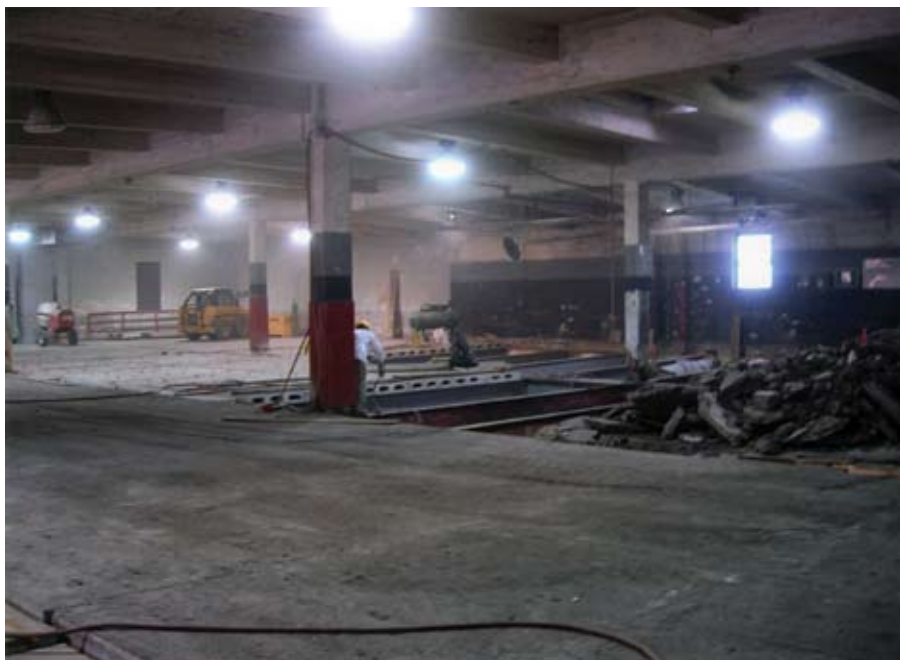
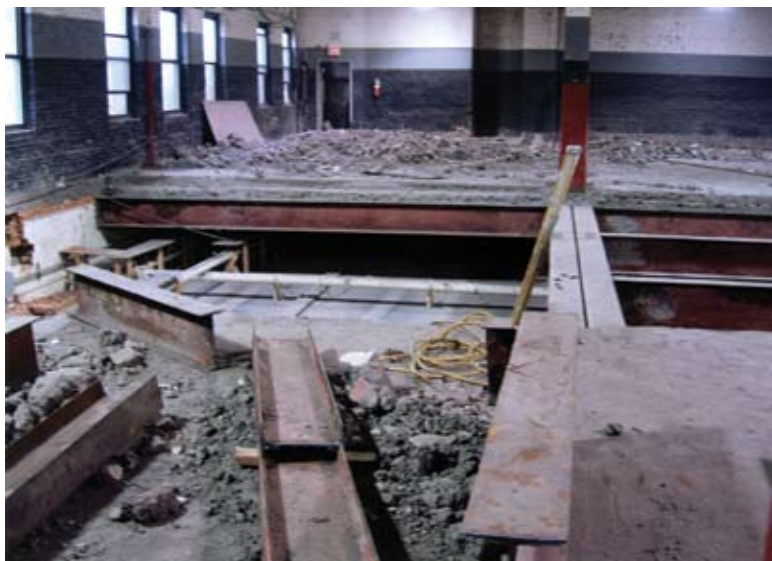
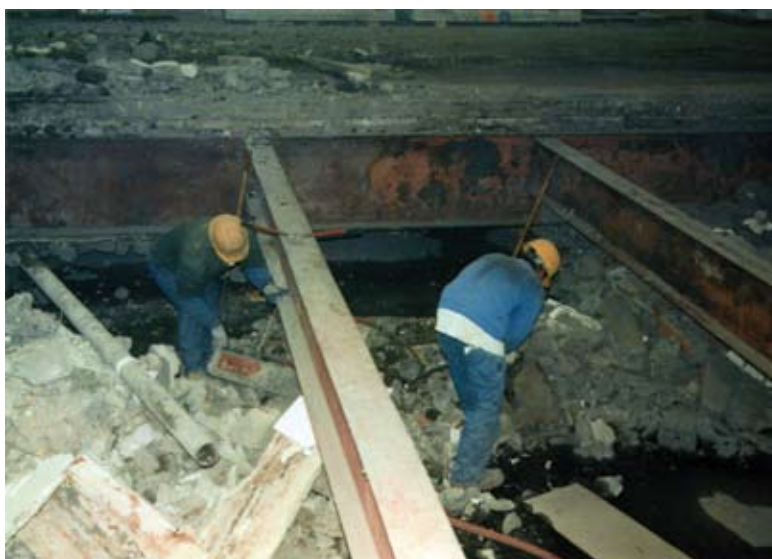
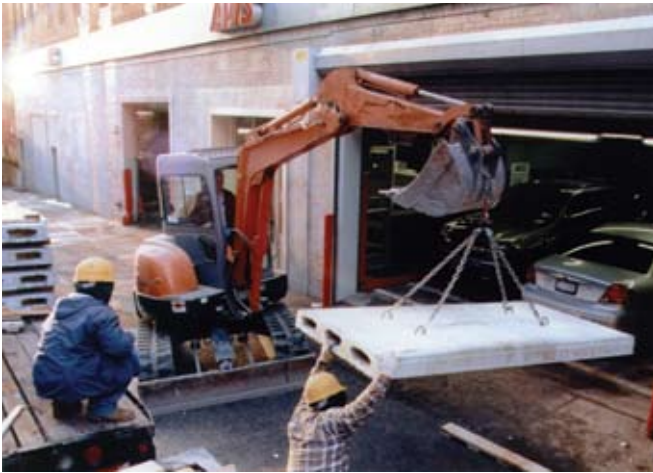
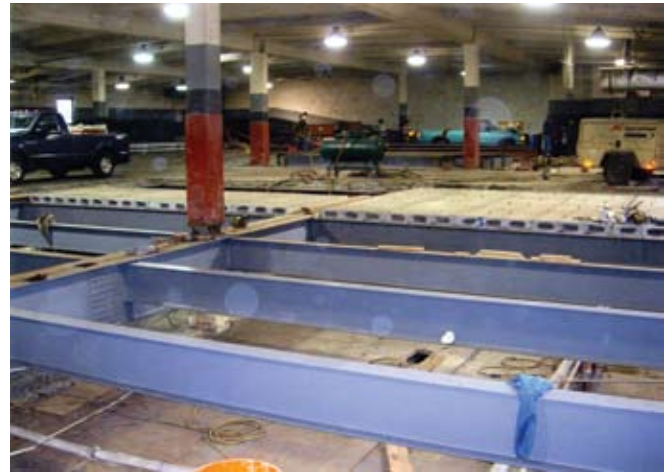
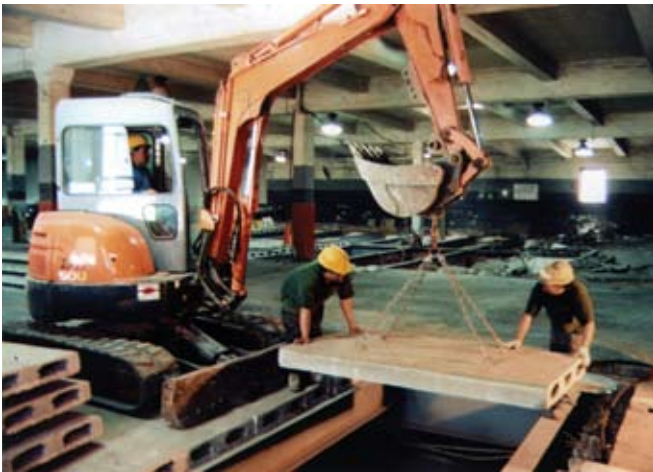
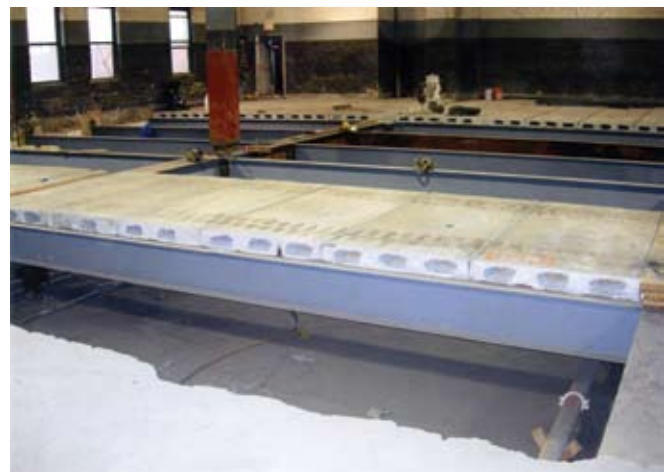
A protective membrane or structural design for vehicle traffic was not considered in the era the structure was built. After many years of vehicle use, the second floor slab began to deteriorate. The deterioration was hidden by the many levels of toppings and concrete encasements; it went unnoticed for years until delaminated concrete began falling from the ceiling to the level below. The owner immediately commissioned an engineering assessment. A survey was performed on the underside of the slab and probes were cut into the top slab and encasement. The assessment discovered heavily corroded slab reinforcement and steel beam flange and web corrosion. The girders and columns were found to be in relatively good condition.

The repair design required the complete replacement of the second floor slab, replacement of 70% of the steel beams, and welded plate reinforcement of 25% of the girders. The new slab design comprised 6 in. (150 mm) thick hollow-core plank with embedded weld plates cast in the bottom and at both ends. The new planks were designed to support heavy construction loads and were to sit on the narrow flange of the steel beams. The planks were to be welded to the steel beams, and the joints between planks and end cells grouted. A heavily reinforced sloped concrete topping slab 4 to 8 in. (100 to 200 mm) thick was to be placed over the planks. A steel perimeter angle was designed to complete the engagement of the slab support of the perimeter walls.

removed from below. On busy days, debris was “mucked-out” from above—a tedious task. The removal and replacement of the steel beams and installation of the precast plank was accomplished with the excavator. A temporary support platform was required under the excavator to avoid collapse of the existing slab.

The new planks were designed so that the machine could operate on them to facilitate the placement of other planks and new steel beams. Once the planks were installed in a 26 ft (7.9 m) wide bay, they were welded to the beams. The joints and end cells were grouted and the exterior floor edge angles were installed. New drains and heavy mesh reinforcement were placed on the planks and a sloped topping slab was cast. A new electric service, a heating, ventilation and air conditioning (HVAC) unit, vacuum system, gas pumps, and other miscellaneous items were installed. The temporary shield was removed, which completed the project.
