CONCRETE REPAIR AND PROTECTION AT HIGH ALTITUDE

SKI AND RACQUET CLUB CONDOMINIUMS

Ski and Racquet Club Condominiums

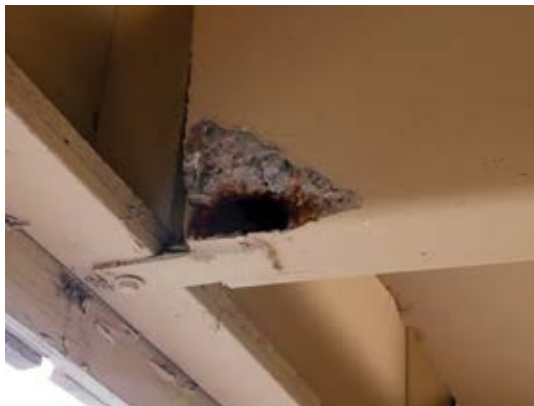
Fig. 1

In 2008, the Owners' Board at Ski and Racquet Club condominiums (Fig. 1) determined that the 40-year old precast triple-tee beam concrete structure needed a new facelift. The Board contracted an architect in Breckenridge, CO, to review the structure and design a new building envelope system. Upon the initial investigation of the structure, the architect found several areas of concrete that looked suspect and determined that a structural

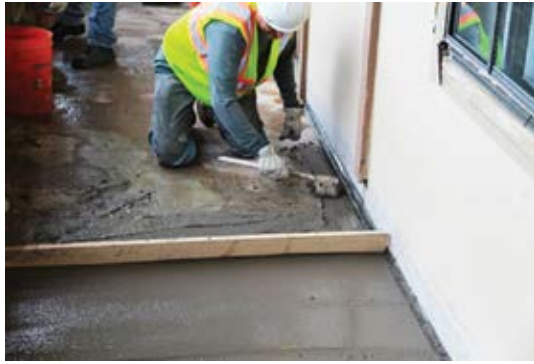
Fig. 5

profile was achieved prior to placing the concrete overlay. The existing walkways (balconies) at the complex were typically at 262 x 5 ft (80 x 1.5 m), for over 12,000 ft² (1115 m²) that needed to be resloped (Fig. 5). Once the carpet was removed, the concrete was ground to remove as much of the old glue as possible. The final step of the surface preparation was to use a concrete scabber to achieve the desired concrete surface profile. As with all concrete repair applications, achieving the proper saturated surface-dry (SSD) condition of the prepared surface prior to concrete placement is critical. As such, the contractor sectioned off the deck into workable sections each day and allowed a soaker hose to keep the deck wet for several hours prior to installing the concrete topping. The second critical step in the overlay process was to make sure a scrub coat of the polymer-modified overlay material (Fig. 6) was used to ensure a good bond. Immediately after the scrub coat was applied, the polymer-modified sloping material was installed by pouring the mortar onto the deck and screeding the material into place between the forms. A light broom finish was applied to the new overlay and cured.
