# Fountain View on the Plaza Parking Garages' Structural Strengthening and Concrete Repair and Protection

## Fountain View on the Plaza Parking Garage

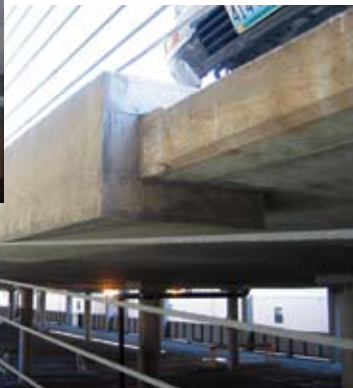
*Fig. 5: Cracking on slab edge shown before and after repair*

2. Repairing hollow-sounding areas of concrete and previous repairs on the underside of the slab below the banded tendons where the concrete/repairs were cracked;
3. Repairing areas of slab with horizontal cracks on the exposed slab edge (Fig. 5);
4. Repairing stressing pockets where the grout-fill had gaps and/or showed signs of leakage, and filling grout pockets that were ungrouted;
5. Injecting epoxy into column cracks resulting from the restraint of slab post-tensioning and other volume changes;
6. Repairing spalled column tops;
7. Routing and filling cracks in the topside of the slab with methacrylate resin;
8. Applying vehicular traffic-bearing waterproofing on the elevated slabs. The waterproofing was extended down the vertical faces of the exposed slab edges to provide additional protection to the ends of the tendons; and
9. Applying penetrating sealer to all the slabs-on-ground.
