# ST. ALPHONSUS CHURCH: REPAIR AND SPIRE INSTALLATION

BY CHRISTIAN HILL AND MARK K. HOWELL

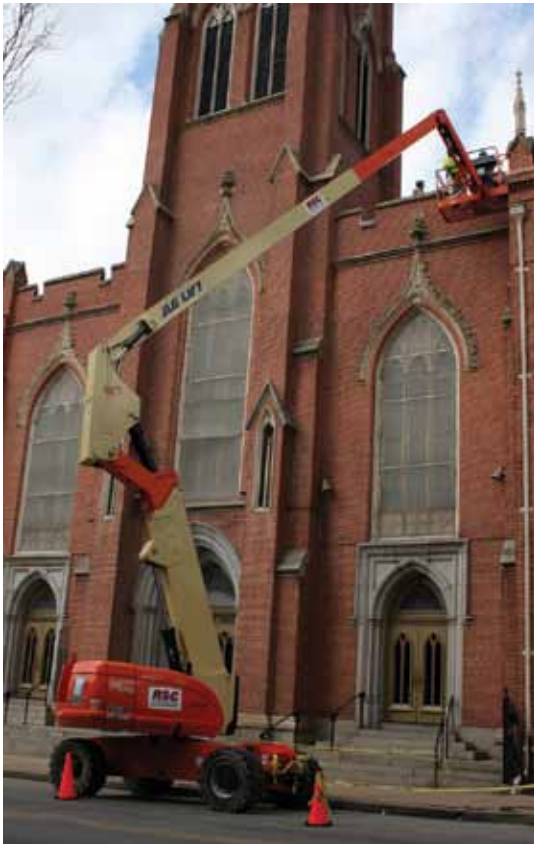
An 80 ft (24.4 m) boom lift was used for safe access to the work

Work performed by the repair contractor prepared the pier caps for the spire installation. Any cracks existing within the capstones were filled with an injection grout and the broken or spalled capstones were built-up with a restoration mortar and carved back to their original shape. Exfoliation was removed from the capstones’ surface with hand tools and rubber mallets, after which a consolidator was applied. Isolated patching repairs were made on the capstones as required. After the capstones were restored, all were covered with a stone stabilization compound. The liquid-applied stone

consolidator is specially formulated to penetrate the substrate, soaking into the pores much like water into a sponge. This action decreases the volume of voids in the top layer of stone, minimizing the locations where atmospheric pollutants could lodge and cause further deterioration. It is important to note that the capstones were not fully restored or replaced in order to retain their architectural and historic value. Fortunately, because initial investigation showed that they were in a fairly good condition, the main objective was to restore them to a sound structural condition prior to spire installation.

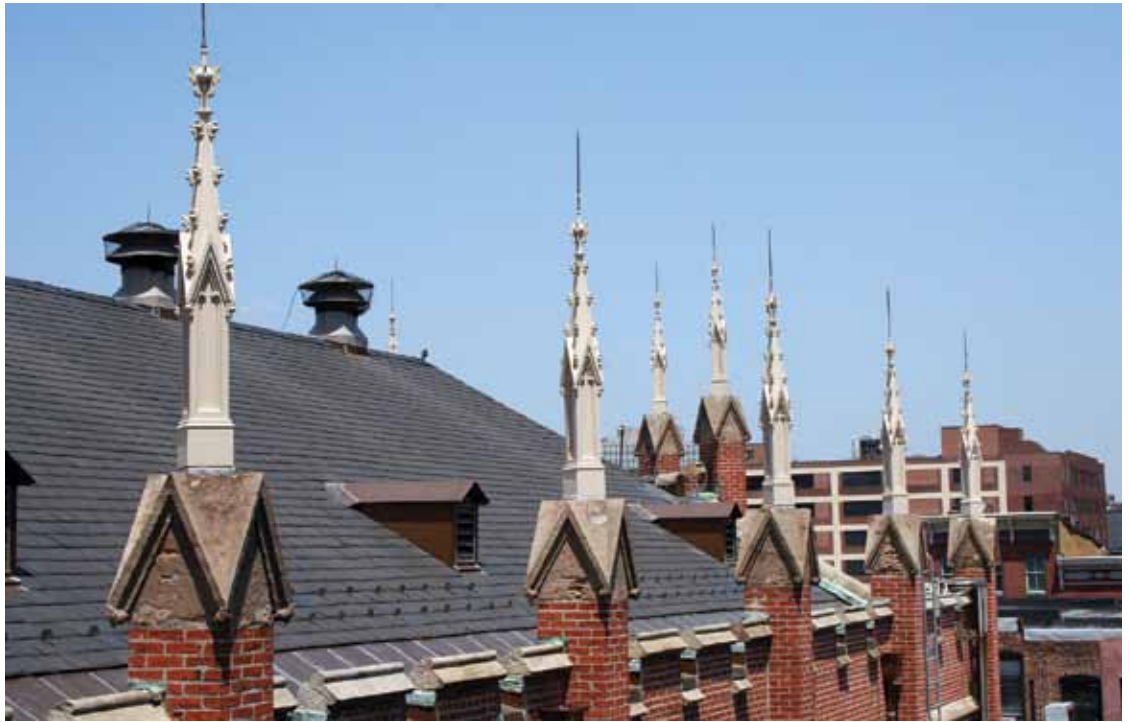
*Like sentinels over the sanctuary, the spires have restored the original beauty for the next generation of parishioners*
