# Montgomery County Underground Garage Restoration

Dayton, Ohio

Submitted by Carl Walker, Inc.

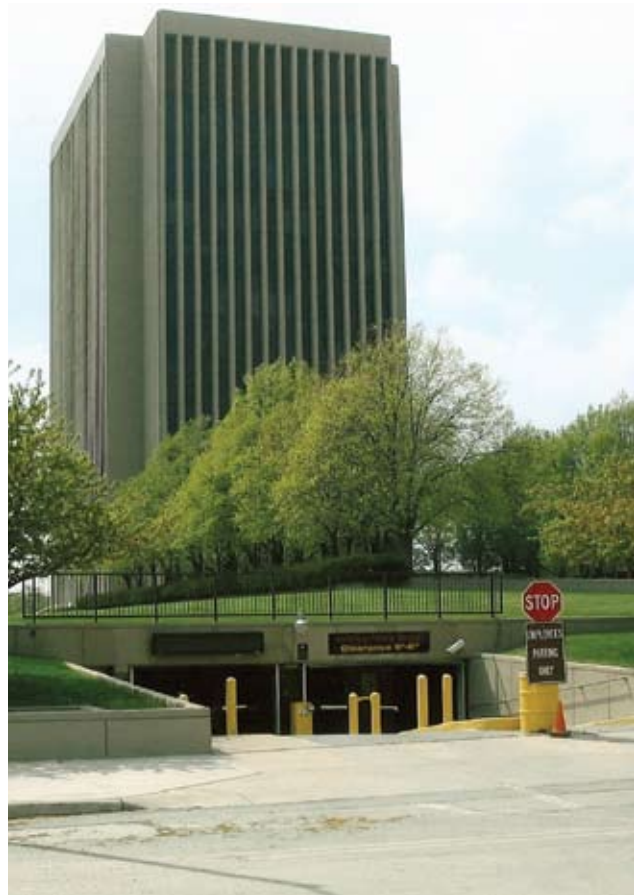
Several floor repair projects had been done in the past. Numerous previous concrete repair patches were evident along construction joints at Levels 1 and 2.

*Montgomery County Garage Underground Parking Facility*
