Strengthening the Structure of St. Nicholas Church

Cracow, Poland

Submitted by Sika Corporation

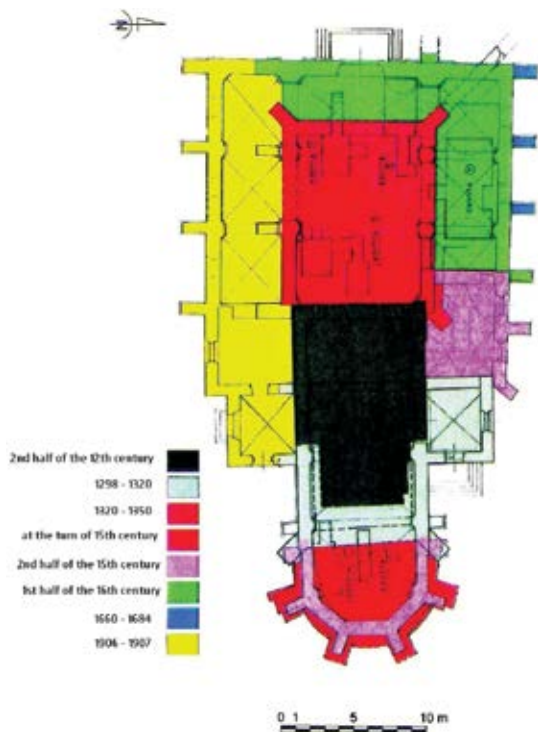
Additions to the church since the 12th century. Spatial stratigraphy of the St. Nicholas church by H. Rojkowska and W. Niewalda

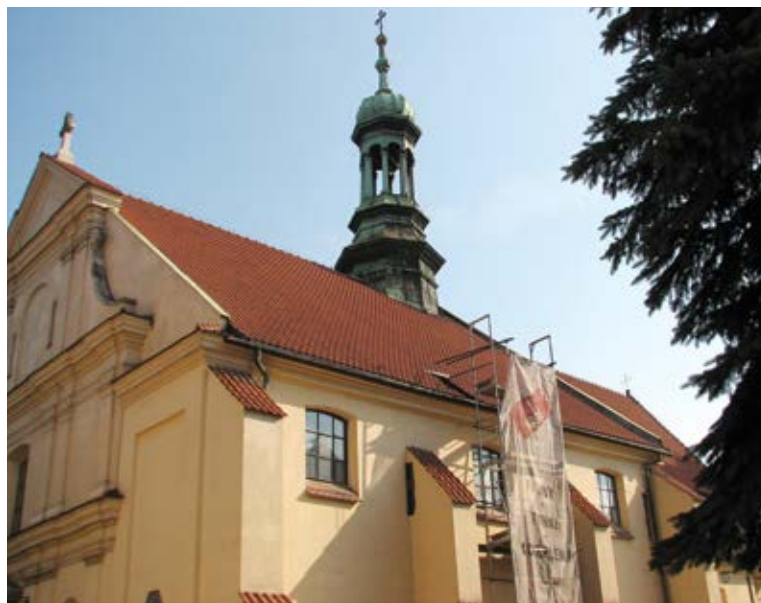
View of the southern façade
