# HIGH-PERFORMANCE FIBER-REINFORCED CONCRETE JACKETING IN A SEISMIC RETROFITTING APPLICATION

BY DARIO ROSIGNOLI, FRANCESCA SIMONELLI, ALBERTO MEDA, AND ROBERTO ROSIGNOLI

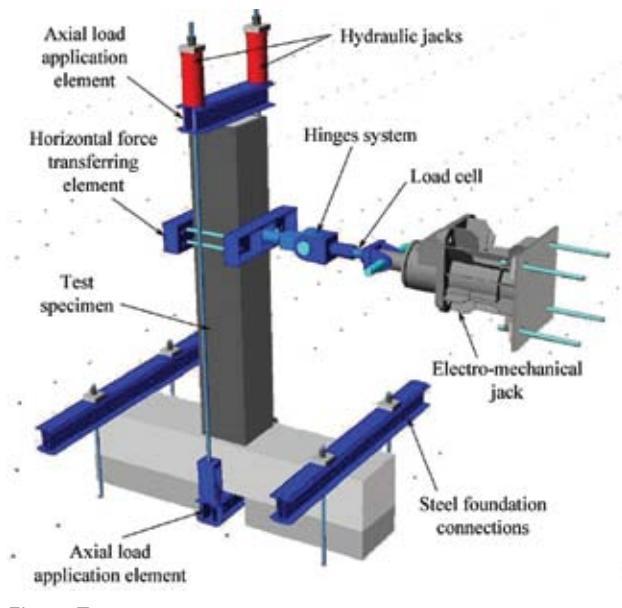
Fig. 4: Test setup

The specimen was placed on the testing frame and an axial load equal to 38,220 lbf (170 kN) was applied by means of two hydraulic jacks (Fig. 4). This axial load was designed to reproduce the effect of the dead loads acting on the column at the time of the jacket application.

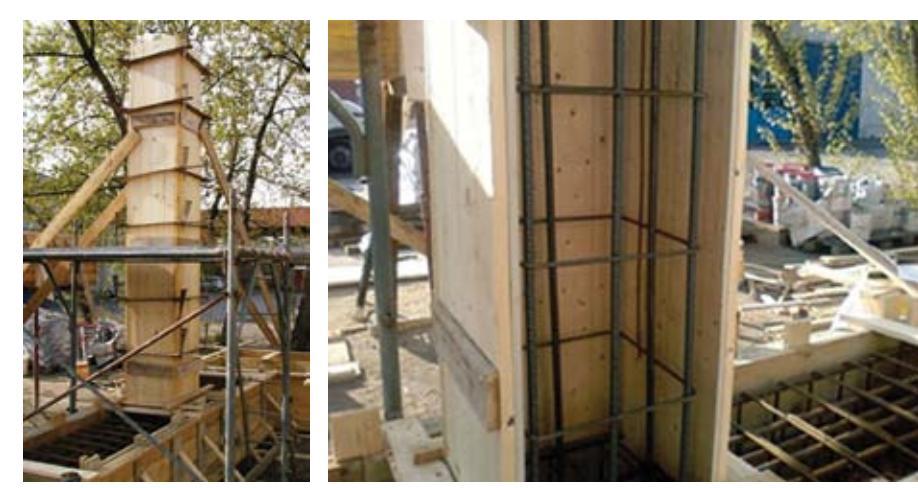
Fig. 2: Column geometry and specimen construction

A column with a 16 x 16 in. (400 x 400 mm) square cross section was tested (Fig. 2). The 10 ft (3 m) high element was cast on a 20 in. (500 mm) thick foundation. The reinforcement and concrete strength were typical of this kind of element in the 1960s and consisted of 0.6 in. (16 mm) diameter longitudinal reinforcement steel and 0.3 in. (8 mm) diameter stirrups spaced at 12 in. (300 mm) with a concrete strength of approximately 2900 psi (20 MPa) (Fig. 3).

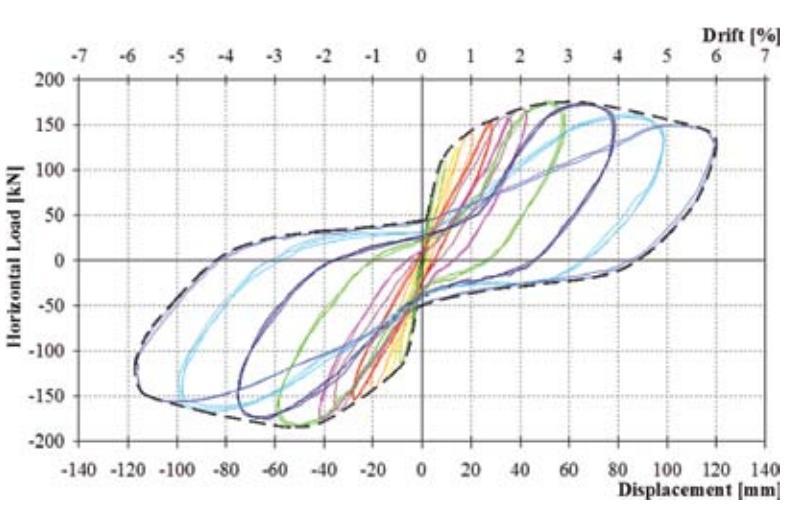
Fig. 9: Horizontal load versus displacement at the load application point. (Note: 1 mm = 0.039 in.; 1 kN = 225 lbf)

The results of horizontal load versus displacement at the level of the load application point are shown in Fig. 9. The column reached collapse during the third cycle at a drift level equal to 6% (4.7 in. [120 mm];  $\delta/\delta_y = 8.6$ ). The collapse was due to the rupture of one of the longitudinal reinforcing steel bars.

After the onset of the flexural cracking at a drift equal to 1%, the behavior was stable up to failure with limited damage. The main crack was located near the end of the high-strength steel mesh that was intended to link the high-performance concrete jacket to the base foundation. Other cracks developed with a spacing of about 11.8 in. (300 mm), which was equal to the stirrup spacing.

The envelope curve (dotted line) in Fig. 9 indicates strength degradation for drift levels higher than 3.5%. The maximum bearing capacity is equal to 39,340 lbf (175 kN), whereas the horizontal load at failure is equal to 32,600 lbf (145 kN)—83% of

the maximum load. The load decrease can be justified because of a progressive slip of the jacket at the foundation base, as shown in Fig. 11.

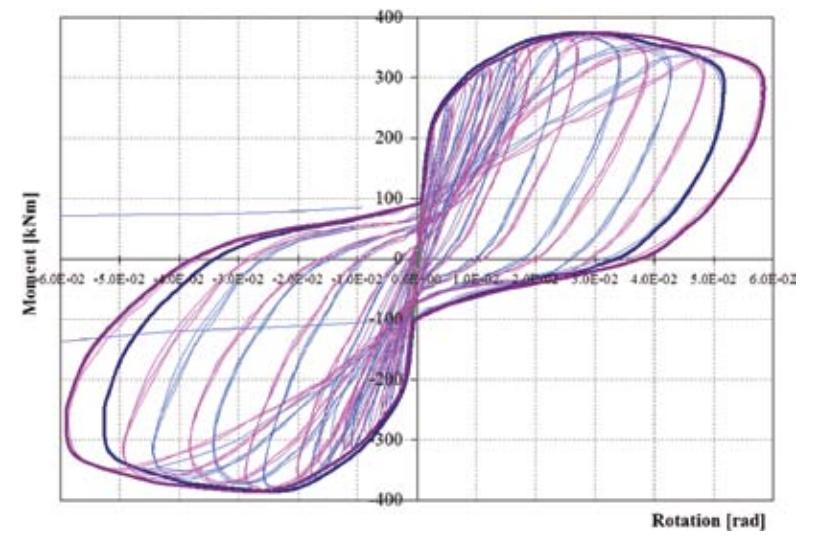
Fig. 12: Moment-versus-curvature curves with and without slip contribution. (Note: 1 mm = 0.039 in.; 1 kNm = 737.5 lbf)

This slip is confirmed in Fig. 12, where the moment-versus-curvature curves at the column base are drawn. In one curve, the curvature was determined by reading the displacement transducers placed on the column, whereas the other curve was determined by reading the transducers measuring the relative displacement between the column and foundation. As a result, the first curve

does not take into account the jacket slip as the second curve does. The two curves tend to diverge with the slip mechanism activation after the maximum moment (horizontal force) is reached. This aspect justifies the load decrease at 3.5% of drift.
