# 2024 SPRING CONVENTION

# CHICAGO RIVER WALL CAP REPAIRS

DUNJA VLA

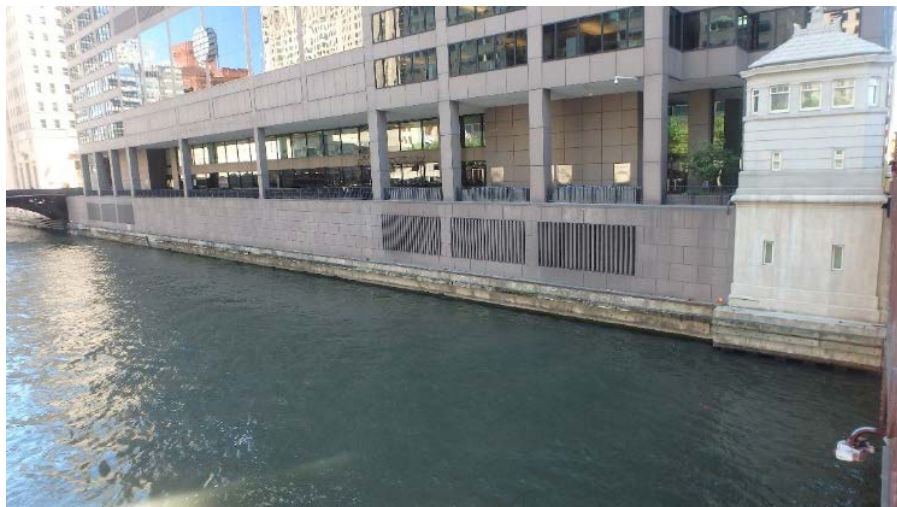
Overall view of river wall from Monroe Street bridge

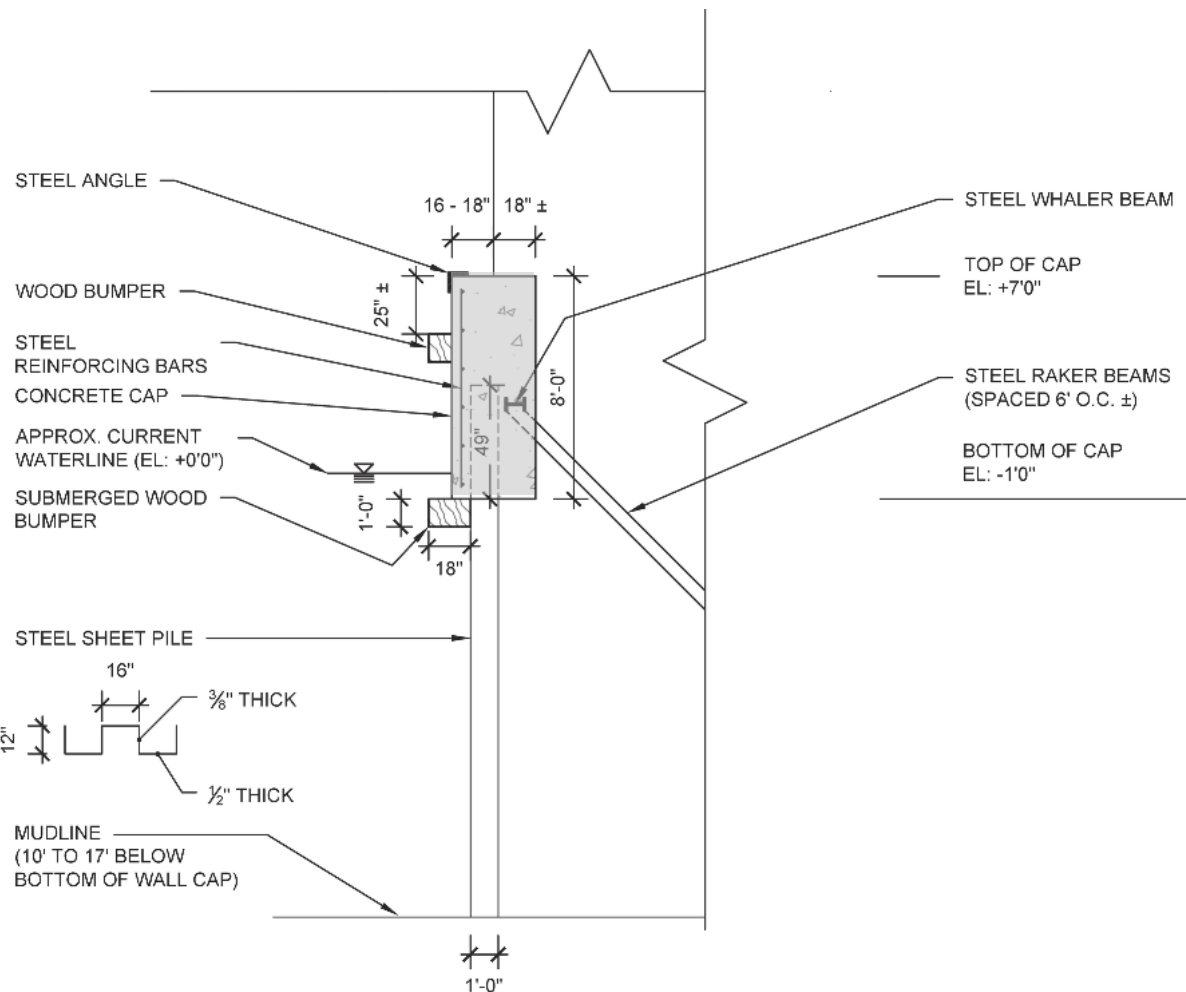
Cross section drawing of typical retaining wall section. CME structure not shown for clarity

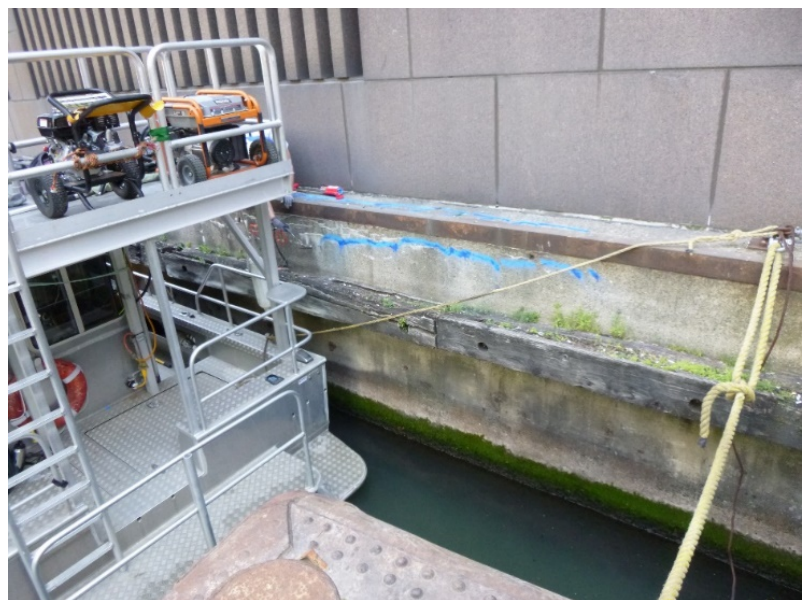
Overall view of sheet pile retaining wall structure above the water level

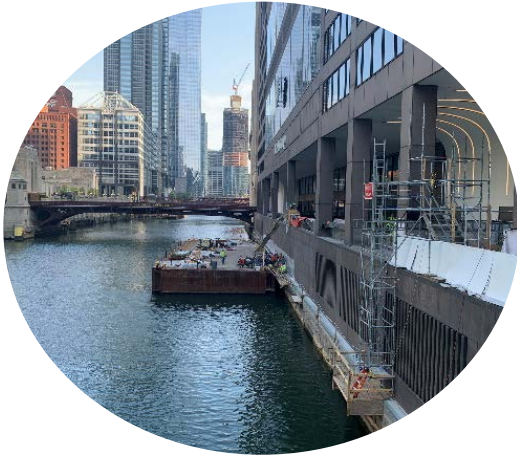
## *THE BARGE*

Everything that was not initially loaded on the barge had to be lowered over the wall and tied off. Barge was moved BY HAND to save \$6k charge from tugboat

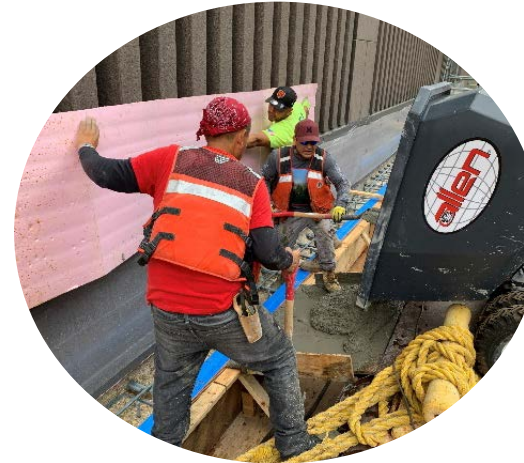
## *VOIDS*

Allied had to learn the nuances of placing underwater concrete. There ended up being voids which we had to later return to fill

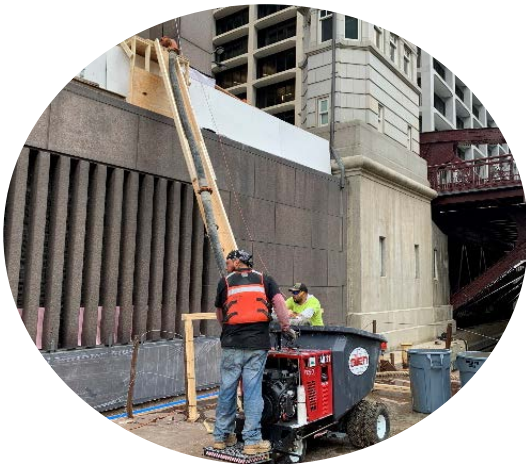
## *ACCESS FOR POUR*

We needed special CDOT permits to stop our trucks at this crucial intersection. Buggies allowed us to cart the concrete to our chute, dump it down, and place before consolidation

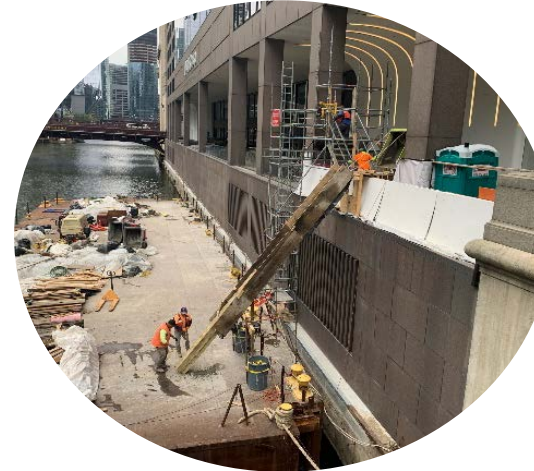
## *WOOD BUMPERS*

Although the work item seems simple, the incredible weight of the wood made the transport and installation of the wood bumpers difficult
