2024 SPRING CONVENTION

➤ **Case Study:**
**Structural Repairs for
an Elevated Plaza**

Christopher Kuenzer, PE

Haider Himairi, PE, LEED AP BD+C, F.ASCE

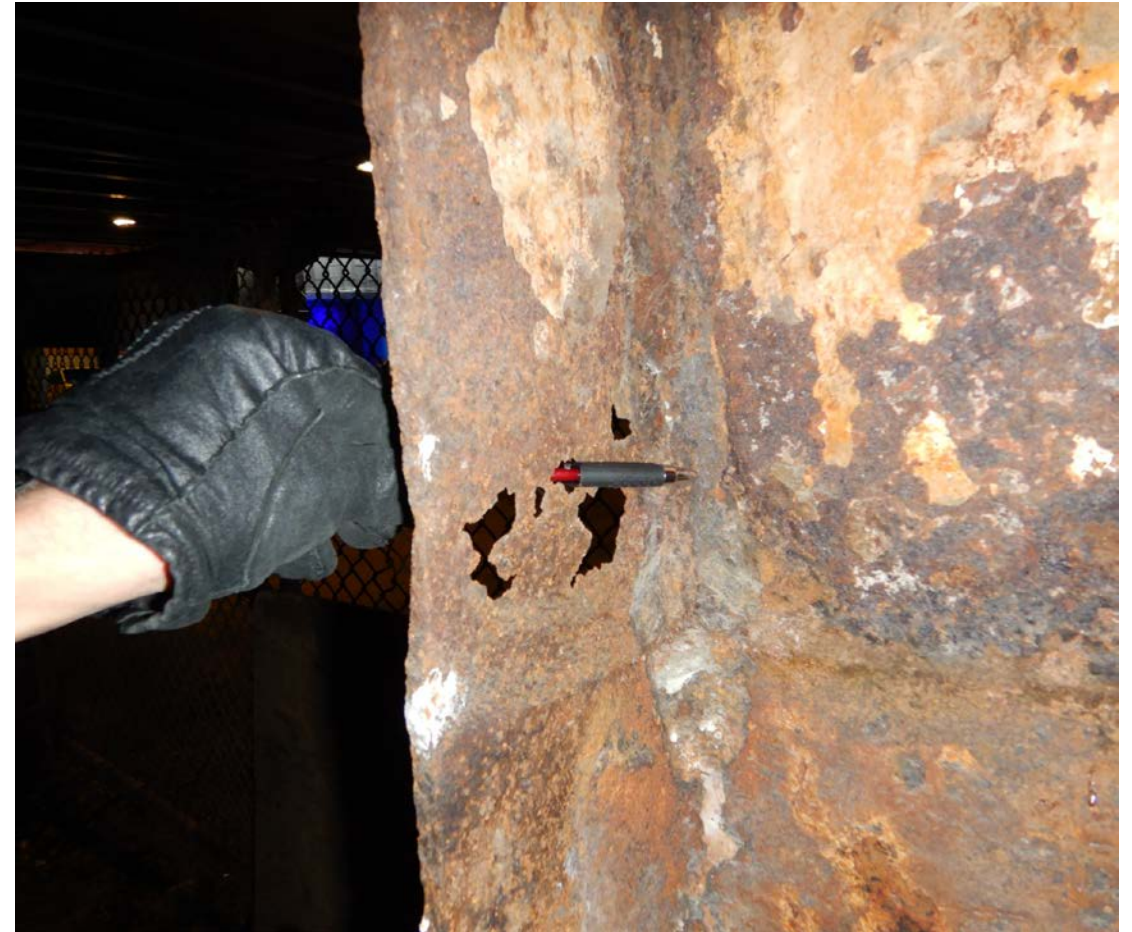
Hole through a column flange

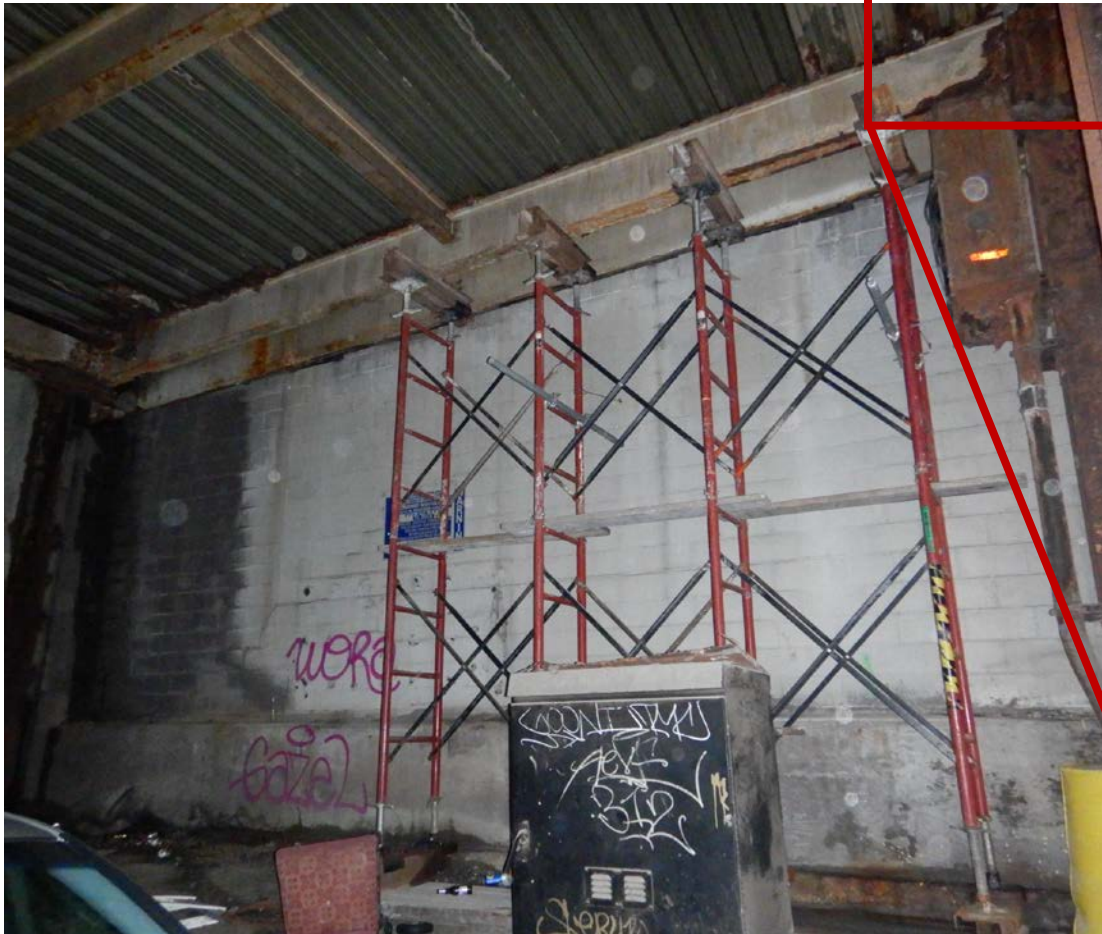
Shoring installed below beam

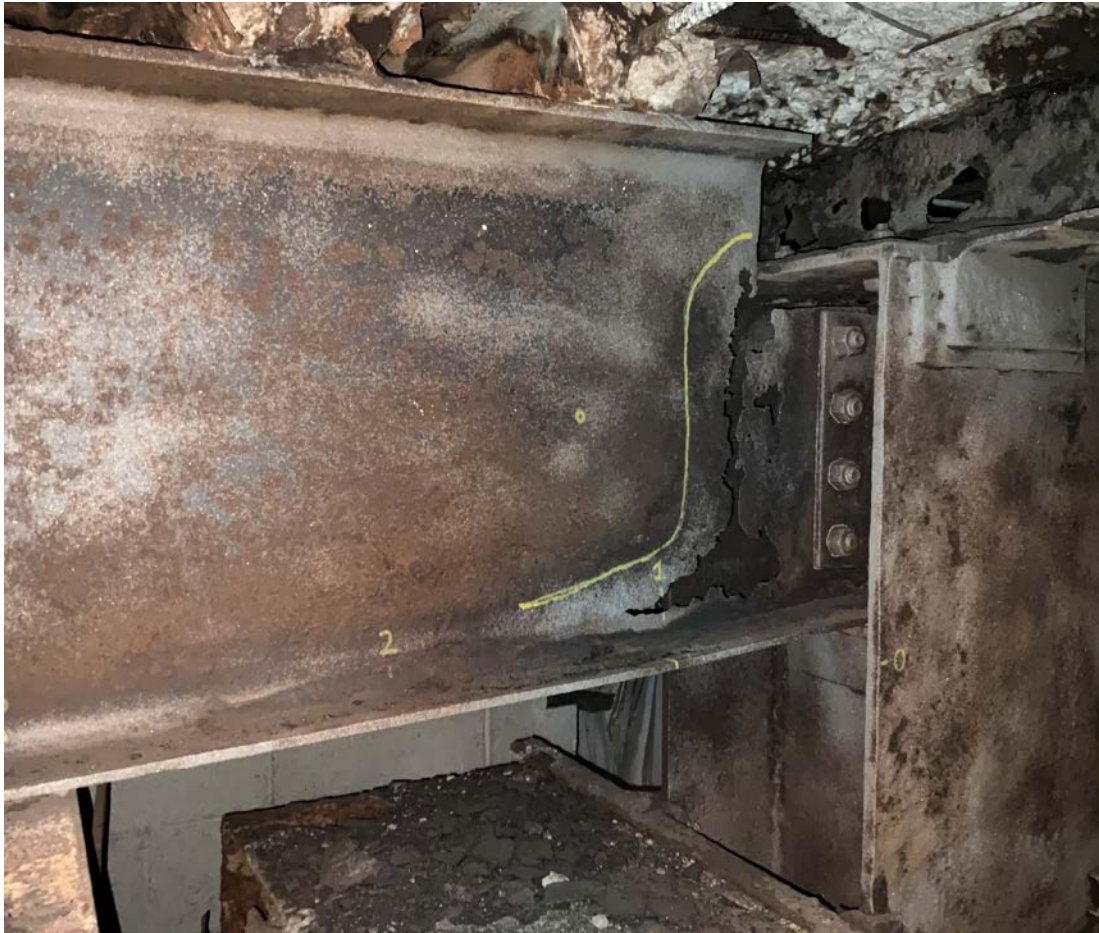
Markings on beam for field notes

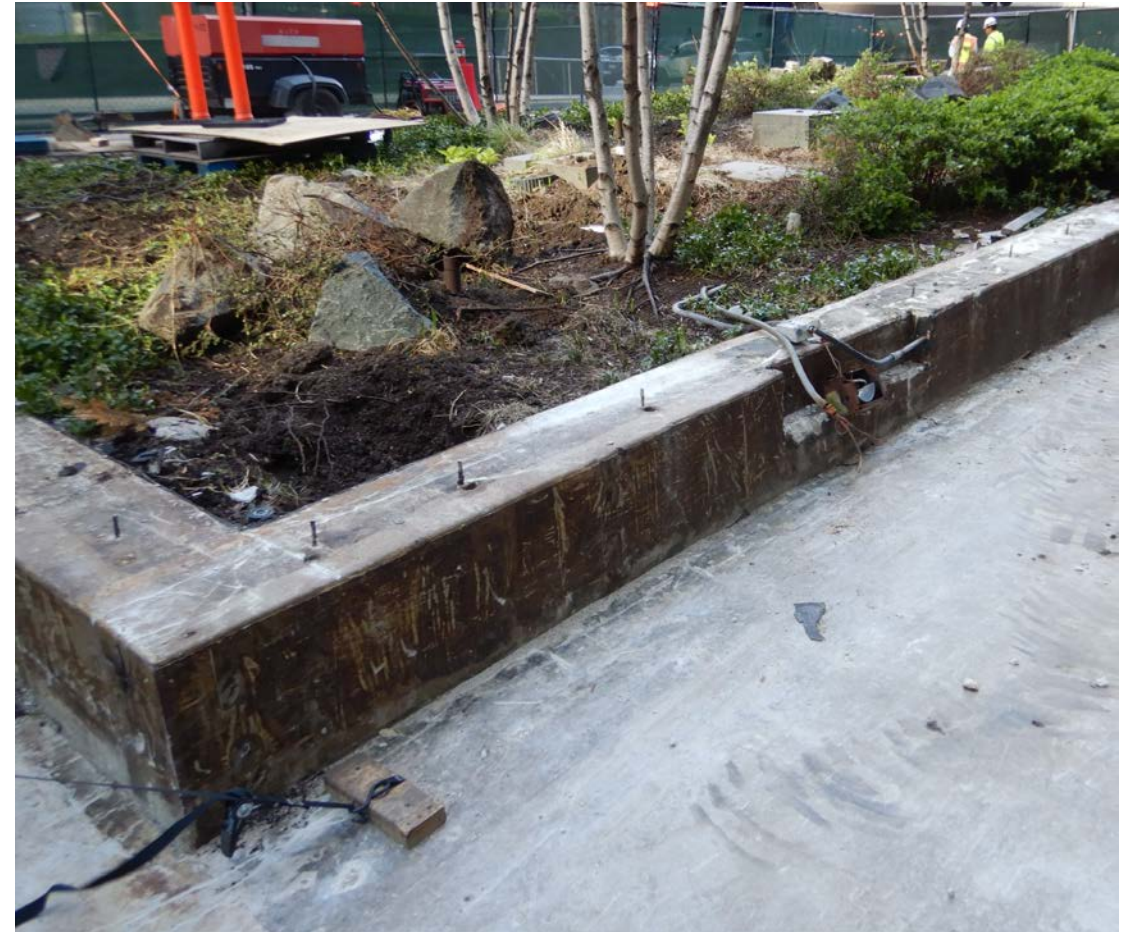
Planter with granite and waterproofing removed

- Salvage existing granite cladding and coping
- Encapsulate concrete planter wall
- Waterproofing in red

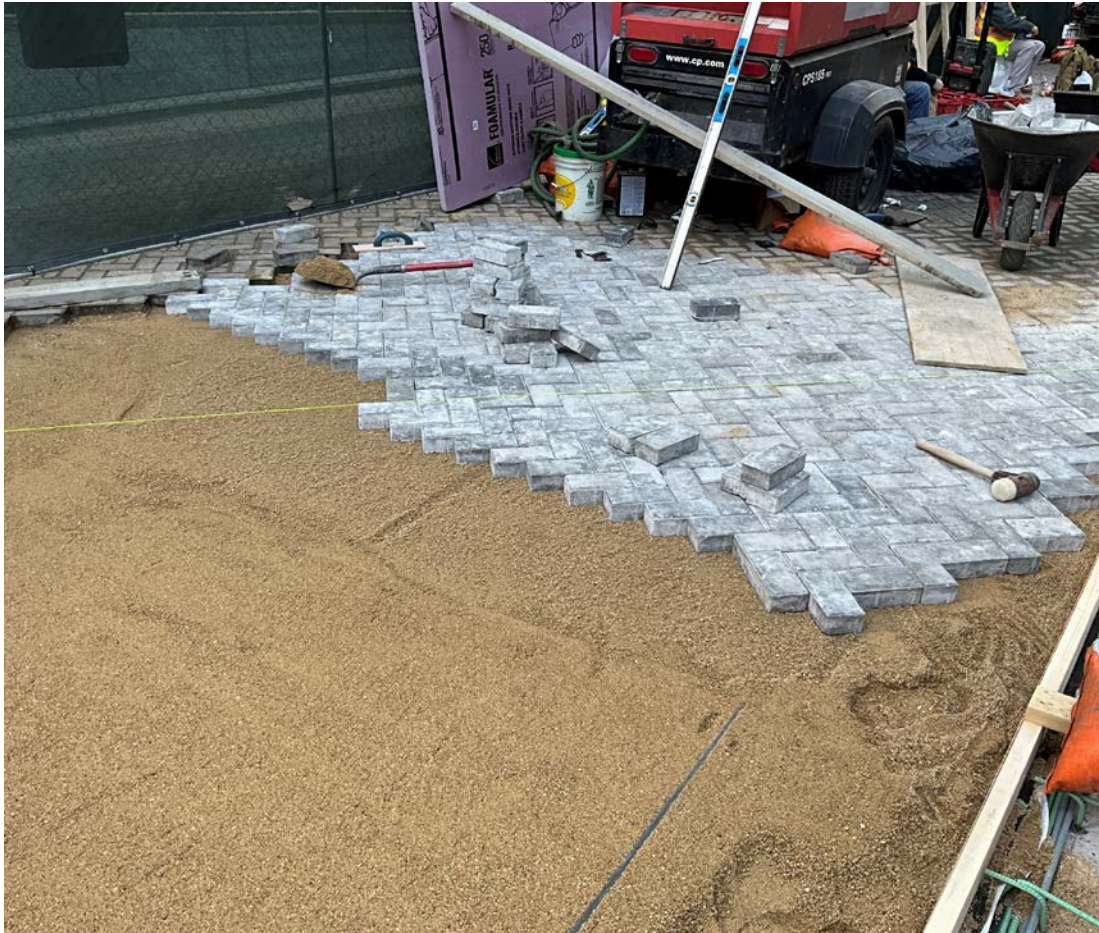
Temporary paver installation in progress

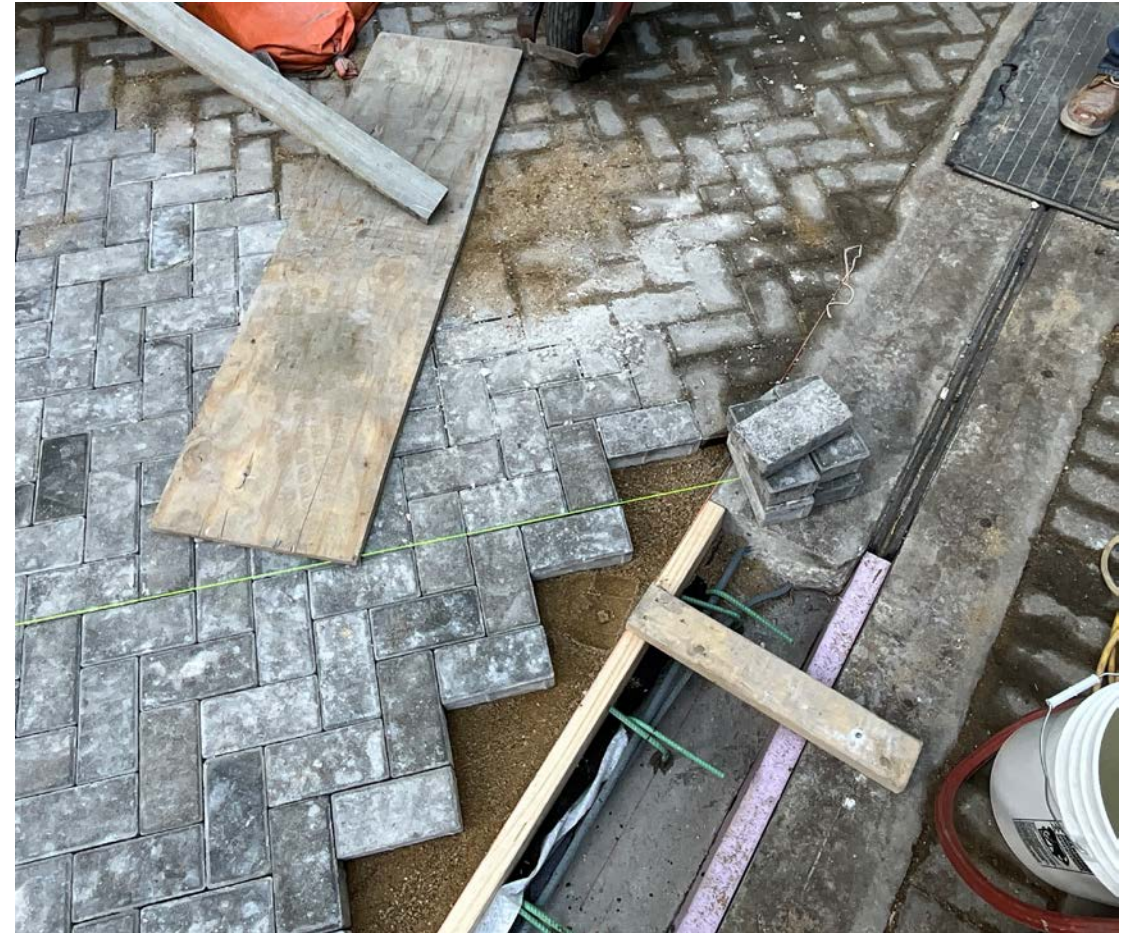
Tying in temporary pavers to existing

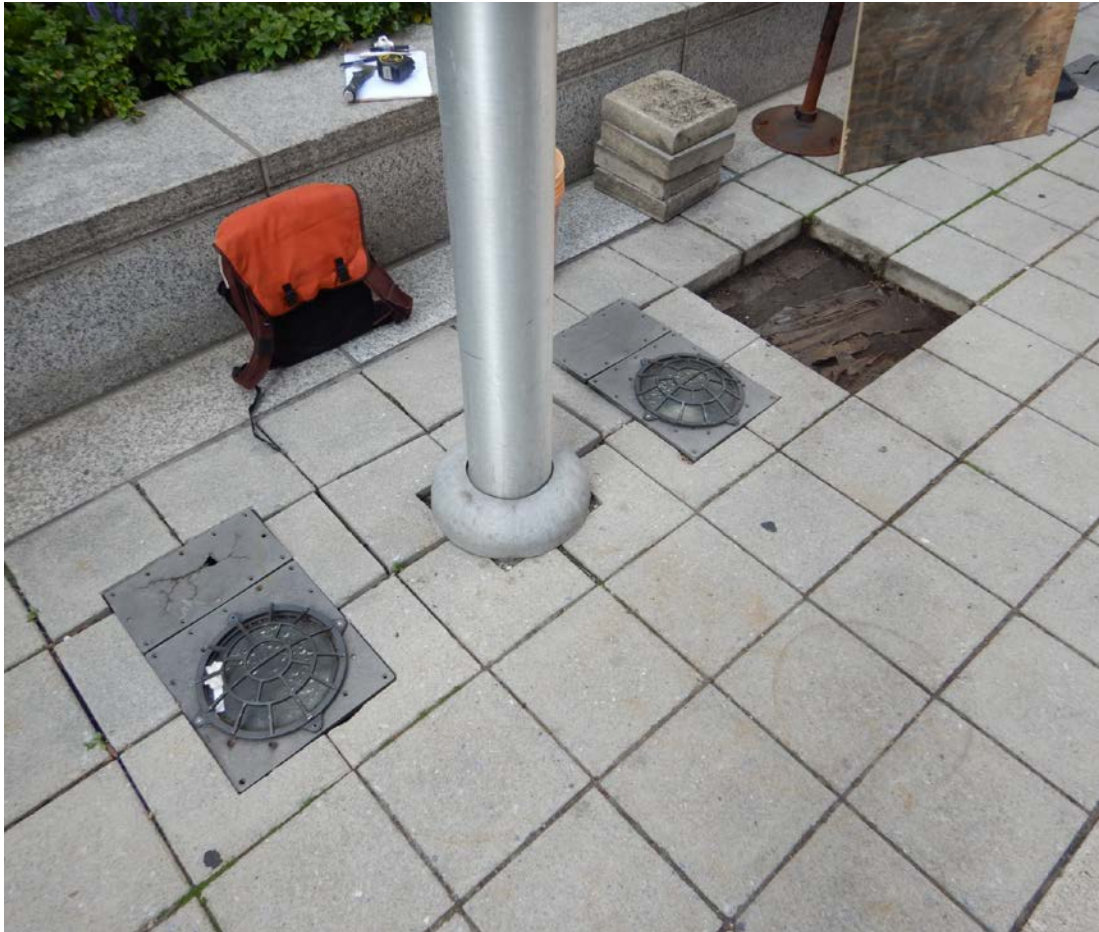
Flagpole and lights at topside

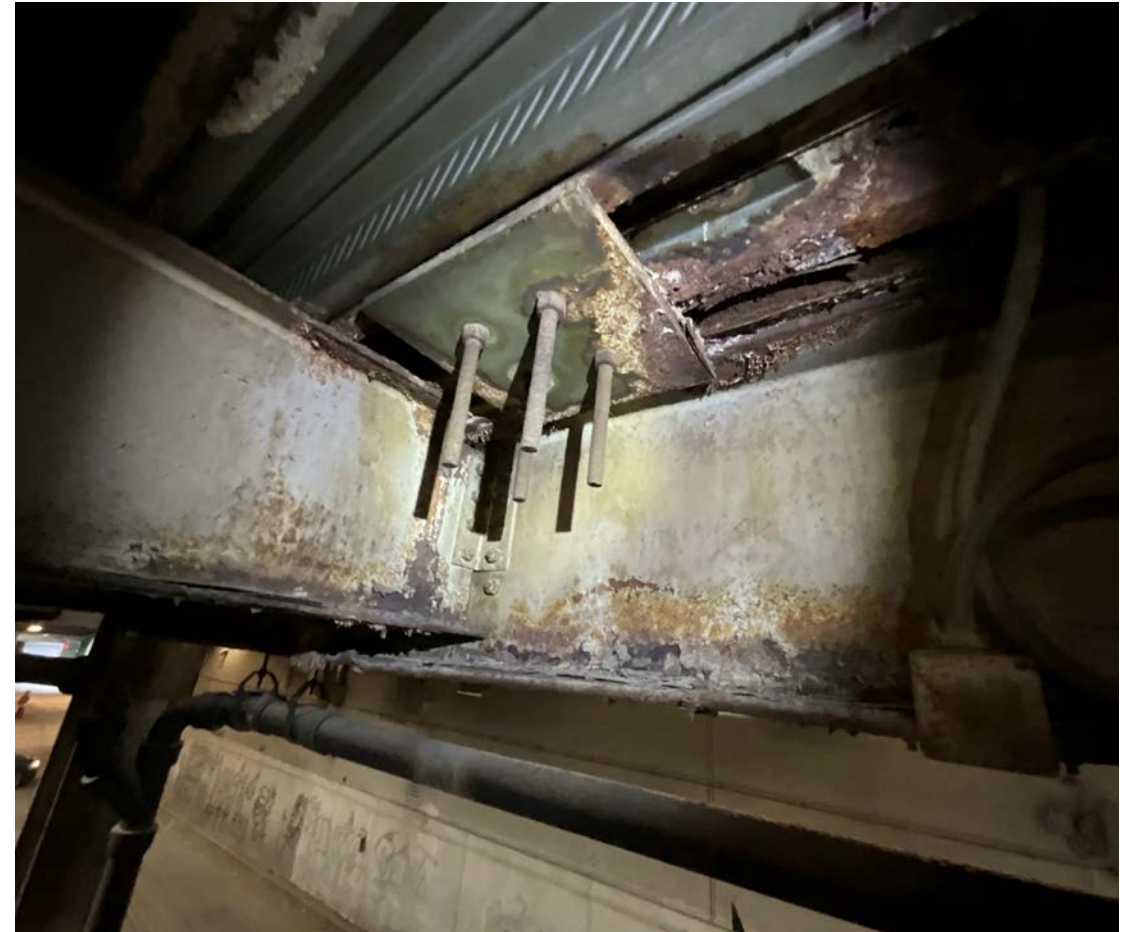
Flagpole attachment from underside
