➤ **Evaluation of ECE, FRP, and Sealers
for
Corrosion Mitigation
in Reinforced Concrete Bridges**

Bridge Substructure Repair: Harvesting 1998 Research for Success

I-394 over Dunwoody (MN Bridge No. 27831)

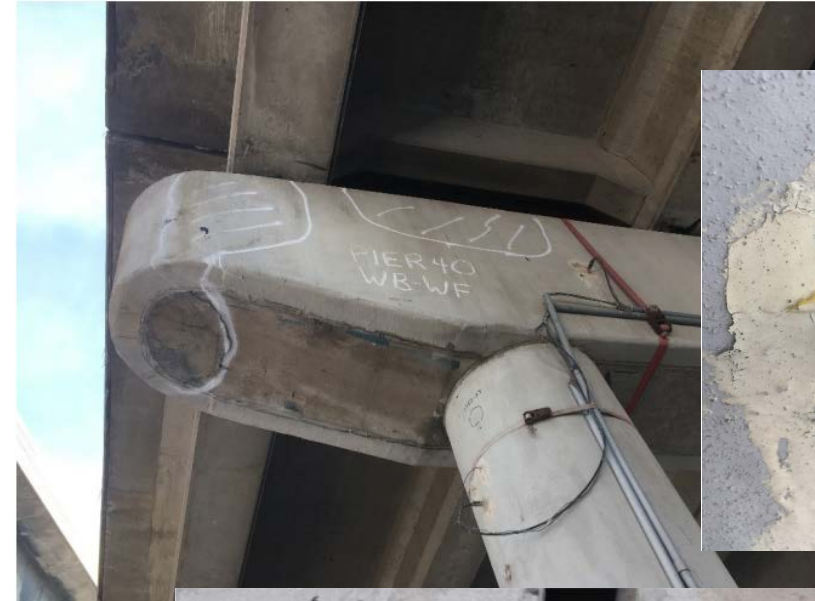
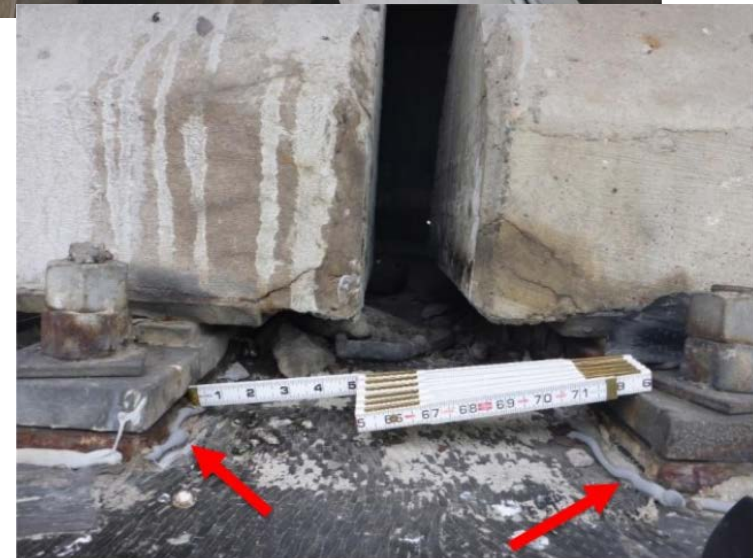
ECE + FRP

- No recurrent distress
- HCP typically passive

ECE + Sealer

- Recurrent distress ~ controls

FRP Only

- Recurrent distress in area of water exposure/joint leakage

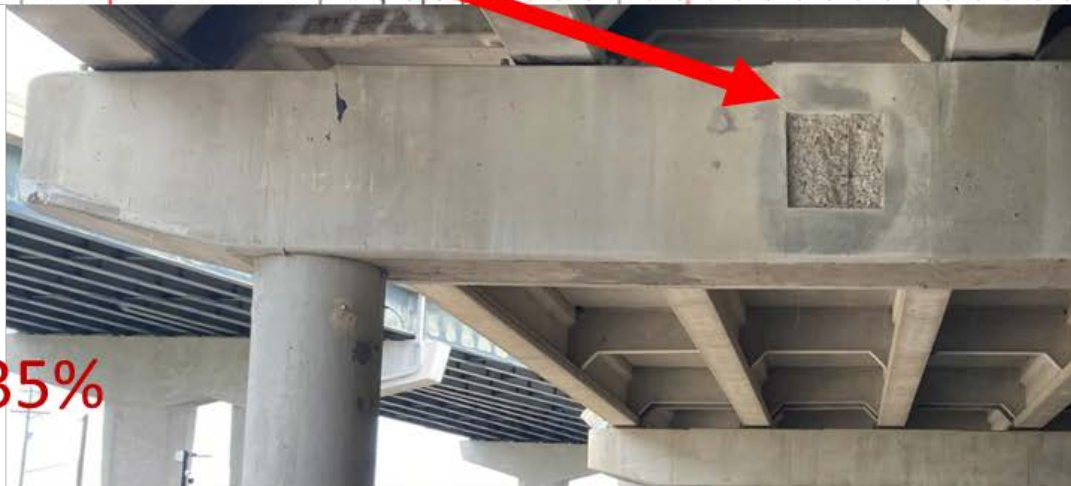
Chloride Influence?

West Face
WB Pier 37
ECE Treated

2022 Chloride content around rebar = 0.066% by wt of concrete

MnDOT has used 0.035% threshold

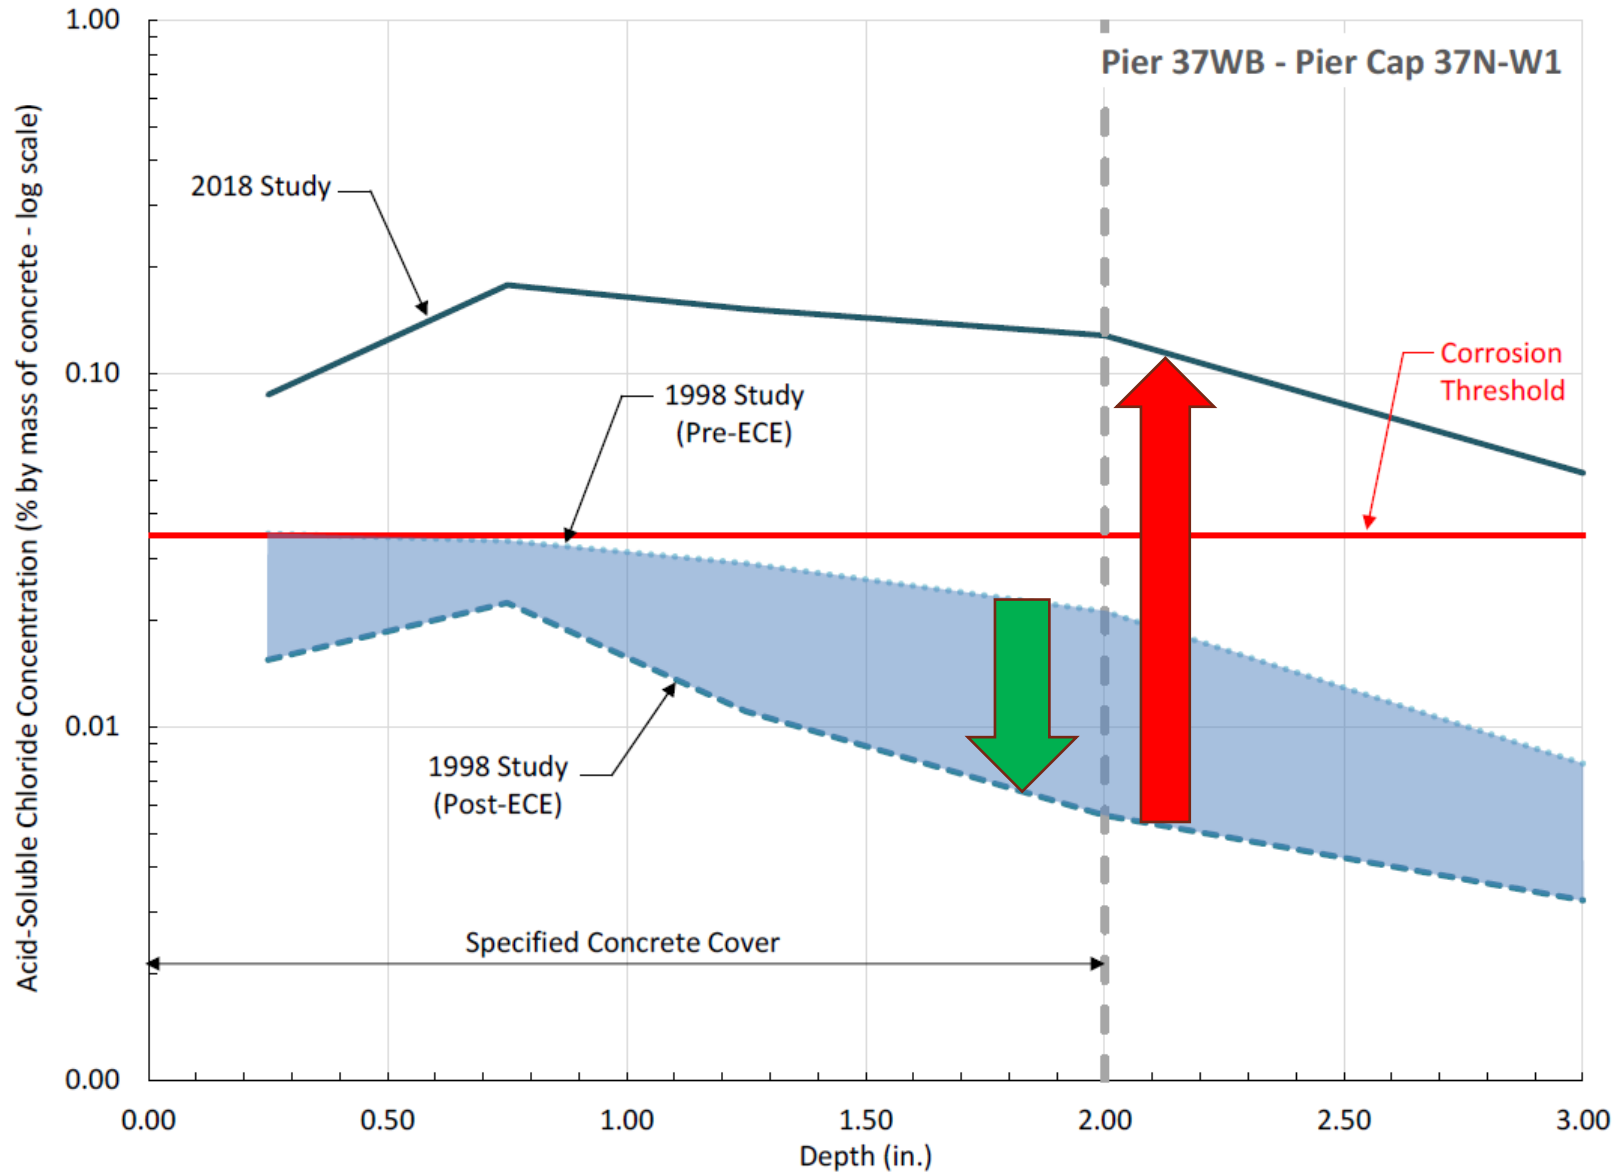
Chloride Influence?

West Face
WB Pier 37
ECE Treated

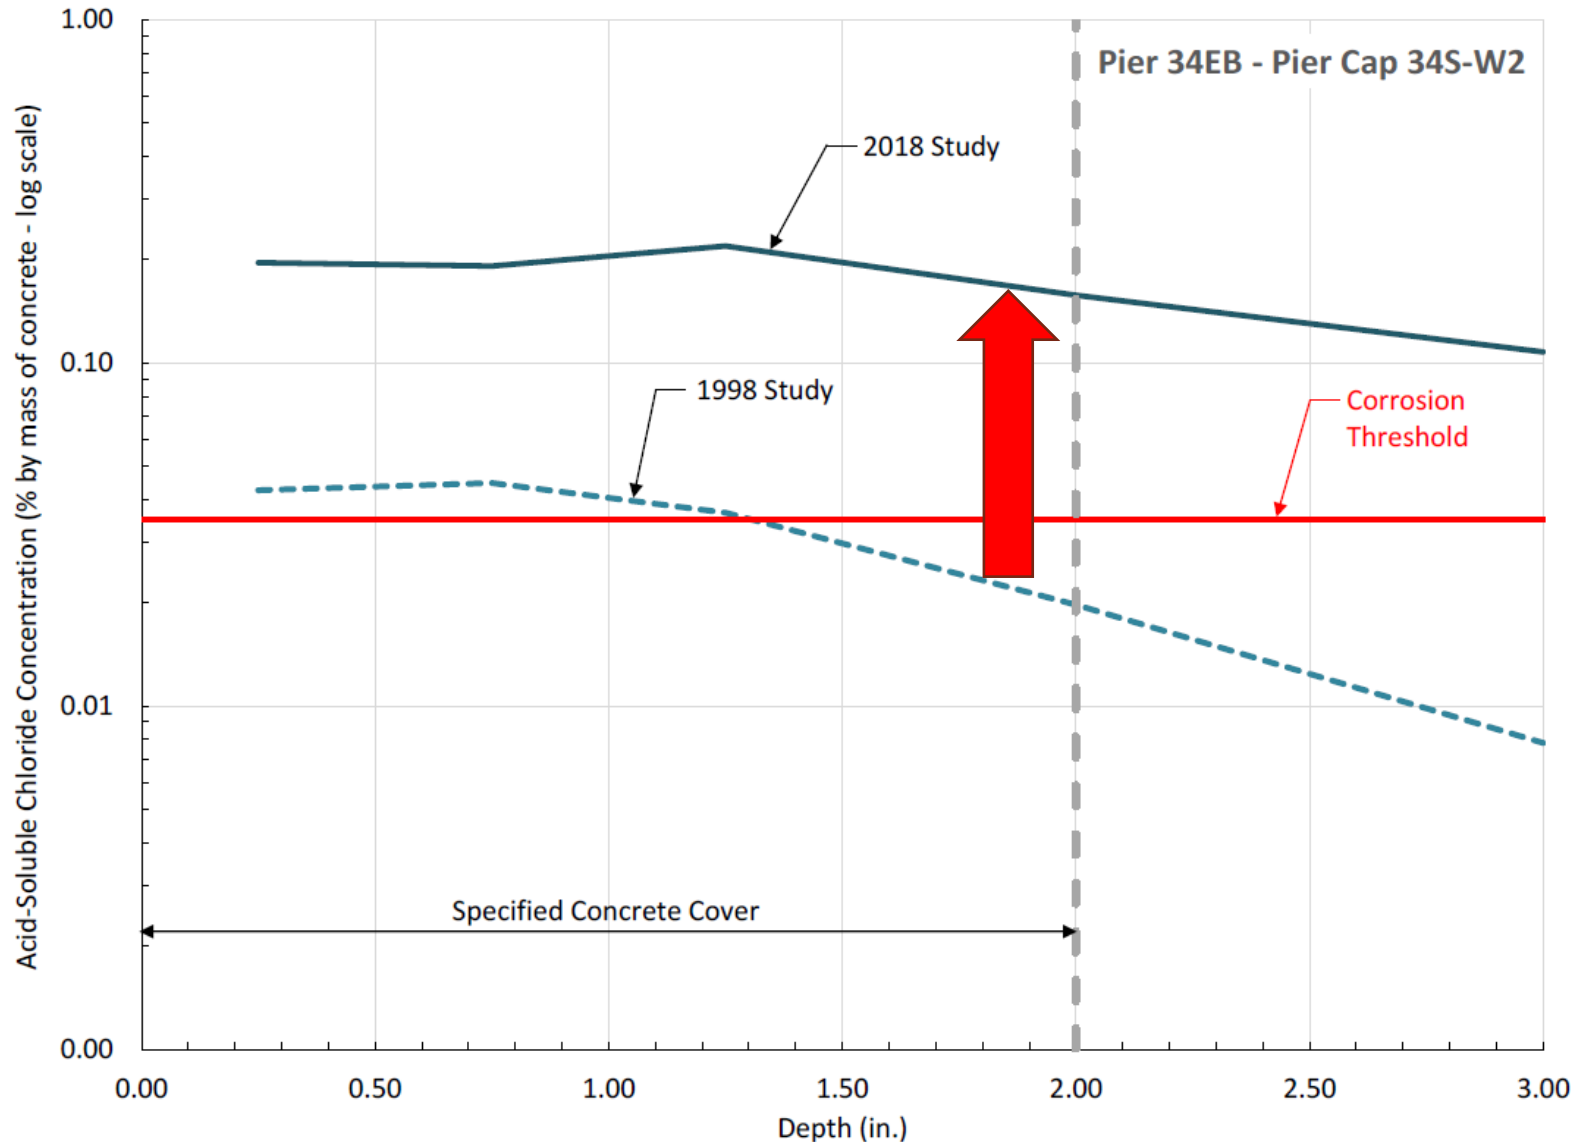
Chloride Influence?

West Face
EB Pier 34

No ECE
