# De-Mystifying Unusual Results on Extraordinary Structures - Case Studies of Concrete Challenges

Gina Crevello

*Echem Consultants LLC*

# CASE STUDIES

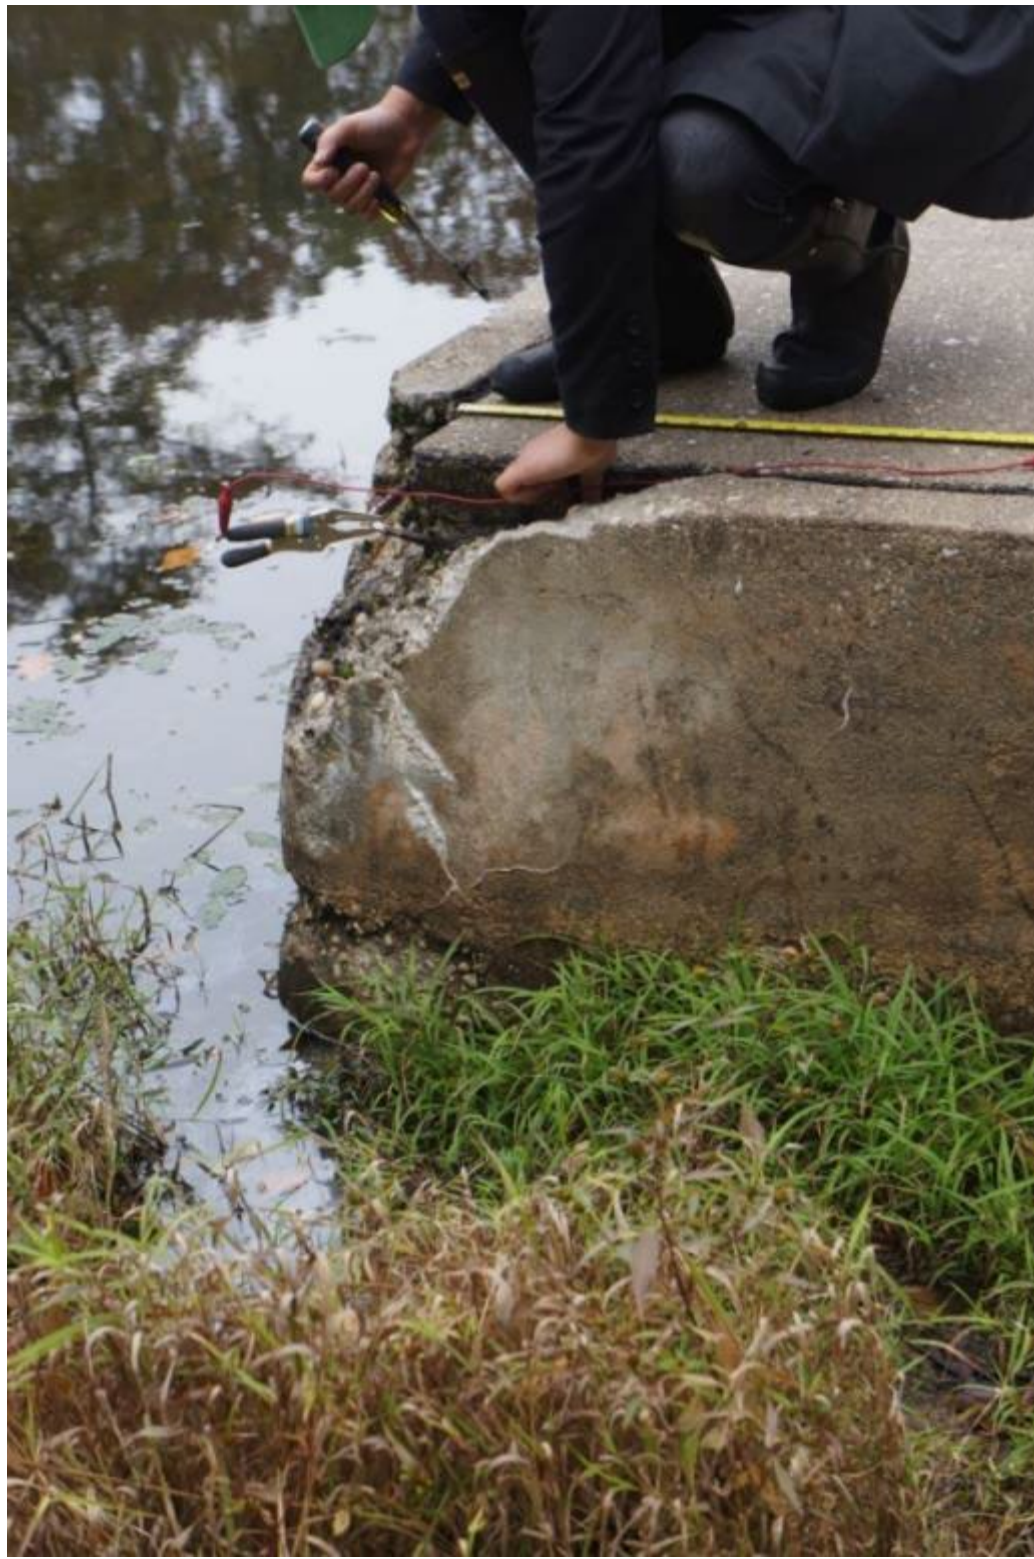
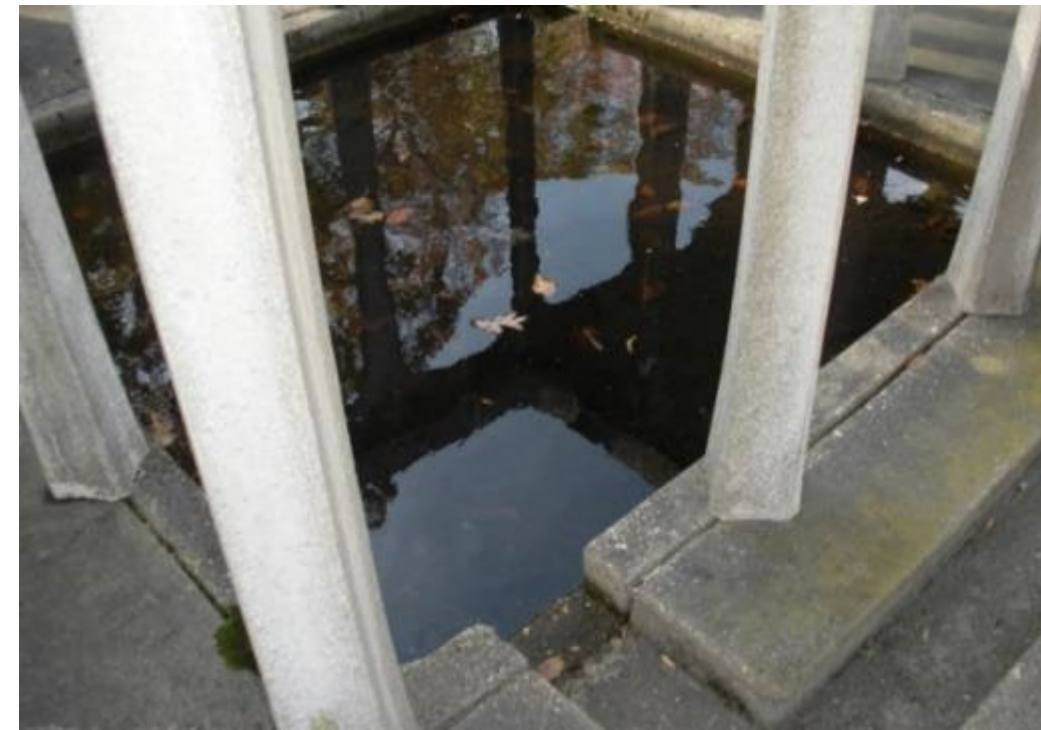
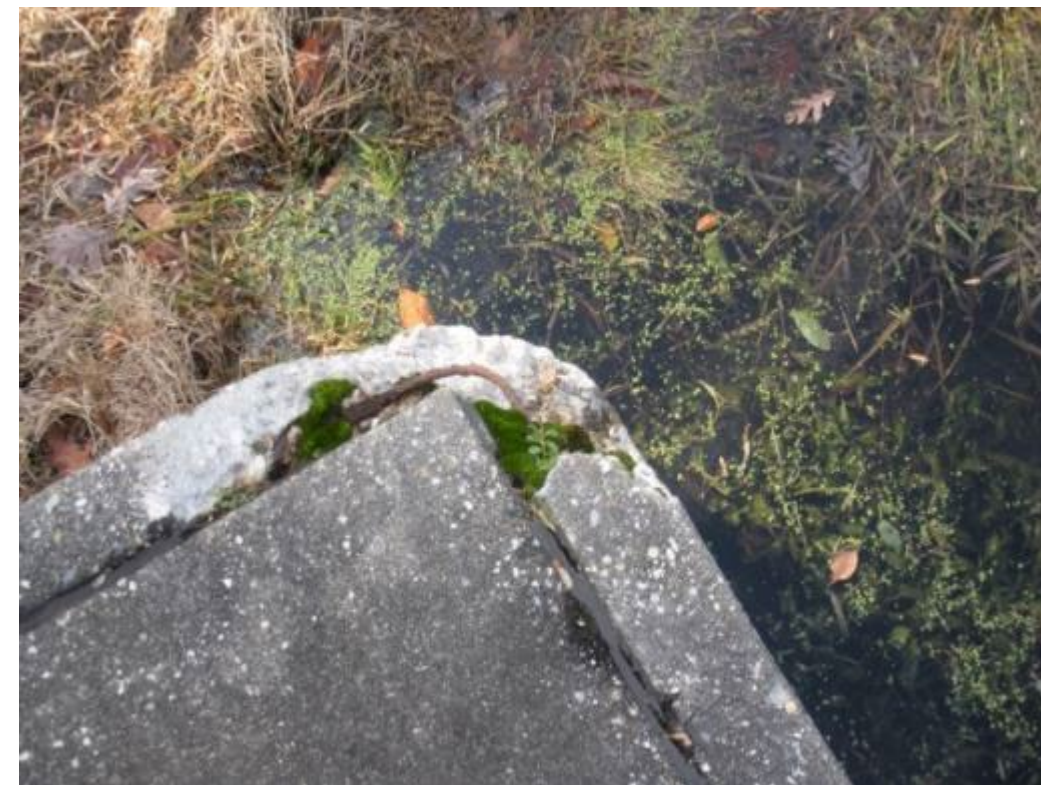
CURB CONDITIONS

- ❑ Carbonated pre-cast structure
- ❑ Corrosion is a result of carbonated concrete
- ❑ Potential was largely influenced by moisture- seen at the base of the column
- ❑ Without the use of LPR Testing, corrosion hot spots would not have been identified.

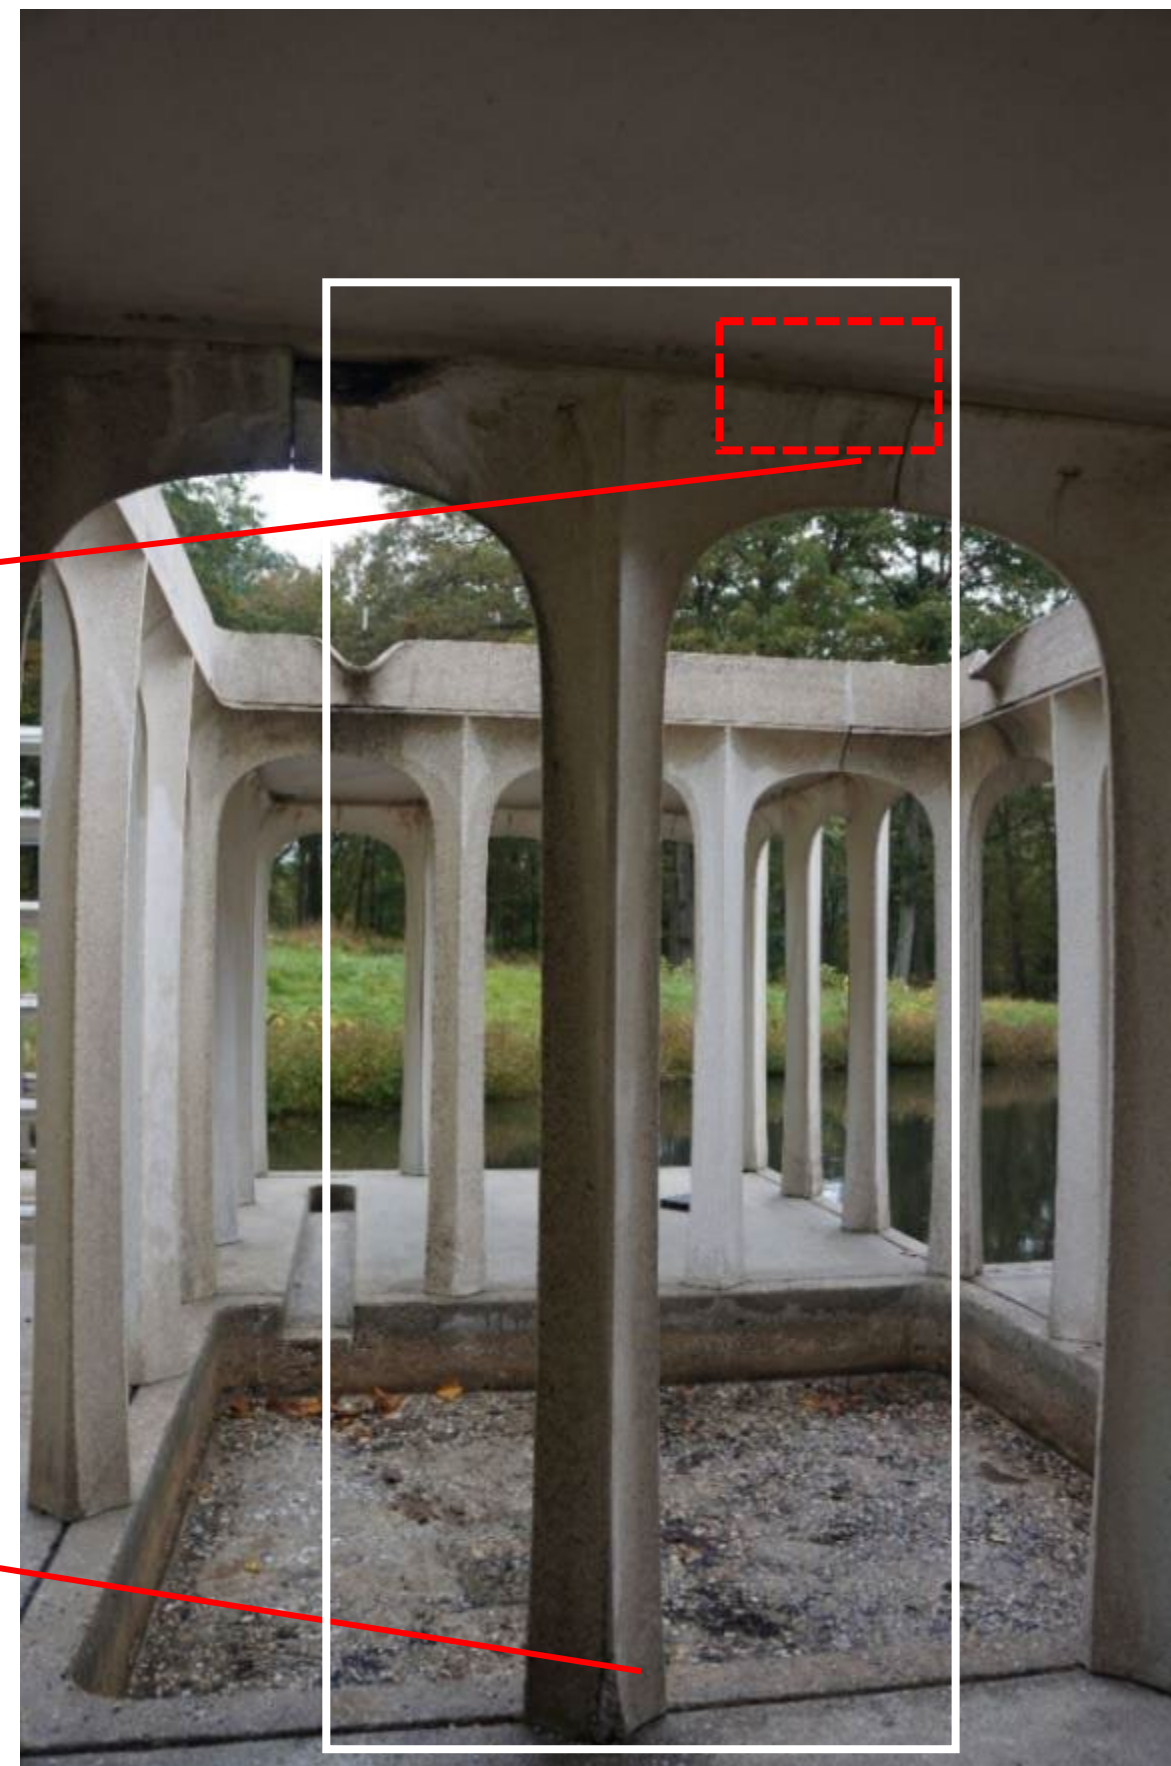
**Corrosion Rate Map**  
( $\mu\text{m}/\text{yr}$ )

**Potential Map (mV)**

| | Potential<br>(mV)<br>w.r.t. Ag/AgKCl | Corrosion Rate<br>(µm/yr <sup>-1</sup> ) | Section Loss<br>(mpy) |
| Minimum | 0.1 | 0.15 | 0.00591 |
| Maximum | -290.9 | 7.82 | 0.308108 |
| Average | -113.2 | 1.16 | 0.045838 |

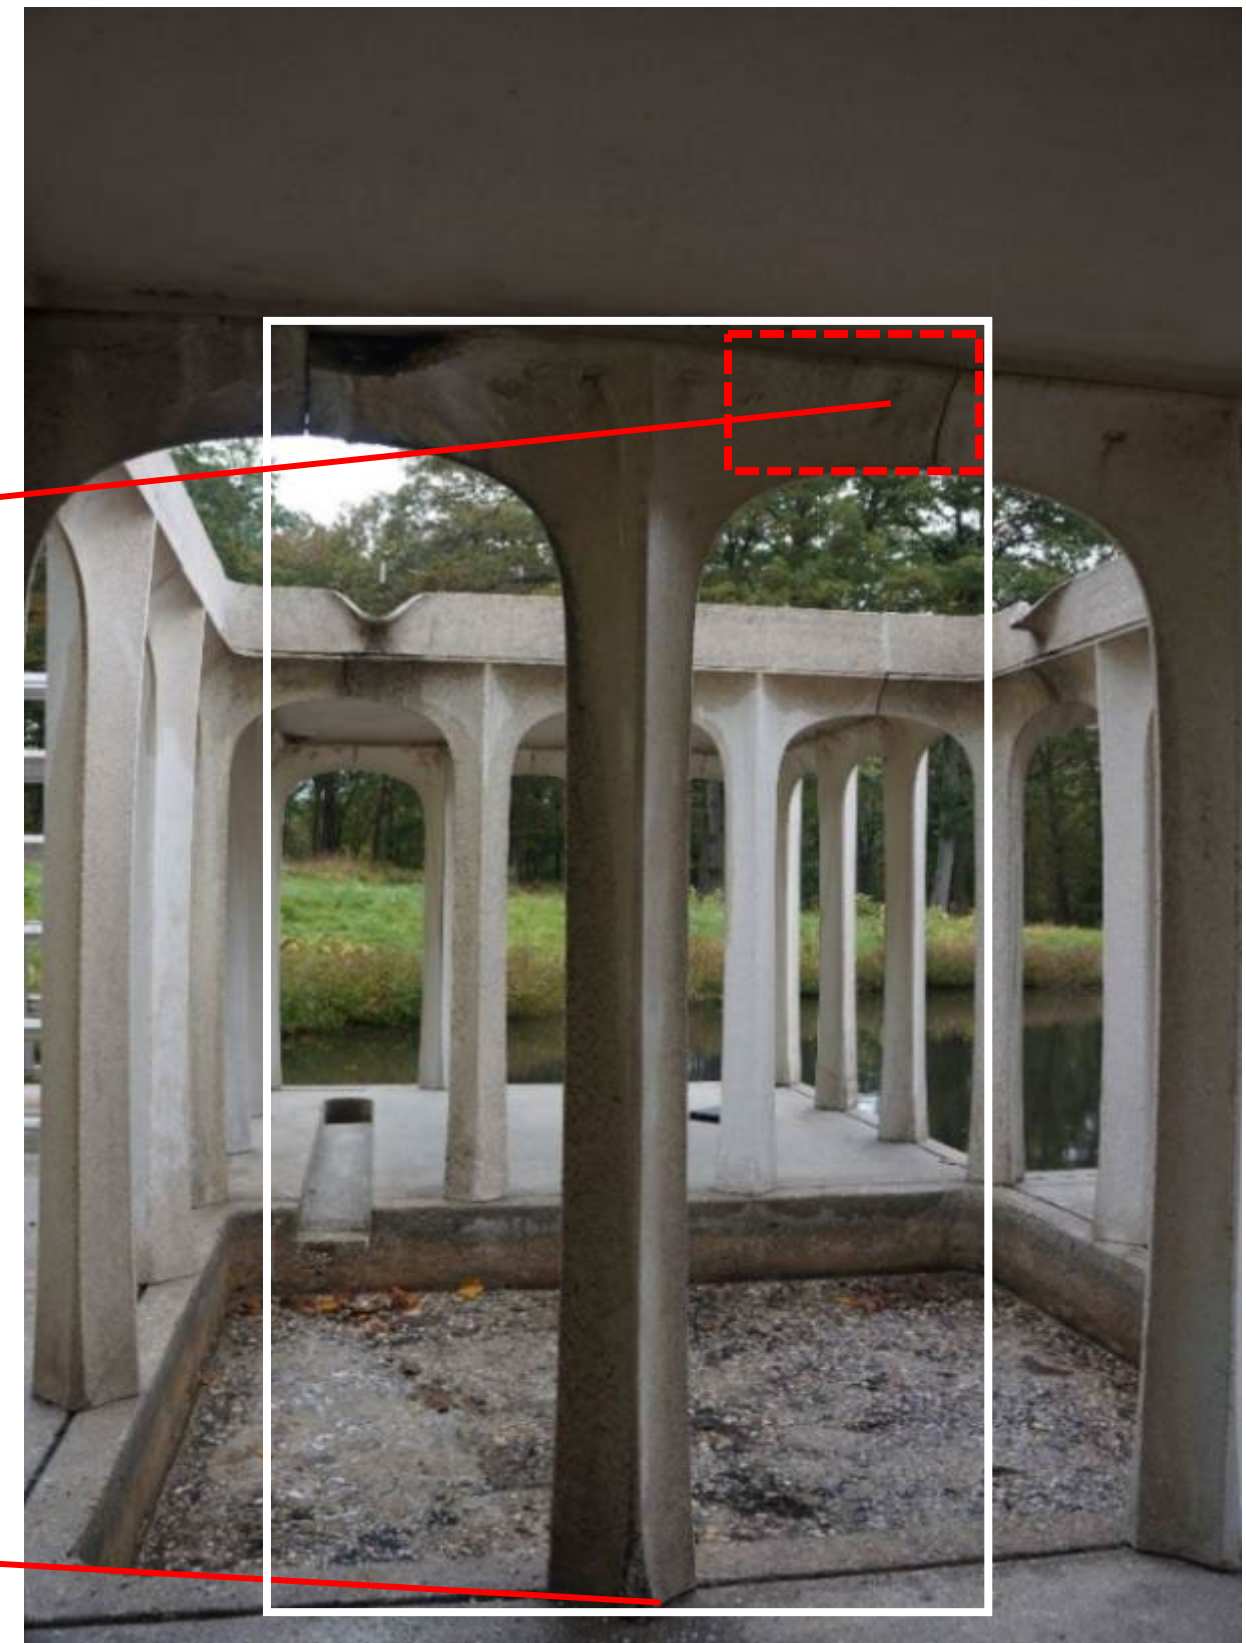
**Corrosion Rate Map**  
( $\mu\text{m/yr}$ )

**Potential Map (mV)**

| | Potential<br>(mV)<br>w.r.t. Ag/AgKCl | Corrosion Rate<br>(µm/yr <sup>-1</sup> ) | Section Loss<br>(mpy) |
| Minimum | -180 | 0.34 | 0.0134 |
| Maximum | -300 | 2.81 | 0.1107 |
| Average | -244 | 1.48 | 0.0583 |

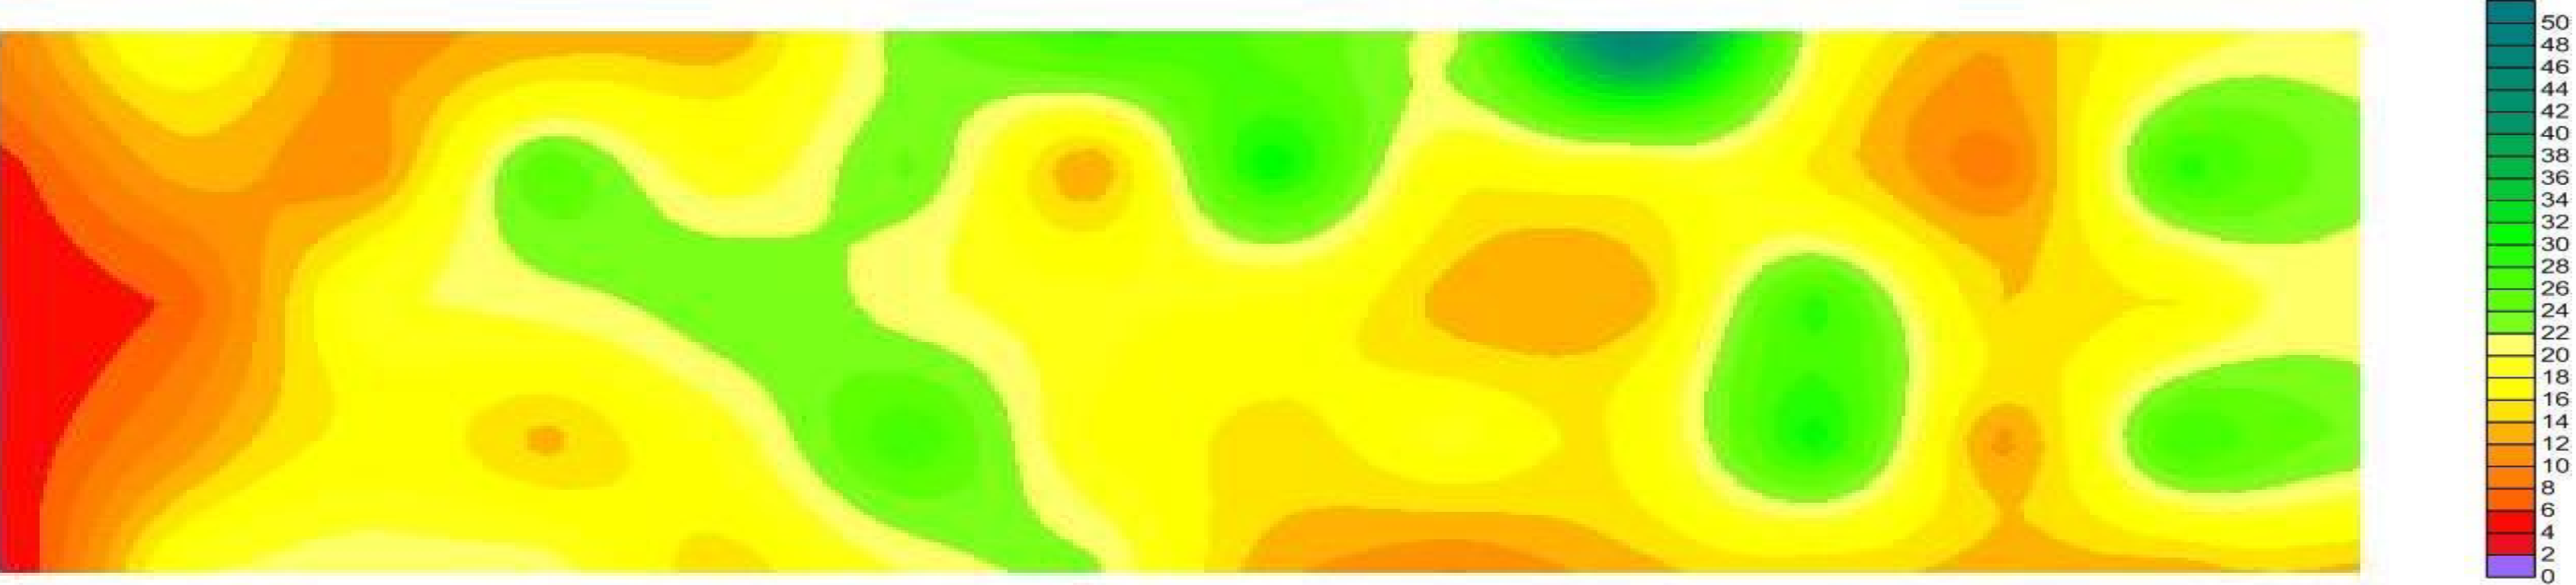
o } éÉèÉÉî j xã ä~{äâ {ç} è} àÖΩ):

| > 20 kΩ cm | Low Corrosion Rate |
| 10 - 20 kΩ cm | Low to moderate Corrosion Rate |
| 5 - 10 kΩ cm | High Corrosion Rate |
| < 5 kΩ cm | Very High Corrosion Rate |

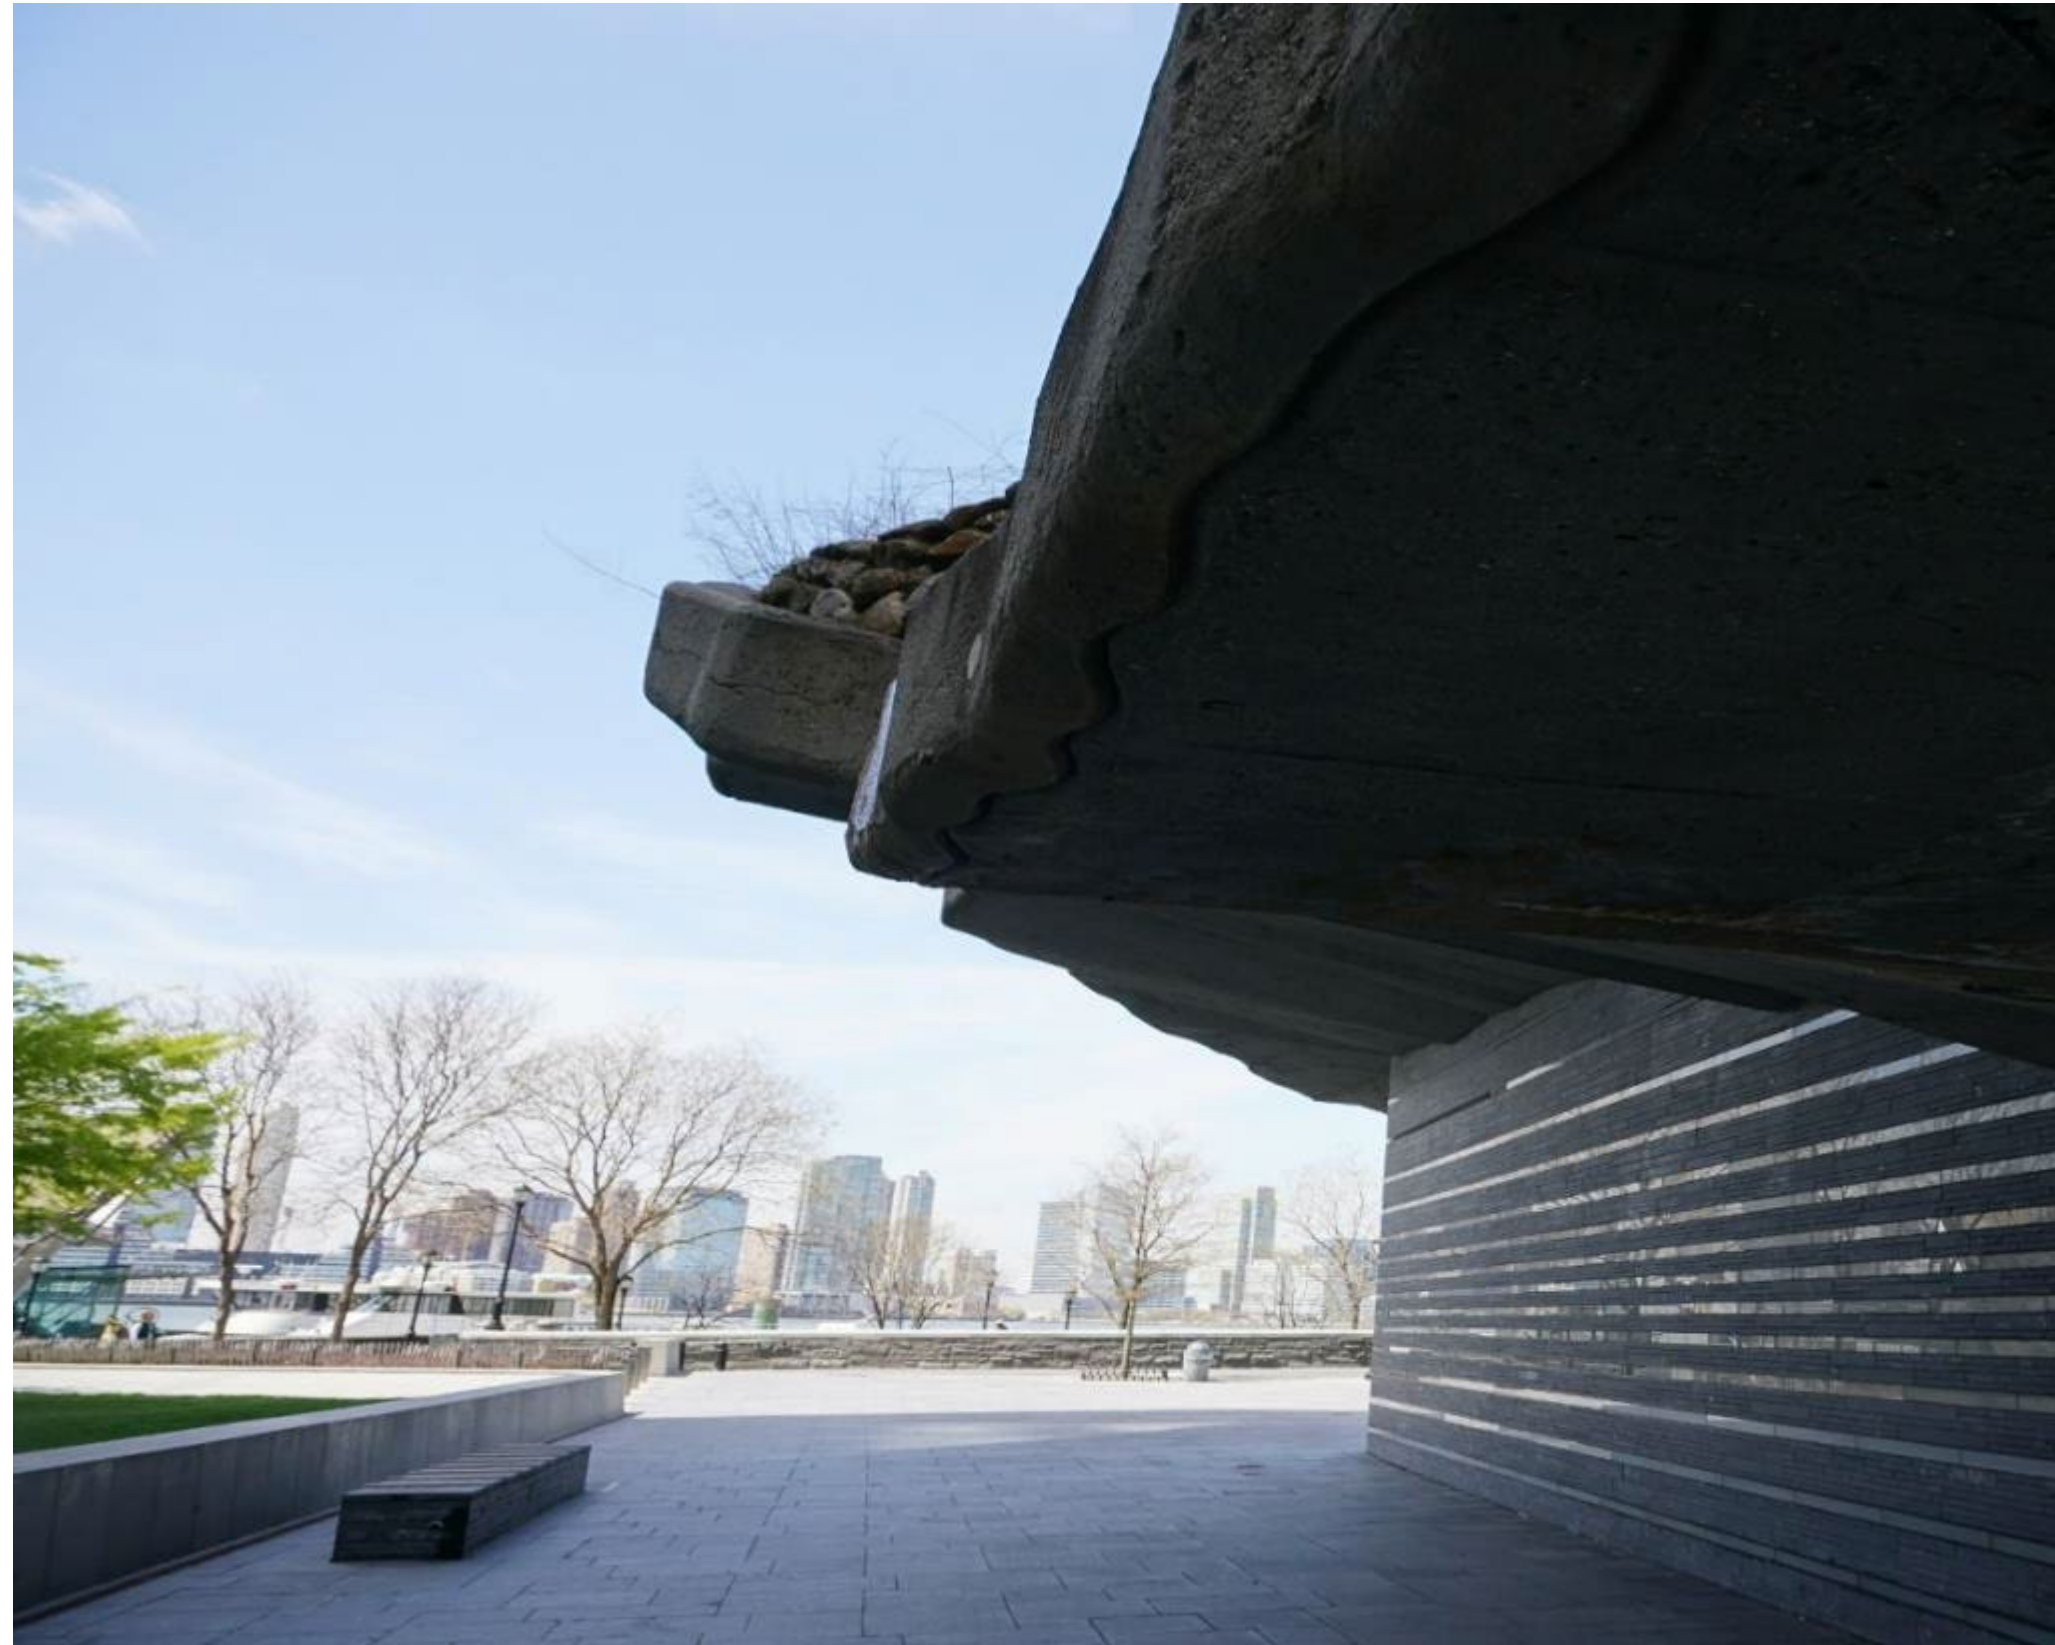
## Irish Hunger Memorial

- ❑ The concrete area tested is at moderate risk of corrosion activity
- ❑ Presence of **Macro-cell**: as half-cell and corrosion rates were detected, it indicates that defects are present in the coating.
- ❑ As the test was conducted on a wet structure, it is anticipated that as the structure begins to dry, corrosion might accelerate.

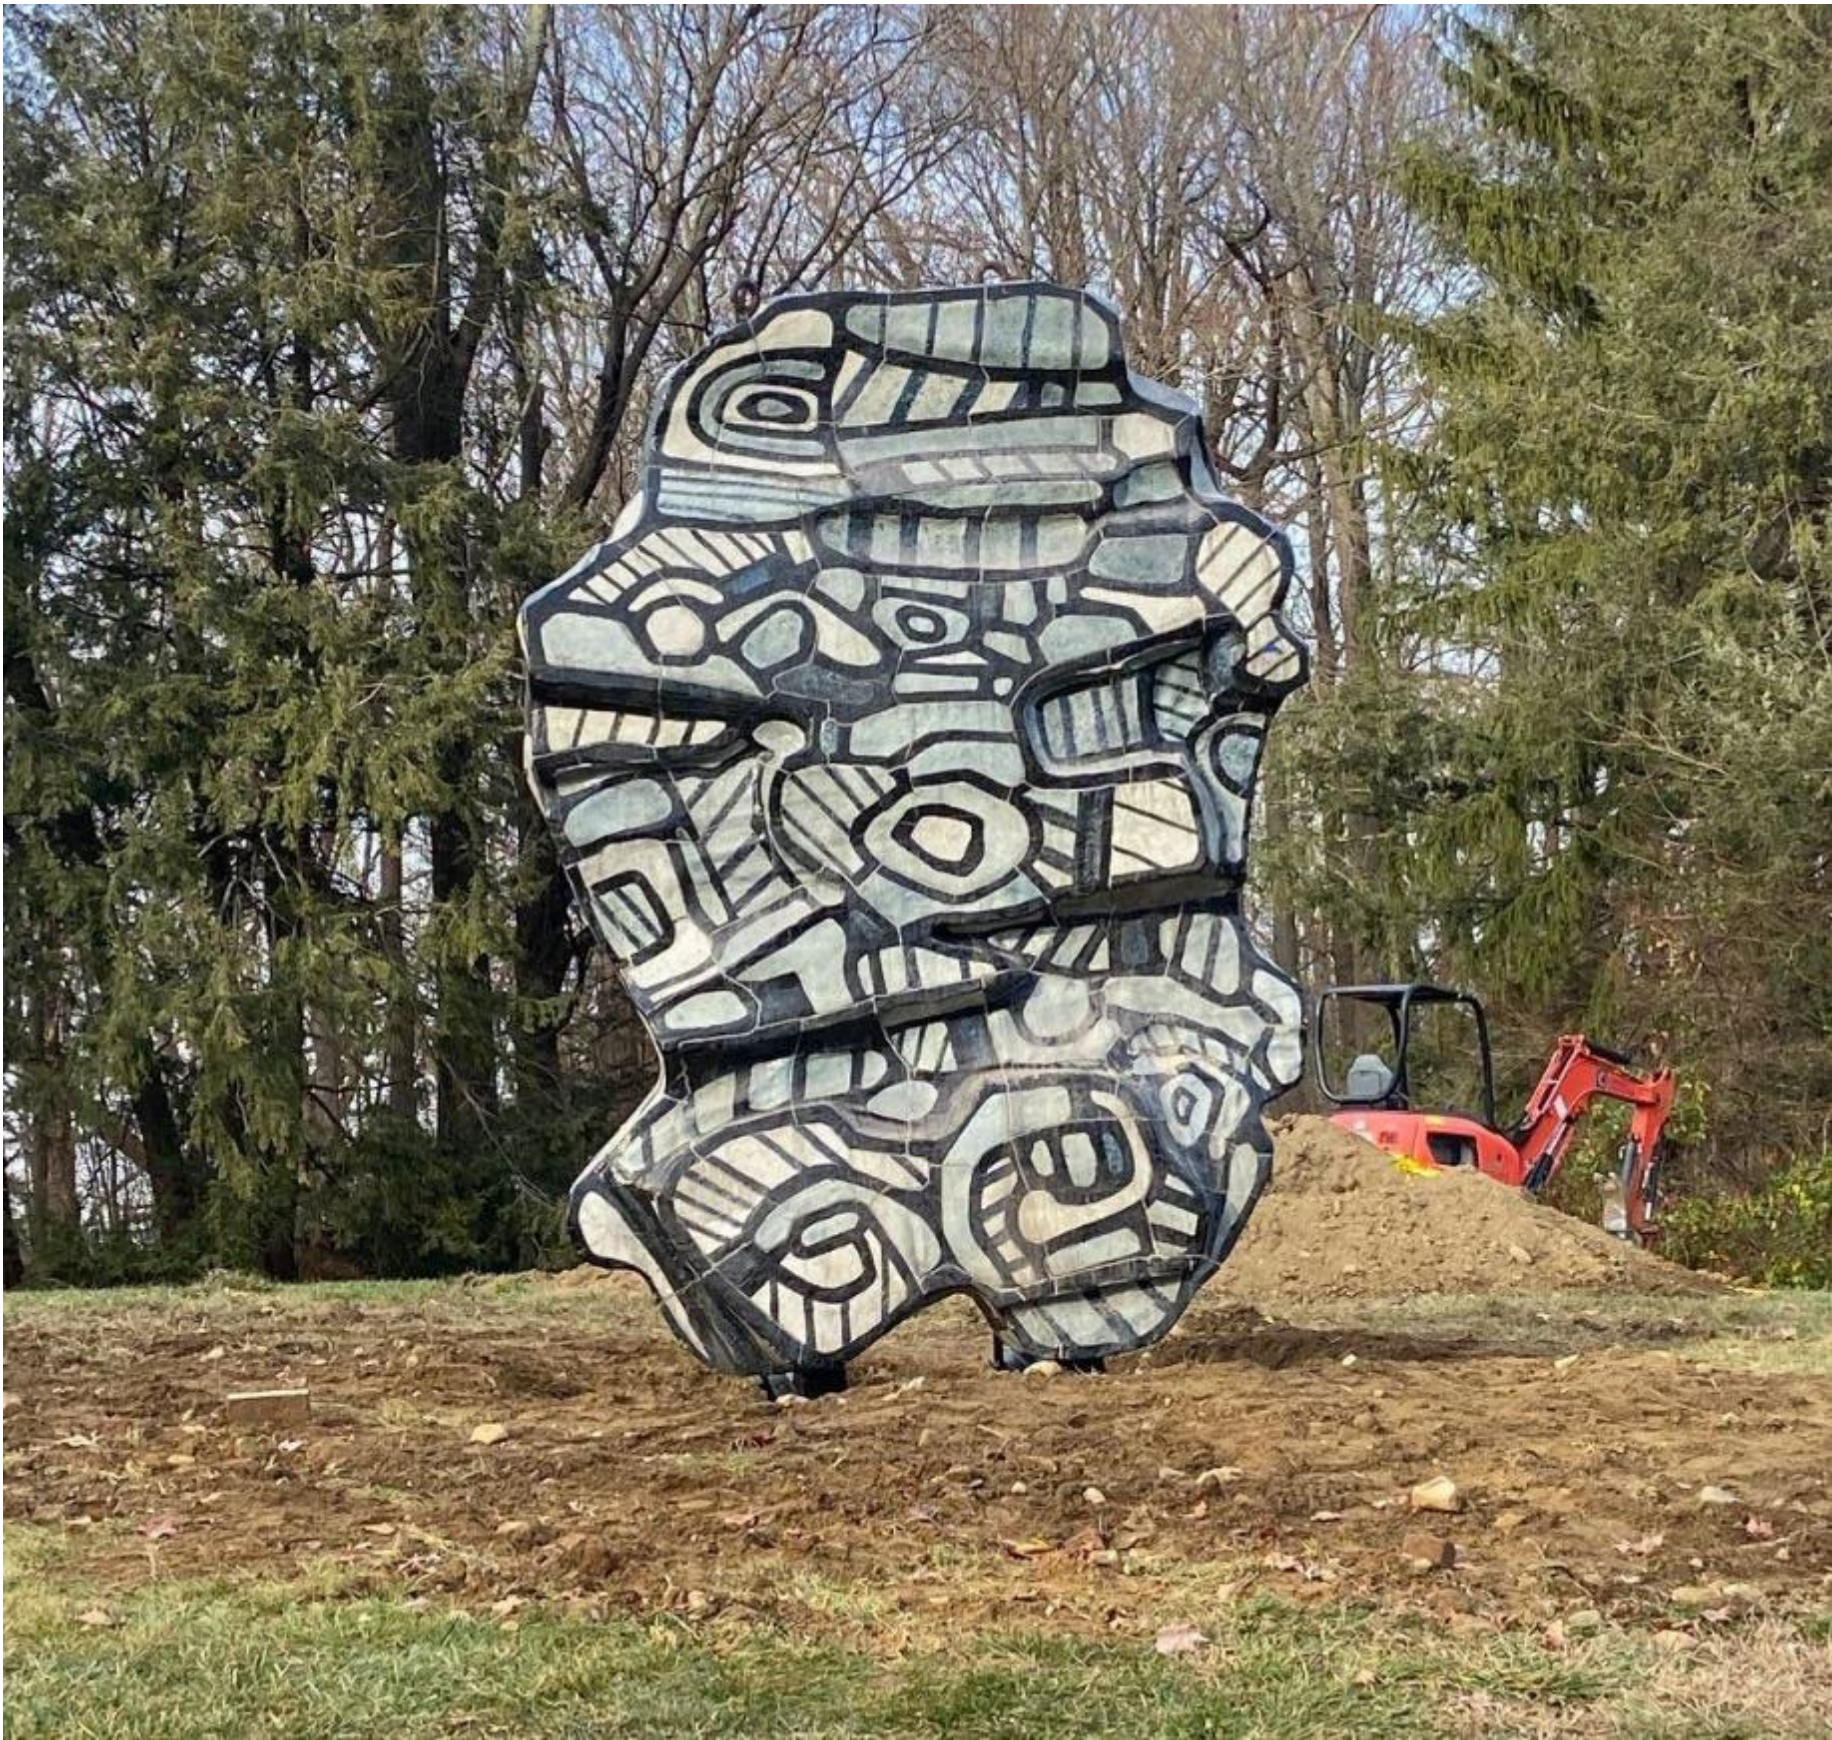
# “L'Erection Logologique Bleue Concrete”

- ❑ THE SCULPTURE IS IN GOOD CONDITION.
- ❑ ALL REINFORCEMENT APPEARS TO BE CONTINUOUS WITHIN ITSELF.
- ❑ DURING THE FIELD WORK, **NO REBAR** WAS EXPOSED DUE TO THE NATURE OF THE OBJECT.

- ❑ DRILLING WAS LIMITED TO METAL ELEMENTS ALREADY EXPOSED SUCH AS HOOKS AND THE FOOTINGS.
- ❑ FROM THE **STABLE** CORROSION TESTING RE, MORE THAN 90% OF THE POTENTIAL DATA COLLECTED SHOWS NO SIGN OF CORROSION ACTIVITY ACCORDING TO ASTM G876 STANDARD. THE HIGHEST CORROSION RATE DETECTED IS 0.80  $\mu\text{M/YR}$  WITH AN AVERAGE OF 0.42  $\mu\text{M/YR}$  WITHIN THE TWENTY-SEVEN [27] MEASUREMENTS RECORDED.

- ❑ THE CONCRETE WAS FOUND TO BE VERY DRY WHICH DIRECTLY INFLUENCED THE POTENTIAL READINGS. AS REPORTED BY THE ROCKEFELLER FOUNDATION STAFF MEMBERS, THE SCULPTURE HAS BEEN STORED IN A WAREHOUSE FOR SEVERAL YEARS WITH LIMITED TO NO EXPOSURE TO ATMOSPHERIC CONDITION.

- ❑ A TREATMENT AND RELOCATION PLAN WAS IMPLEMENTED BY EVERGREENE ARCHITECTURAL ARTS, NOW IN ITS CURRENT LOCATION, HIGH ON HILL AT KYKUIT, ROCKERFELLER’S ESTATE IN TARRYTOWN, NY.

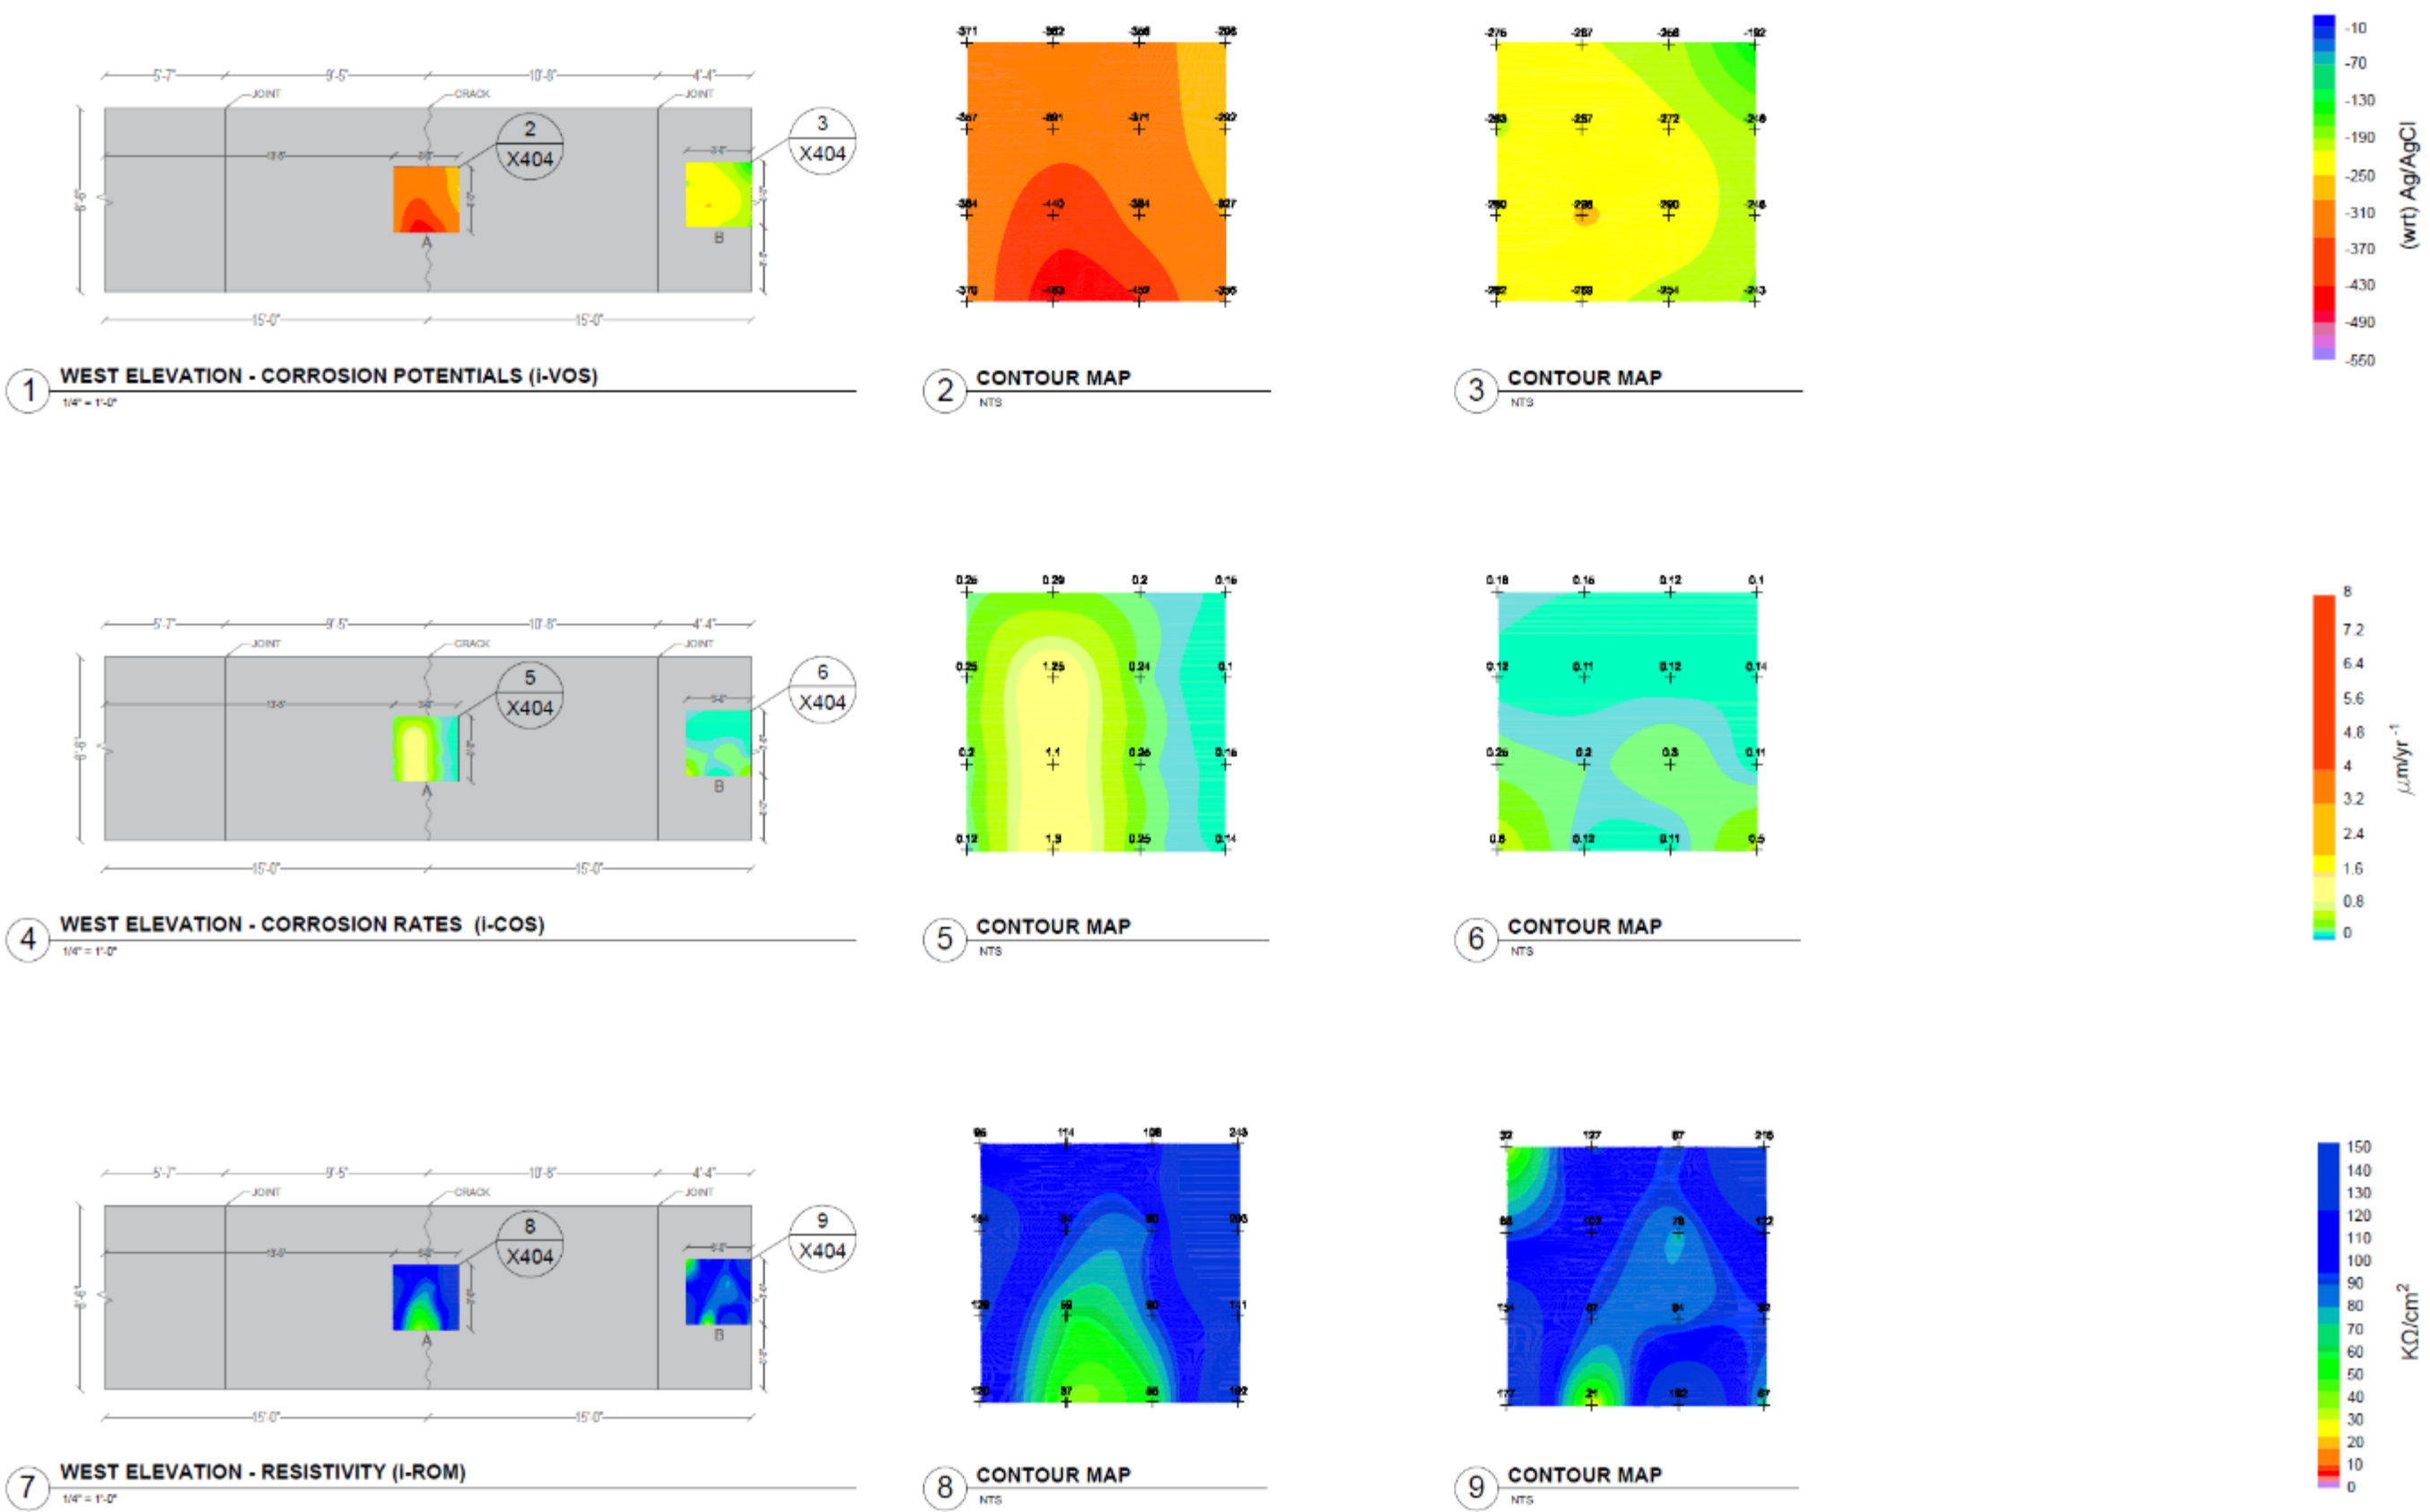
- ❑ ASR affected concrete
- ❑ High Moisture driving corrosion

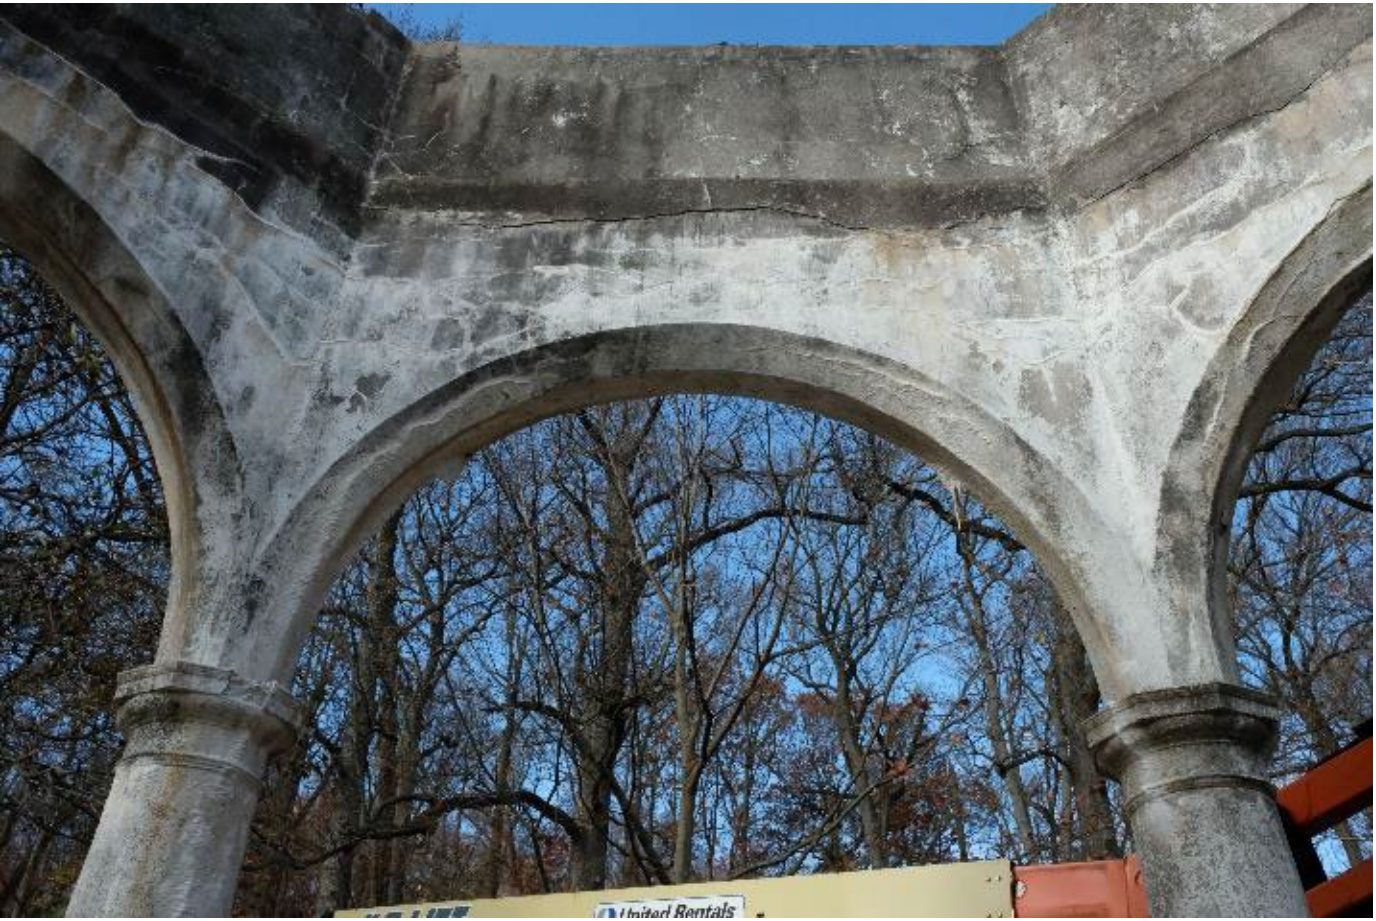
Likely ASR related issues

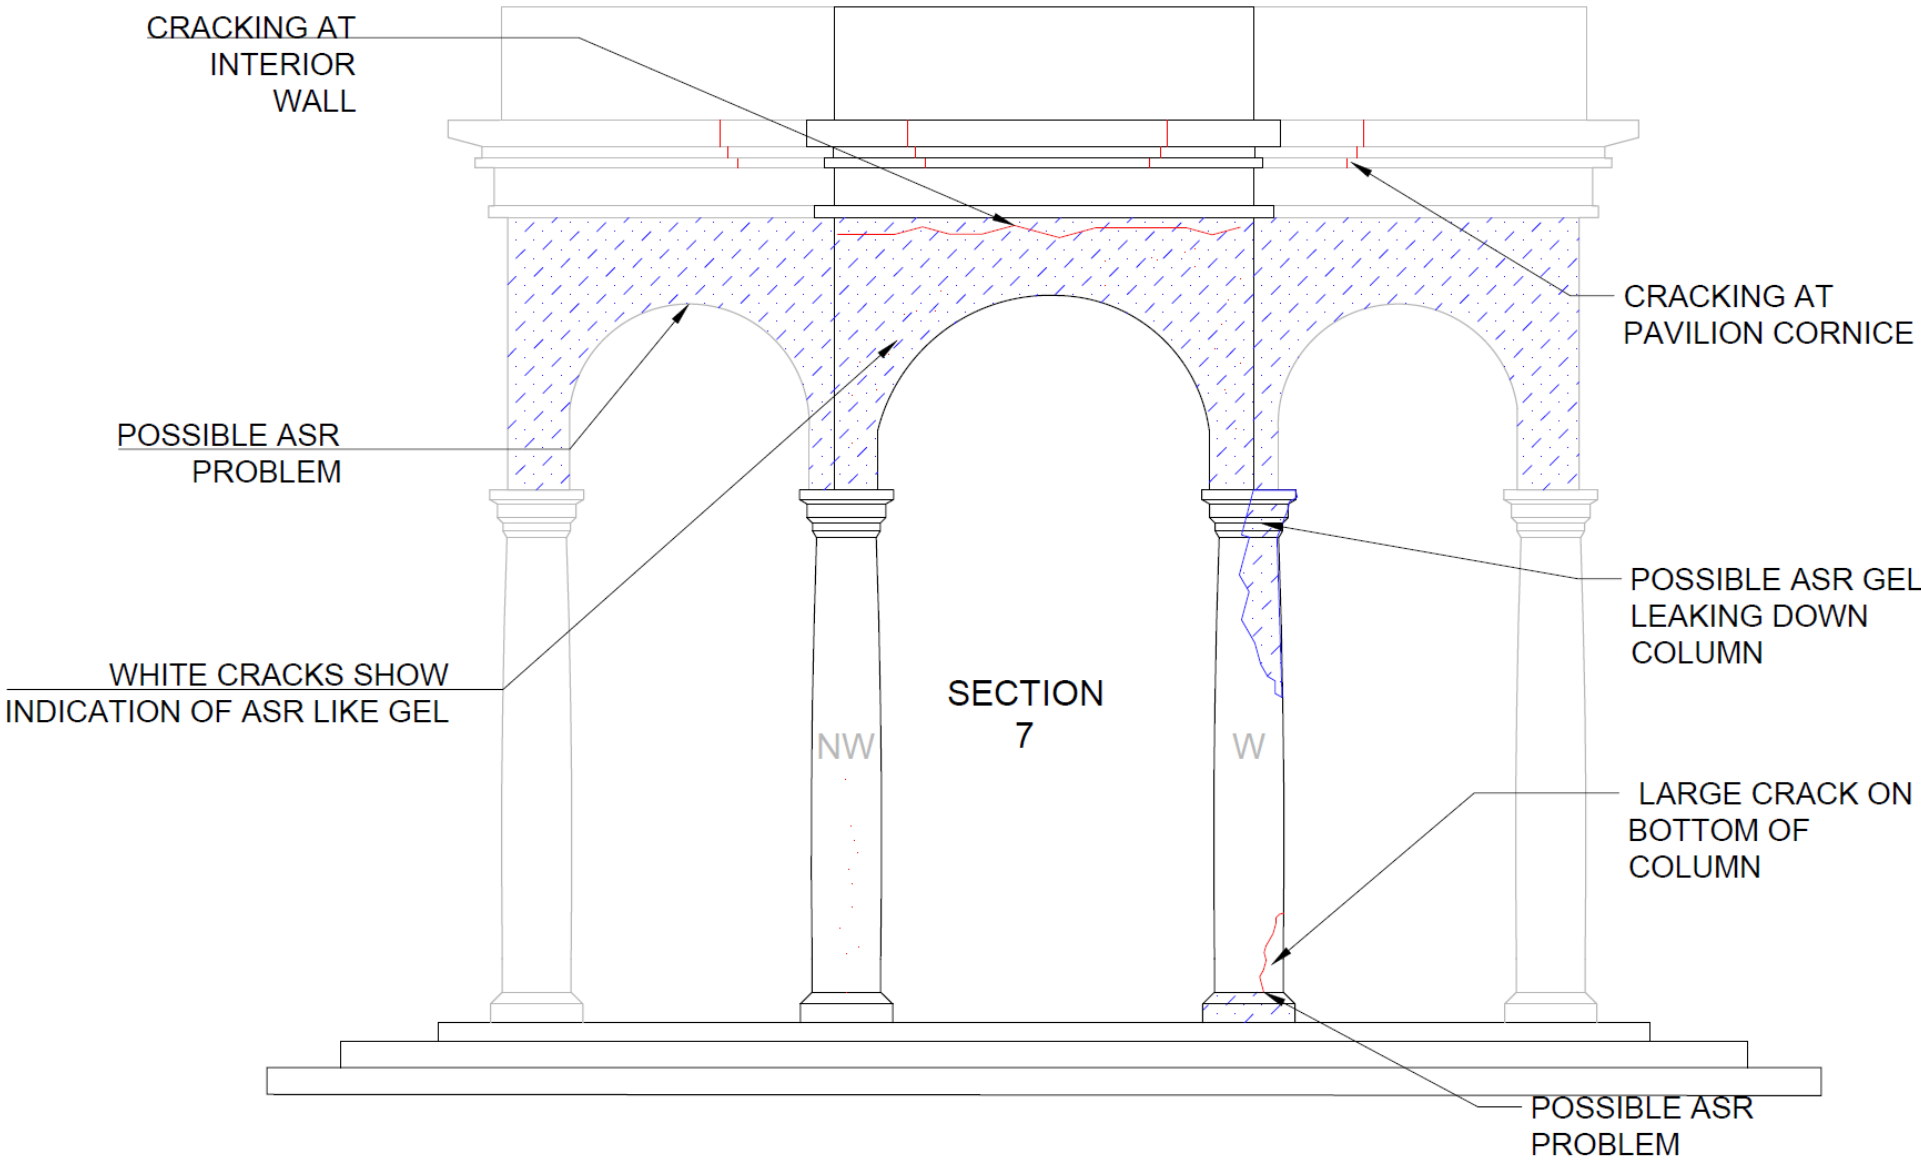
Delamination spalling issues
