# De-Mystifying Unusual Results on Extraordinary Structures - Case Studies of Concrete Challenges

Gina Crevello

*Echem Consultants LLC*

# CASE STUDIES

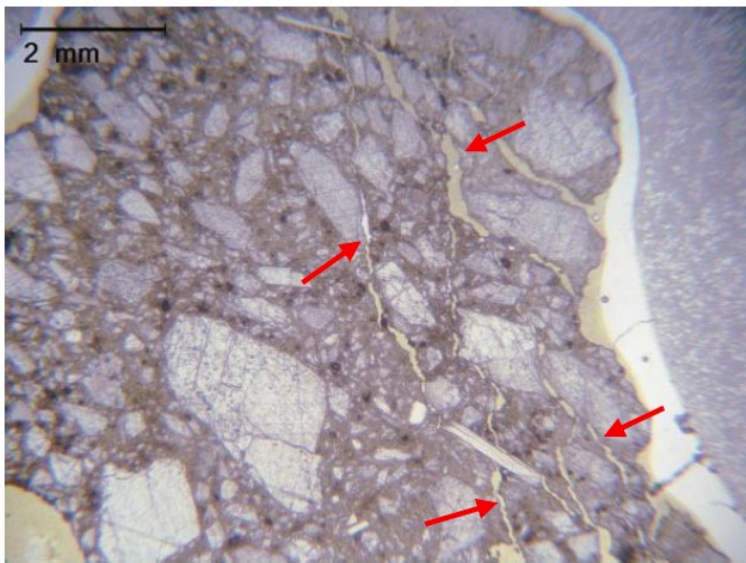
Plane Polarized Light

- Comprise of historic **Portland cement** and **dolomitic marble** with ratio of **1:3.25**
- NO evidence of ASR
- Cracking occurred most likely due to **freeze and thawing cycles.**

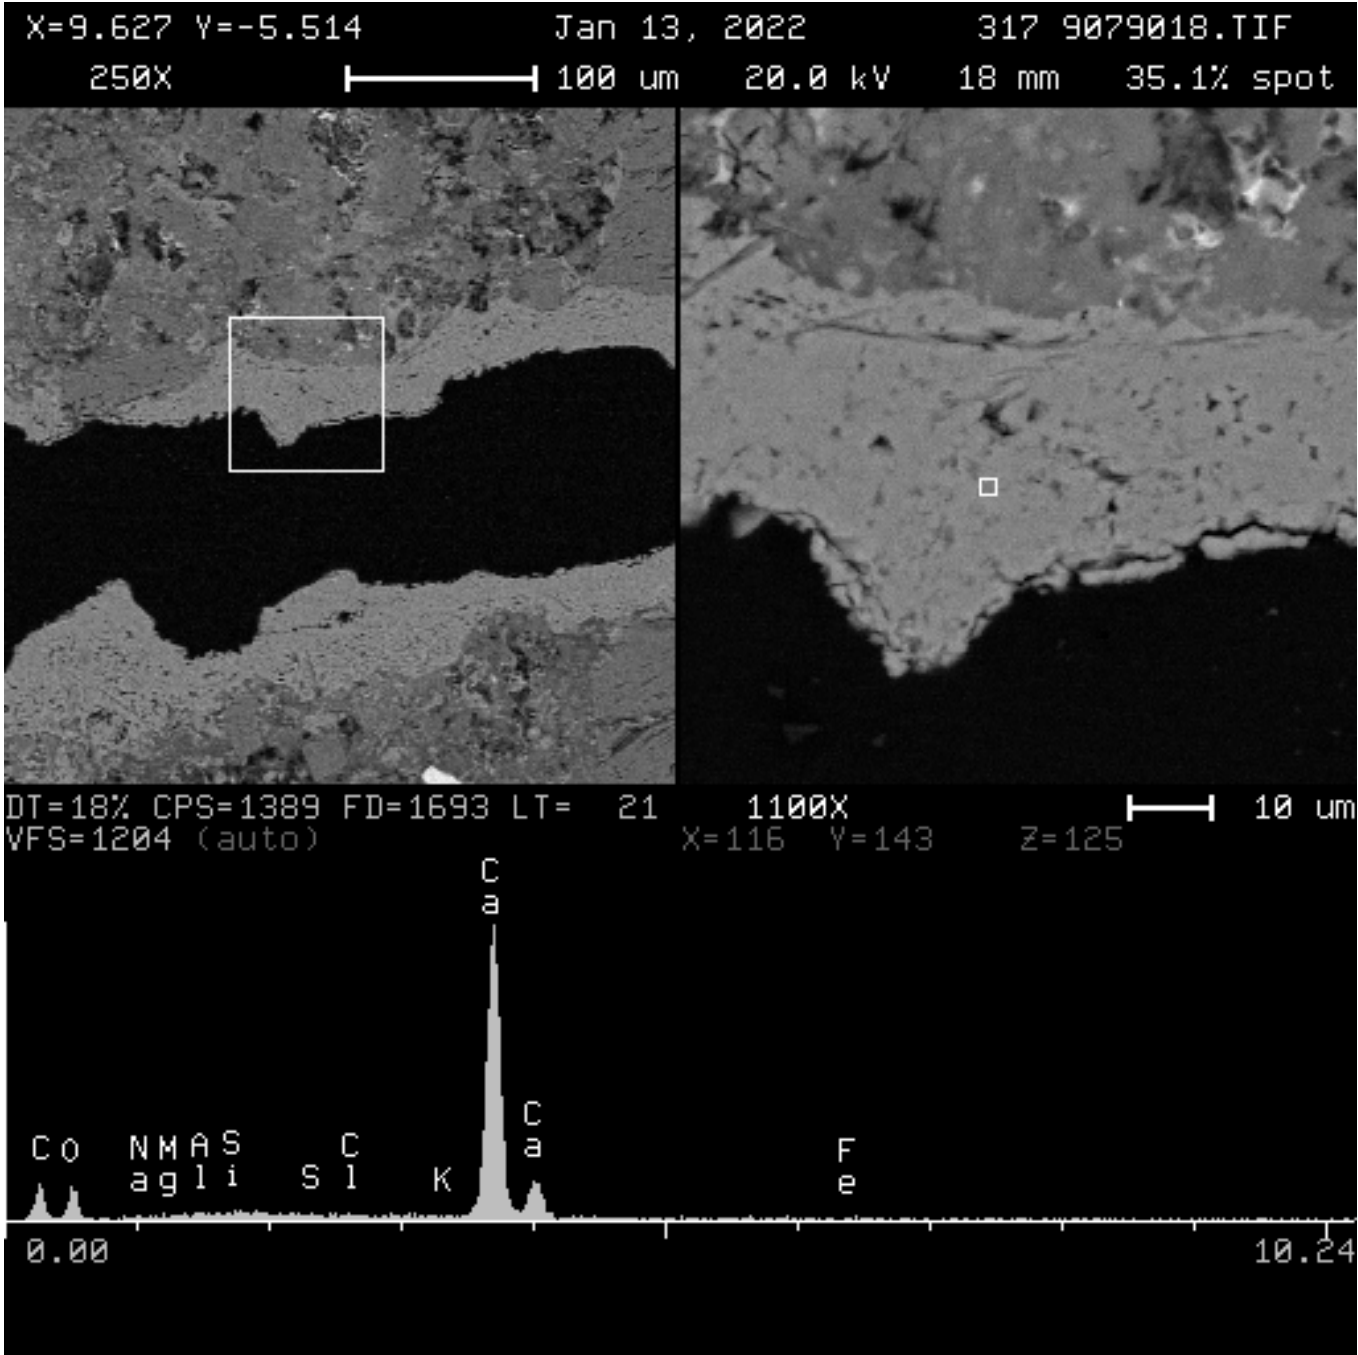
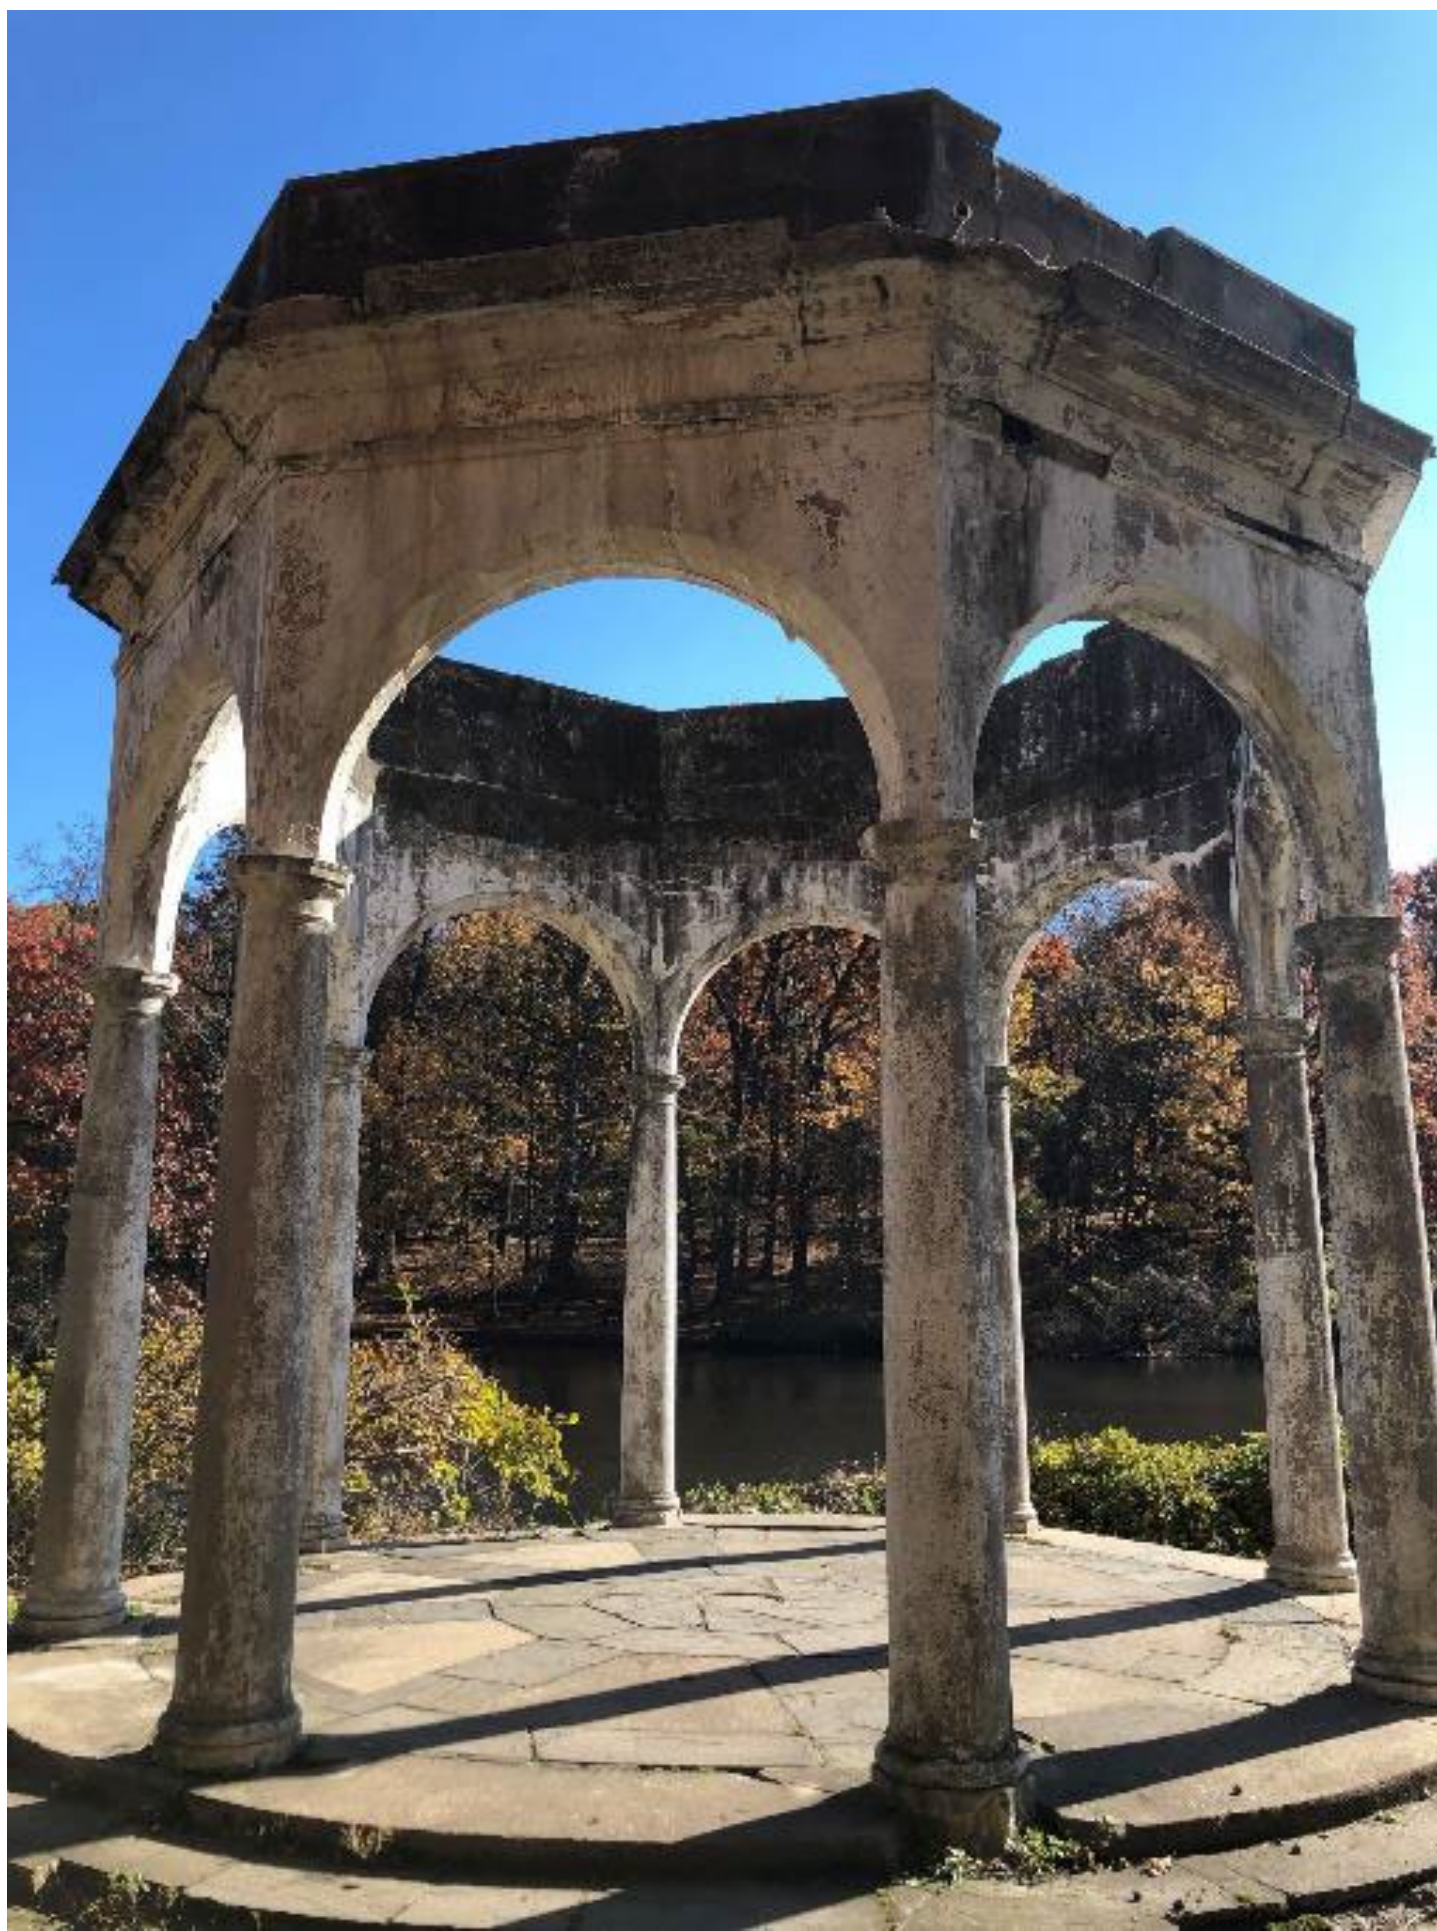
## TIBBETTS PARK PAVLION

- ❑ Freeze Thaw affected concrete
- ❑ High Moisture
- ❑ Significant Delaminations
