2025 SPRING CONVENTION

A Seemingly Improbable Crisis:
The Perfect Storm at Oroville Dam

Presented by:
Jeremy Begley, PE
MAPEI Corporation

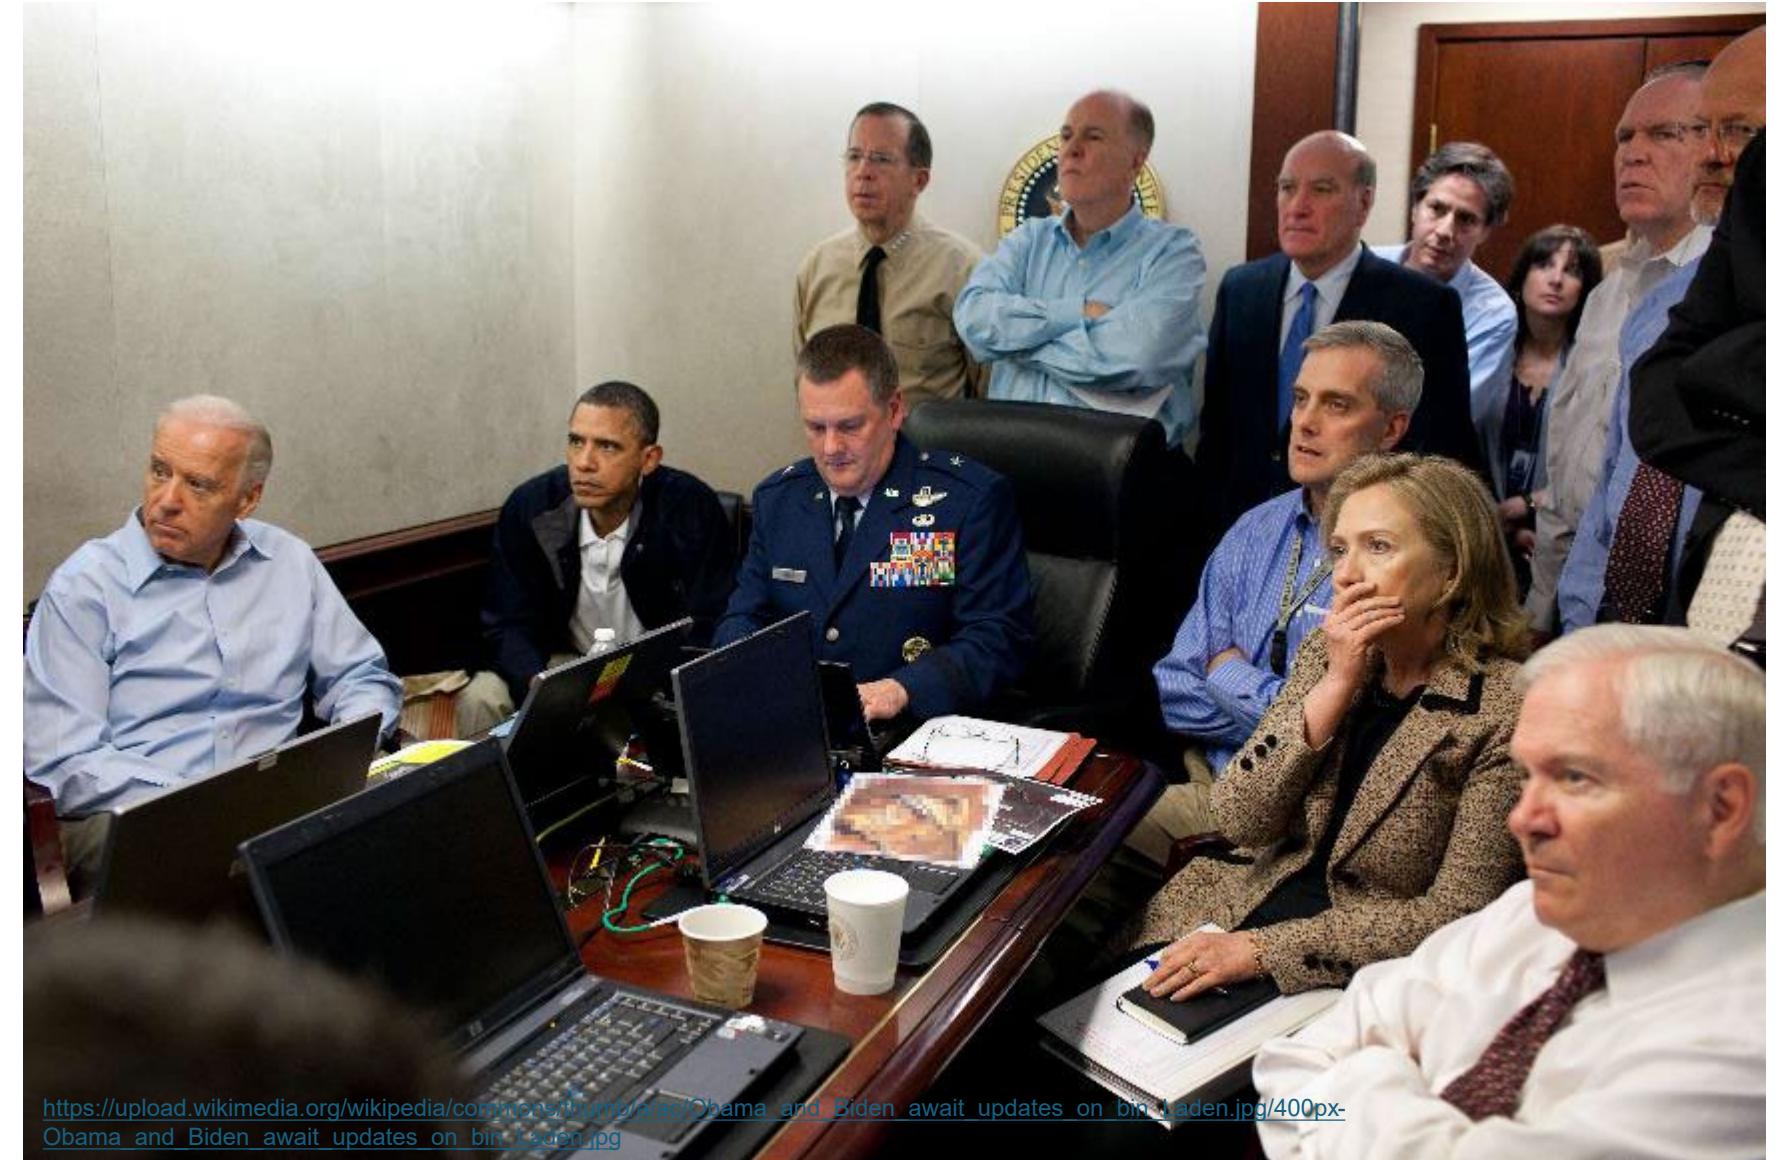
- **Incident Trigger :**
 - Chute slab failure and erosion
 - Closure of service spillway gates for damage assessment.
- **Risk Tradeoffs:**
 - Difficult choices
- **Key Dilemma:**
 - Further spillway damage
 - Potential damage to transmission tower
 - Debris buildup causing potential powerhouse flooding
 - Overtopping emergency spillway weir
 - Possible erosion
- **Strategic Response:**
 - “Sweet spot”
 - Controlled use of the service spillway with minimal discharges
 - Goal: prevent overtopping the emergency spillway weir
 - All hands on-deck to make the call

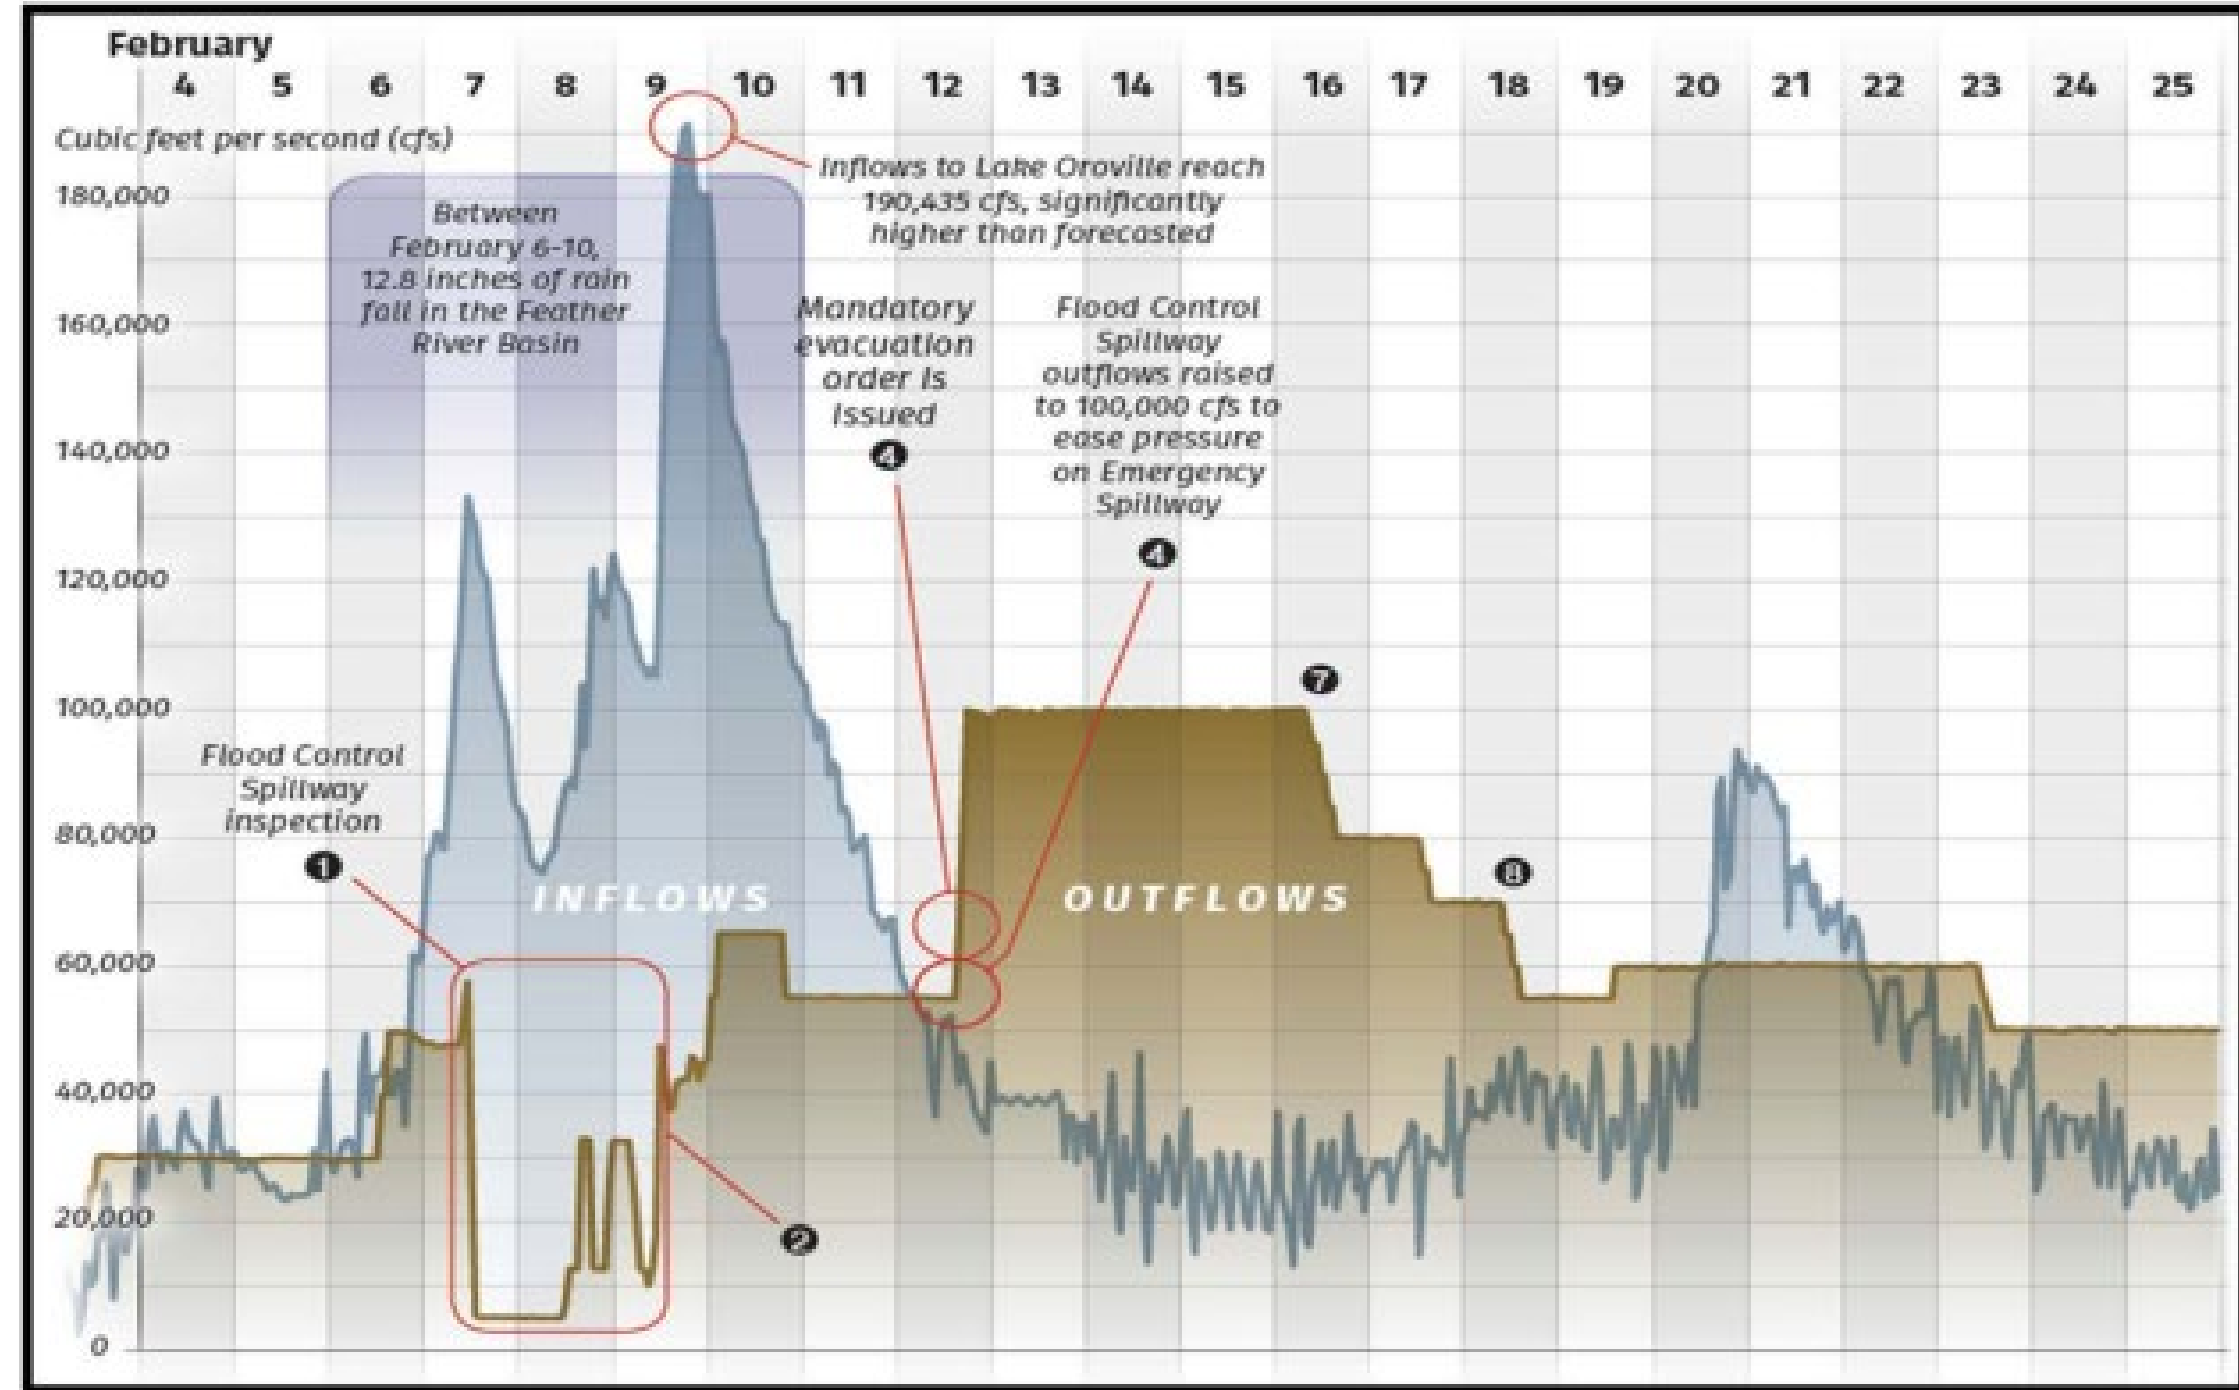
- **February 12: 3:44 PM**
 - Evacuation Order
 - Risks too great
 - Safety of lives downstream
 - 188,000 people evacuated
- **Feb 12: 7:00 PM**
 - FCO discharge increased to 100,000cfs
 - Maintained until Feb 16, 8:00 AM
- **Feb 14: 3:30 PM**
 - Downgrade to evacuation warning
- **Reservoir Management:**
 - Target level El. 850, 50 feet below full pool
 - Feb 20, 3:00 PM: Target reached and maintained
 - Feb 16–27: Discharges adjusted (80,000–50,000 cfs)
- **Feb 27: 7:00 AM**
 - Spillway gate closure began
 - Fully closed by 1:00 PM—investigations initiated

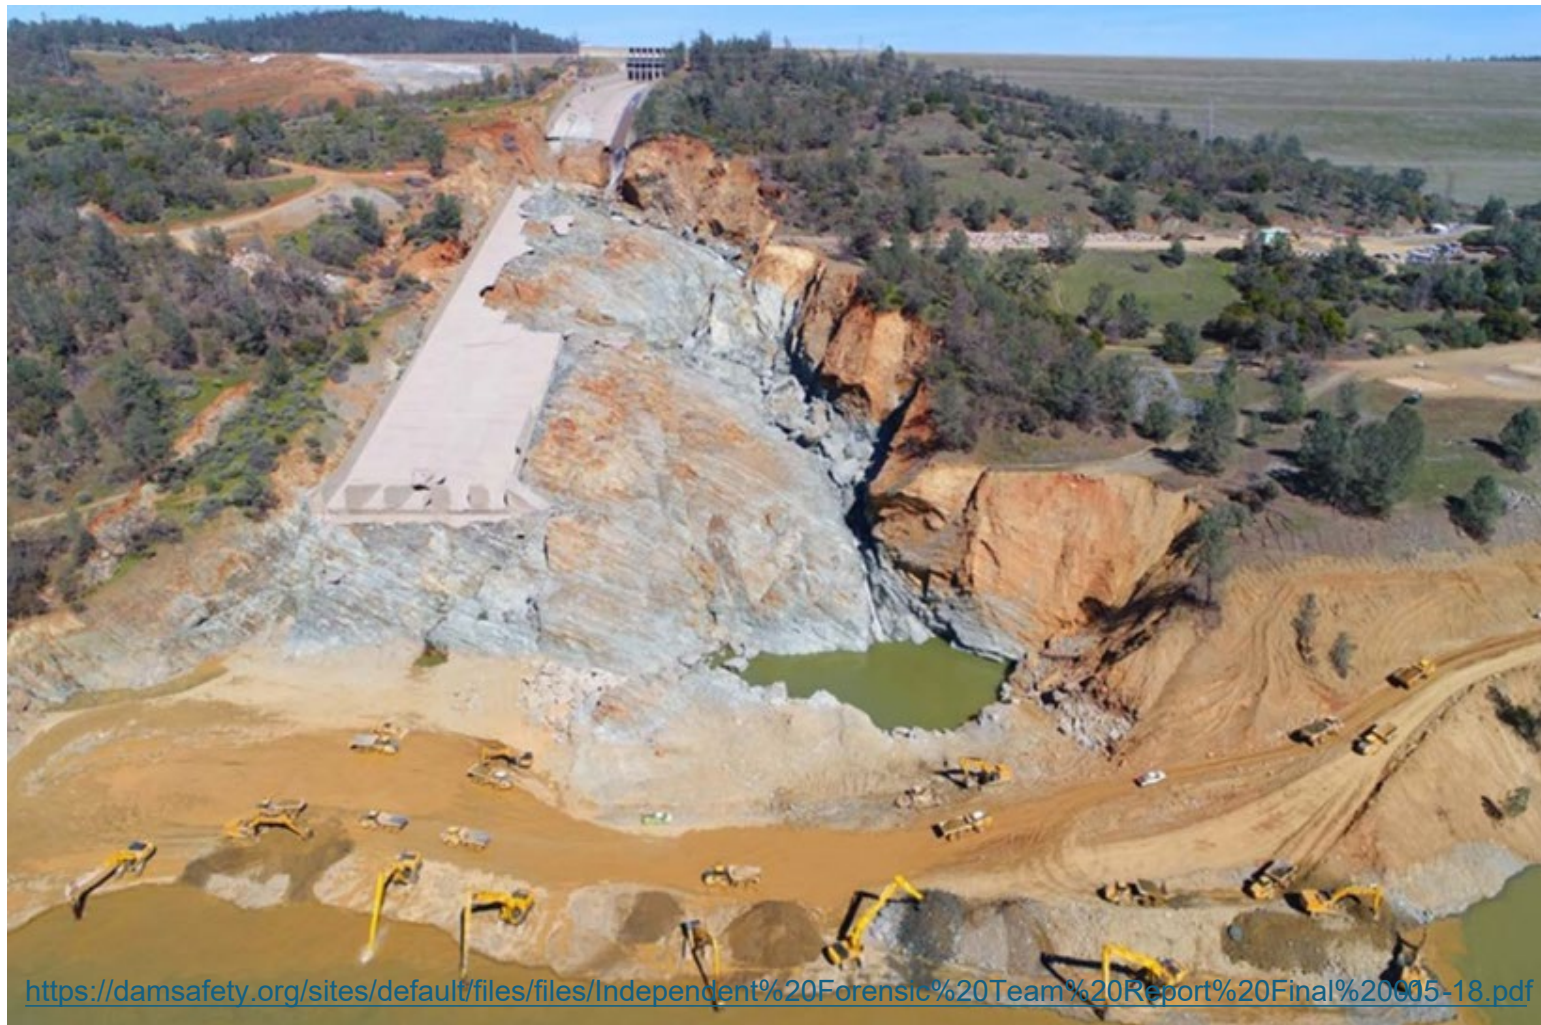
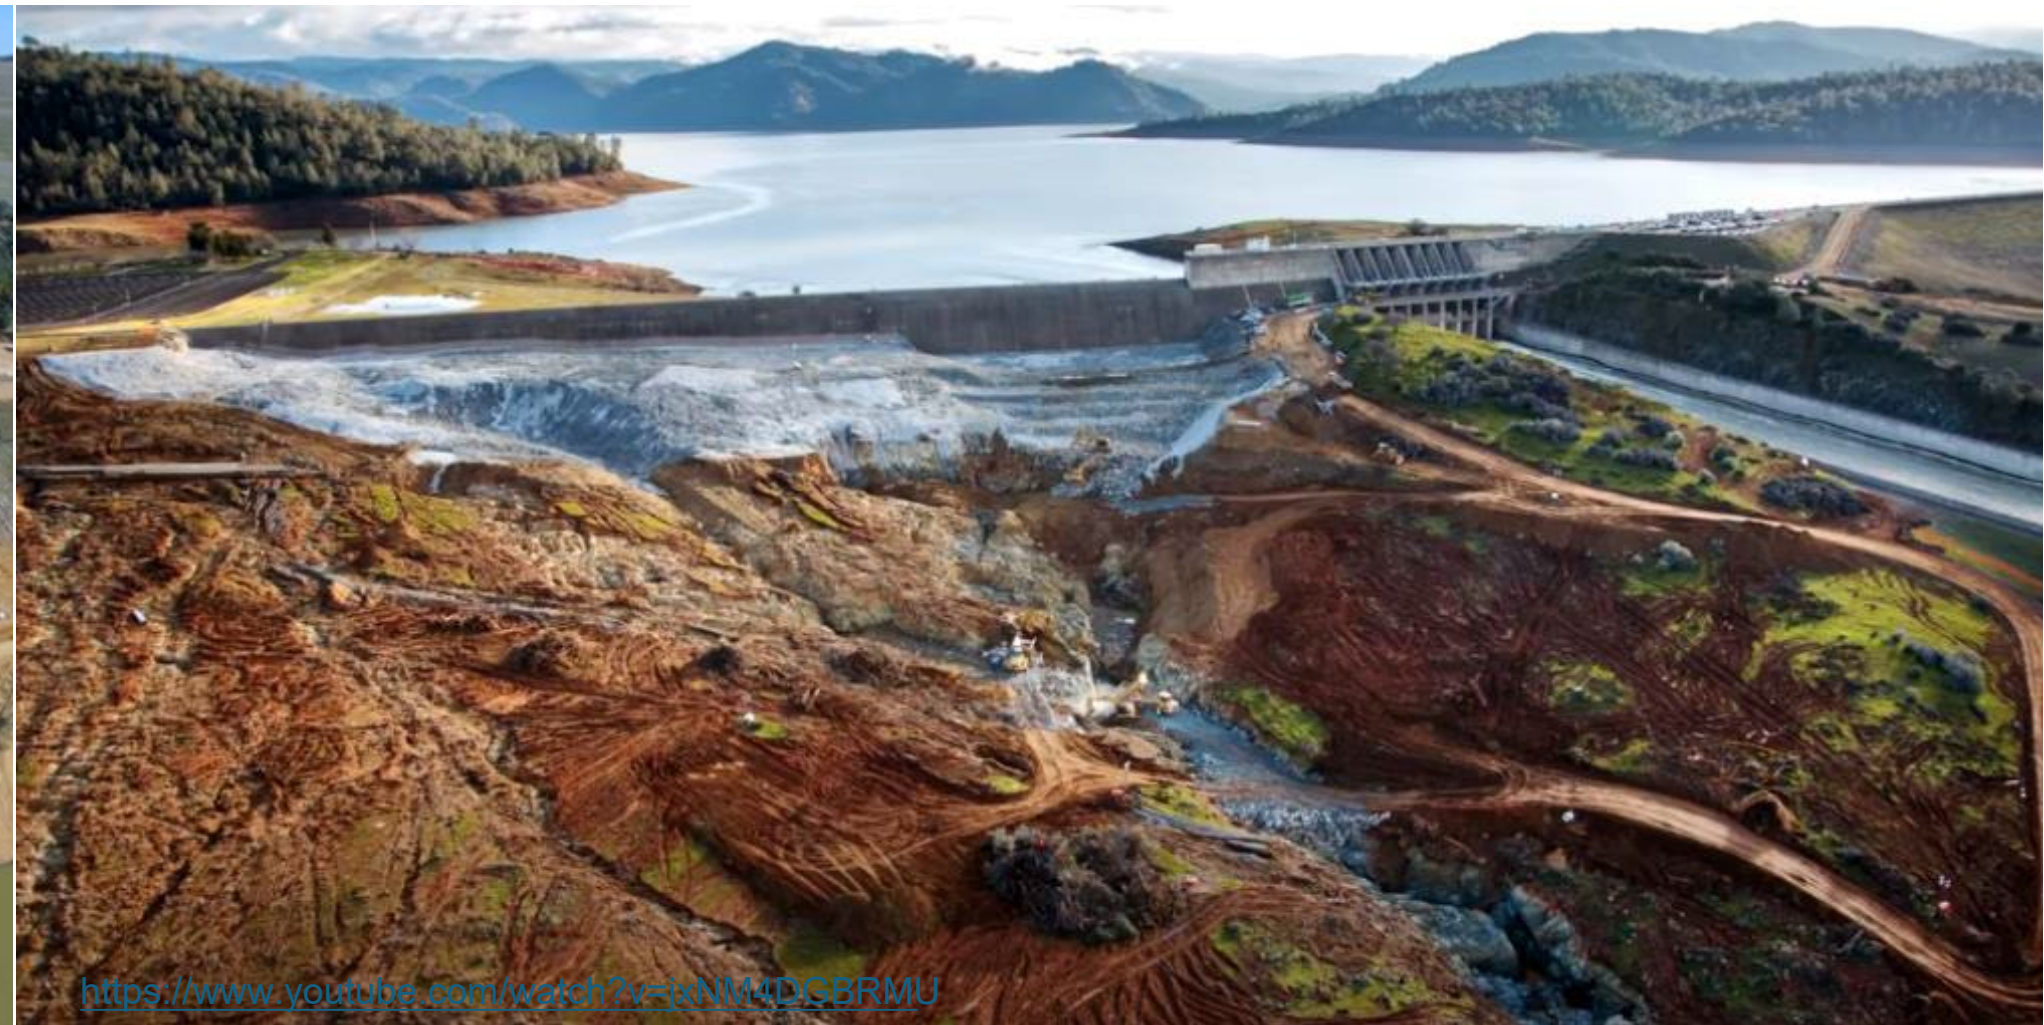
- Assessing the damage

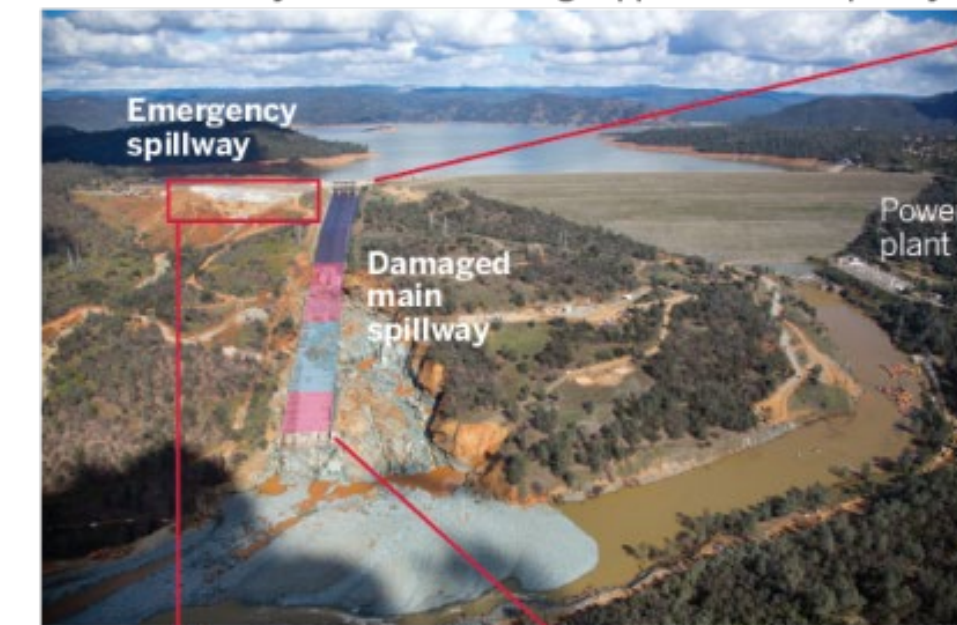
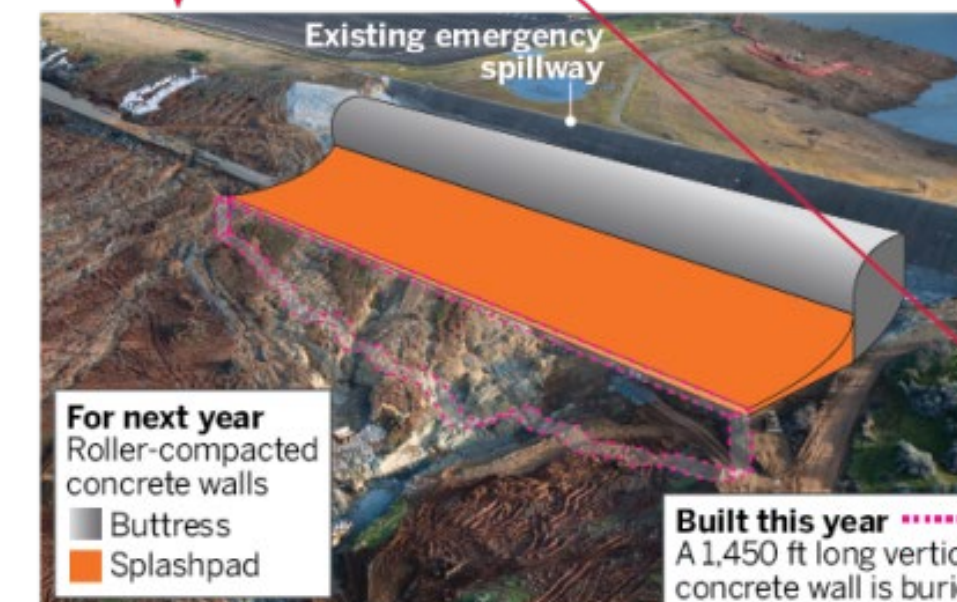
Feb. 27 — 20 days after initial damage appear on main spillway

Emergency spillway
The existing structure will be reinforced with a new buttress, splashpad and retaining wall.
