# Concrete Repair or Artwork Conservation? – The Whispering Bench

Matthew Sherman, P.E., F.ICRI  
Senior Principal  
*Simpson Gumpertz & Heger, Inc.*

Guy Battaglia  
Operations Manager  
*Reg Hough*

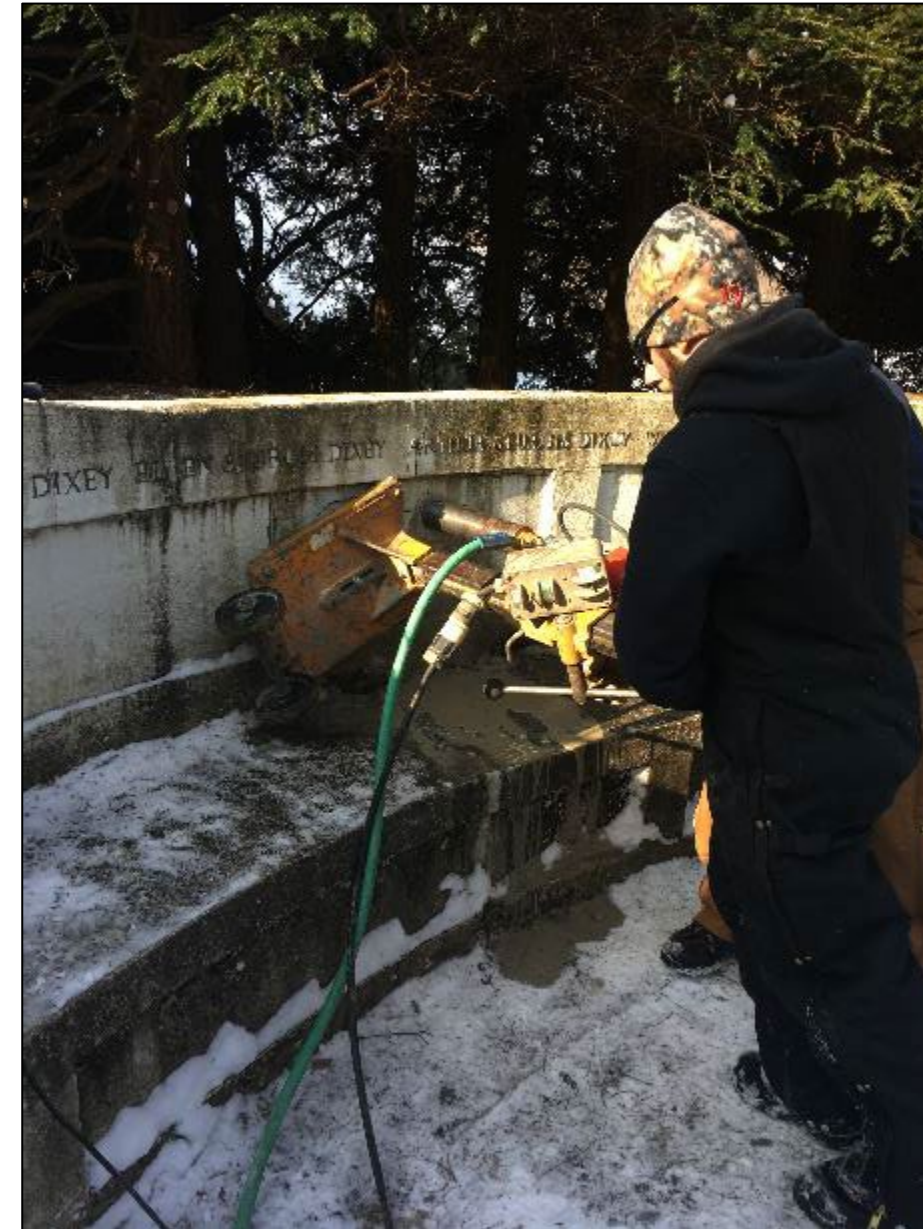
- Understanding internal conditions and cause(s) of distress critical
- Cored from areas of different performance to understand initial and current conditions
- Petrography to evaluate
- Samples served as basis for go/no-go decision on restoration

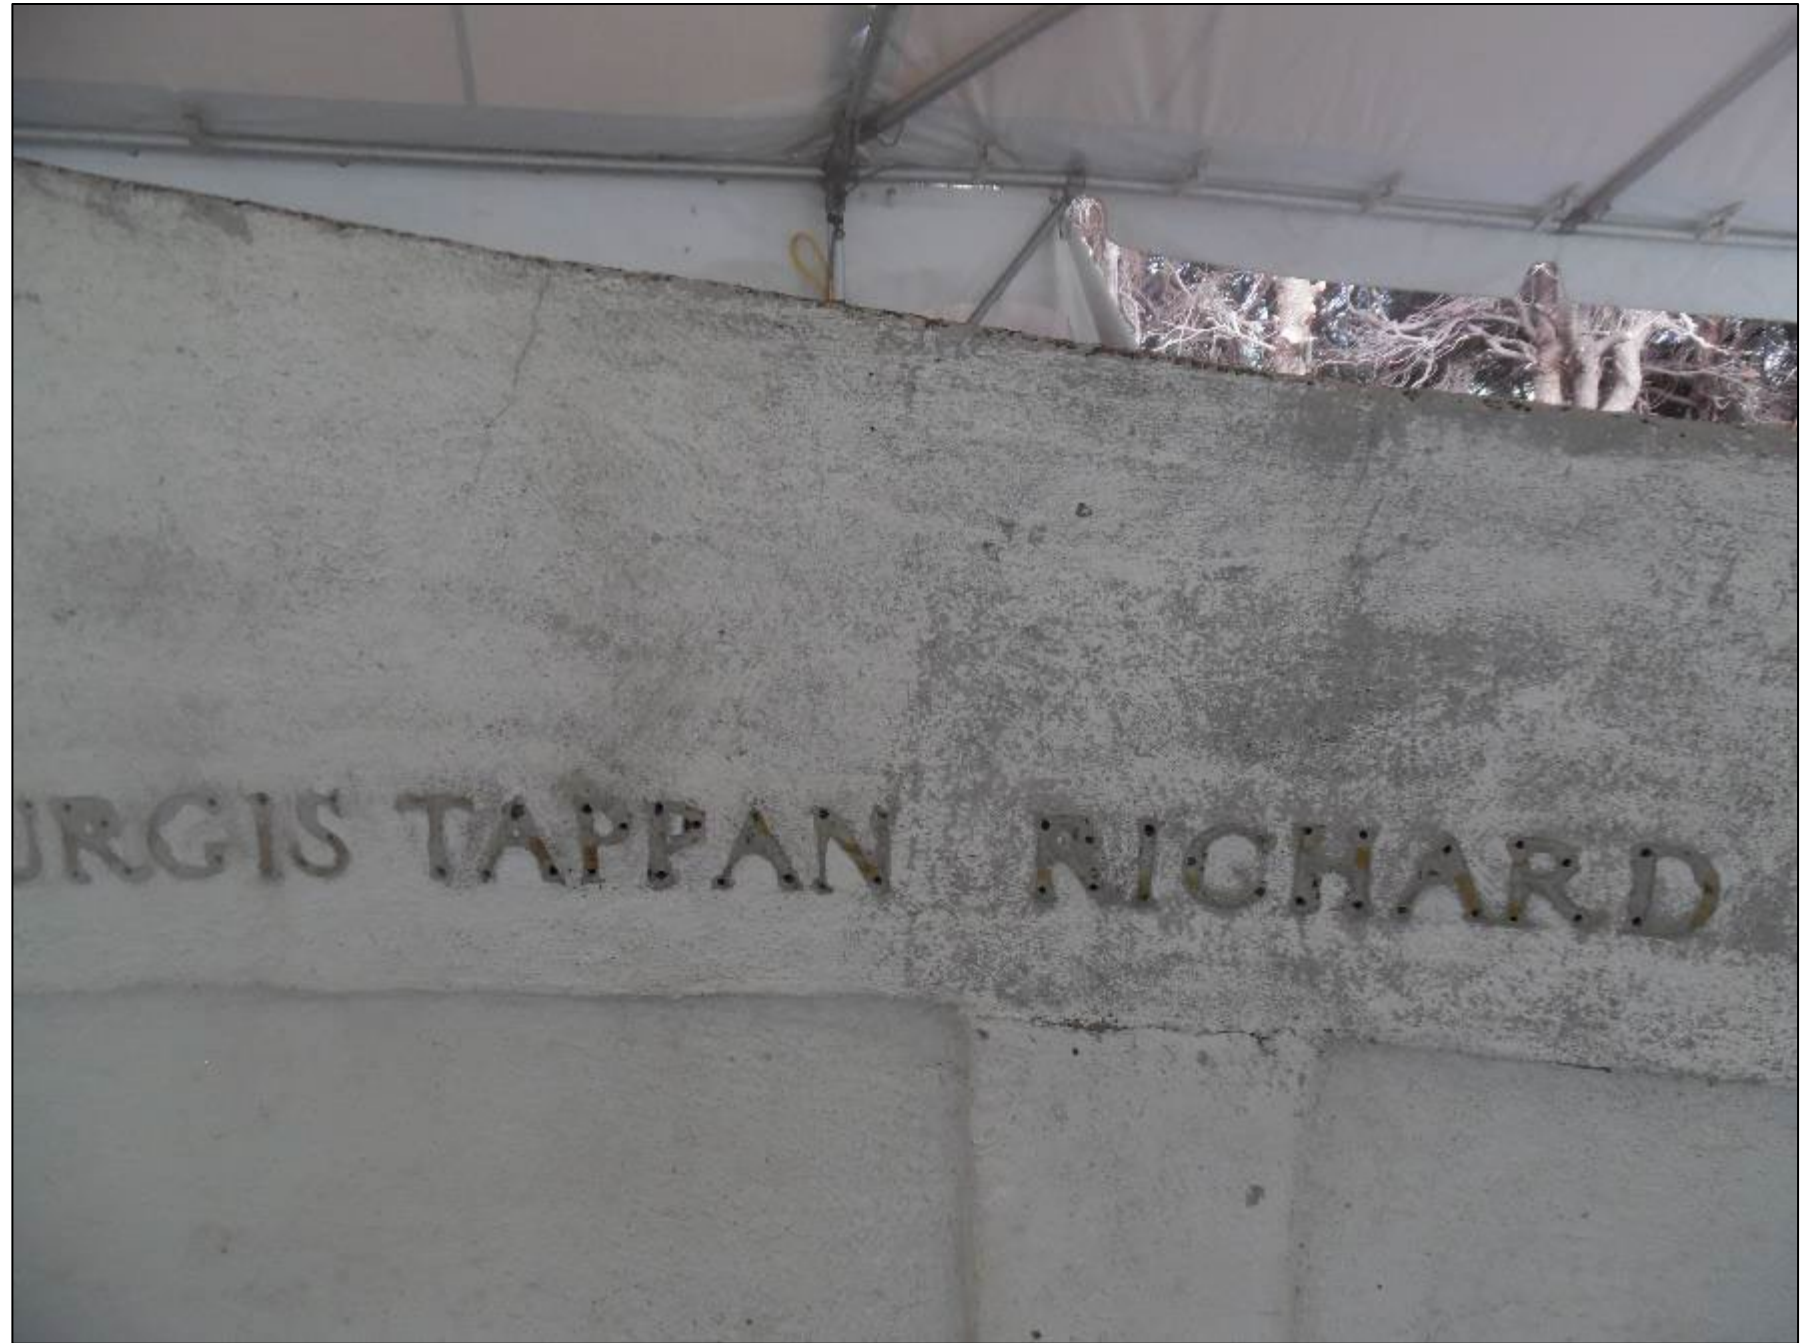
# Cleaning

- Overall cleaning went well
