Evaluating Unbonded Post-Tensioned Structures

By Gail S. Kelley, P.E.

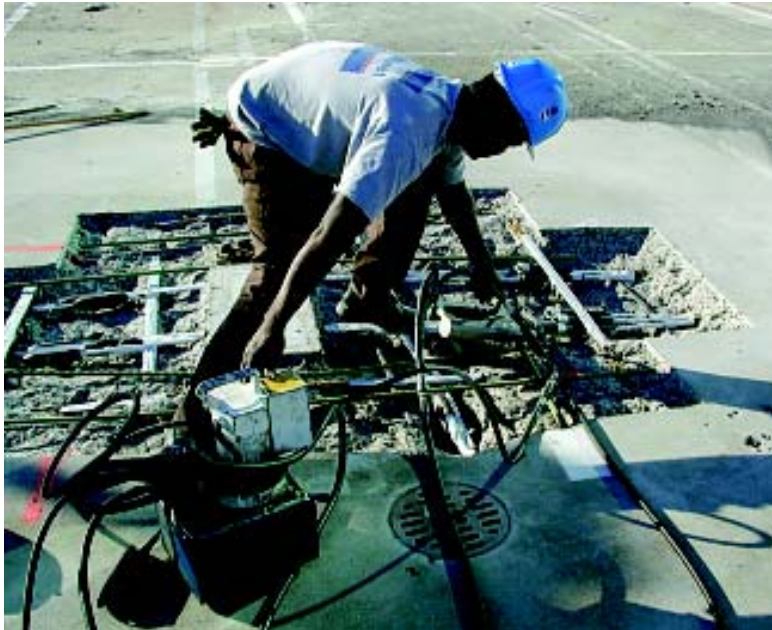
Fig. 1: Repair to a two-way flat plate parking structure built in 1971. Two-way structures built during the 1960s and 1970s often used a “basket-weave” tendon layout; tendons were distributed in both directions. Current practice is to band the tendons in one direction

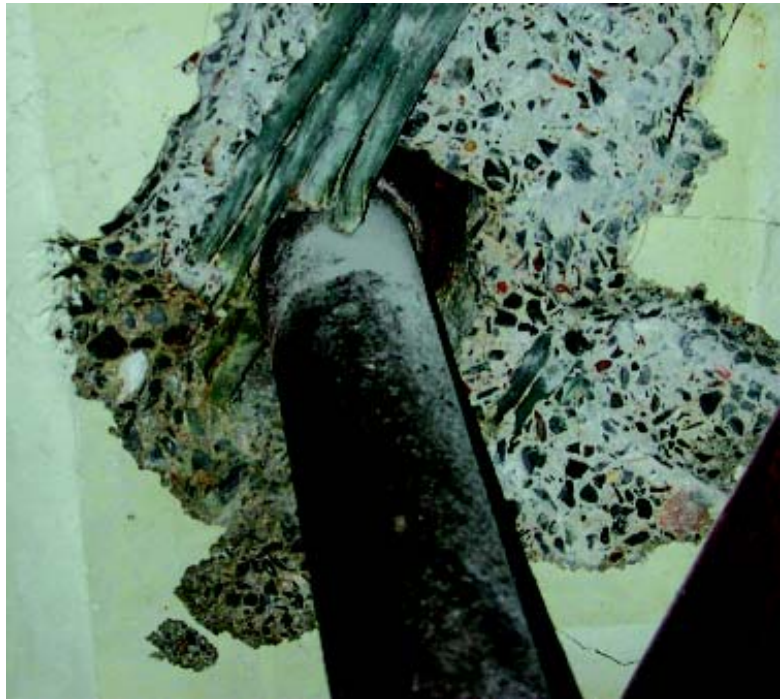
Fig. 2: Tendons that have been damaged during building renovations, such as new pipe penetrations, may be difficult to find. Often, the area where they were damaged will have been patched back or otherwise covered up

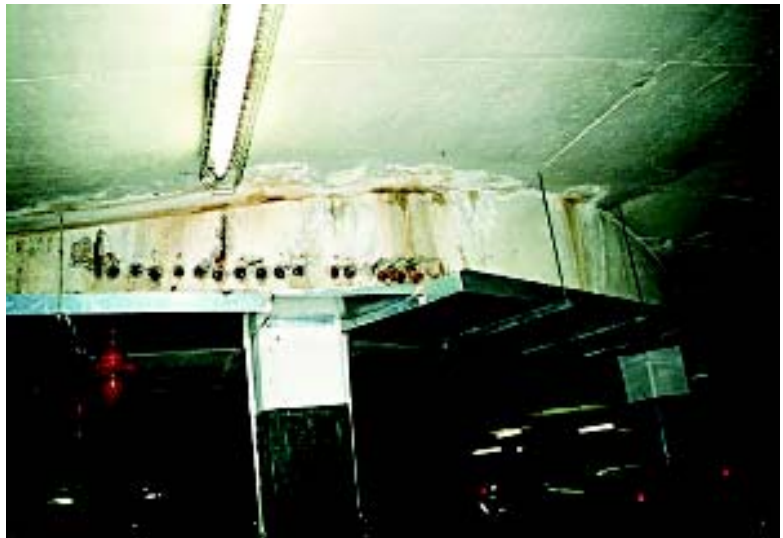
Fig. 3: Water leaking from an open construction joint at a slab/wall joint has severely corroded all of the anchors in this band. Several of the anchorages have failed. Drip pans have been installed along the length of the joint

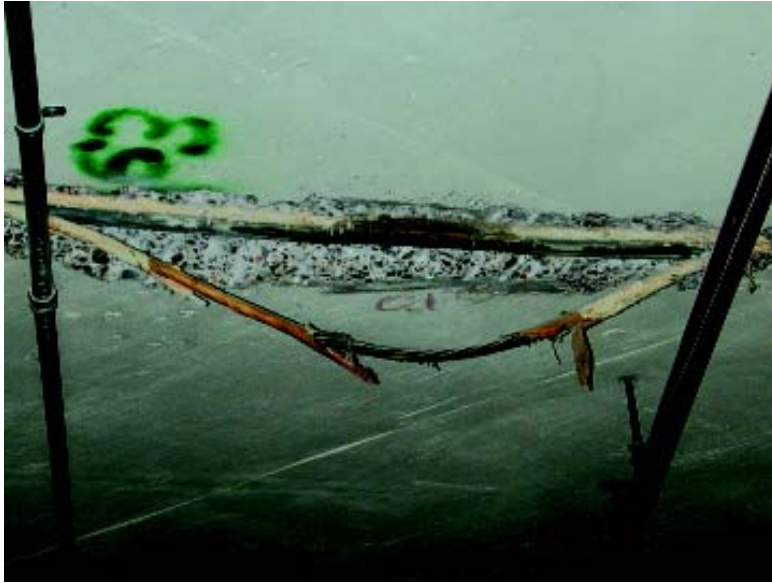
Fig. 4: Paper-wrapped tendon that had broken through the slab at a low point when the anchorage released

The most obvious sign of tendon damage is a loop of strand sticking out of the slab. When a strand is stressed during construction, the steel elongates. If the strand subsequently breaks or the anchorage fails, this elongation is released, and an energy wave travels down the tendon as the strand returns to its original, unstressed length. In areas where the concrete cover over the tendon is low and the tendon curvature is high, the released energy may be enough to split the concrete. Tendons are most likely to loop out at a high or low point at the end opposite where the anchorage failed or the

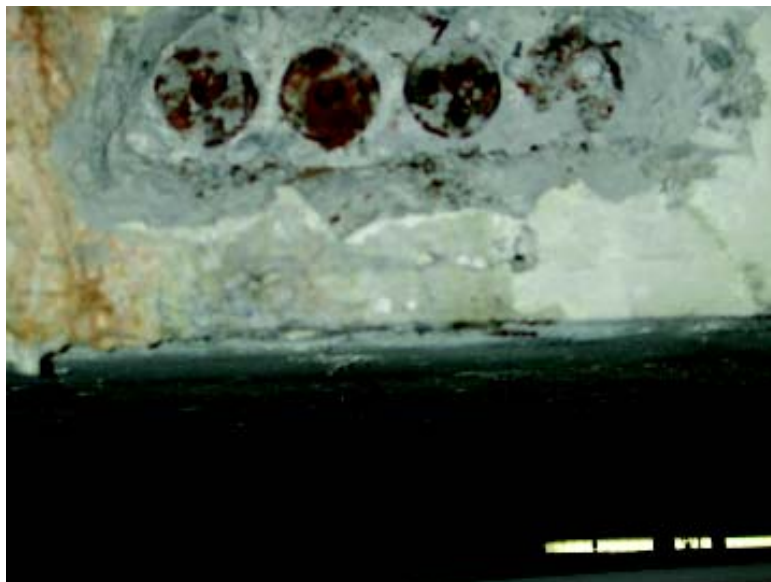
Fig. 5: The anchorage for the tendon in Fig. 4 is the second from the left. Years of water and salts leaking from a planter on the plaza caused the strand within the wedges to corrode to the point where the wedges could no longer grip it
