Quality Control in Concrete Repair: Does It Exist?

By Gail S. Kelley, P.E.

VIEWPOINT

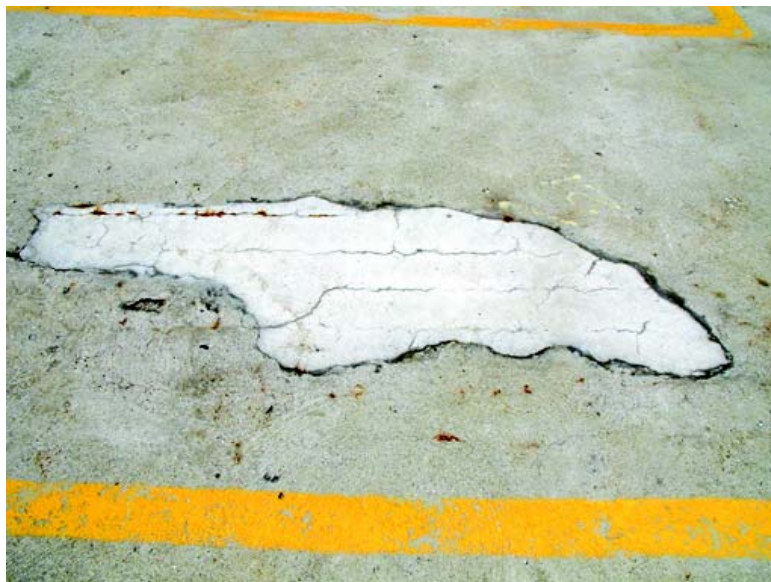
Fig. 1: Patch repairs like this one are all too common

repair projects. Figure 1 shows a patch on the roof level of a post-tensioned parking garage in Detroit. The patch, completed 3 years before the picture was taken, clearly shows the outlines of the corroding reinforcing bars over the columns. The same picture could probably be taken in any city where deicing salts are used.
