Impact-Echo Scanning Evaluation of Grout/Void Conditions Inside Bridge Post-Tensioning Ducts for Tendon Corrosion Mitigation

By Yajai Tinkey and Larry D. Olson

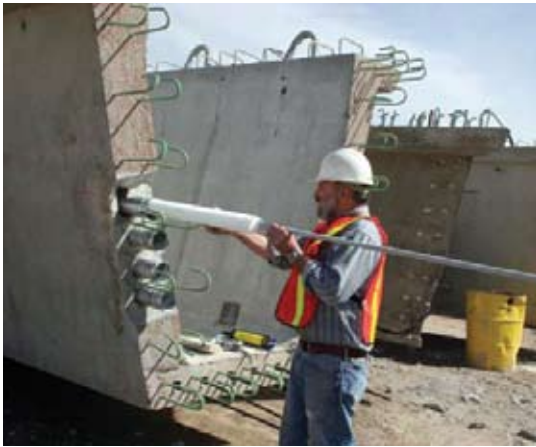
Fig. 2: U-shaped bridge girder (west end) and insertion of Styrofoam™ void prior to duct grouting

The primary specimen used in this study was a full-scale, U-shaped bridge girder (Fig. 2). The length of the girder was 100 ft (30 m). However, only the first 20 ft (6 m) were included in this study. There were four empty 4 in. (102 mm) diameter steel ducts inside each wall of the girder (a total of eight ducts). Several pieces of Styrofoam™ were inserted inside the ducts and positioned on the roofs of the ducts to simulate real-world grout defect. The size of the foam used ranged from as small as 16% duct perimeter/6% depth lost to 84% perimeter/94% depth lost with some full void. A comparison of grouted versus voided duct IE frequency displacement spectrum results from IE scanning tests is shown in Fig. 3.

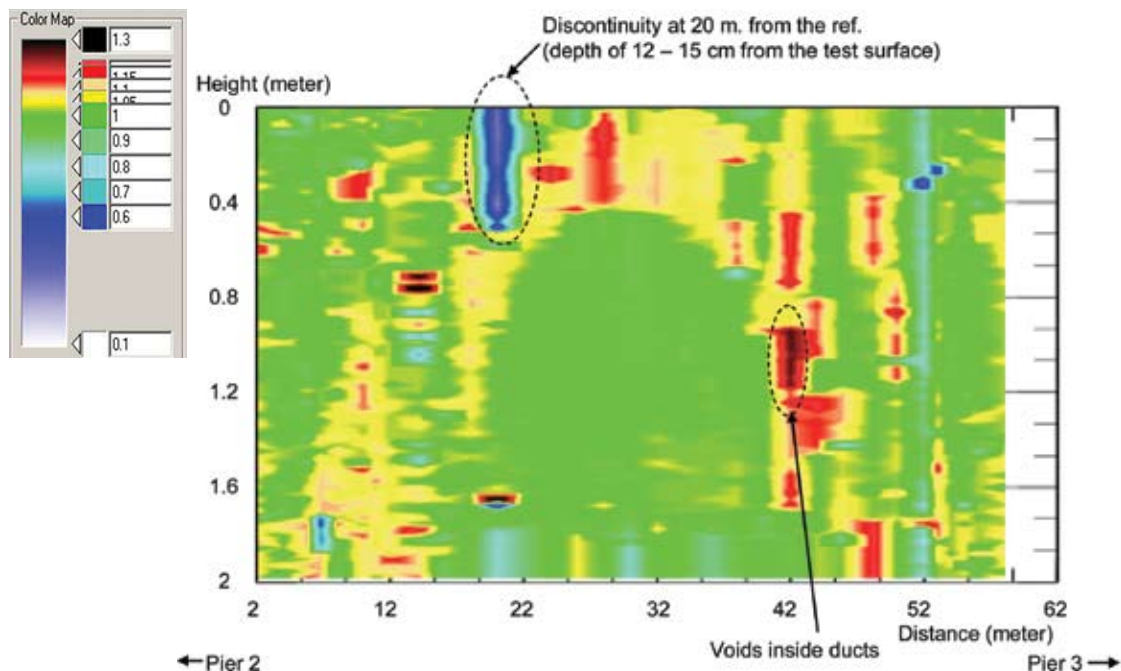
Fig. 7: 3D normalized thickness tomogram of Span 2 of North Box (general condition)

The results from the tests are presented in a thickness tomogram fashion for each web wall for each tested span. An example test result from one of the spans is presented in Fig. 7. Reviews of Fig. 7 show discontinuities or voids located at 65 ft (20 m) from Pier 2 and from the bottom of the wall (location where the scan started) to a height of 2 ft (0.6 m). The IE records indicated cracks/voids at depths of 4.5 to 6 in. (12 to 15 cm) from the test surface. In addition, the plot in Fig. 7 also indicated a thicker area (presented in black color) representing voids inside the duct(s) located at 138 ft (42 m) from Pier 2 and from heights of 2.9 to 3.8 ft (0.9 to 1.15 m). The color map in Fig. 7 shows normalized thicknesses (the IE thickness divided by the nominal thickness at the tested line) by color from 0.1 to 1.3.
