#### Full Scale Load Test for USPS Milwaukee Truck Maneuvering Area

#### July 21-24, 2008

Evaluations leading up to the test Planning issues and logistics Load test media options Test procedures and code requirements Instrumentation Results and conclusions

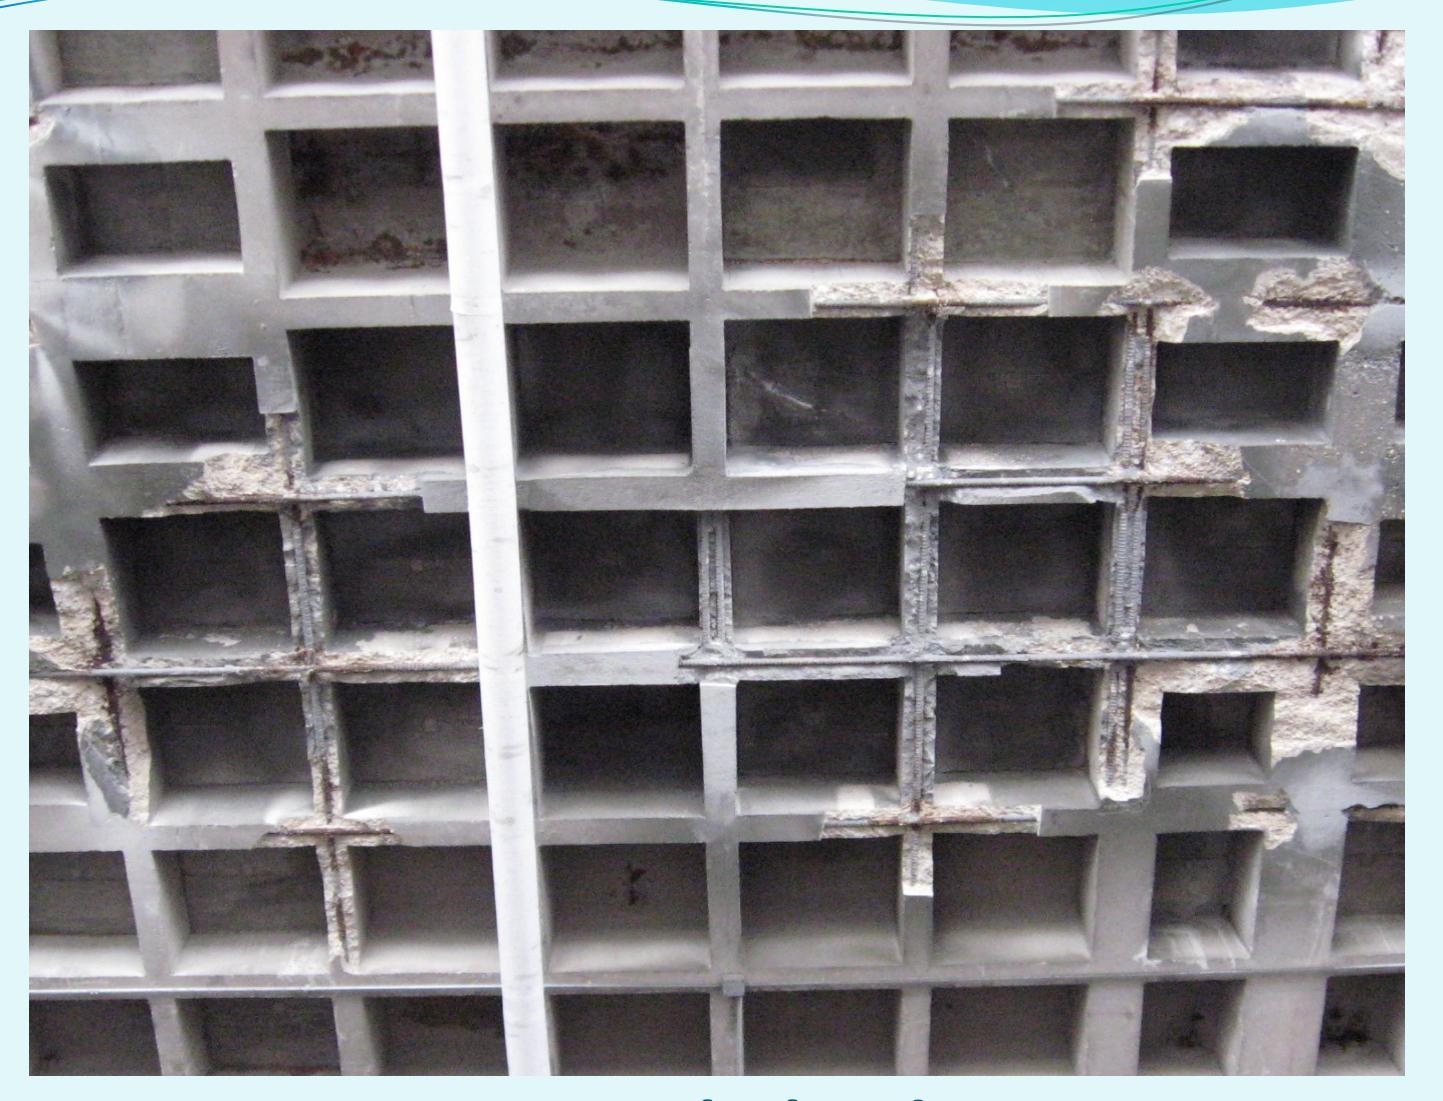
# Worst case slab deterioration

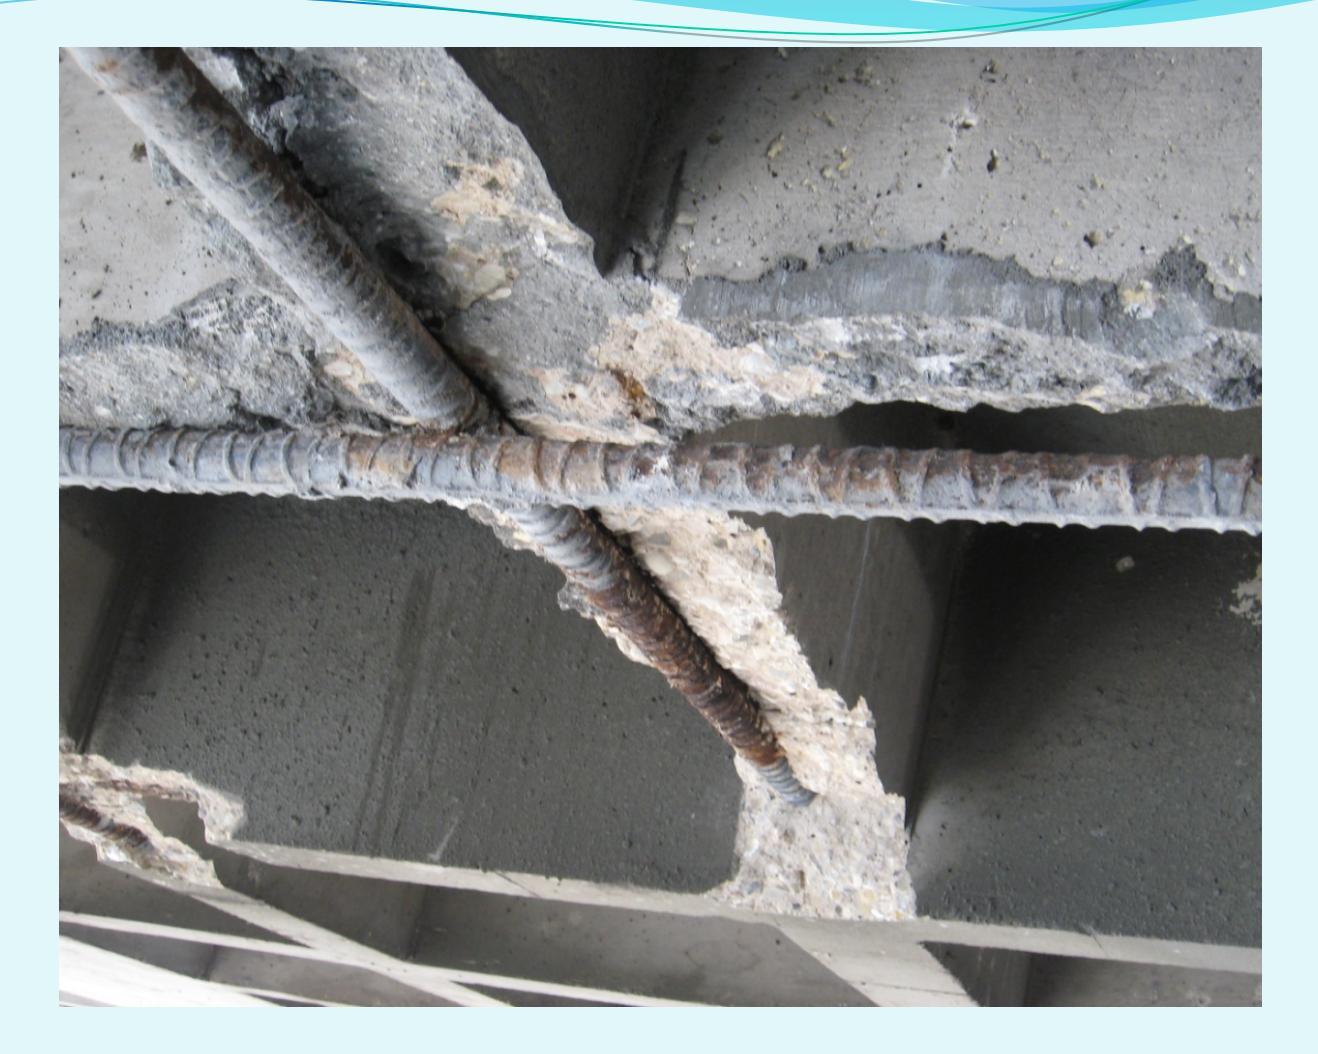
### Previous repair attempts failed

- > Numerous waffle stem repairs attempted over several years.
- > Walker designed top of slab repairs in 2002
  - Top 2" concrete replaced and new top steel in selected areas

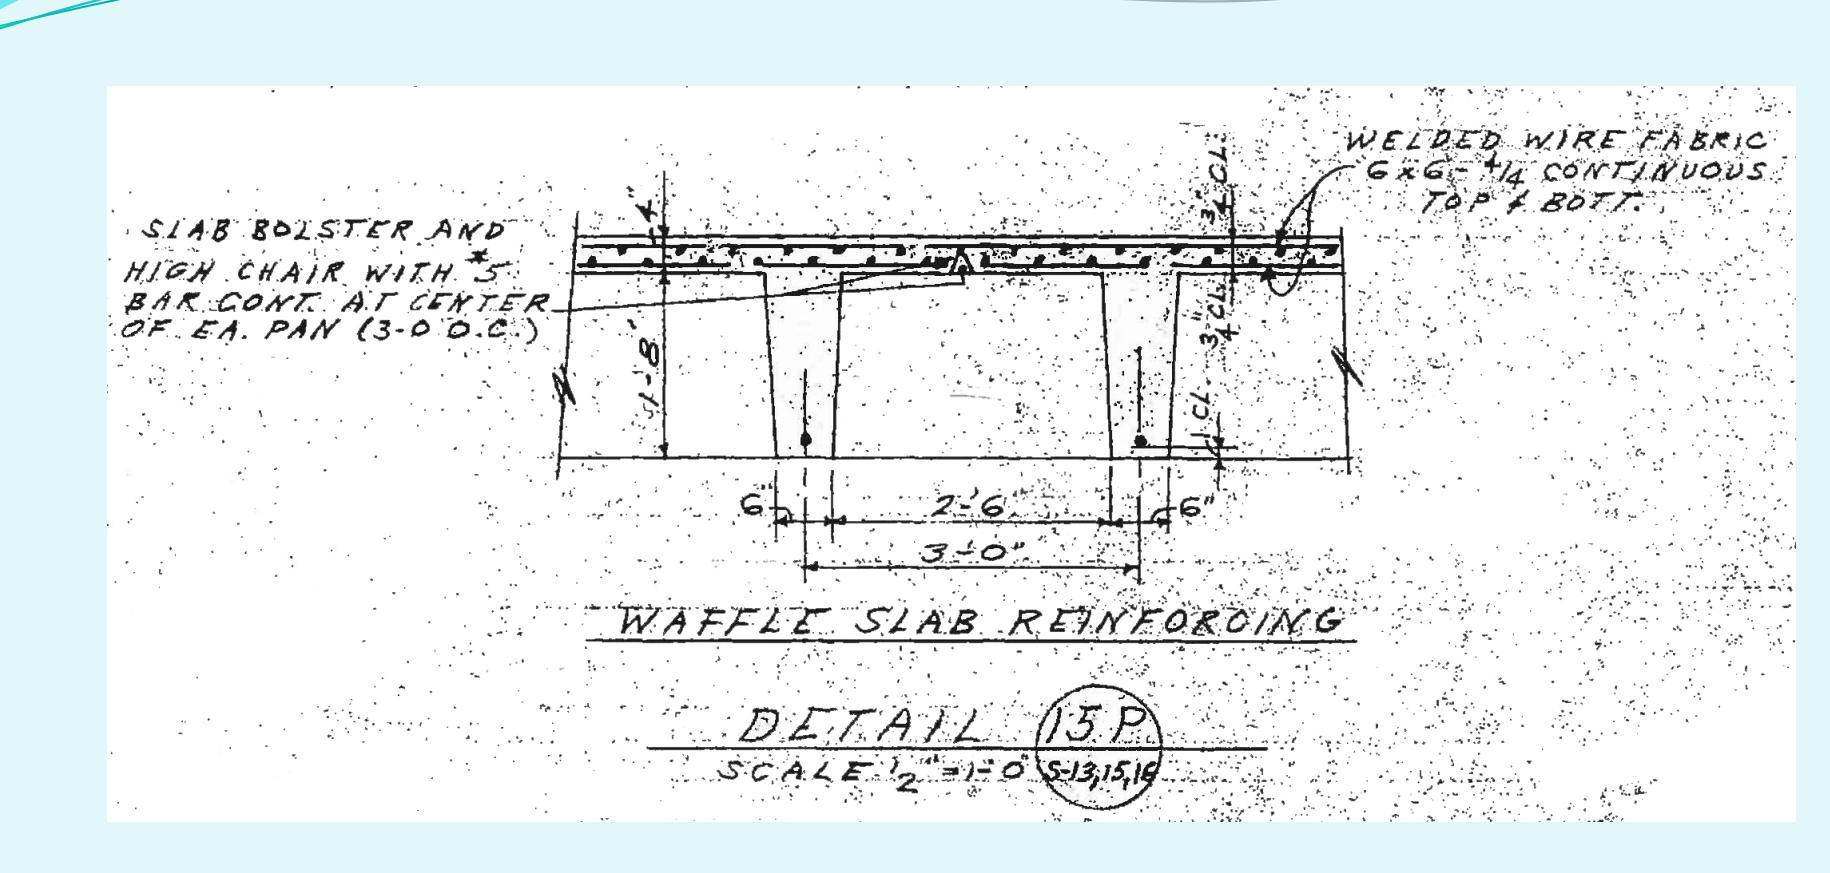
## Section of Waffle Slab Reinforcing

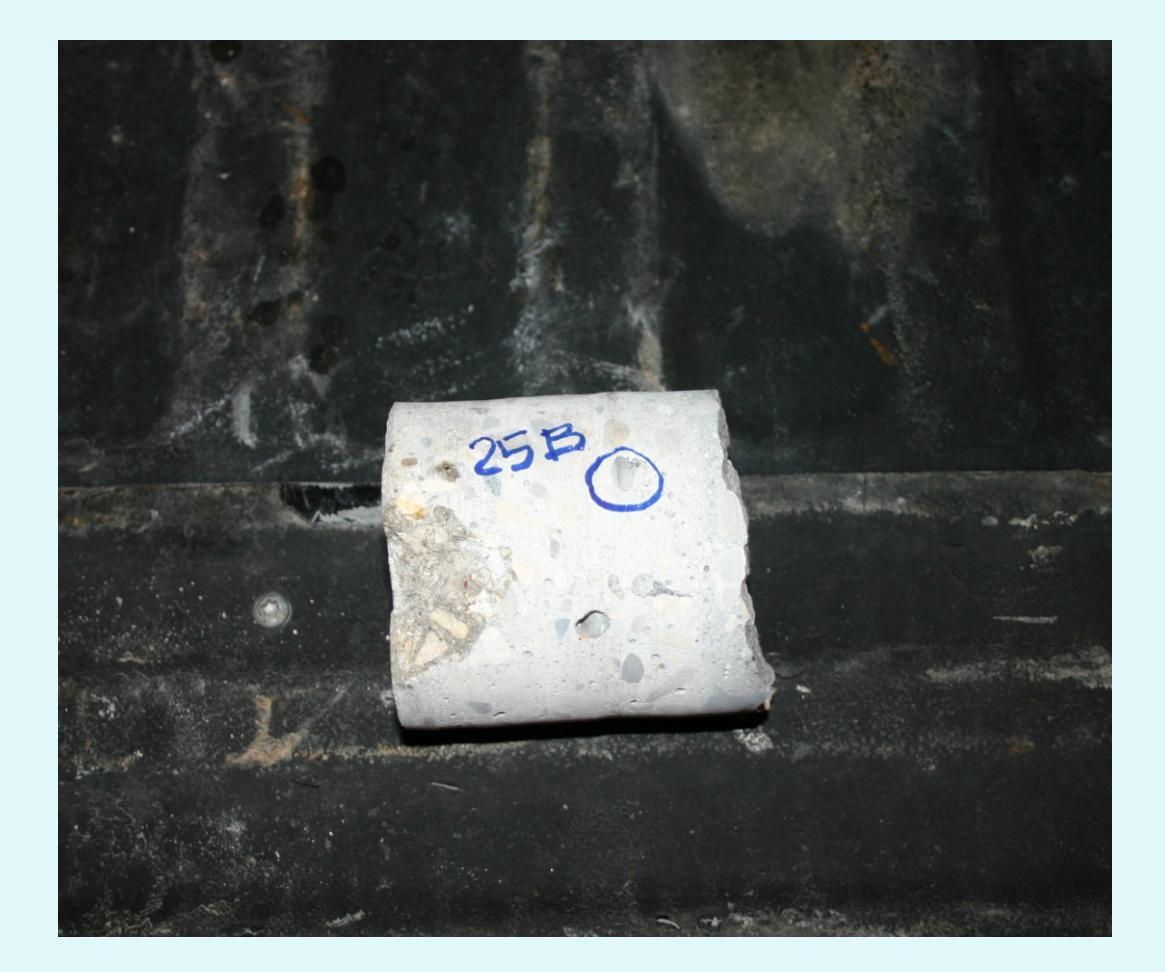
#### Verification of topping and reinforcement condition

- Cores show good concrete quality and no rebar corrosion
- No significant cracking, no spalling based in visual inspection

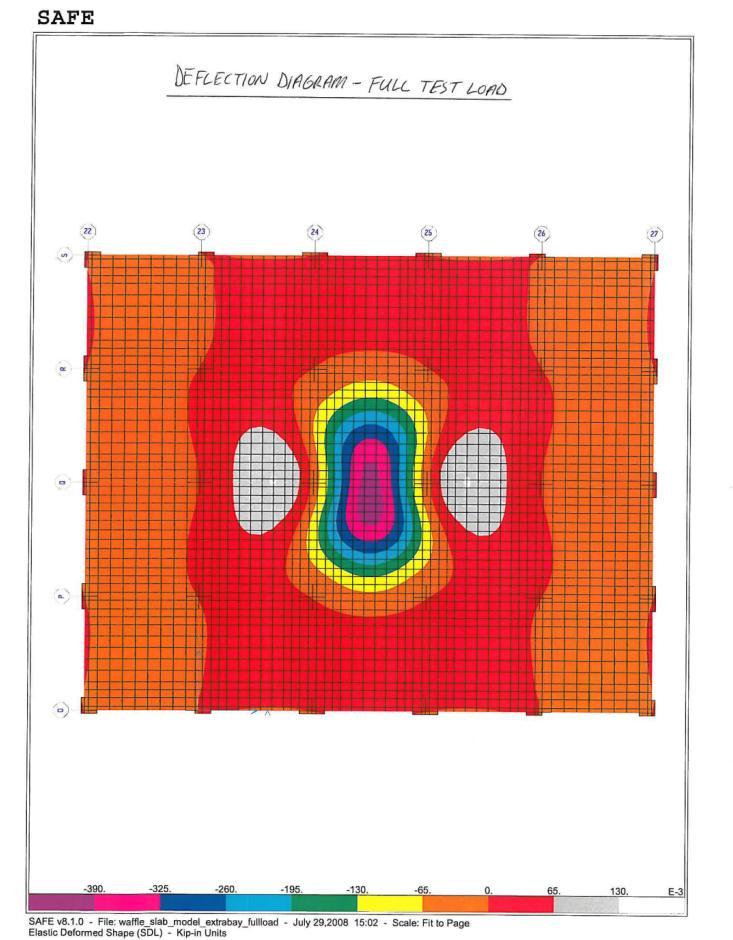
#### SAFE Model

Deflection analysis for each load stage:

Load Stage	Max. Deflection
1	0.094
2	0.187
3	0.281
4	0.375
5	0.422

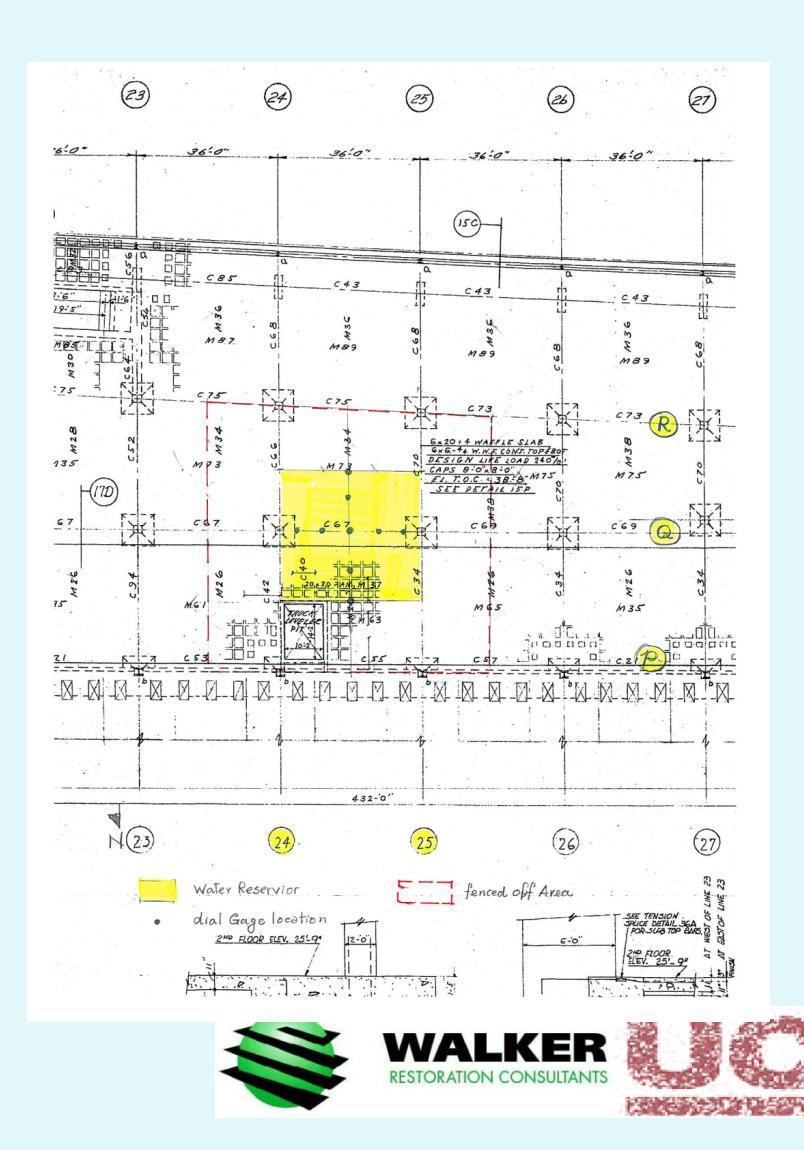
#### Select Test Location

Selection Criteria:

USPS operations restrictions such as loading docks that can be closed and keeping drive lane open at all times.

Worst case or nearly worst case condition

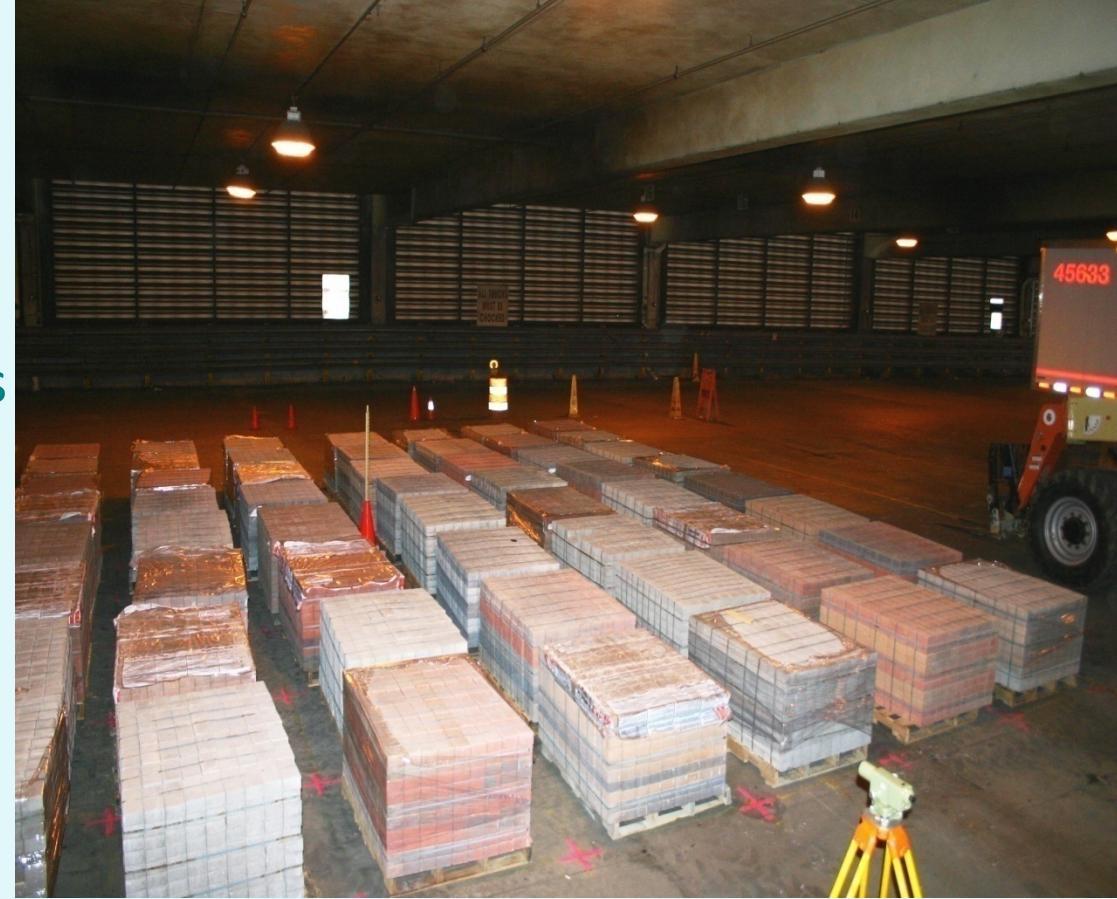
## Brick pallets selected as load medium

Average weight per pallet = 3,209 lbs.

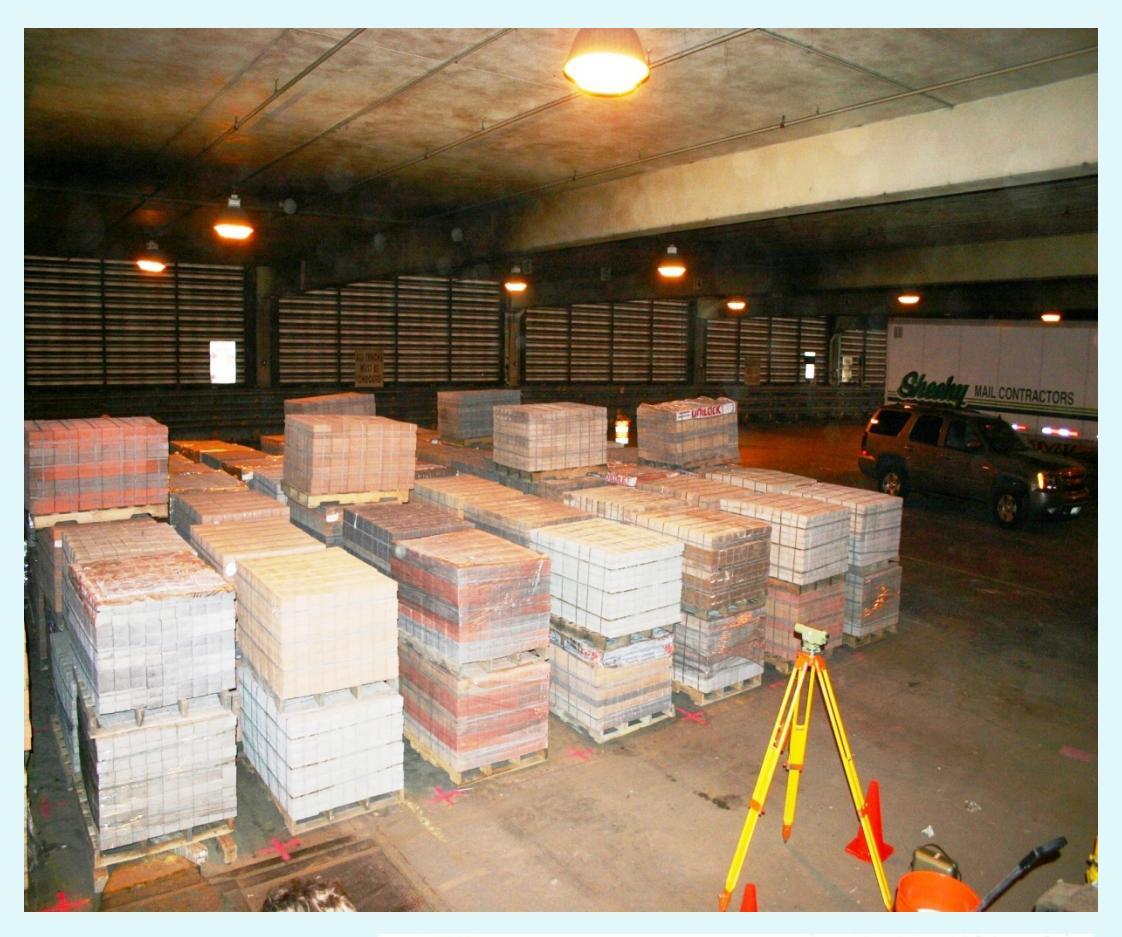
## Final (5<sup>th</sup>) load stage

432,400 lbs.

#### Max. deflection = 0.279 inches (after 24hrs)

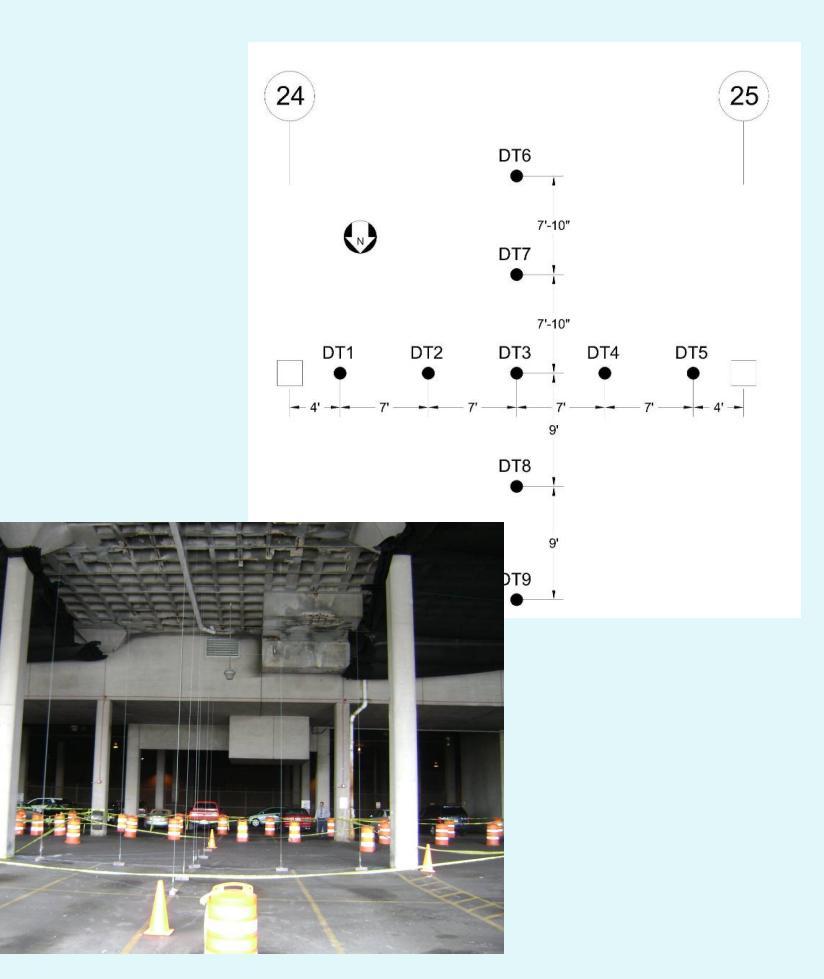
Low Voltage Displacement Transducers Typical LVDT gauge

- Goal was to provide accurate displacement measurements on a deteriorated, 2-way waffle slab throughout loading sequence.
- Displacement transducers were placed symmetrically along midspan in both directions.
- A total of nine (9) transducers were utilized. Two (2) traditional dial gages were also used.

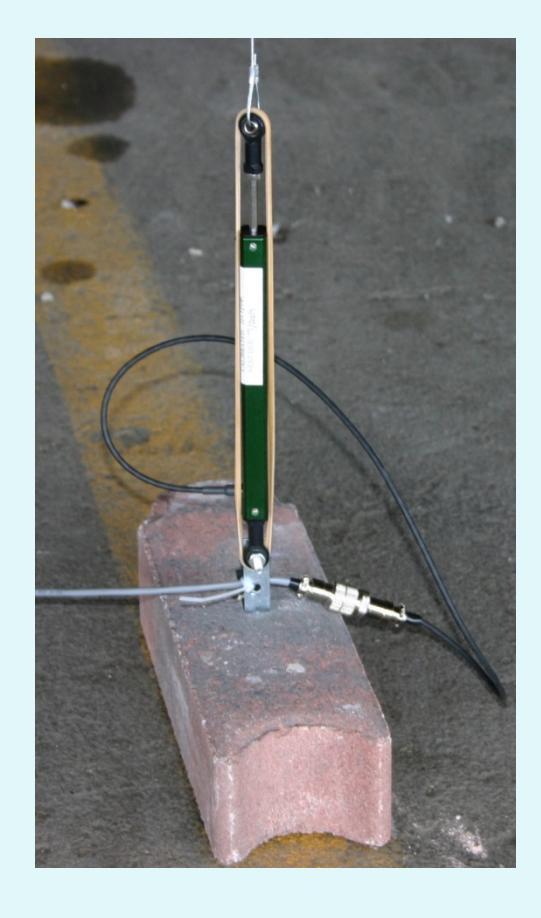
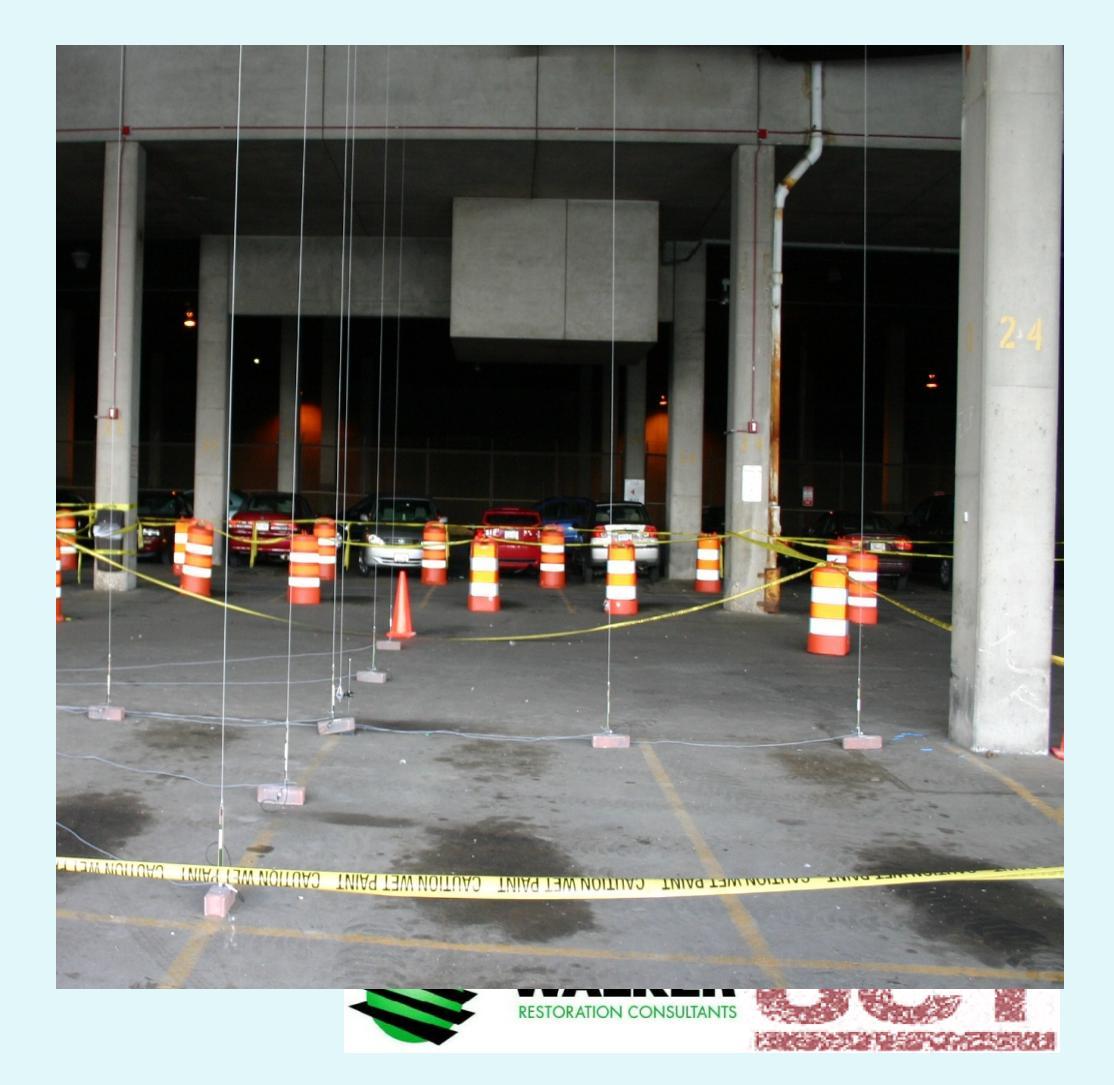
#### **Gauge placement**

- Displacement transducers calibrated to 0.001 inches.
- Transducers positioned below the test points and braided steel extension cables extended to the structure.
- Each transducer was confirmed as perfectly vertical prior to the initiation of the load test.

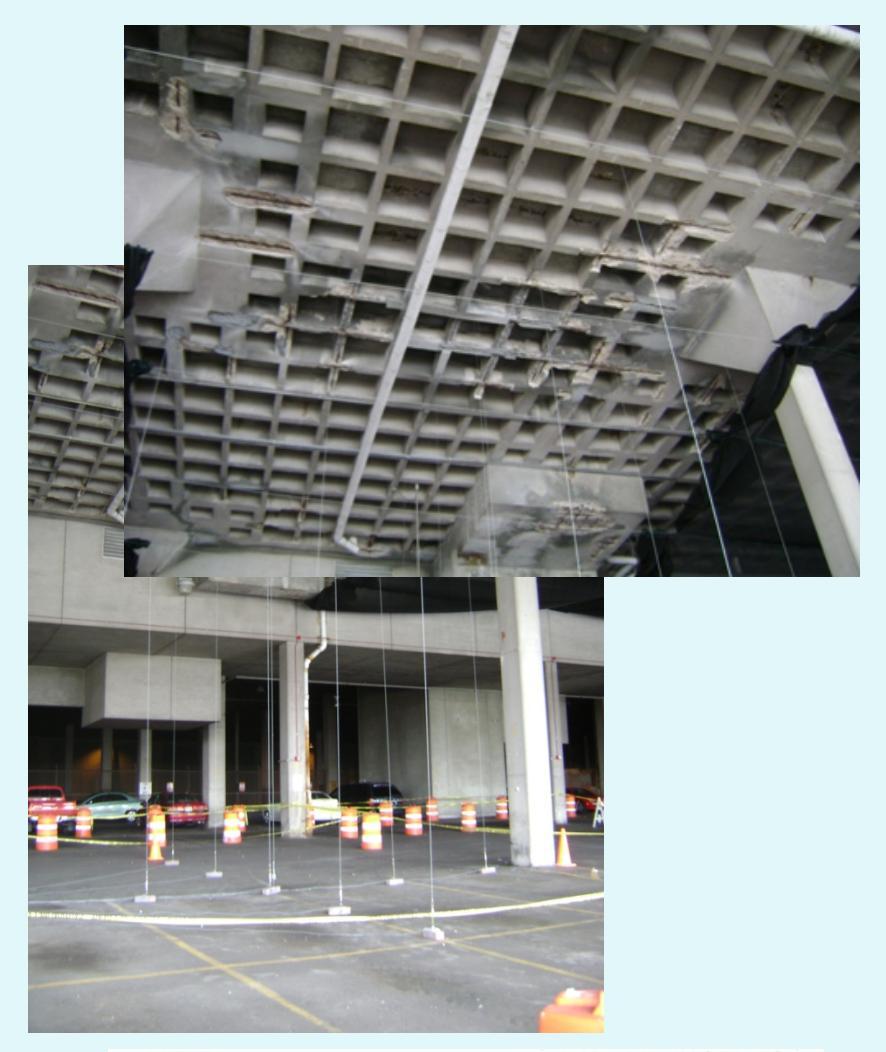
- Transducers connected to data acquisition hardware and signal monitored and recorded by customized data acquisition program.
- Measurements taken at 15 seconds intervals throughout the entire loading program.
- Represented approximately 18,000 data points.
