# Pier 11 Resurfacing

by Richard Toman

*New York City's Pier 11 is located at the end of Wall Street, just five blocks from the World Trade Center site. This five-slip pier is a primary commuter ferry location, serving as many as 50,000 commuters daily*

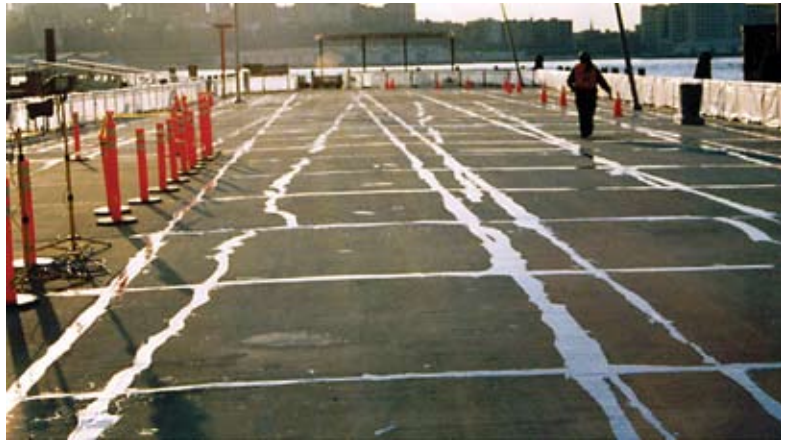
*Surface detailing and proper preparation were critical to the project*

Surface detailing and preparation were to be very important to the overall success of the project. Outside perimeter railing and benches remained in place, forcing work crews to use hand preparation and cleaning equipment around the entire perimeter of the pier structure.

The contract specifications called for a shot-blast surface preparation on the open areas of the pier to achieve a CSP-3 to CSP-5 surface profile as specified in ICRI's Technical Guideline No. 03732 "Selecting and Specifying Concrete Surface Preparation for Sealers, Coatings, and Polymer Overlays."

After initial surface preparation, the work crews routed, filled, and overband sealed the cracks and joints greater than 1/8 in. (3 mm) in width. All evident cracks less than 1/8 in. (3 mm) in width were overband sealed. Small surface scaling, depressions, and delaminations were repaired and detailed as evident and necessary throughout the pier surface area.

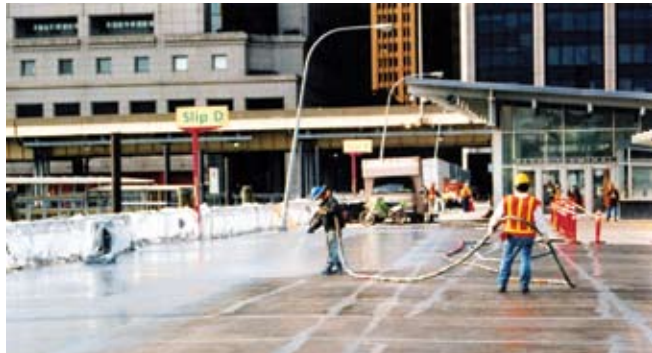
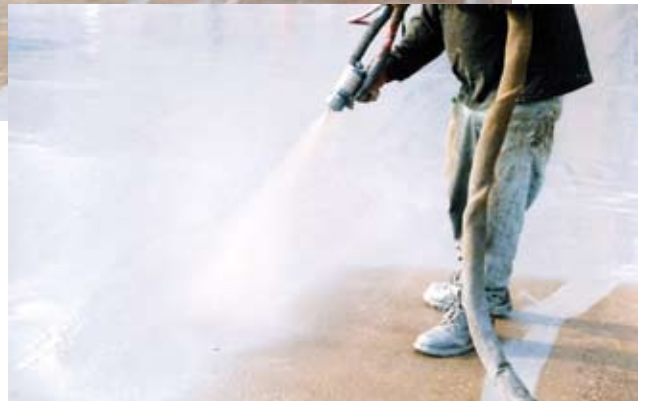
*Spraying the coating*

Following a manufacturer-approved thin-film priming application, a high-build pure polyurea coating was spray-applied to the entire surface area in neat form to serve as the primary waterproofing layer of the overall coating system. A pure polyurea-based aggregate-reinforced broadcast overlay was subsequently placed over the entire surface area in two lifts. Excess aggregate was removed after cure from both lifts.

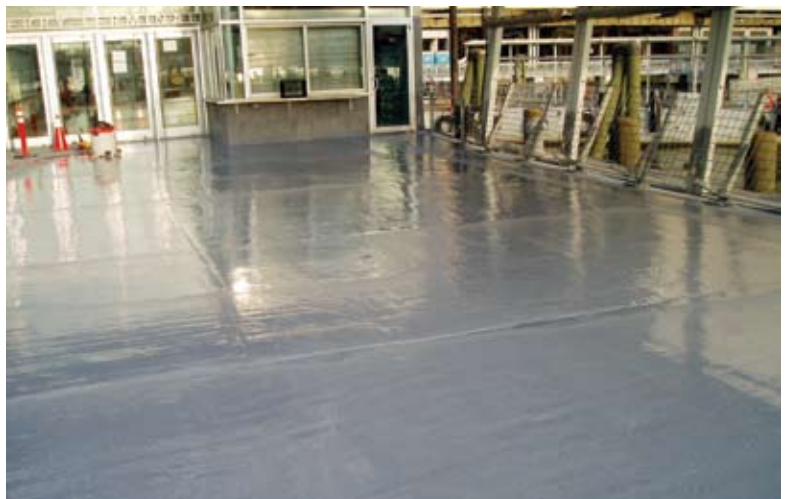
*The completed area shines with the waterproof base coat, prior to the placement of the aggregate overlay lift*

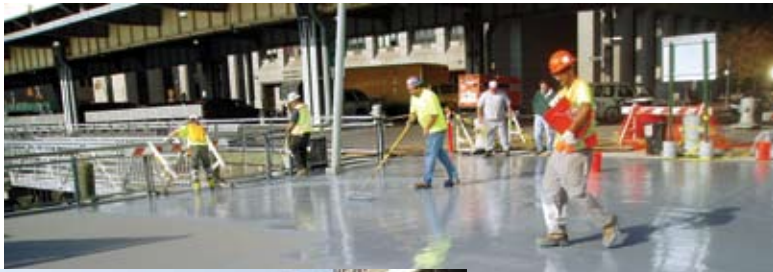
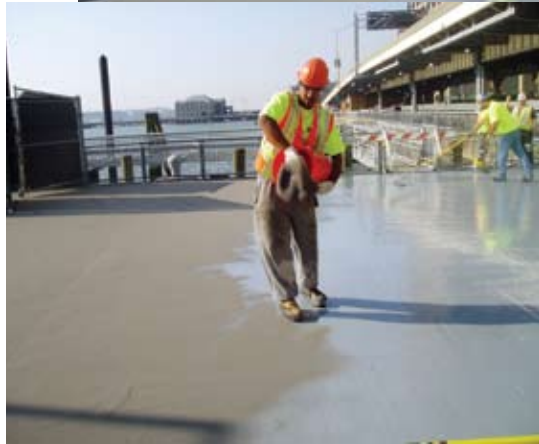
*A pure polyurea-based aggregate reinforced broadcast overlay was placed over the entire surface in two lifts*

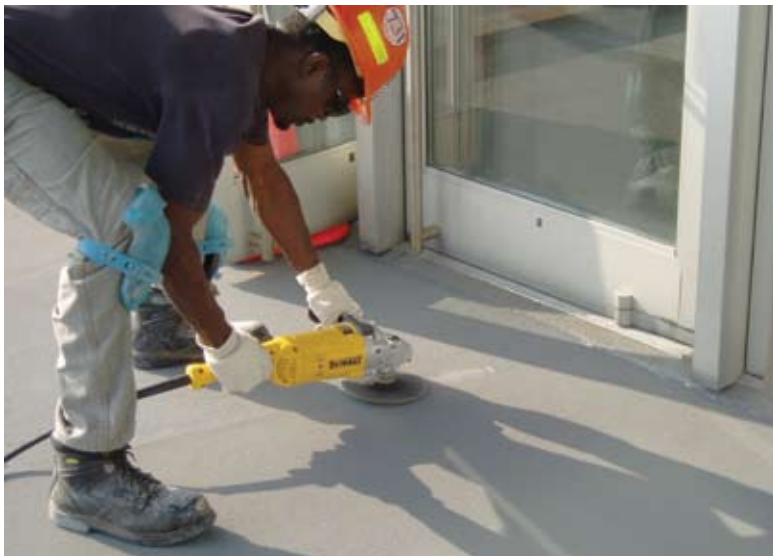
*A crew member uses a grinder for minor surface detailing between overlay lifts*

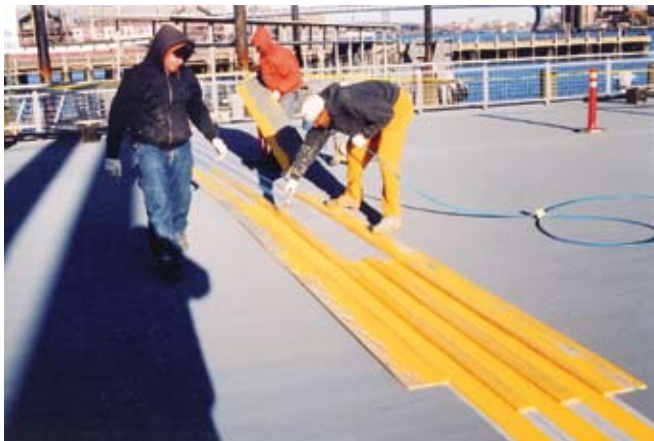
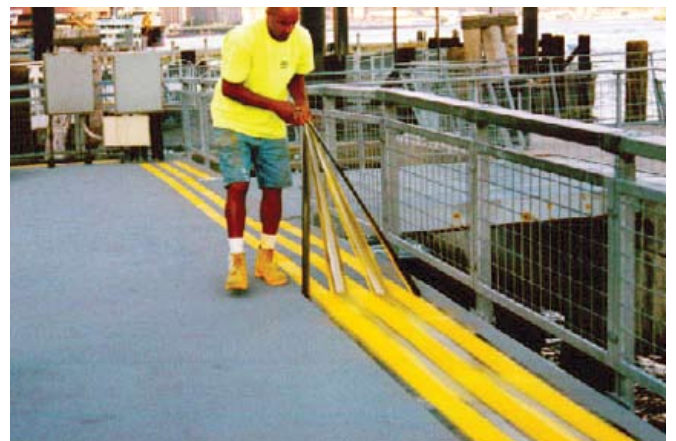
*The final step of the project was the application of safety markings*

In addition, a functional yet aesthetic striping pattern was laid out and placed along the perimeter of the piers and at the slip entranceways. Finally, the wooden benches were replaced and the 100% complete pier was turned over to NYEDC.

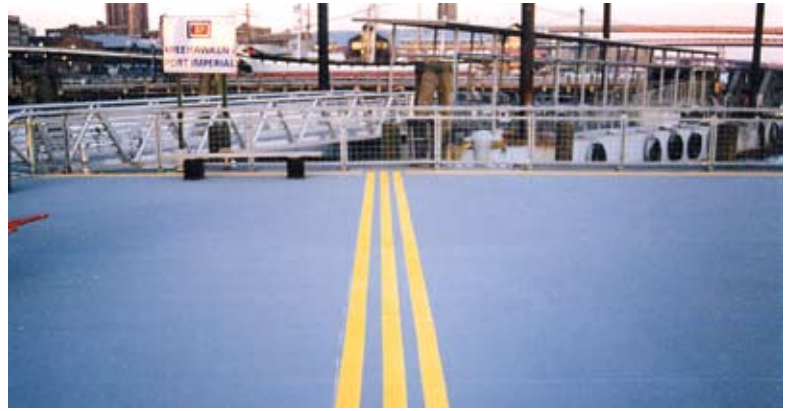
*Bright yellow stripes improved safety by providing a trafficway that is visible at night*

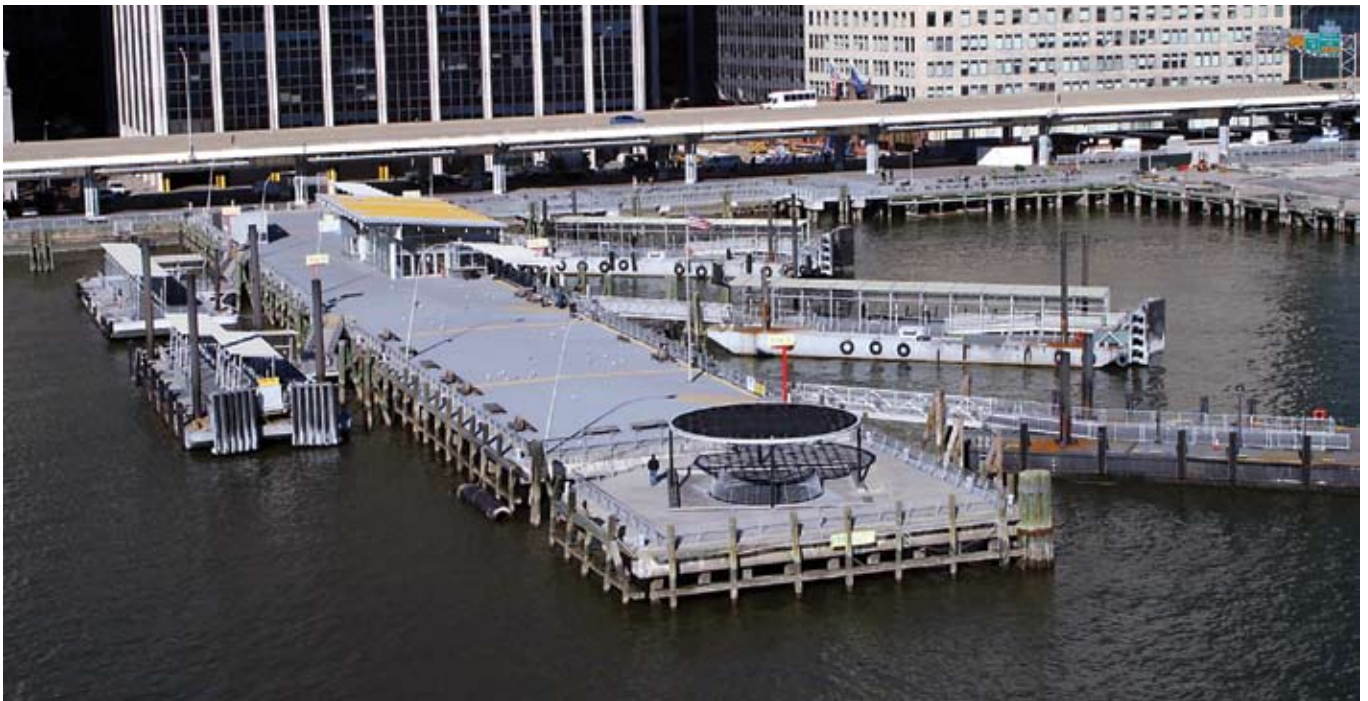
*Completed project*
