Baylor Cancer Hospital Concrete Strengthening for Collins Family Bridge of Hope

Dallas, TX

Submitted by Raymond L. Goodson Jr., Inc.

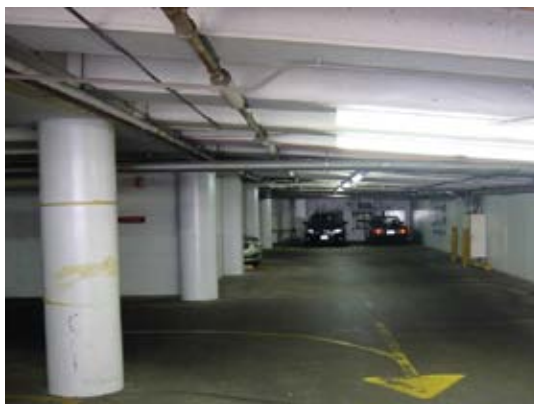
Condition of existing garage with primary exit lane below the south plaza where the Bridge of Hope was to be located

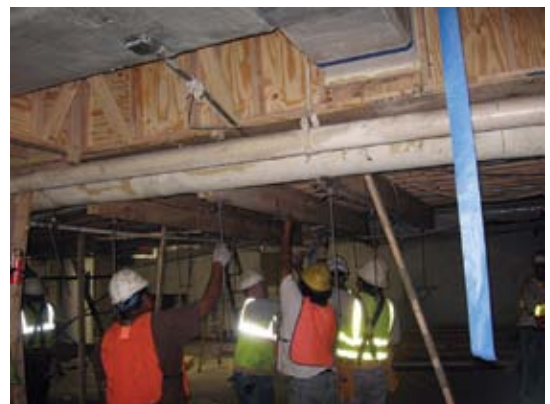
Workers installing the formwork suspended from the slab above that allowed existing utilities to remain in place during strengthening

Having chosen a suitable mixture design, the next step was developing a forming system that had minimal impact on the daily garage operations. A system was designed to suspend from the structure above. Formwork would fit between the structure and MEP systems to avoid costly re-routing. It would be partially prebuilt and raised into position in a few hours. Once the formwork was in place, the lanes beneath could be reopened.

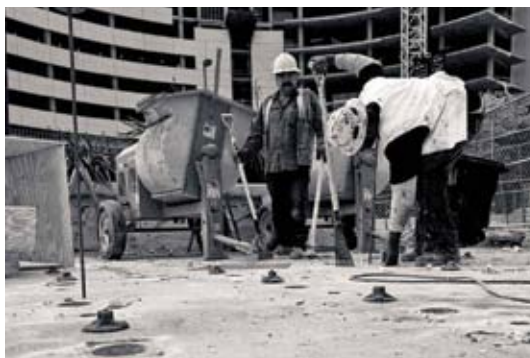
Workers placing concrete through holes in deck

It was important to determine if a high-early-strength concrete mixture could be designed with the high flow required to place a large quantity of concrete through holes in the existing slab. The selected mixture, a high-performance, high-flow concrete mixture, was a two-component, polymer-modified cementitious mortar with a penetrating corrosion inhibitor. The bagged mixture was extended with 25 lb (11.3 kg) of 0.5 in. (13 mm) river rock (not limestone) saturated surface-dry (SSD), 25 lb (11.3 kg) of 3/8 in. (9.5 mm) river rock SSD, and a high-range water-reducing admixture to improve flow and delay set.

Full-size mockups and strength tests were performed. The concrete for the mockups was placed manually as planned for the actual installation through 4 in. (102 mm) diameter holes. Based on the results of the mockups and experimentation with

mixers, a very controlled mixing sequence using only mortar mixers was specified. Concrete with a 10 to 11 in. (254 to 279 mm) slump, excellent aggregate distribution, and 5500 psi (37.9 MPa) 7-day strength was achieved.

Multiple mortar mixers were used with a crew for each mixer. Large wood funnels were built to gravity-feed concrete through placement holes.

The deck slope affected concrete flow, making it important to start from the lowest point and work uphill. This minimized the potential for damming in the forms.

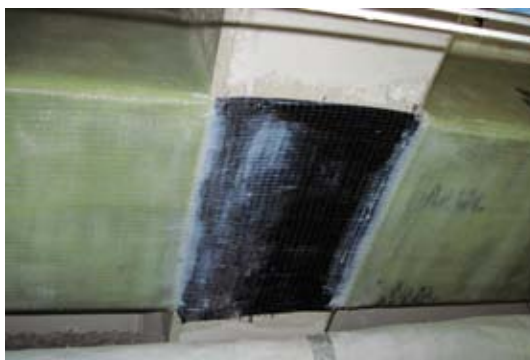
Installed CFRP on bottom of beam for flexural reinforcement and GFRP U-wrap for shear reinforcement

The third leg of the solution used externally applied FRP to reinforce beams not requiring additional stiffness. ACI 440 limits on strengthening were followed to ensure that structural members possessed sufficient strength during a fire. Members not meeting these requirements were reinforced by section enlargement. Glass fiber-reinforced polymer (GFRP) wet layup was selected for shear

reinforcement. Concrete fiber-reinforced polymer (CFRP) wet layup and prepreg systems were used for flexural reinforcement. Cracks exceeding 0.010 in. (0.25 mm) were epoxy injected, and a CSP-3 surface profile was achieved by mechanical profiling. After installation, fabrics were covered with an intumescent coating to meet UL assembly standards for flame spread and smoke generation.

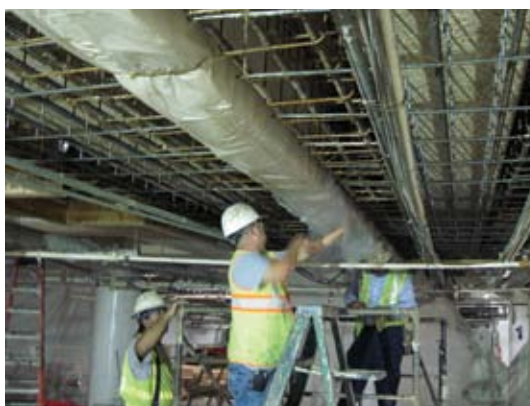
Workers installing reinforcing steel for section enlargement and distribution ribs with existing utilities still in place

beams. The design crux was creating new distribution ribs between existing beams stiff enough to behave as beams on elastic foundations, distributing loads to existing beams proportional to their stiffness. A wide rib was selected and reinforced with both conventional reinforcing and post-tensioned tendons. Post-tensioned tendons were installed through holes cored through existing beams to provide a measure of continuity that would have been difficult to achieve with conventional reinforcing.

The analysis and design of distribution ribs and transfer beams was achieved through an iterative process of analysis of a beam on elastic foundations, design of section enlargement, recalculation of cracked section properties, and re-analysis with new properties until reasonable closure was achieved. With final sizes of enlarged sections determined, enlarged sections were reinforced with conventional reinforcing steel.
