# Concrete Repair and Corrosion Mitigation of Disraeli Bridges Concrete Piers

Winnipeg, MB, Canada

Submitted by Vector Construction, Ltd.

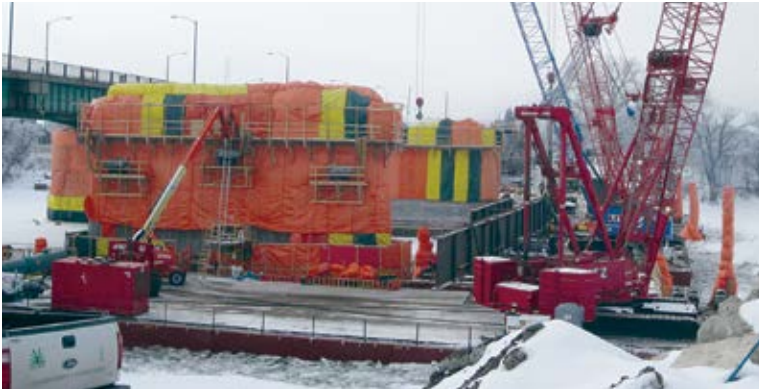
Repair and corrosion mitigation of piers proceeded inside heated enclosures

The Red River Bridge has an approximate length of 1050 ft (319 m) and spans over four concrete piers: two on land and two in the river. To complicate matters, the repairs would need to be completed during difficult winter conditions. Access to the middle two piers would be off the frozen river and all structures would be heated to allow work to proceed.

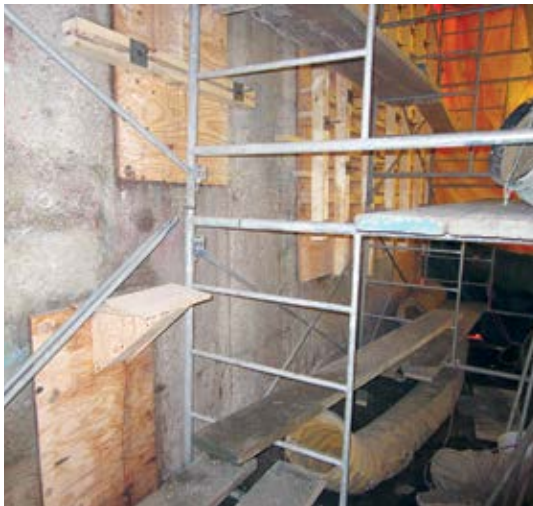
Plywood formwork in place for form-and-pour repairs

After the damaged concrete was removed, the repairs were sandblasted to remove any loose material and create a rough but sound surface for mechanical bond of the repair material. Prior to placing the flowable concrete, the substrate was maintained in a saturated surface-dry condition, then concrete was placed using a concrete pump. A total of 2120 ft<sup>2</sup> (197 m<sup>2</sup>) of structural concrete repairs were completed from January to March of 2012. Structural cracks in the piers, potential areas of vulnerability for future chloride-ingress, were epoxy-injected using low-viscosity resin and a plural component pump.

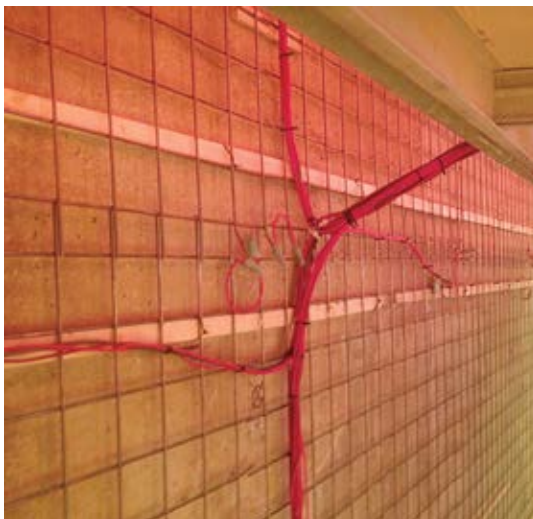
Temporary anode mesh and wiring in place for electrochemical chloride extraction treatment for the two land-based piers

Electrochemical treatments such as electrochemical chloride extraction (ECE) are nondestructive technologies that directly address the root cause of corrosion problems by changing the environment around the steel and mitigating active corrosion. The ECE treatment generates increased alkalinity while significantly reducing the amount of chloride around the reinforcing steel. This dual action positively alters the chloride-hydroxide ratio to ensure continued reinforcing steel protection. The first structure in North America to be treated with the ECE in was the Burlington Skyway in Ontario in 1989 and the treated area remains in a noncorroding state.

A total area of 6860 ft<sup>2</sup> (637 m<sup>2</sup>) was treated by the ECE process between November 2012 and March 2013. Because of the project schedule constraints, the ECE treatment duration lasted as long as possible with all equipment and materials removed prior to the spring thaw. Each zone was energized for 41 days, achieved an average current of 1508 A-hrs/m<sup>2</sup>, and chlorides at the level of the steel were reduced by 68 to 88%.

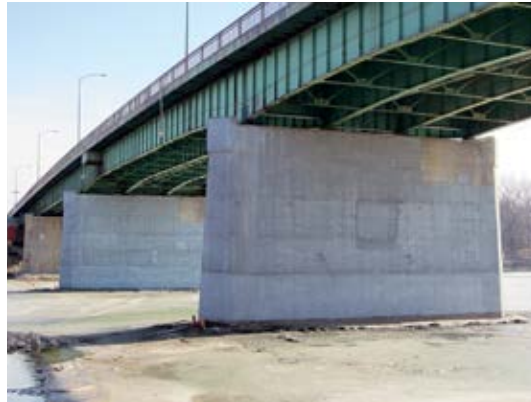
*Humectant-activated arc sprayed zinc was used to protect the two interior piers*

With a galvanic system, the protective current is generated by the potential difference between the zinc anode and the steel reinforcement. The metalized zinc anode is applied to the surface of the concrete and serves as a sacrificial anode that corrodes in preference to the reinforcing steel. The zinc anode can be applied to complex concrete surfaces and the finished surface has a similar appearance to concrete.

In certain environments such as non-marine bridge piers, “unactivated” arc spray zinc may not provide an adequate level of protection unless the anode is subject to periodic direct saltwater wetting. In some cases, the current generated by arc spray zinc without periodic wetting can decrease to nearly zero. Humectants were developed to improve the performance of arc spray zinc systems. The humectant solution promotes the retention of moisture which lowers the system resistance, thus allowing the anode to function more efficiently.

On this project, a humectant activated arc spray zinc system was installed to protect a total area of 9392 ft<sup>2</sup> (873 m<sup>2</sup>). High-purity zinc was applied onto the prepared concrete surface at a thickness of 20 mils (500 µm). Connection to the reinforcing steel was made using flattened expanded zinc mesh plates bolted to the surface over threaded reinforcing bar connections with galvanized nuts and washers. After zinc application, the humectant activator solution was sprayed on the surface of the zinc anode at rate of 0.0026 gal./ft<sup>2</sup> (100 mL/m<sup>2</sup>).

Quality control procedures included verification testing of anode thickness and bond strength. The thickness was confirmed by coupon testing every 64 ft<sup>2</sup> (6 m<sup>2</sup>) of anode surface. The bond of the anode to the concrete was tested using the direct tension method every 1000 ft<sup>2</sup> (92 m<sup>2</sup>) to verify that the bond strength exceeded 145 psi (1 MPa).
