2024 SPRING CONVENTION

➤ **Case Study:**
**Structural Repairs for
an Elevated Plaza**

Christopher Kuenzer, PE

Haider Himairi, PE, LEED AP BD+C, F.ASCE

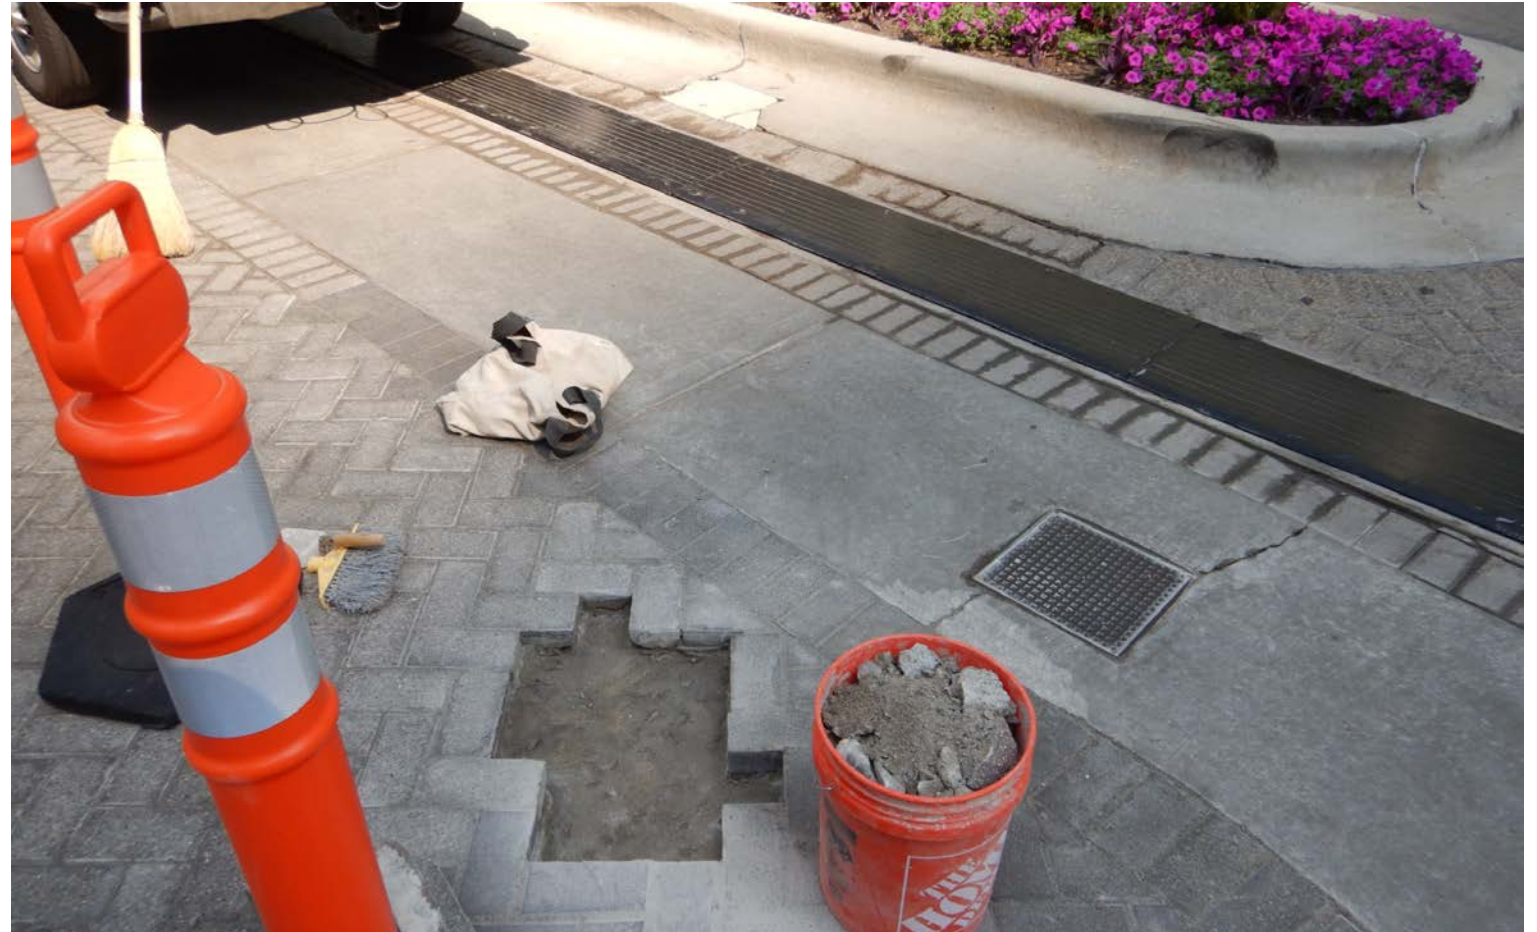
- Measure components of paver system
- Check condition of waterproofing

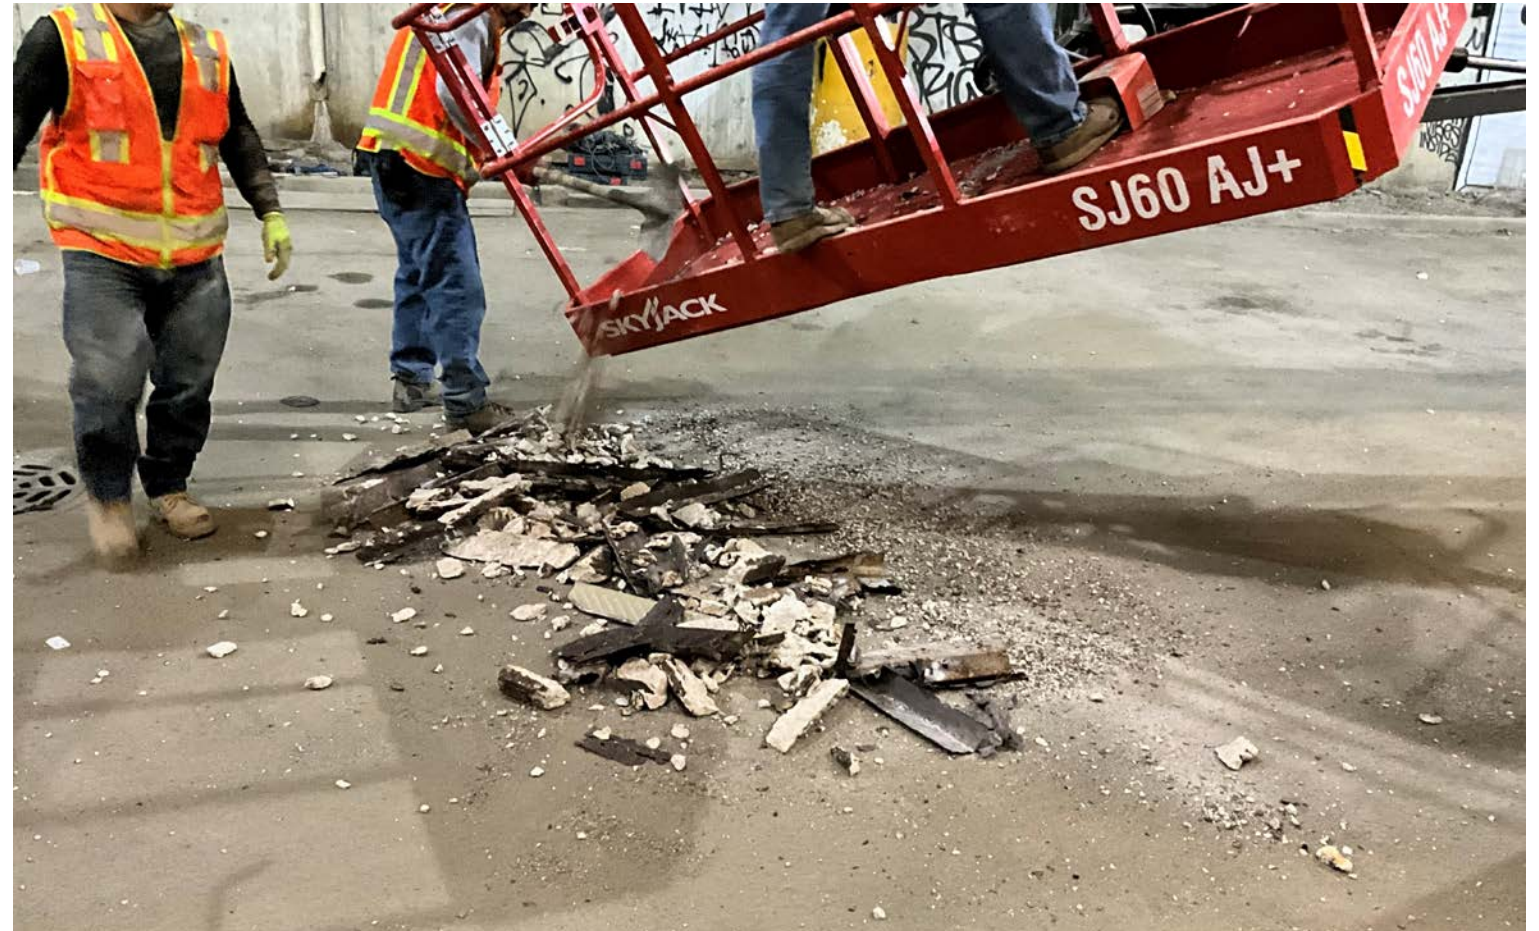
- Remove overhead falling object hazards
- General identification of concrete and steel repair locations

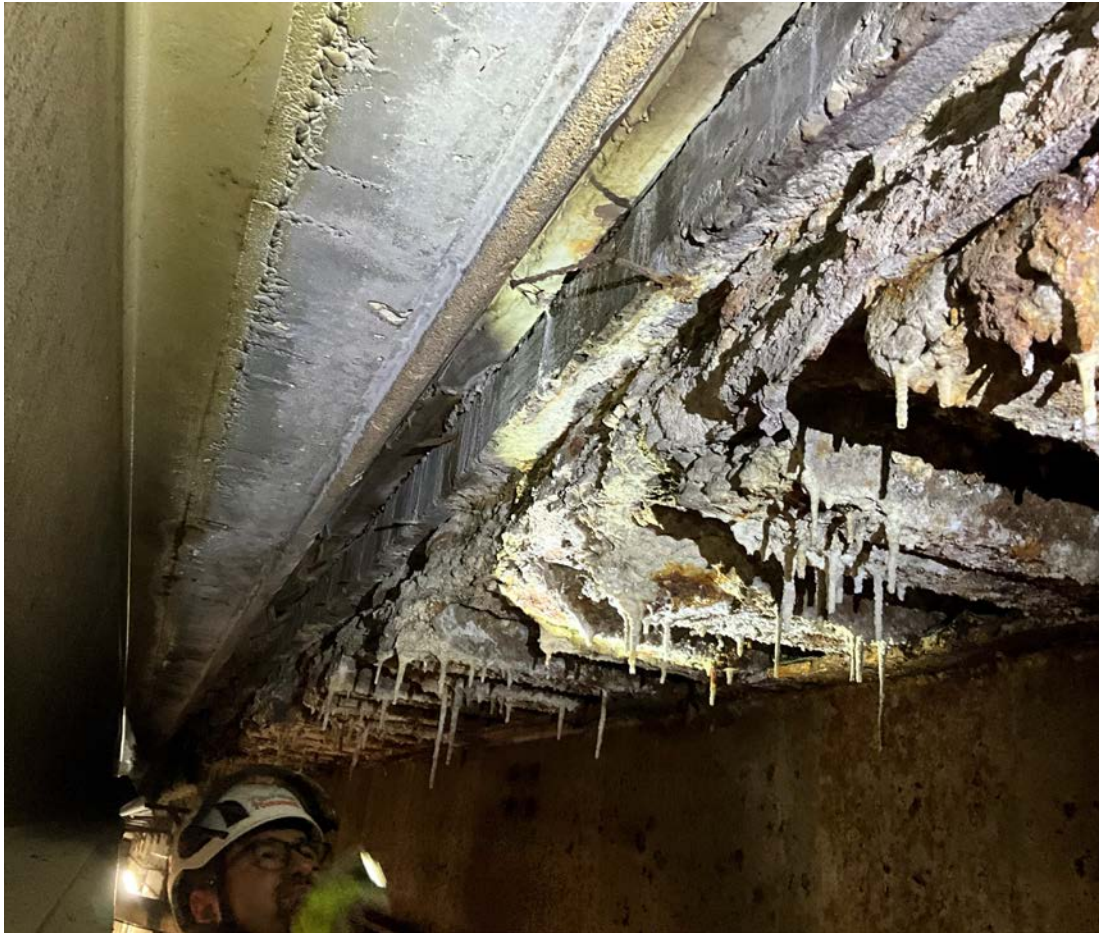
During investigation

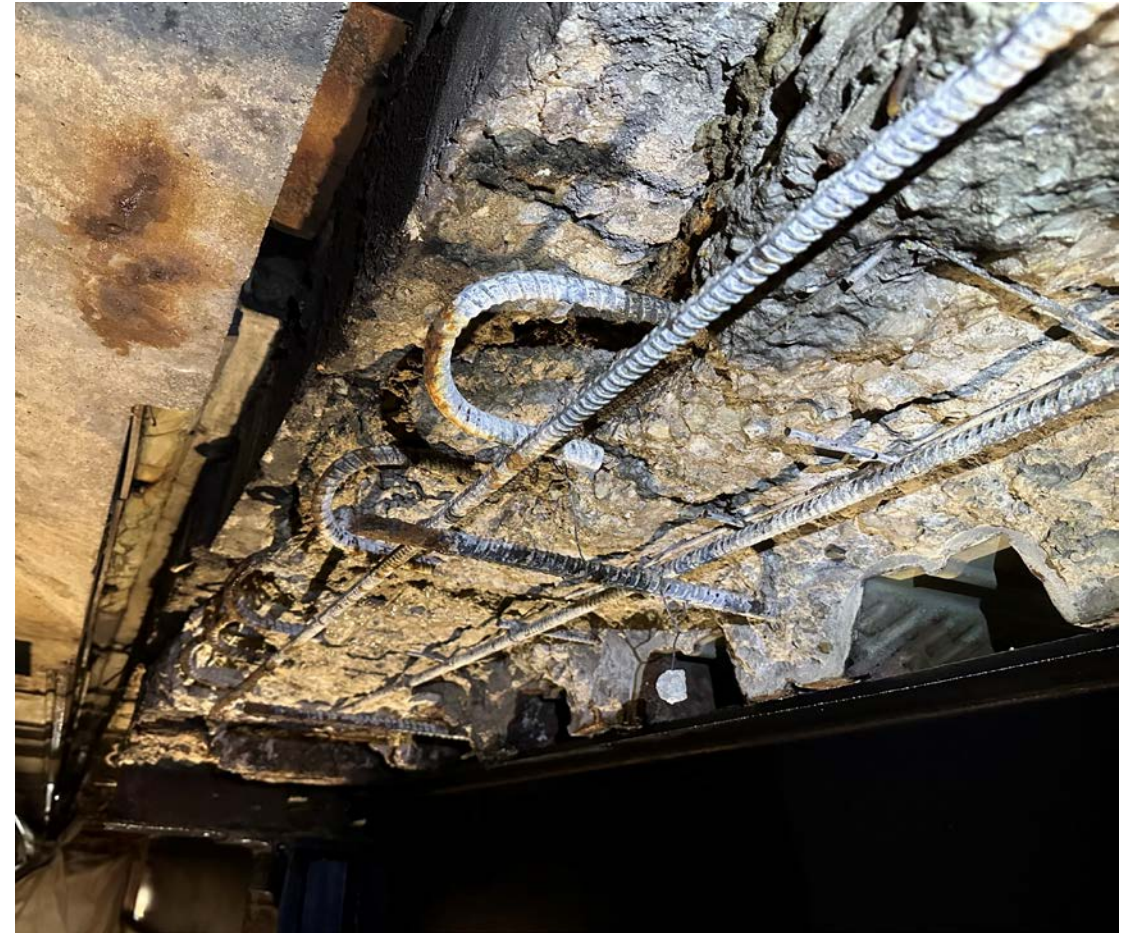
After pick-and-clean

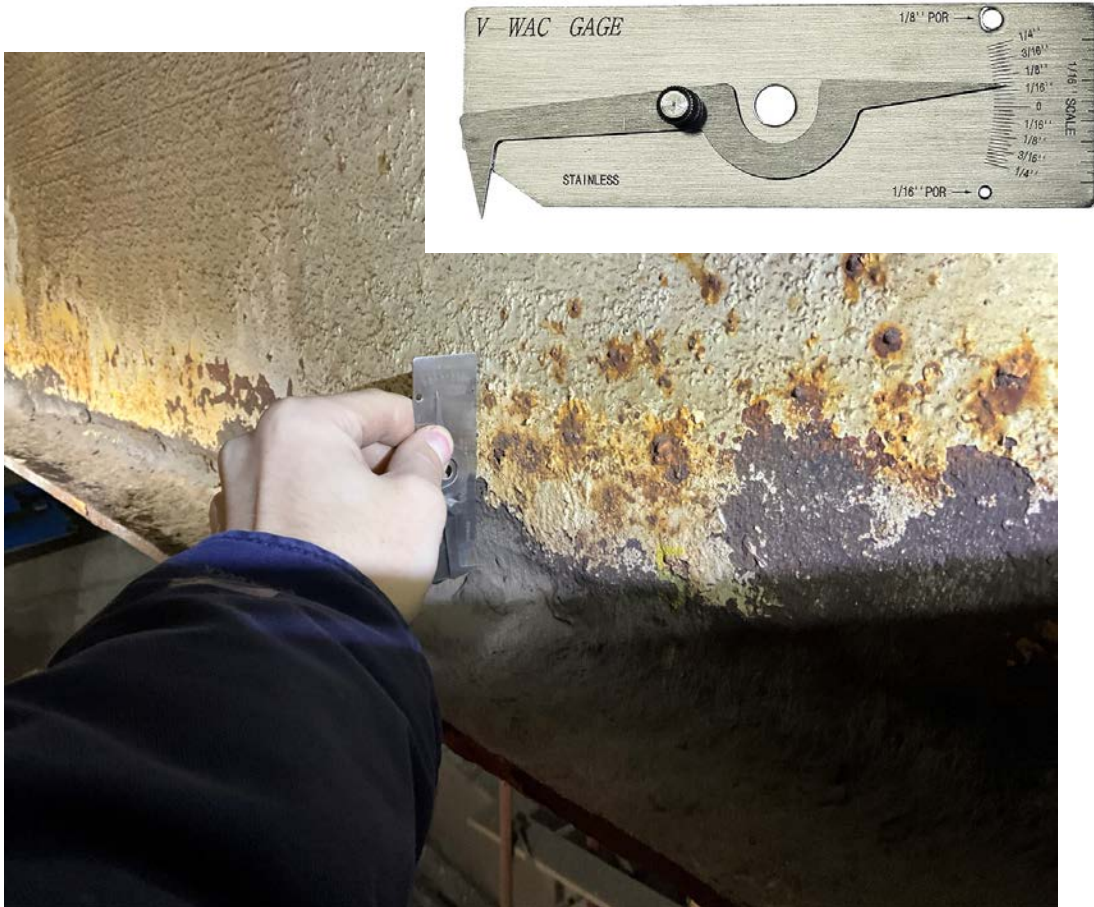
V-WAC gage for measuring pitting

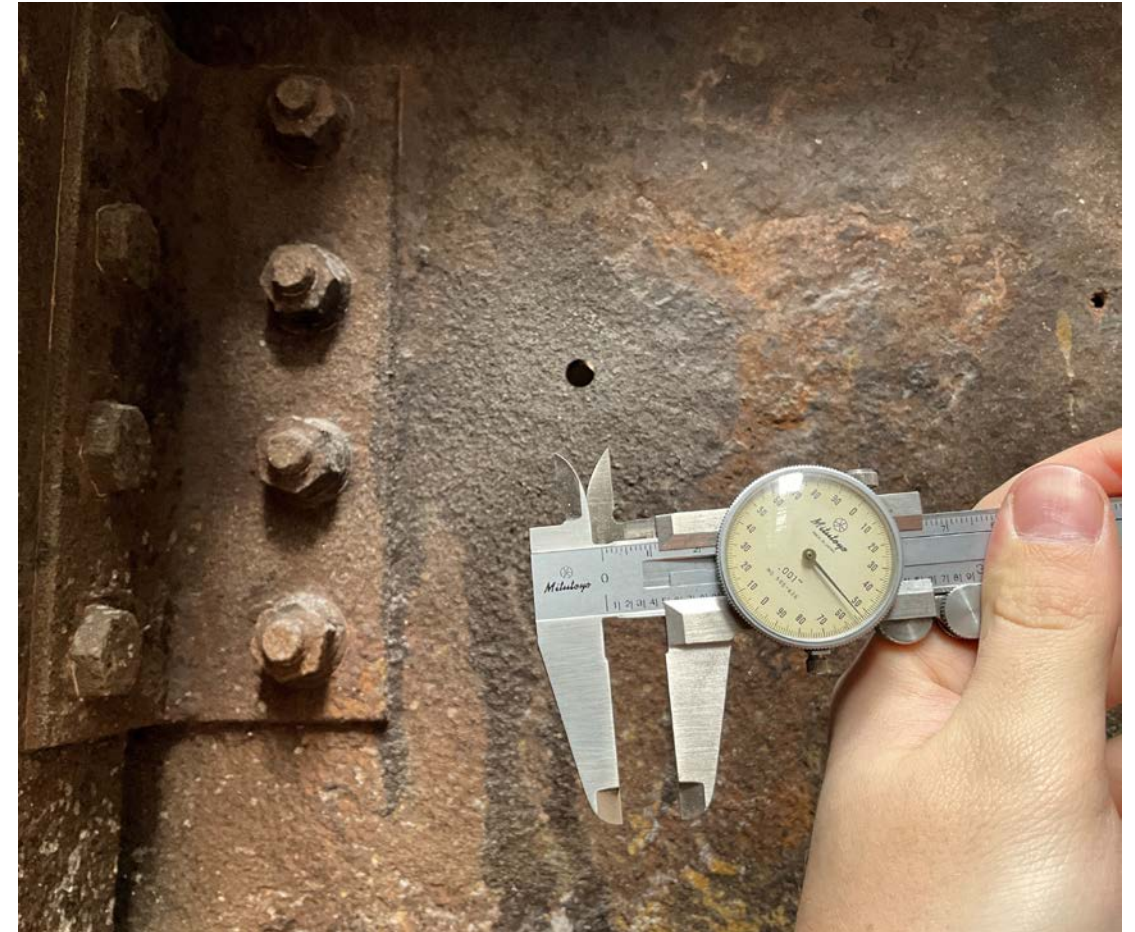
Calipers for measuring thicknesses

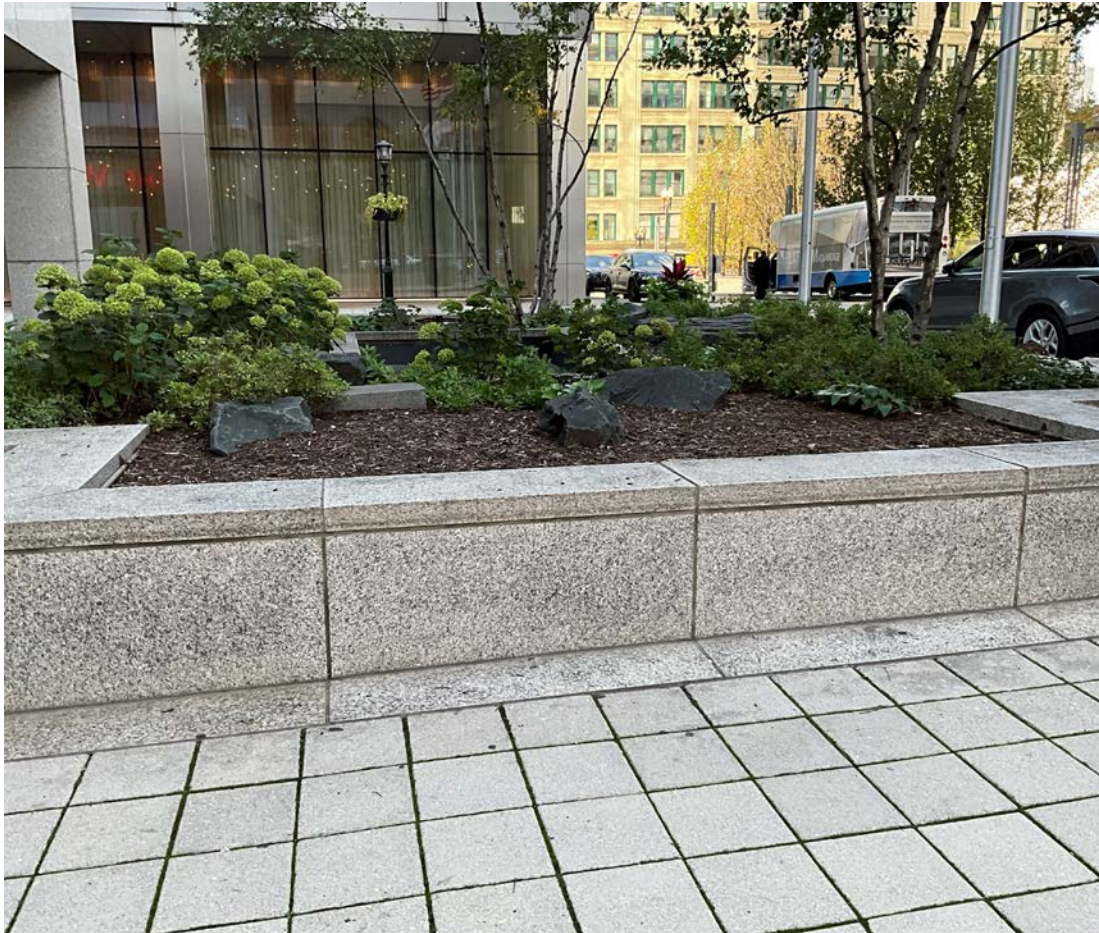
Planter clad with granite
