➤ Holistic Repair Strategy Wando River Viaduct

Mt. Pleasant, SC

Evaluation, design and implementation of a holistic repair strategy to extend the service life of the post-tensioned I-526 Wando River Viaduct

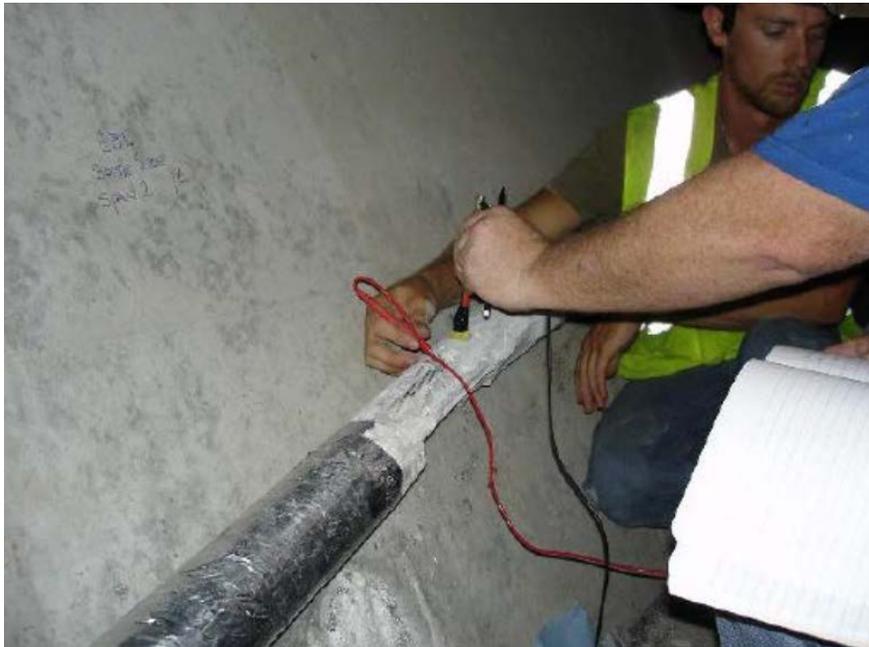
Table 4.2-2. Corrosion potential measurements.

- Corrosion Potential

No corrosion activity.
 Corrosion activity is uncertain.
 Active corrosion.

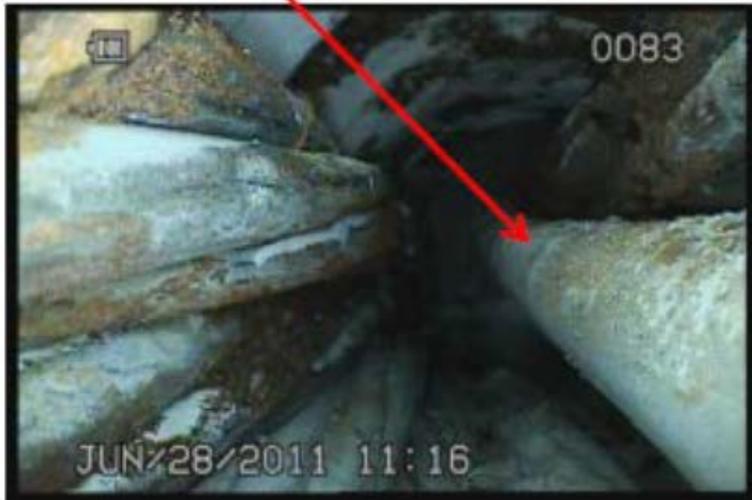
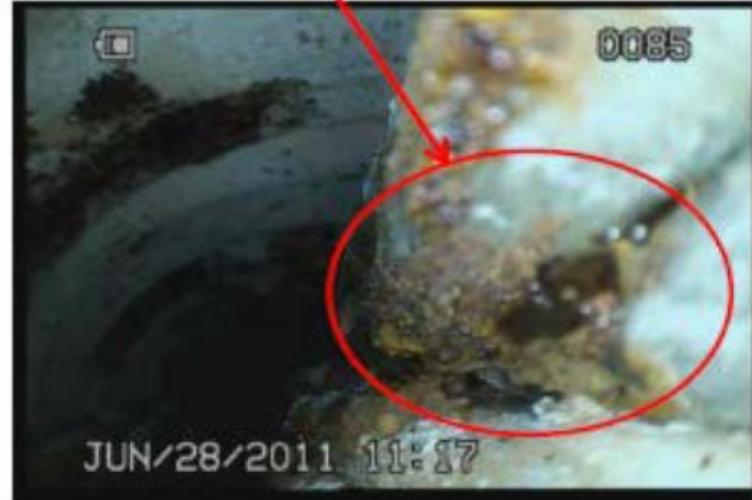
Examples of corrosion products oozing out of crevices between individual wires.

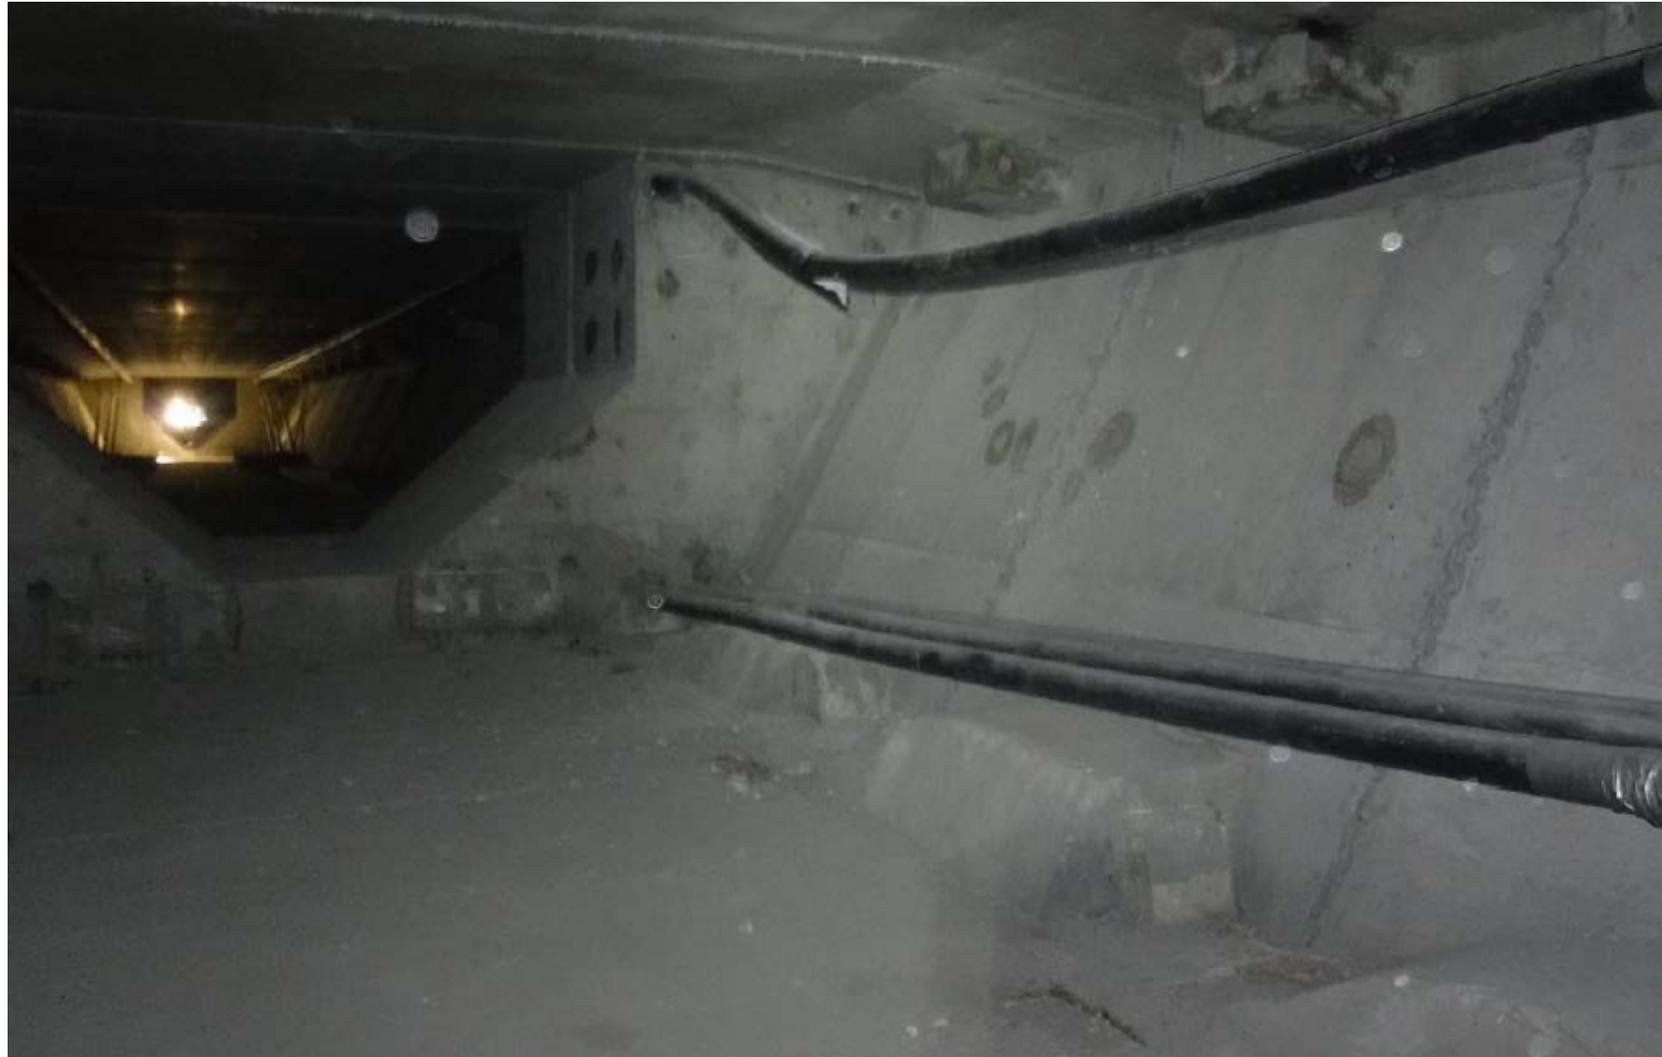
- M1 = Main Span; Continuous between Piers 24-29
- External Tendon 1,010 ft in length
- 19 stand tendon
- Tendon removed and replacement installed
- Supplemental tendon installed

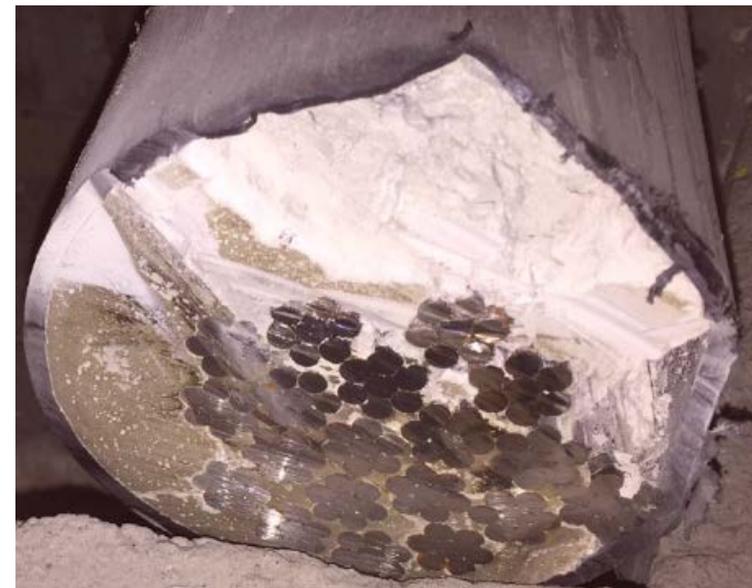
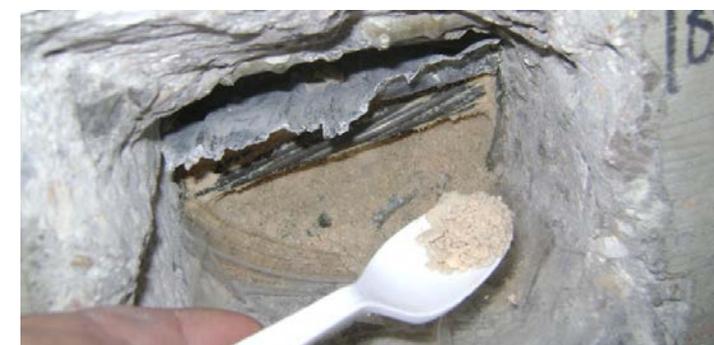
➤ Grout Segregation

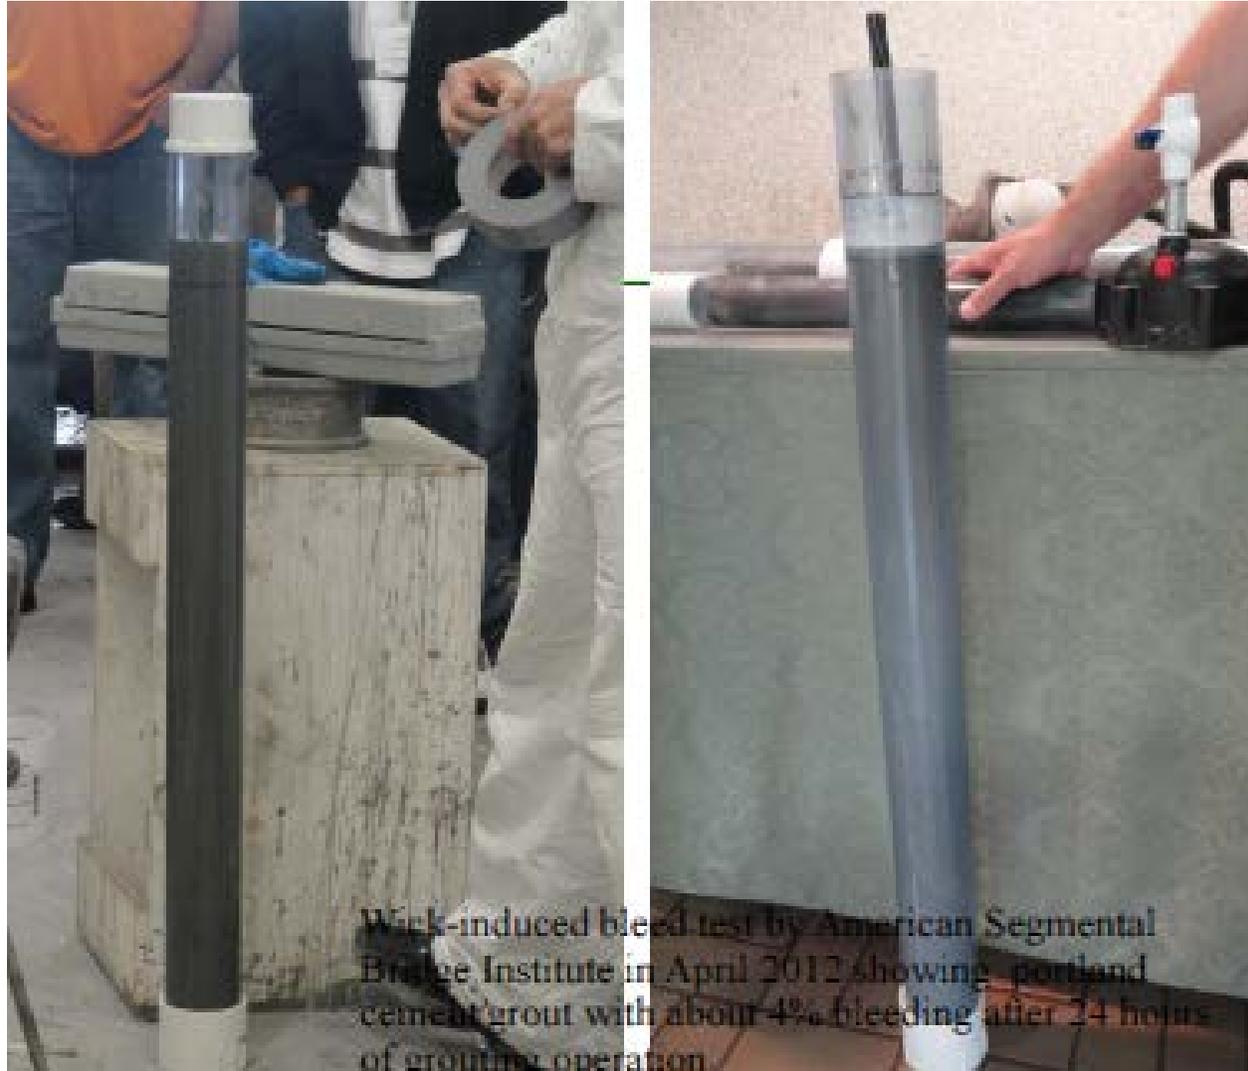
➤ Bleed Water Separation 4%

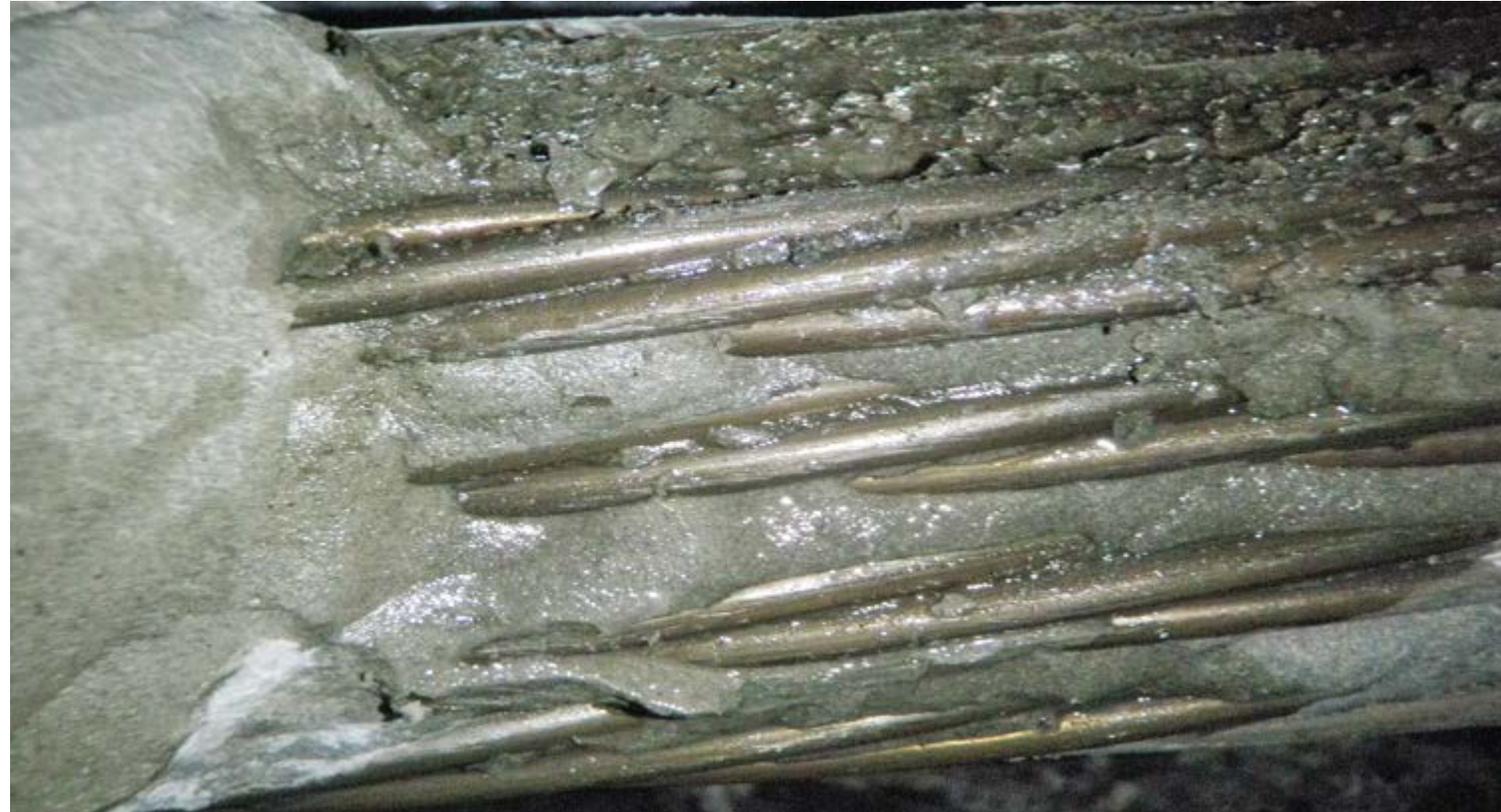
Grout Saturated
